# IndianOil

## JOURNEY RISK MANAGEMENT (JRM) STUDY

### Salem Terminal to ROHINI AGENCIES

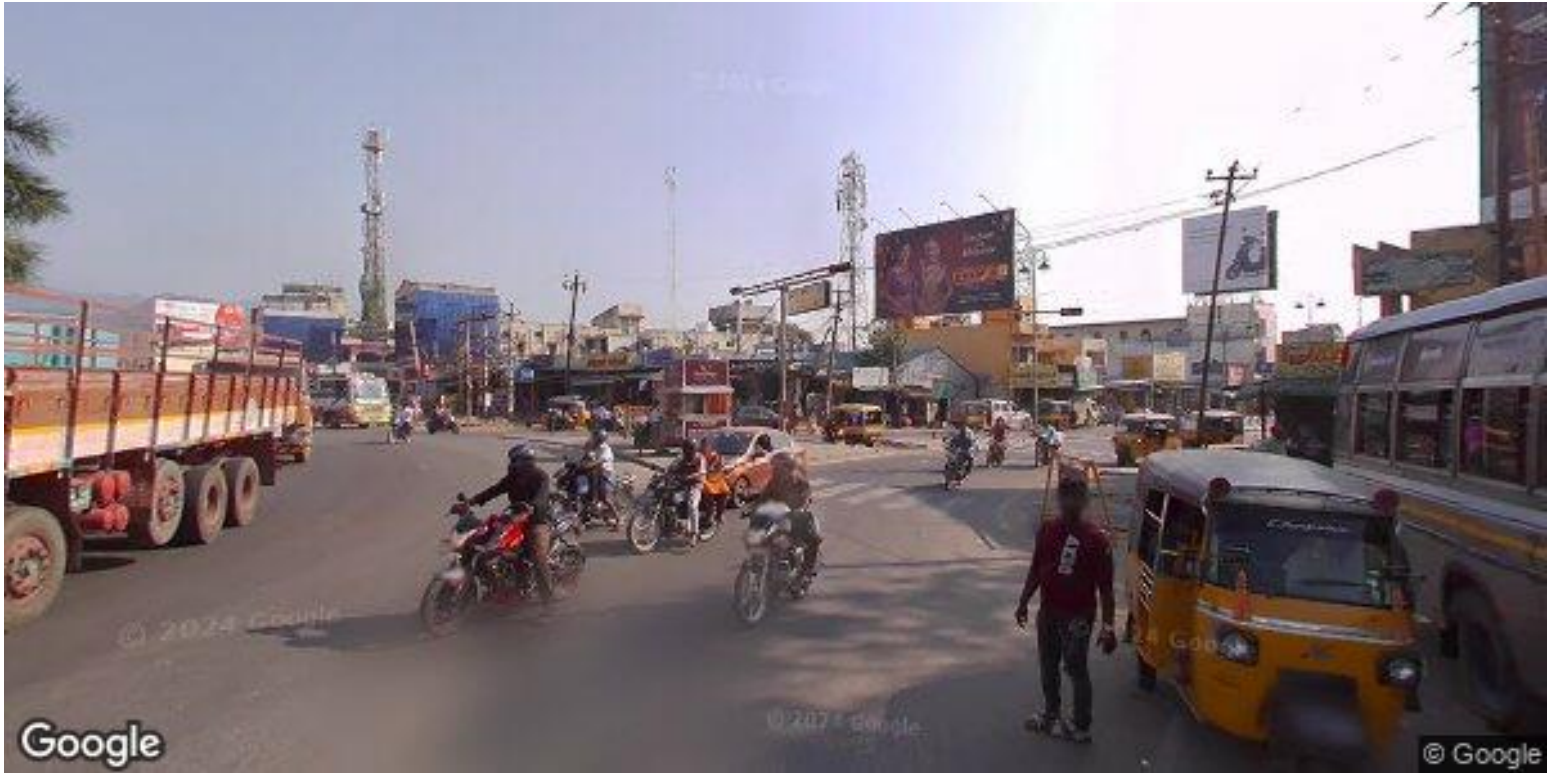
Risk Type: Roundabout  
Risk Level: High  
Speed Limit: 15 KM/Hr  
Coordinates: 11.63266, 78.12699

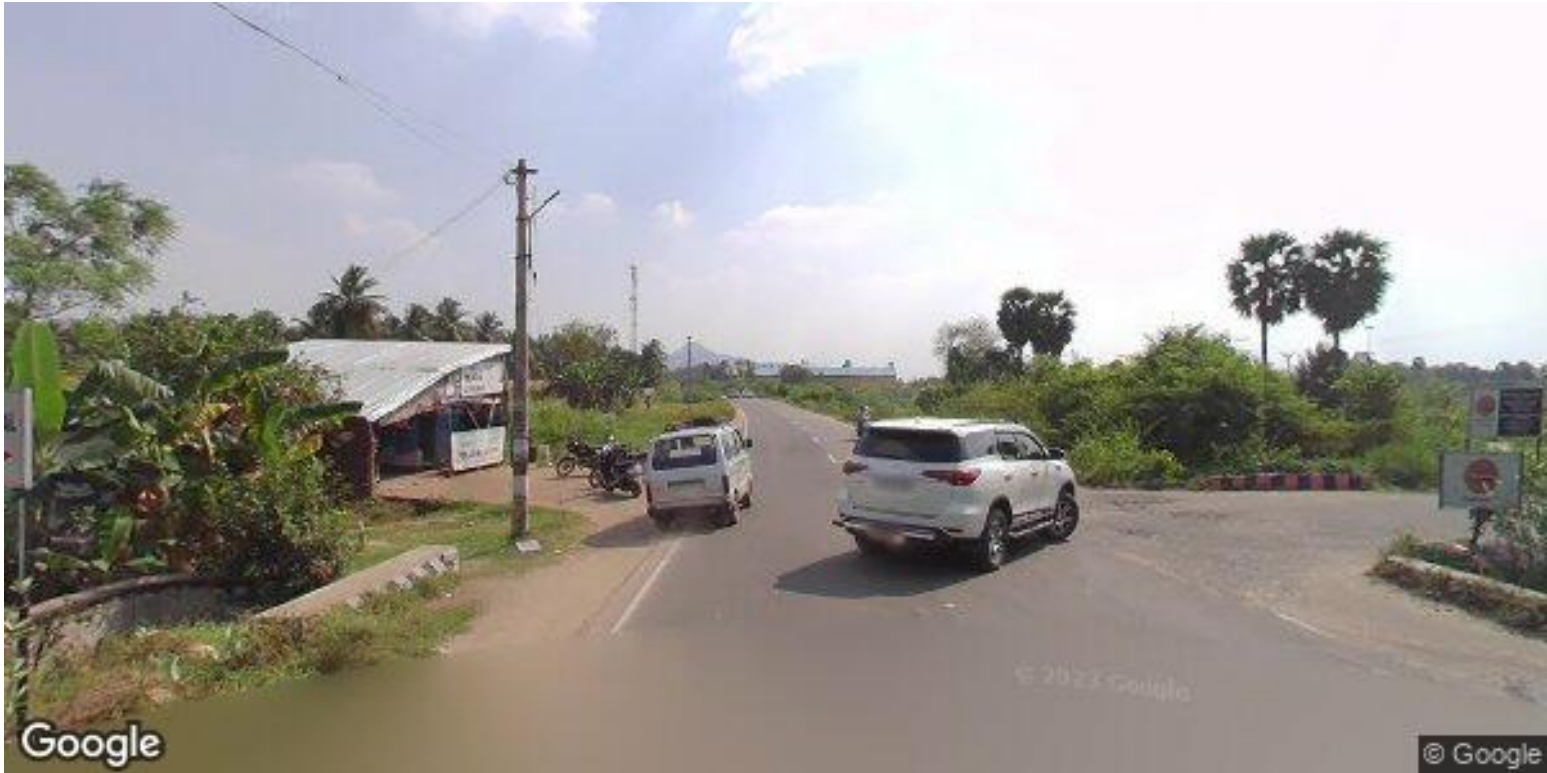
Risk Type: Turn  
Risk Level: High

**Speed Limit: 15 KM/Hr**  
**Coordinates: 11.44029, 77.87544**

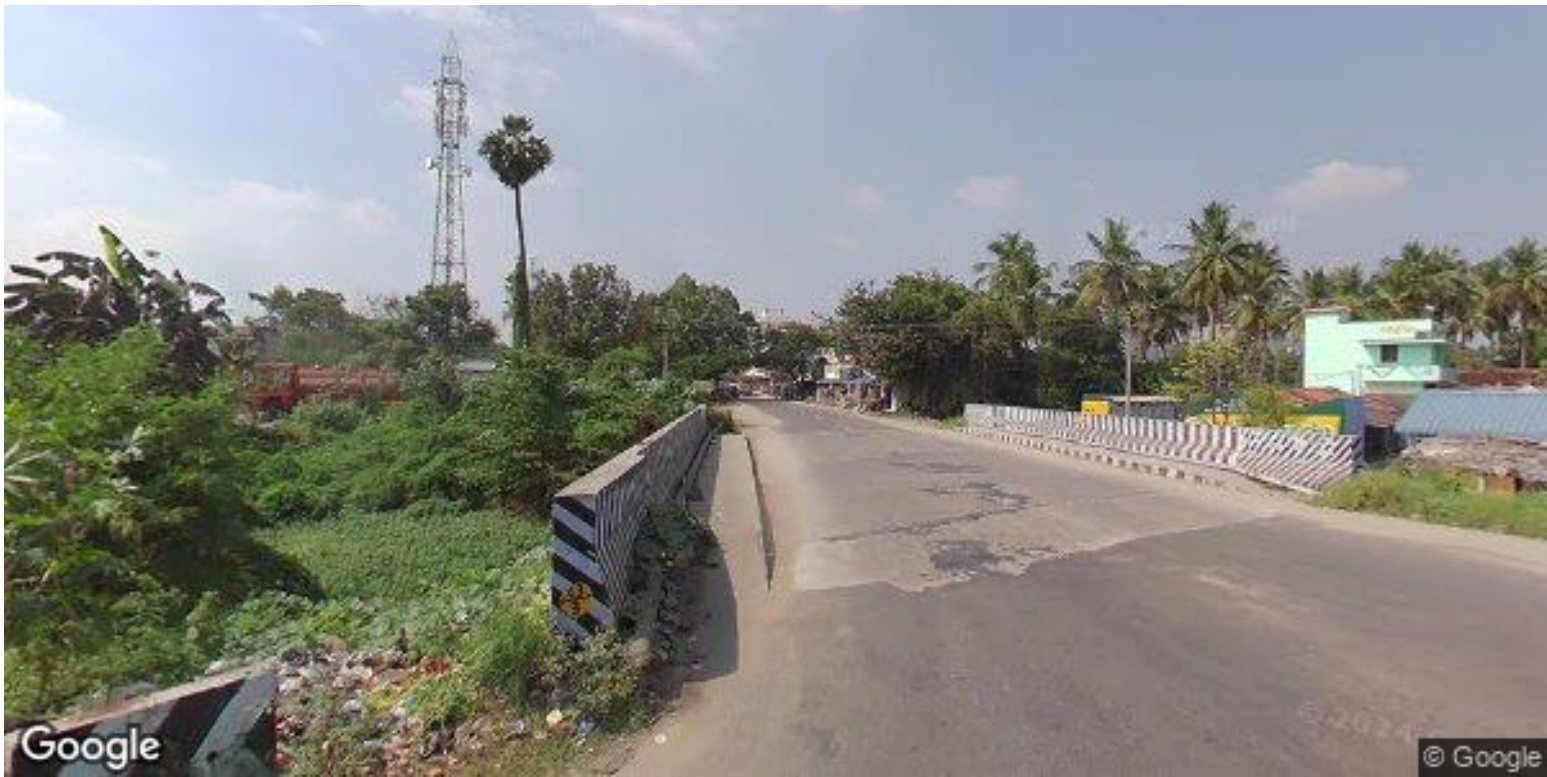
**Risk Type: Turn**  
**Risk Level: Medium**  
**Speed Limit: 30 KM/Hr**  
**Coordinates: 11.44900, 77.87406**

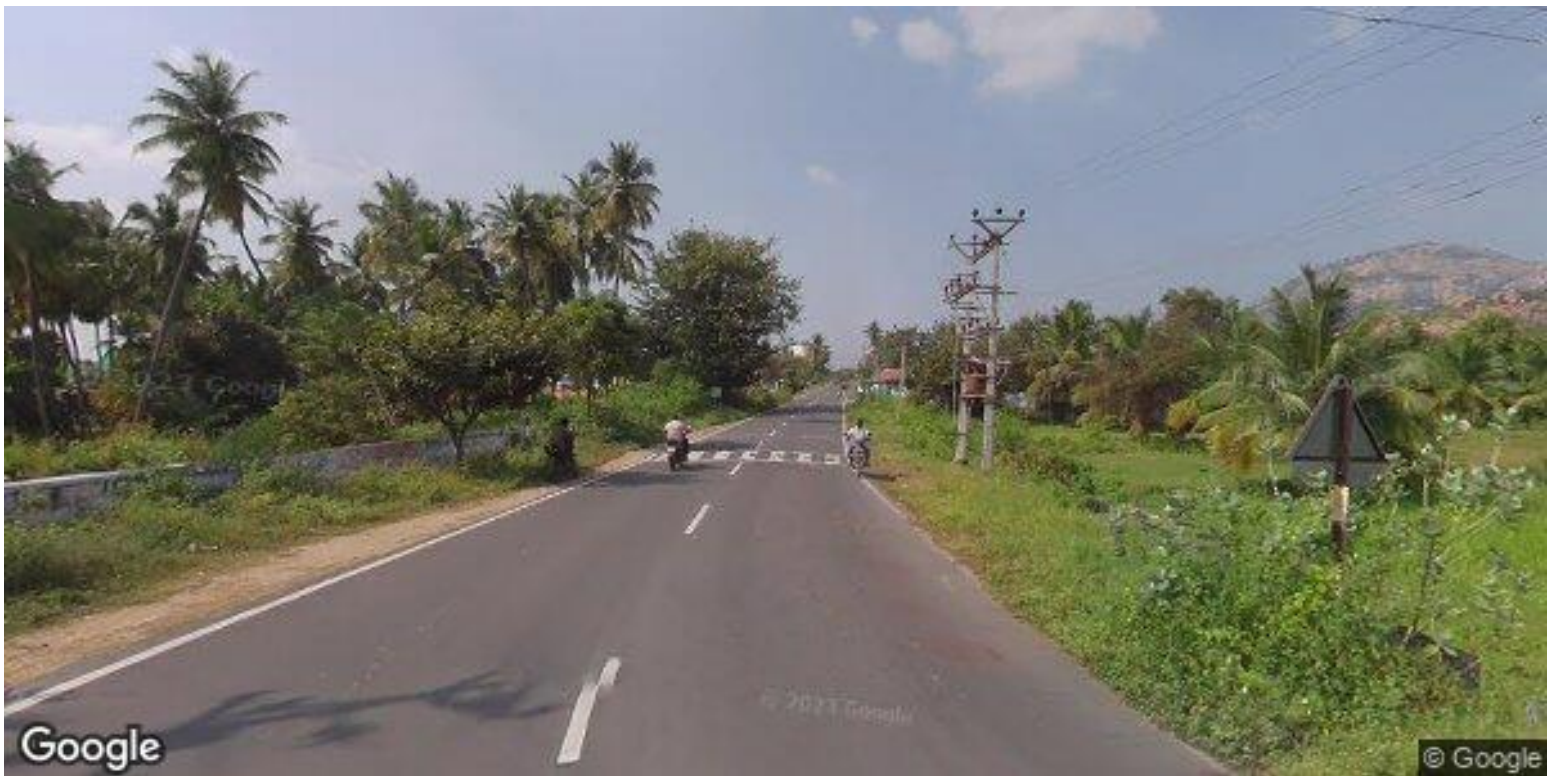
**Risk Type: Turn**  
**Risk Level: High**  
**Speed Limit: 15 KM/Hr**  
**Coordinates: 11.45352, 77.85698**

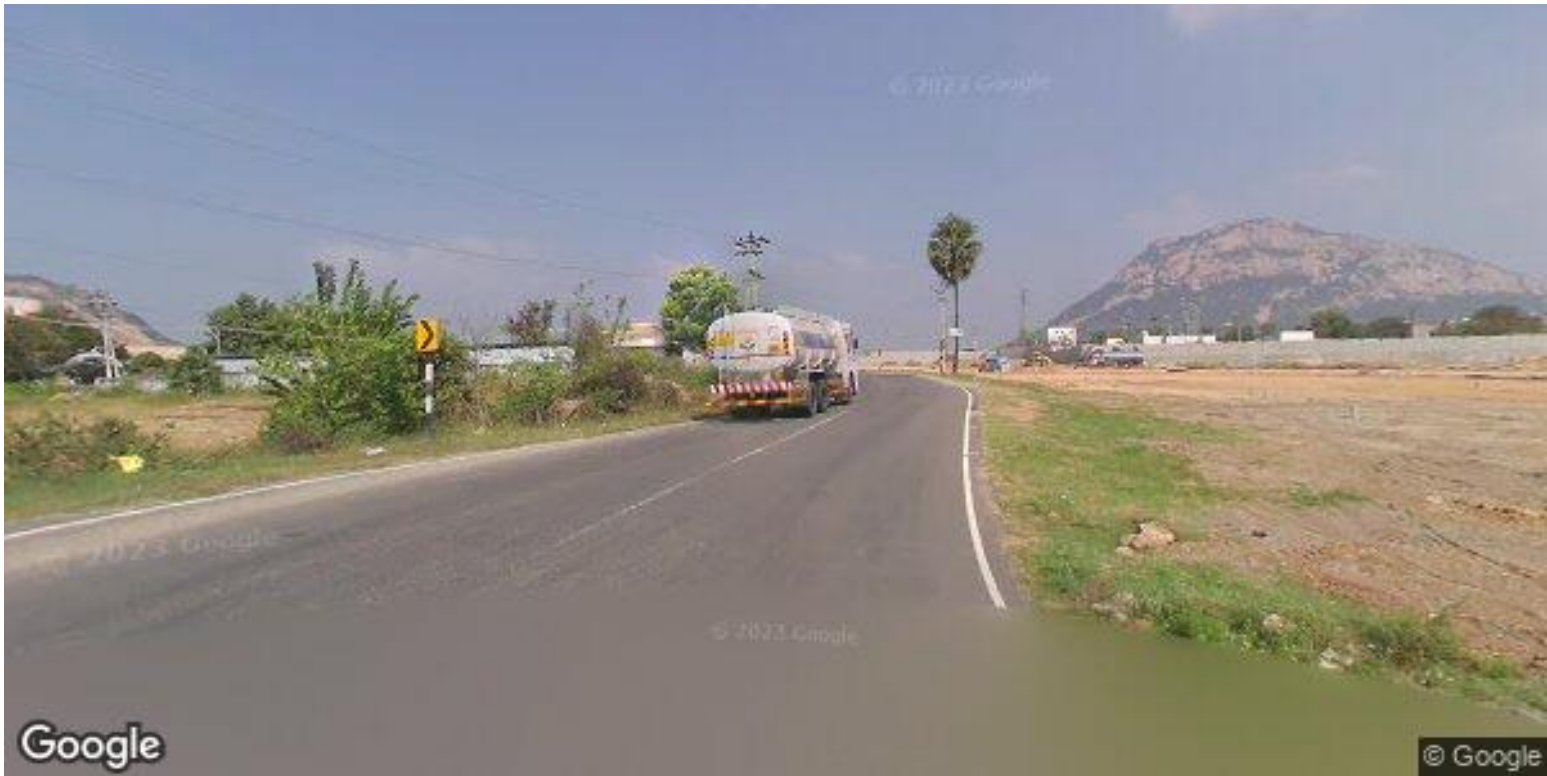
**Risk Type:** Turn  
**Risk Level:** Medium  
**Speed Limit:** 30 KM/Hr  
**Coordinates:** 11.45847, 77.85140

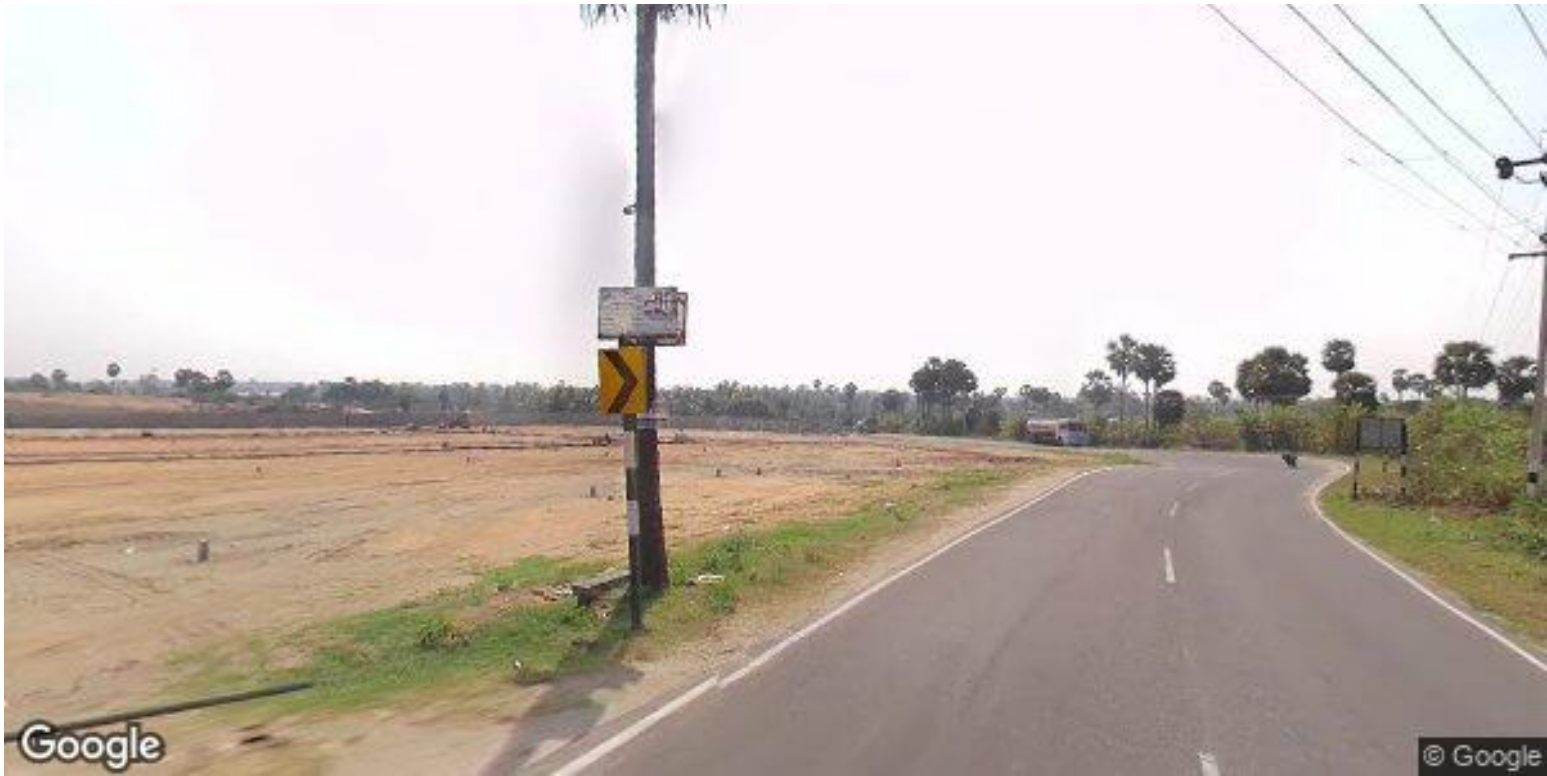
**Risk Type:** Turn  
**Risk Level:** Medium  
**Speed Limit:** 30 KM/Hr  
**Coordinates:** 11.45898, 77.85135

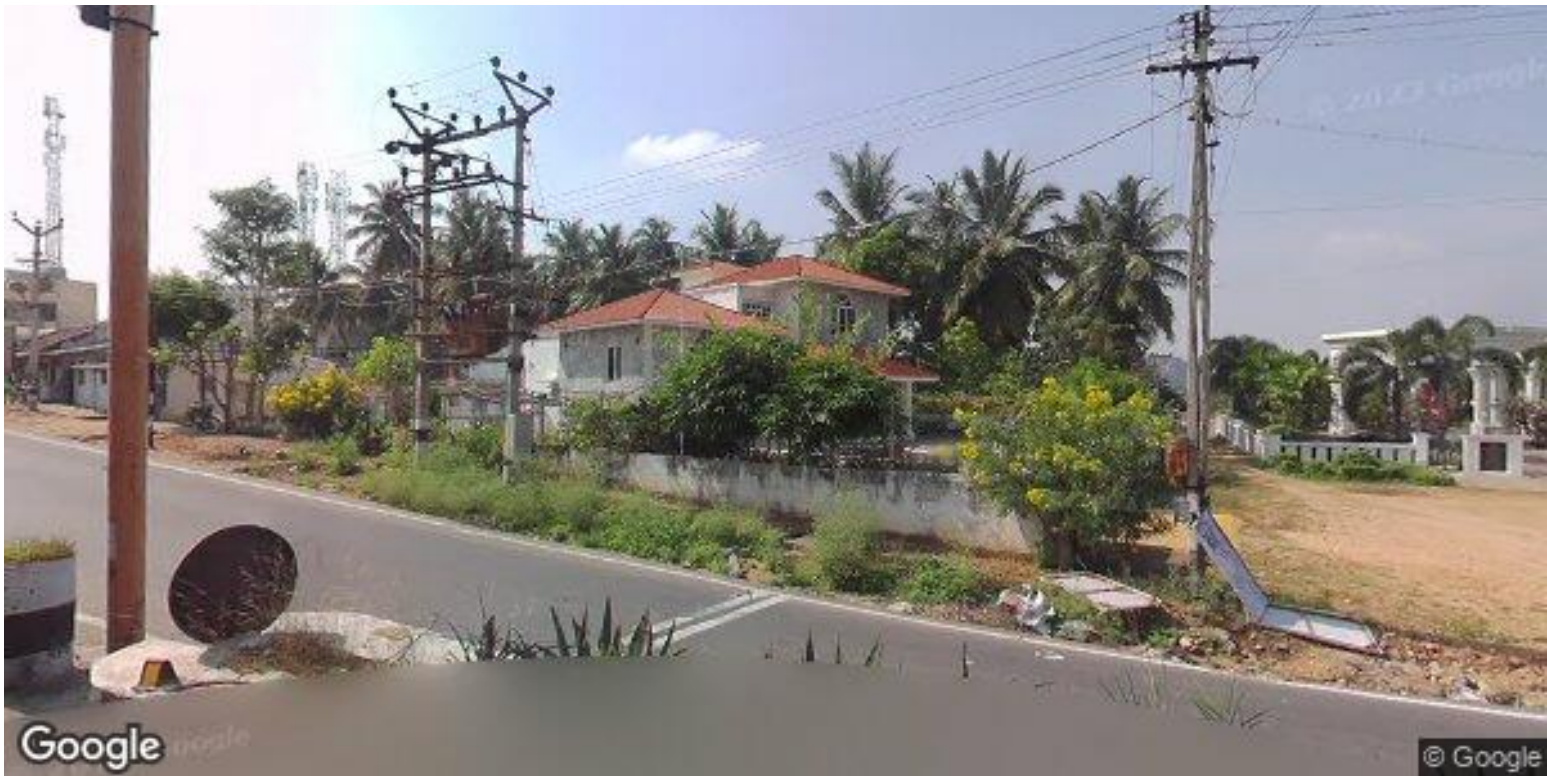
**Risk Type:** Turn  
**Risk Level:** High  
**Speed Limit:** 15 KM/Hr  
**Coordinates:** 11.46303, 77.84945

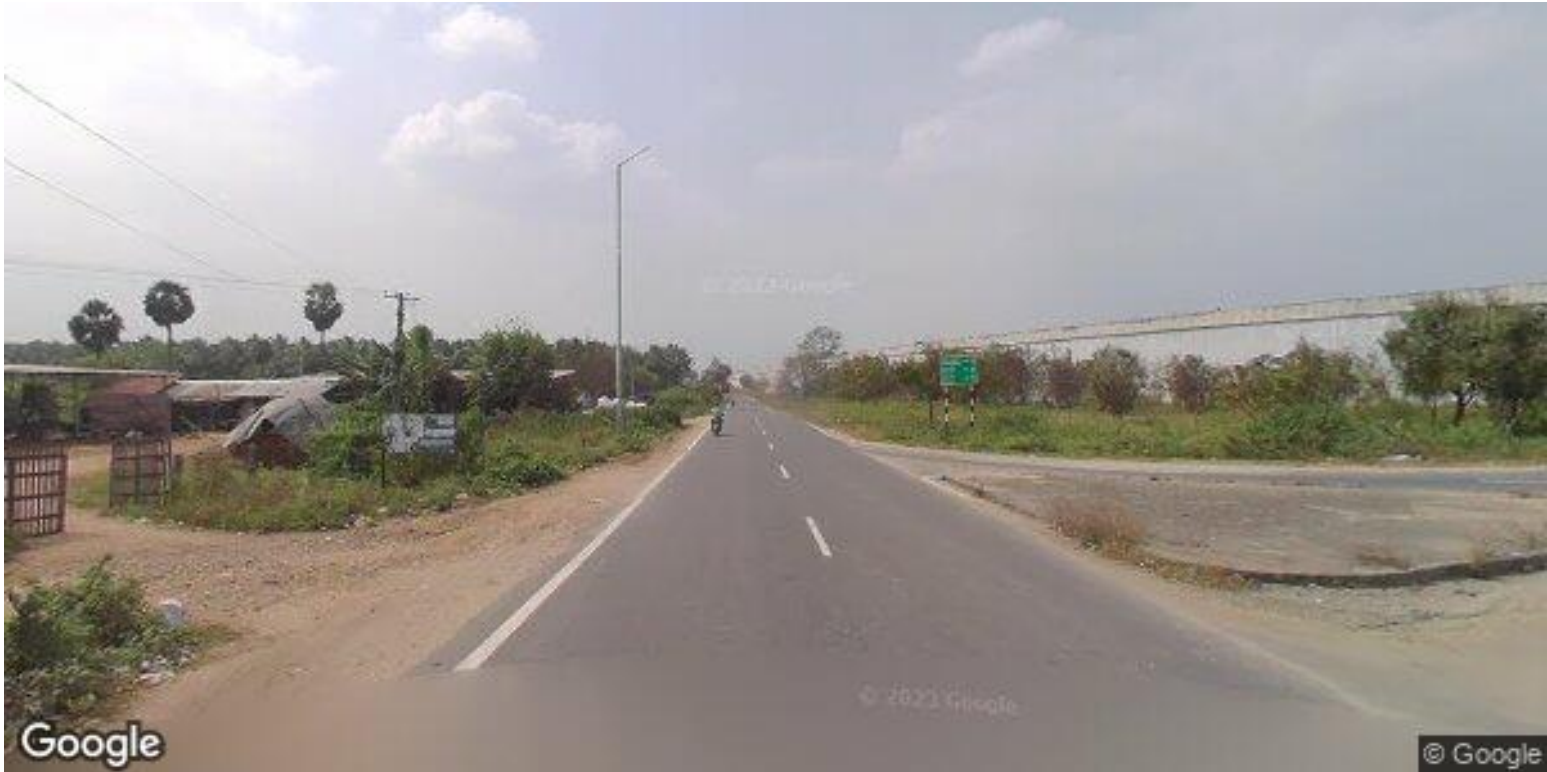
**Risk Type:** Turn  
**Risk Level:** High  
**Speed Limit:** 15 KM/Hr  
**Coordinates:** 11.45542, 77.81725

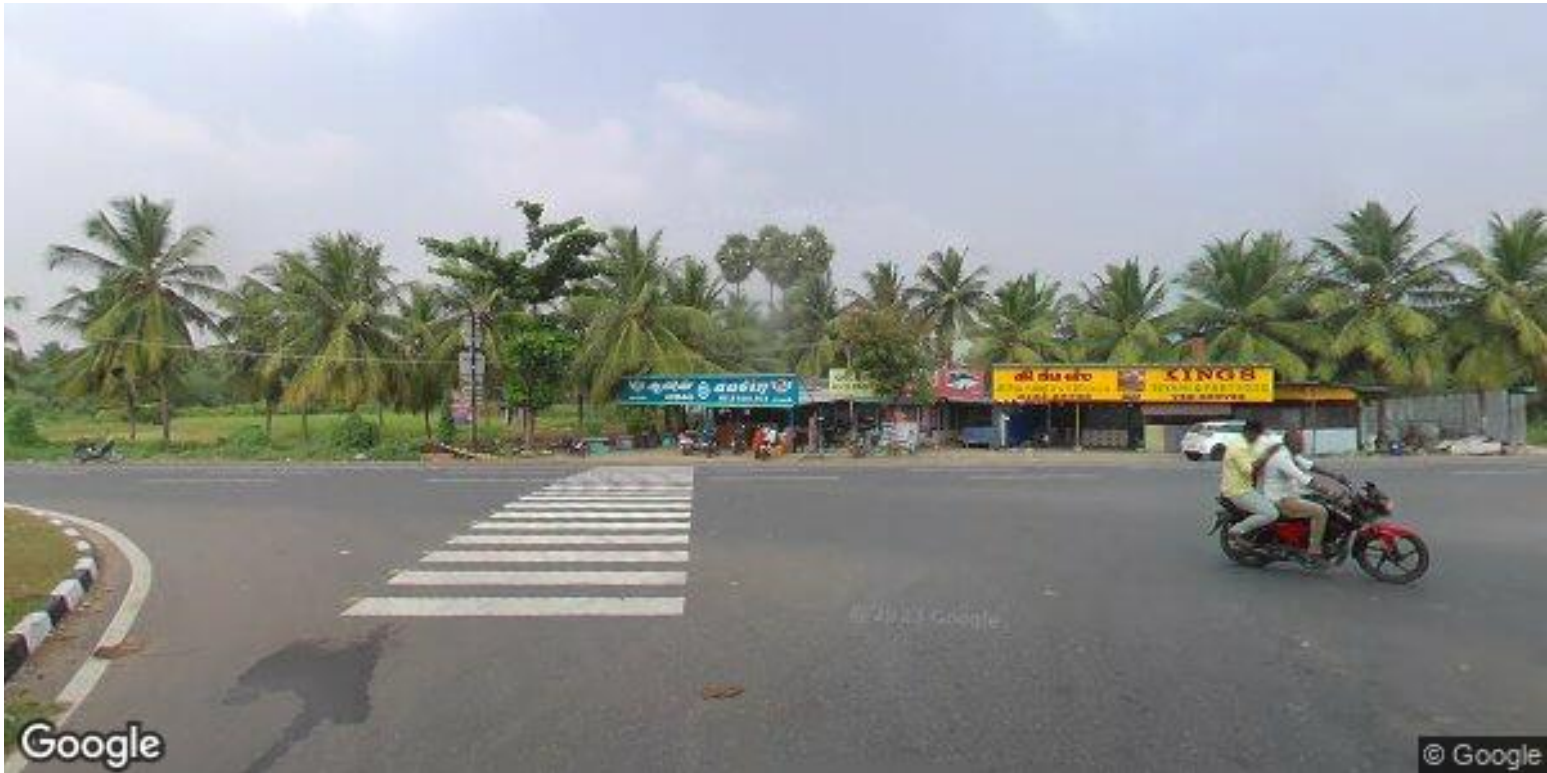
**Risk Type:** Turn  
**Risk Level:** High  
**Speed Limit:** 15 KM/Hr  
**Coordinates:** 11.45615, 77.81677

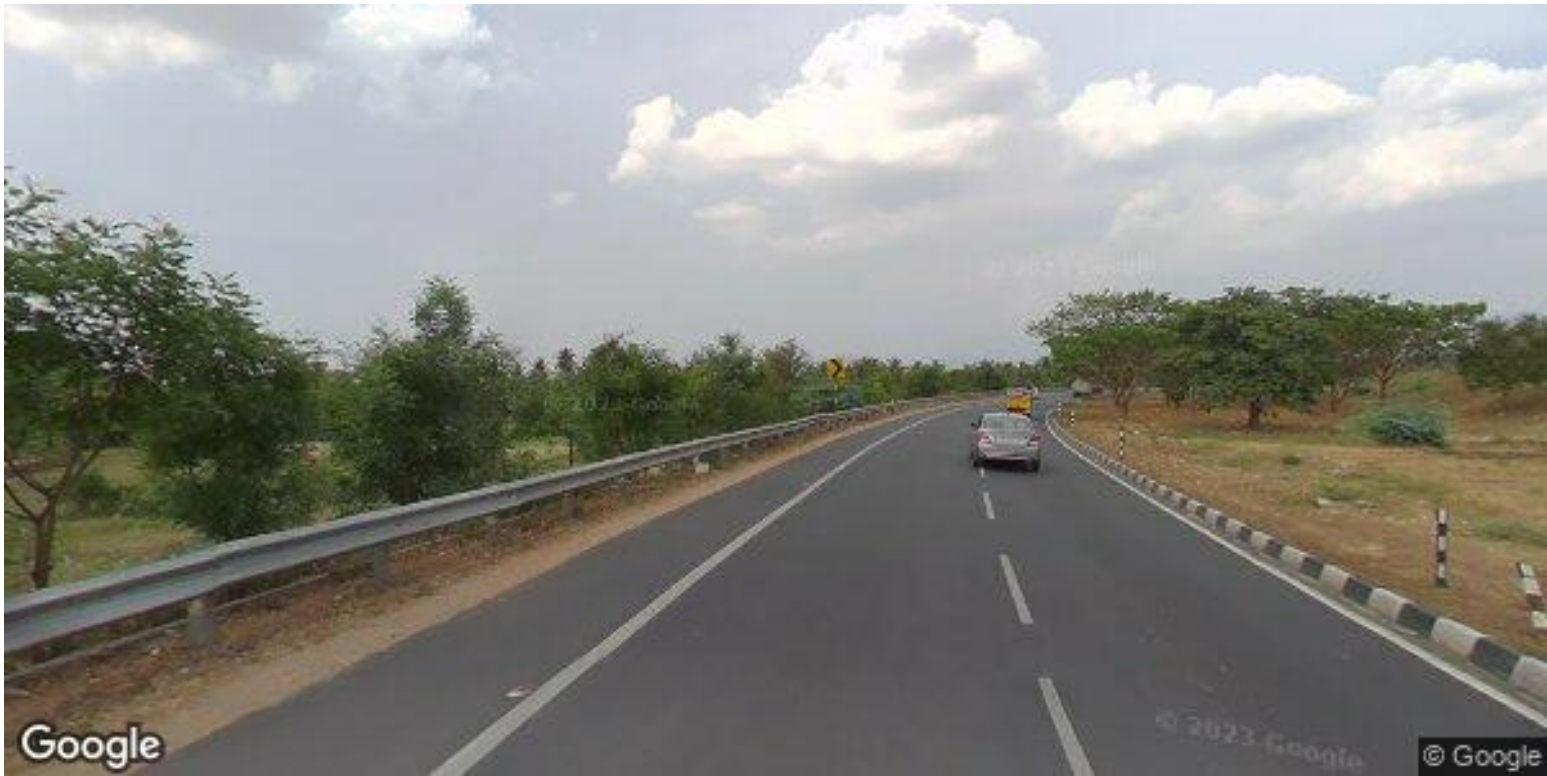
**Risk Type:** Turn  
**Risk Level:** Medium  
**Speed Limit:** 30 KM/Hr  
**Coordinates:** 11.53560, 77.95773

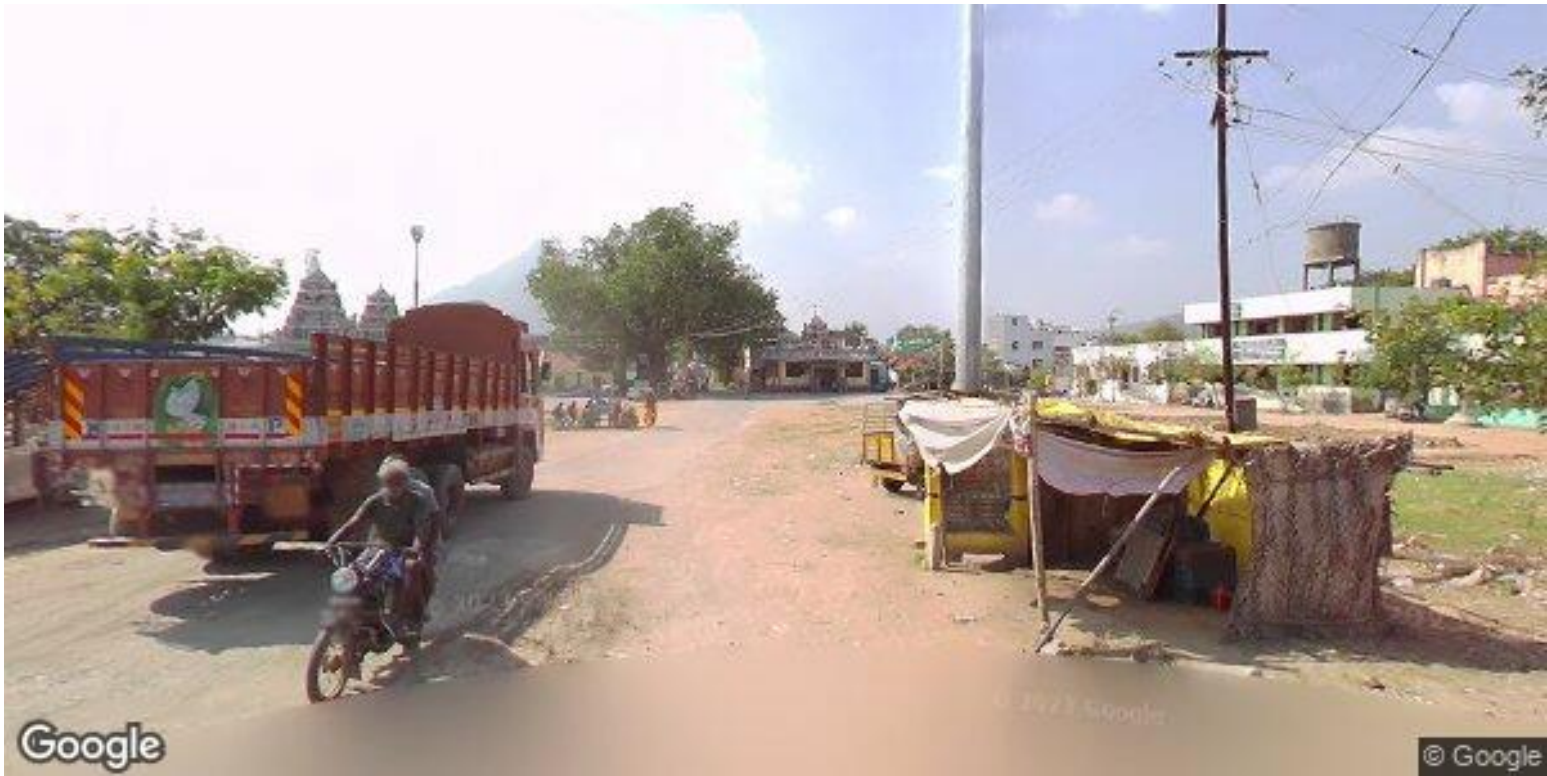
**Risk Type:** Blind Spot  
**Risk Level:** Blind Spot  
**Speed Limit:** 10 KM/Hr  
**Coordinates:** 11.62145, 78.10740

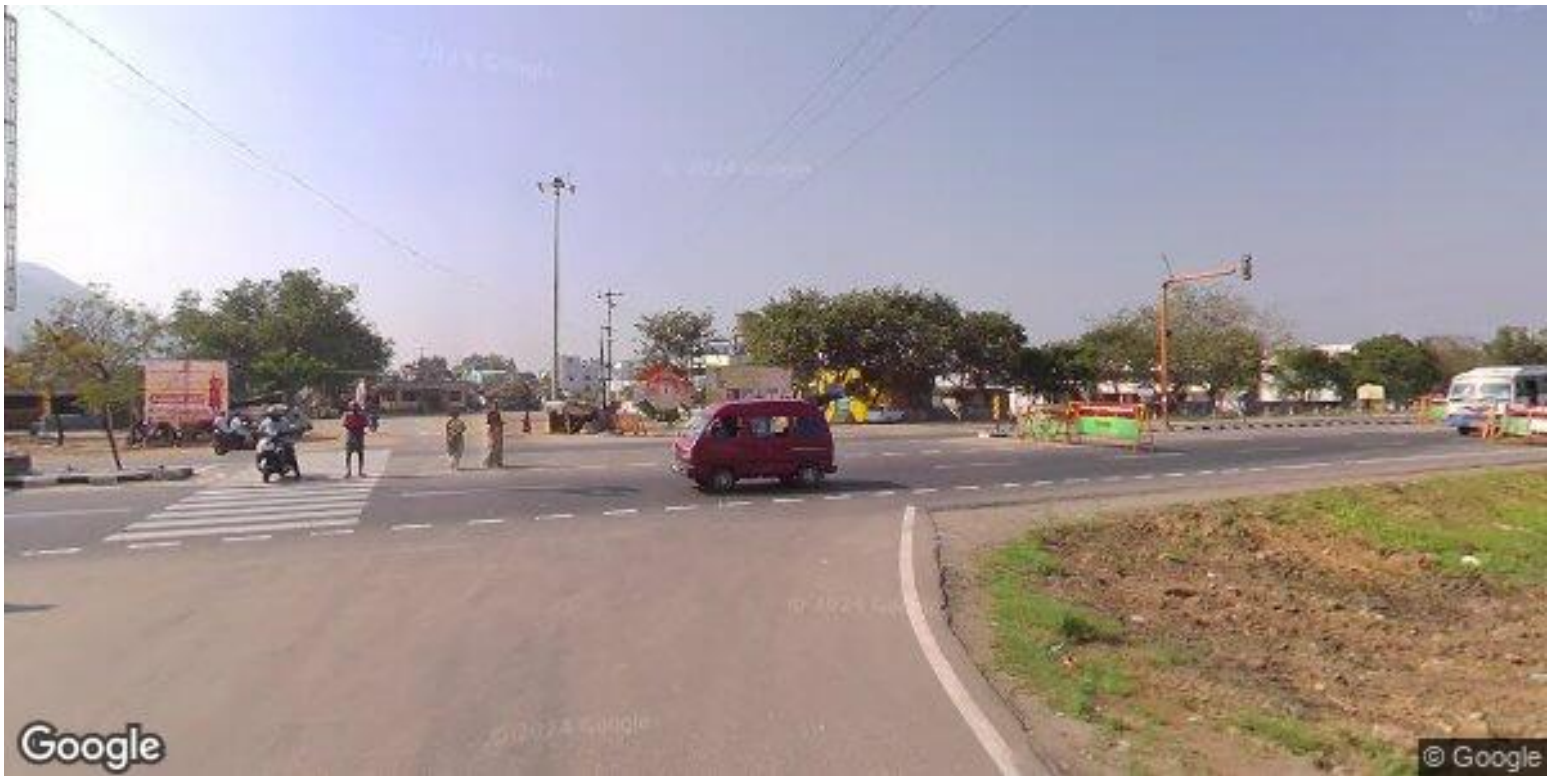
**Risk Type:** Turn  
**Risk Level:** High  
**Speed Limit:** 15 KM/Hr  
**Coordinates:** 11.62130, 78.10776

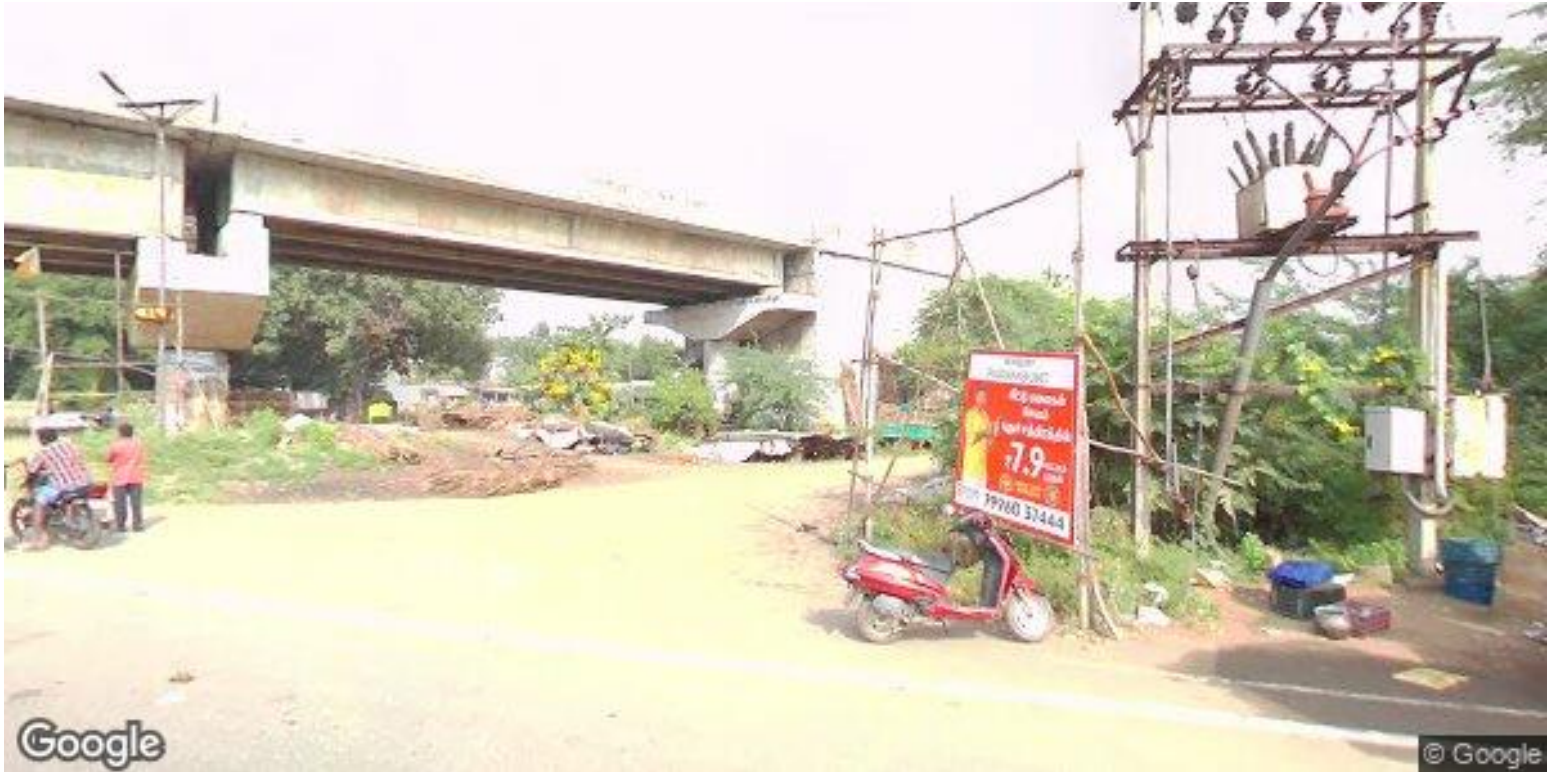
**Risk Type:** Blind Spot  
**Risk Level:** Blind Spot  
**Speed Limit:** 10 KM/Hr  
**Coordinates:** 11.61235, 78.10438

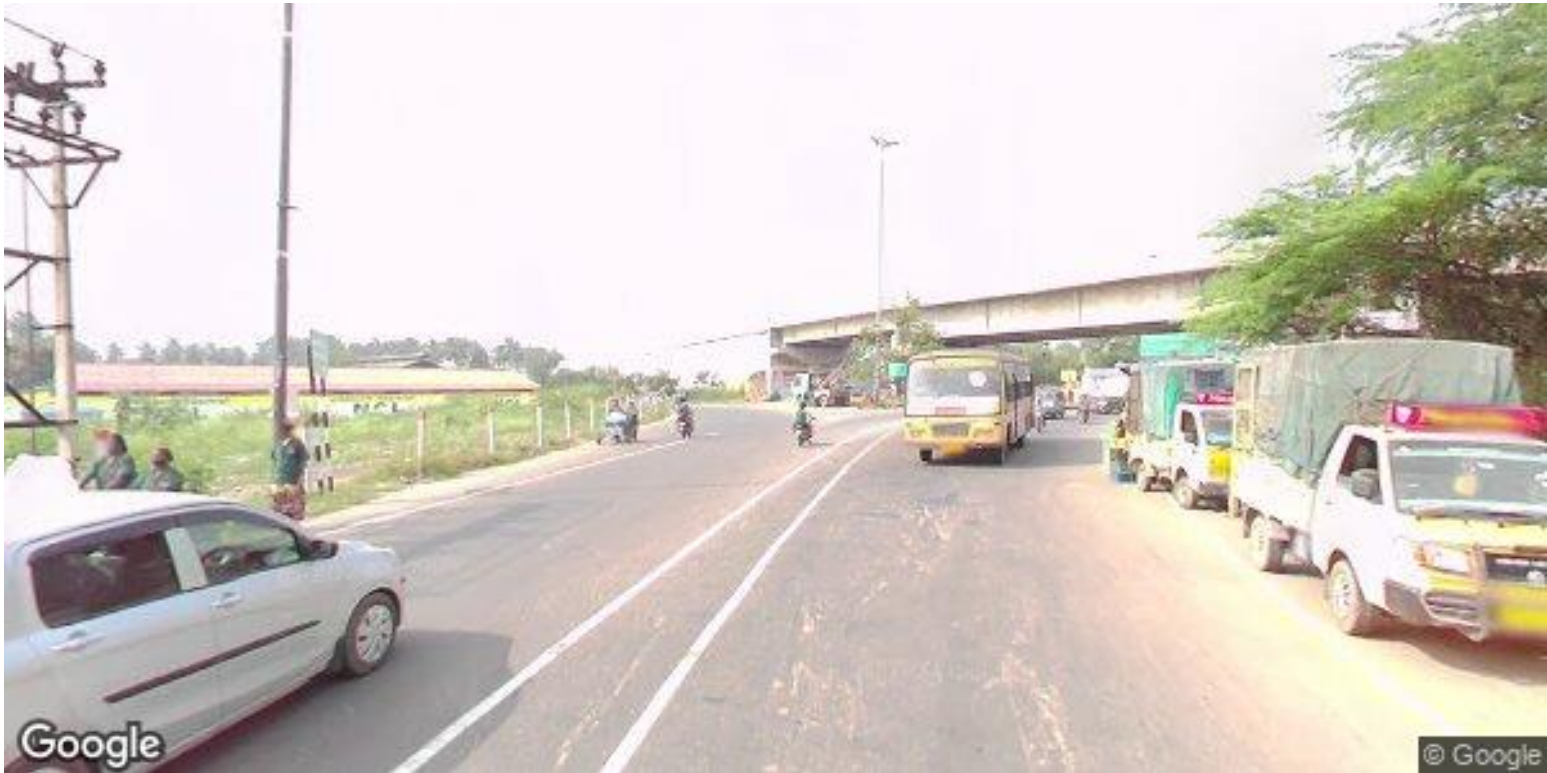
**Risk Type:** Turn  
**Risk Level:** Medium  
**Speed Limit:** 30 KM/Hr  
**Coordinates:** 11.61224, 78.10469

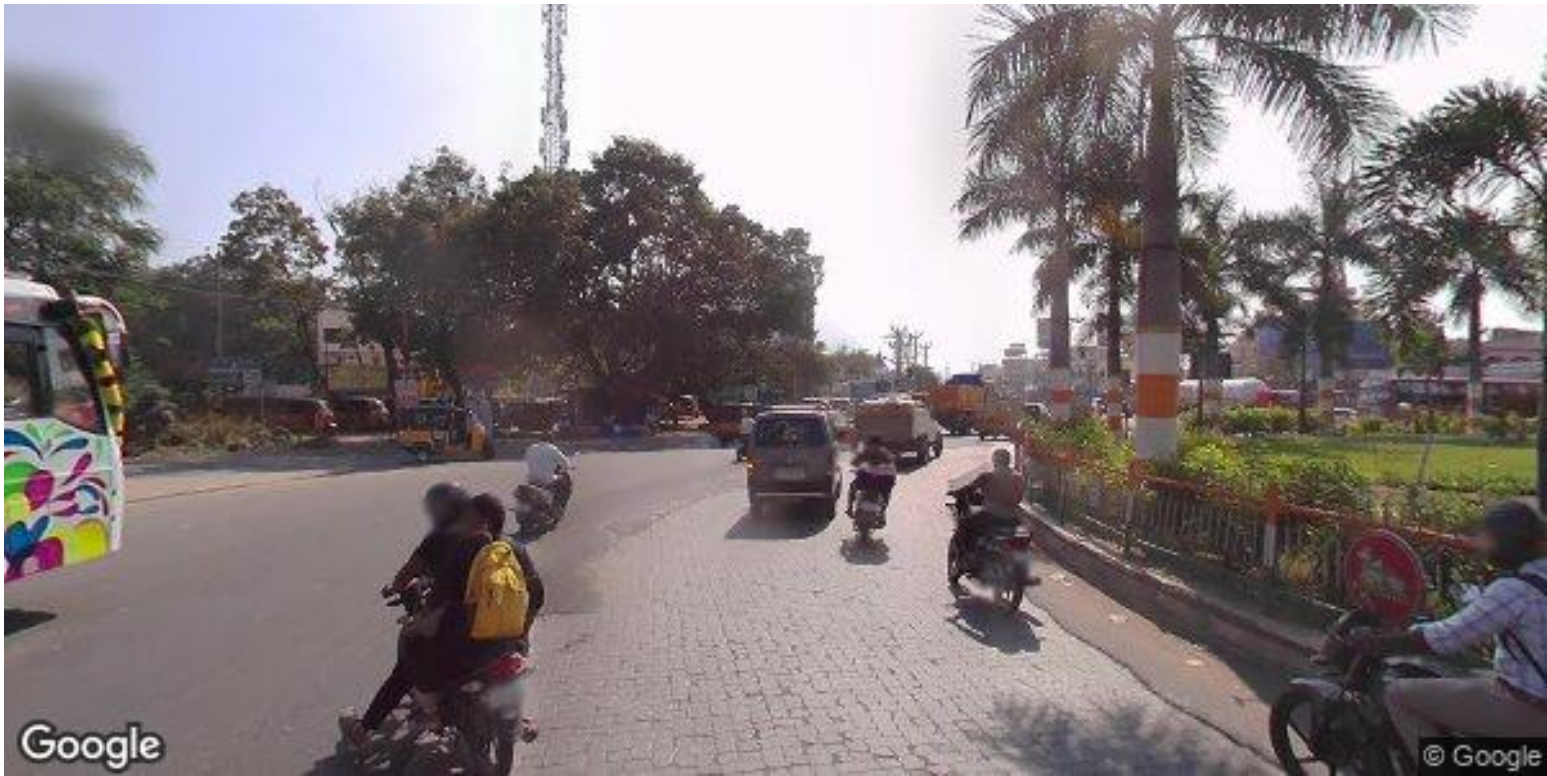
**Risk Type:** Turn  
**Risk Level:** High  
**Speed Limit:** 15 KM/Hr  
**Coordinates:** 11.63304, 78.12738

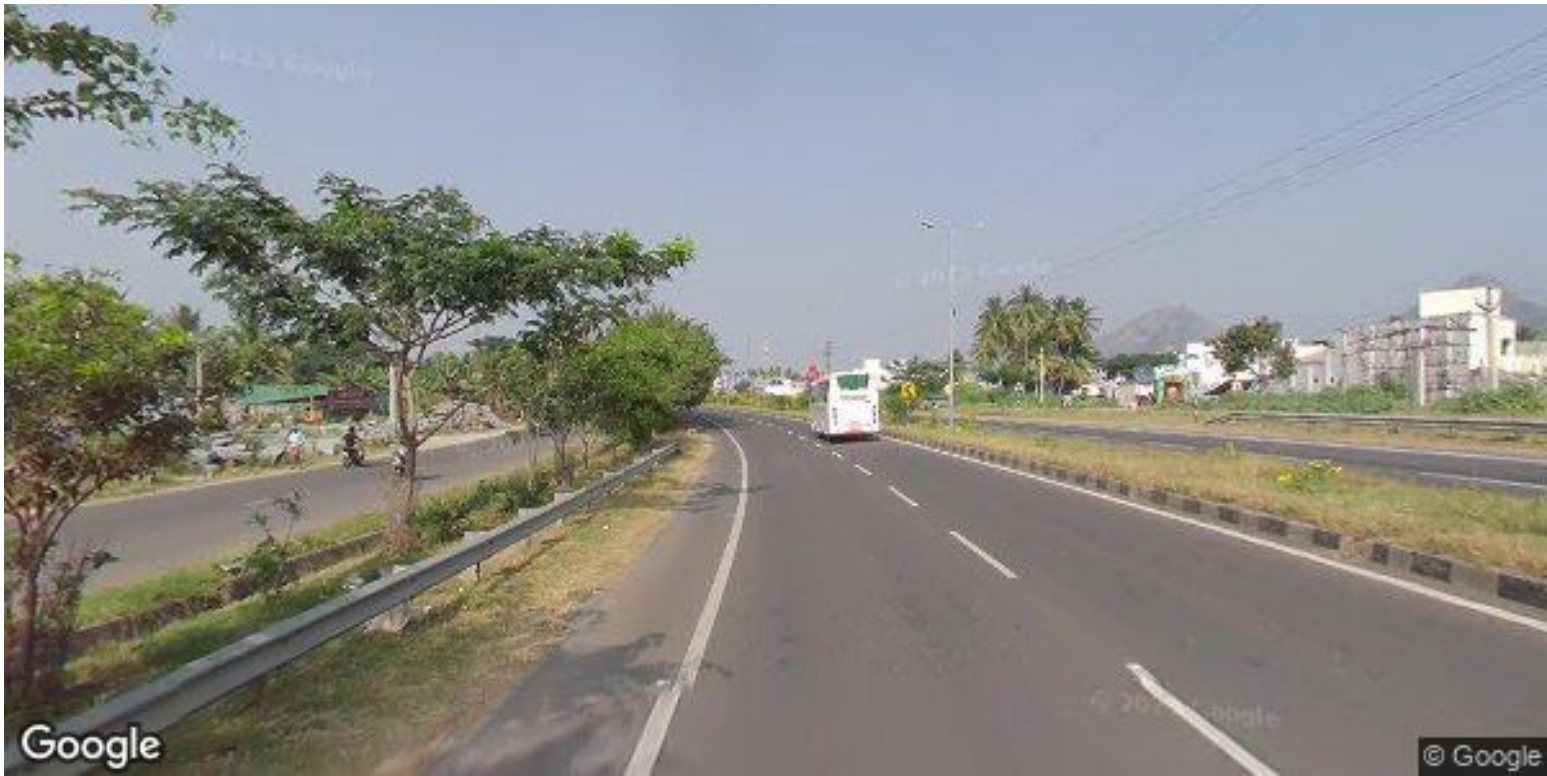
**Risk Type:** Turn  
**Risk Level:** Medium  
**Speed Limit:** 30 KM/Hr  
**Coordinates:** 11.62901, 78.16571

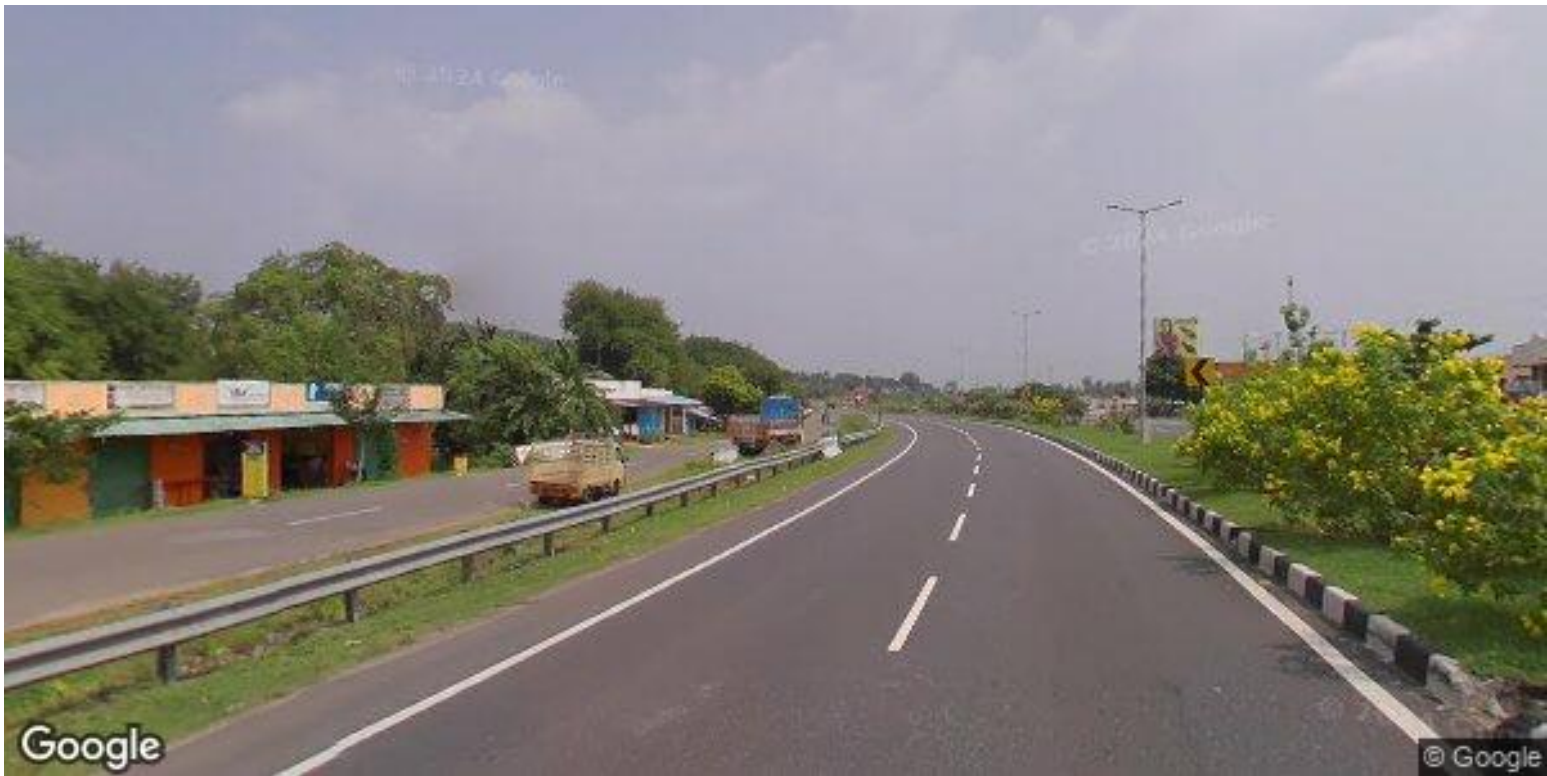
**Risk Type:** Turn  
**Risk Level:** Medium  
**Speed Limit:** 30 KM/Hr  
**Coordinates:** 11.65154, 78.35013

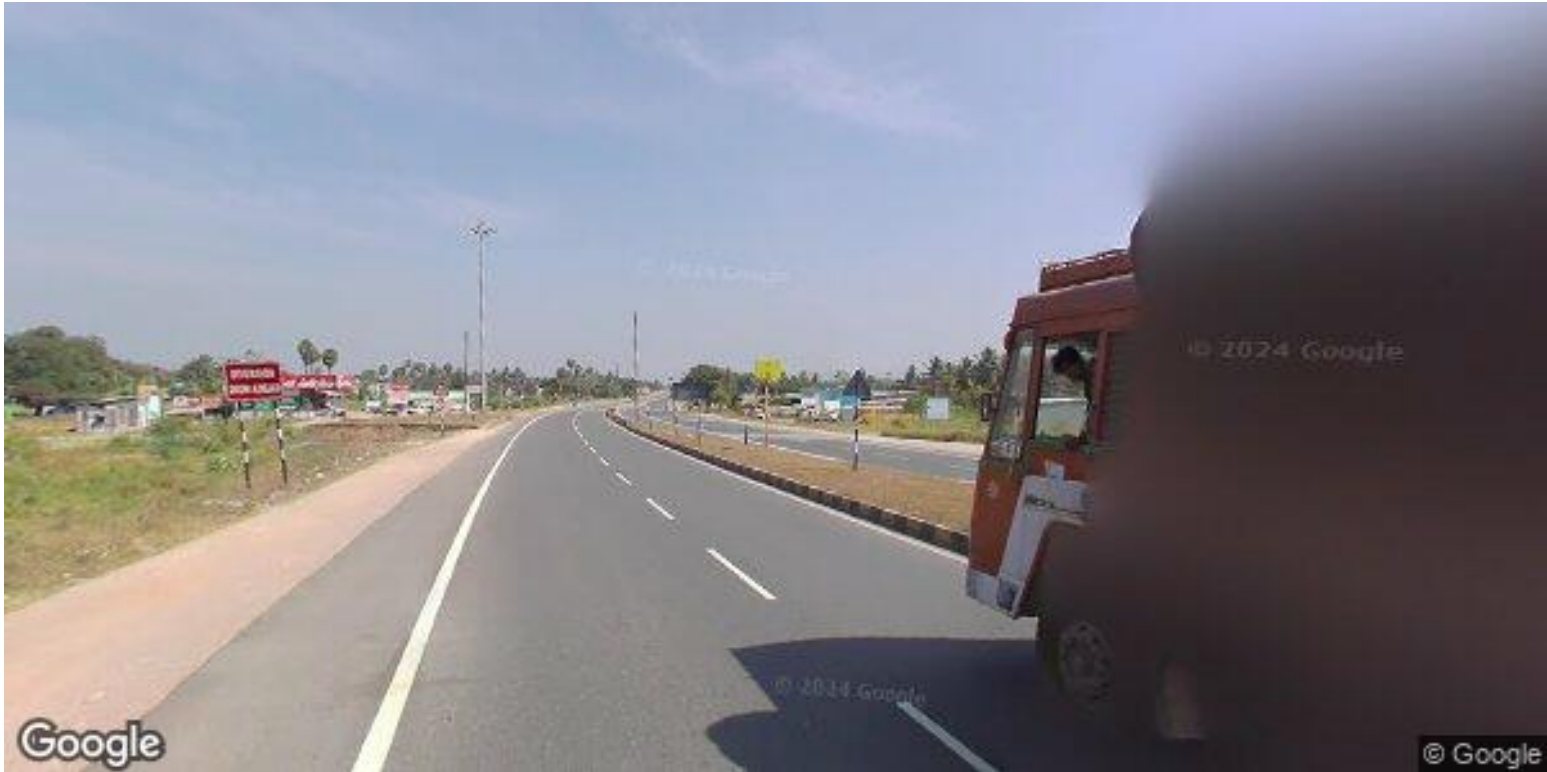
**Risk Type:** Turn  
**Risk Level:** Medium  
**Speed Limit:** 30 KM/Hr  
**Coordinates:** 11.65459, 78.37964

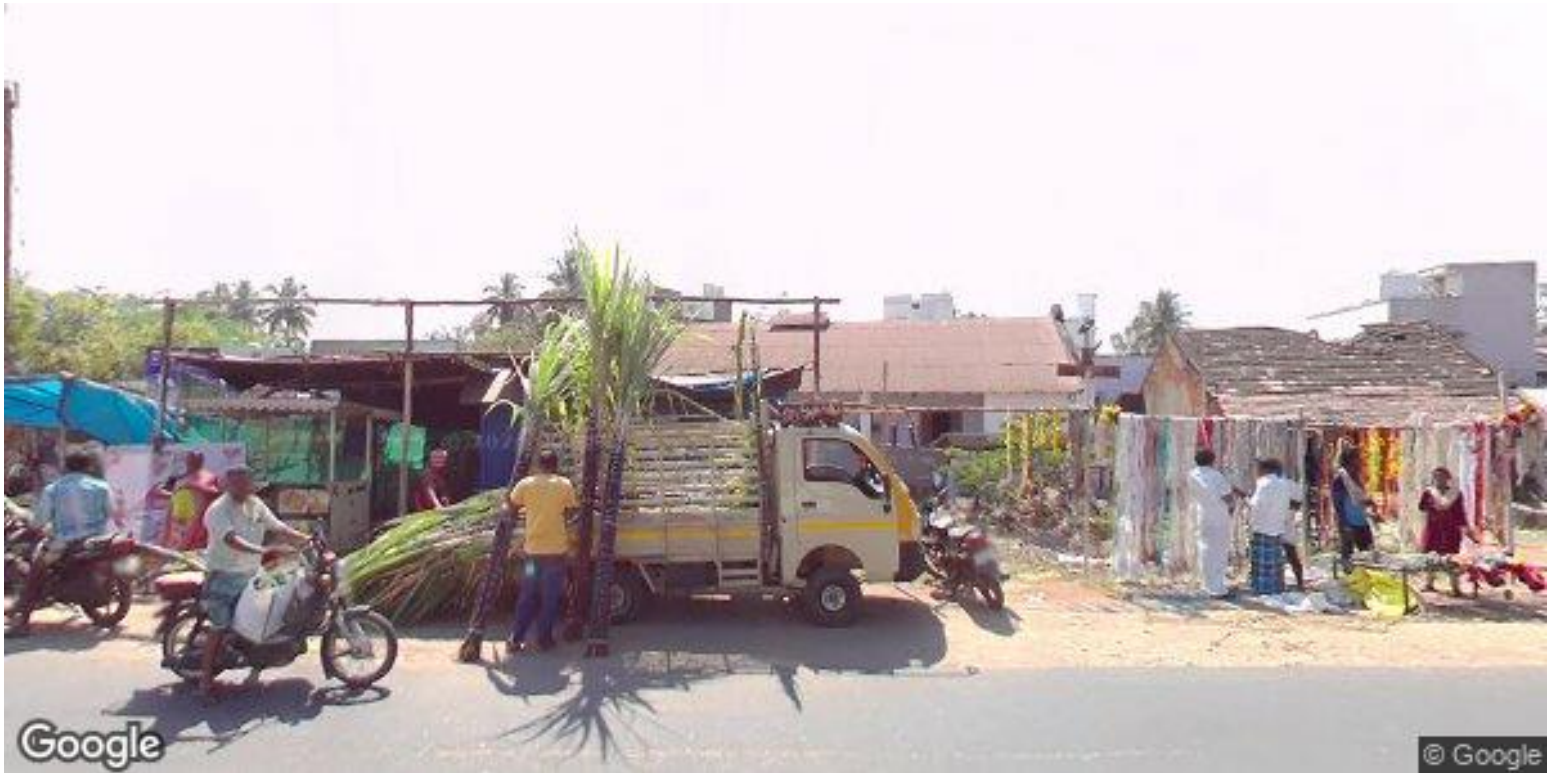
**Risk Type:** Turn  
**Risk Level:** High  
**Speed Limit:** 15 KM/Hr  
**Coordinates:** 11.65719, 78.40574
