# IndianOil

## JOURNEY RISK MANAGEMENT (JRM) STUDY

### Salem Terminal to ROHINI AGENCIES

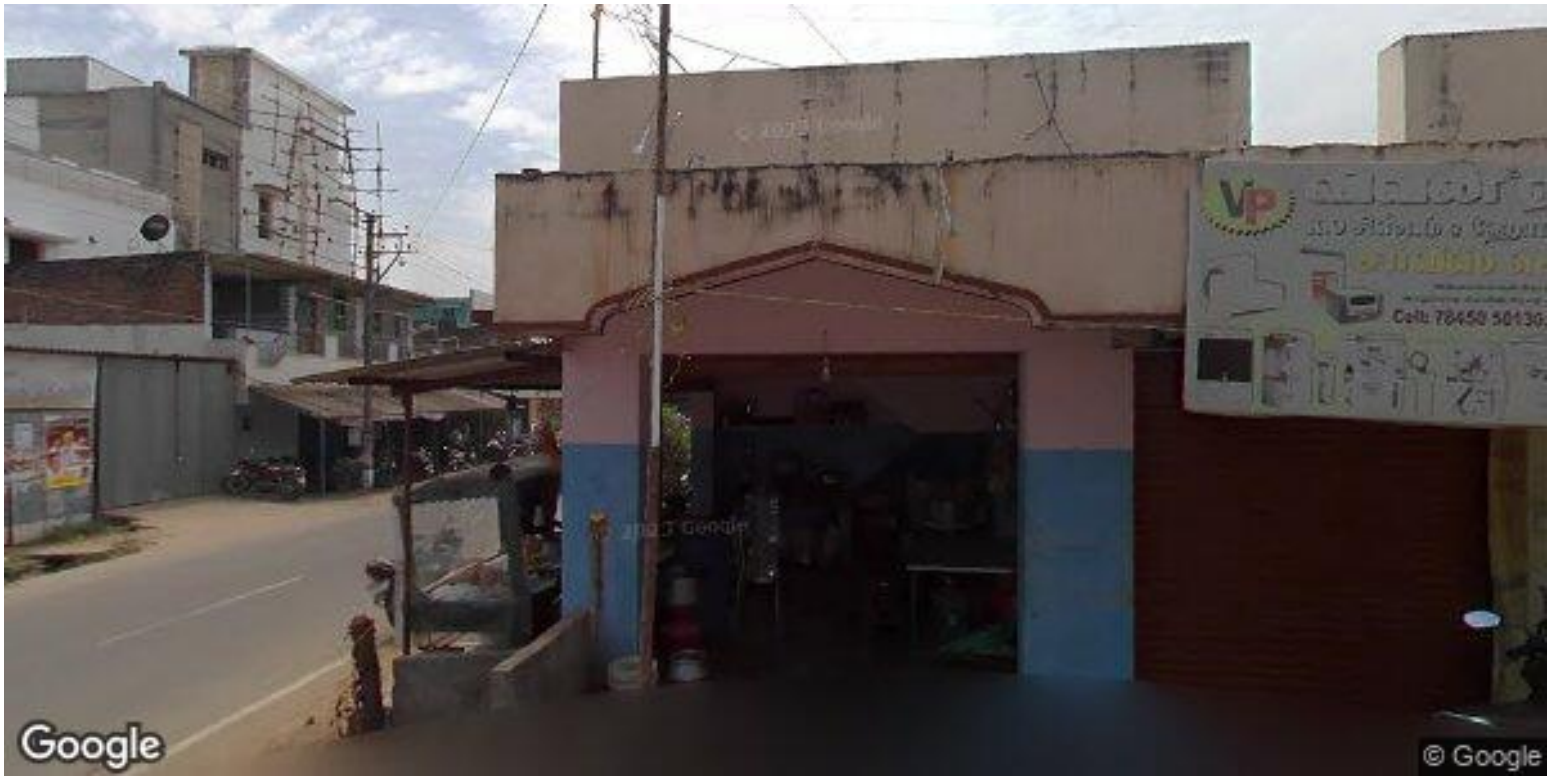
**Risk Type:** Turn  
**Risk Level:** Medium  
**Speed Limit:** 30 KM/Hr  
**Coordinates:** 11.70578, 78.41337

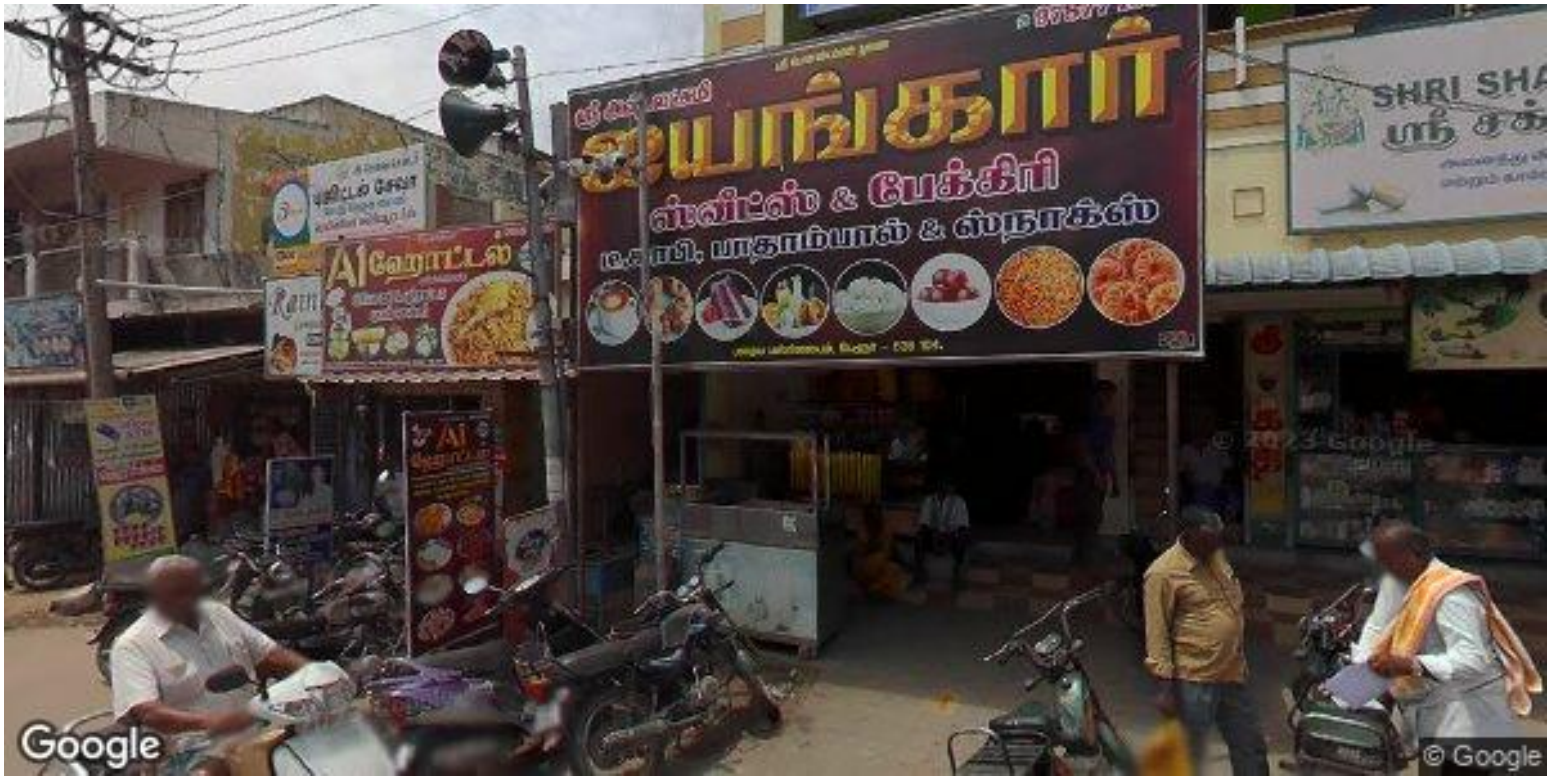
**Risk Type:** Turn  
**Risk Level:** High  
**Speed Limit:** 15 KM/Hr  
**Coordinates:** 11.70684, 78.41358

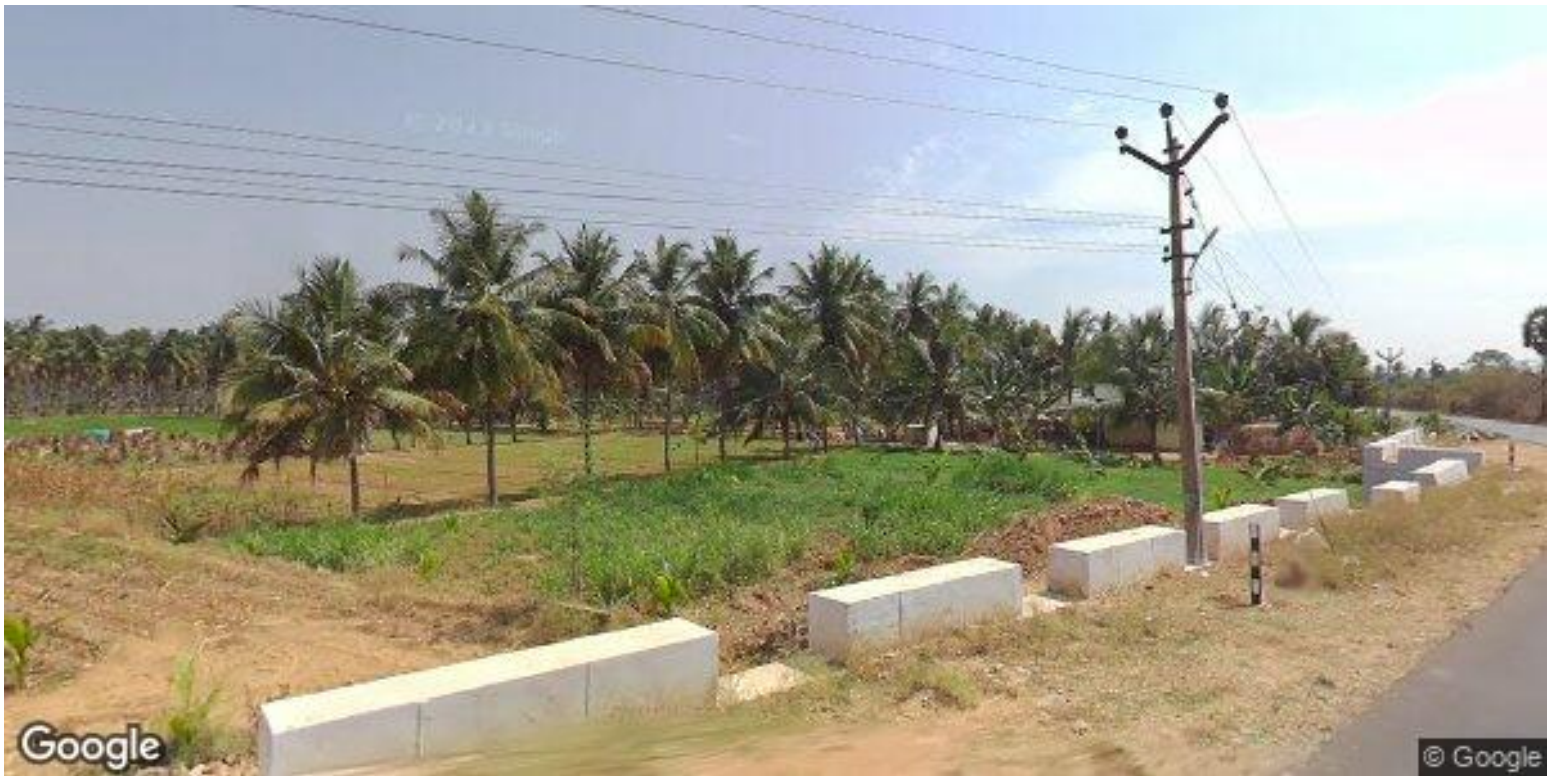
**Risk Type:** Turn  
**Risk Level:** Medium  
**Speed Limit:** 30 KM/Hr  
**Coordinates:** 11.71737, 78.44125

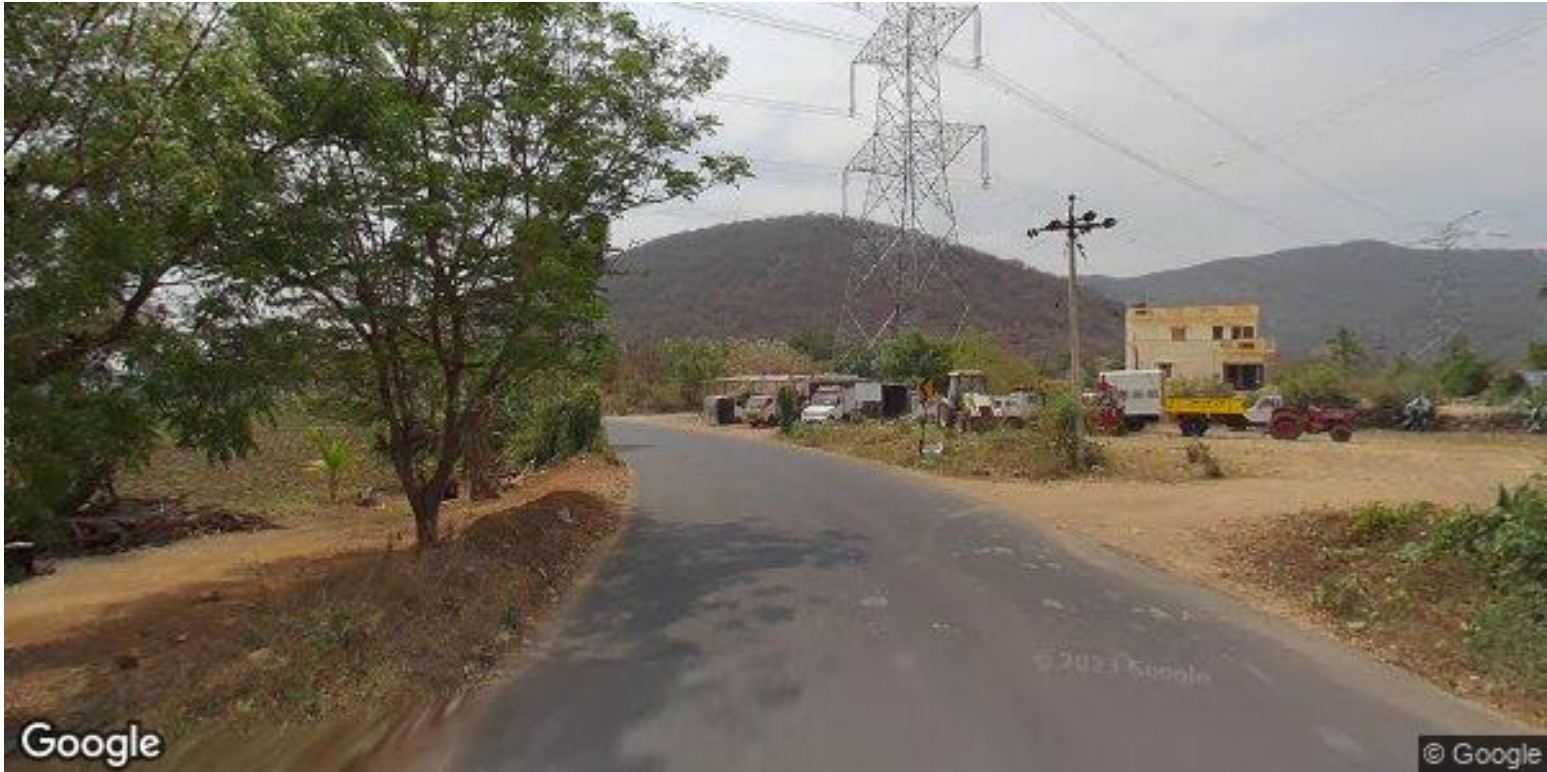
**Risk Type:** Turn  
**Risk Level:** Medium  
**Speed Limit:** 30 KM/Hr  
**Coordinates:** 11.72309, 78.44895

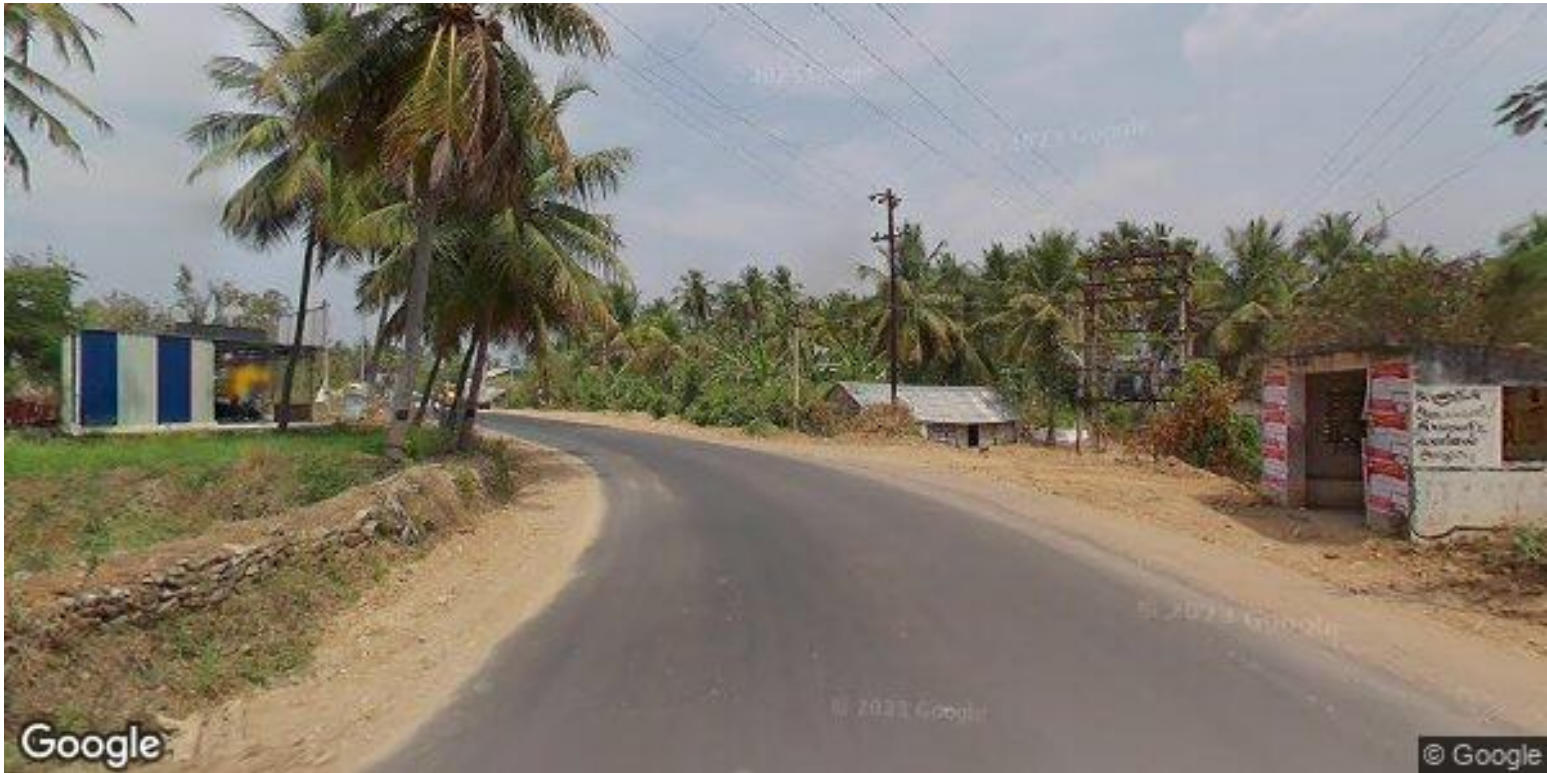
**Risk Type:** Turn  
**Risk Level:** Medium  
**Speed Limit:** 30 KM/Hr  
**Coordinates:** 11.72313, 78.44971

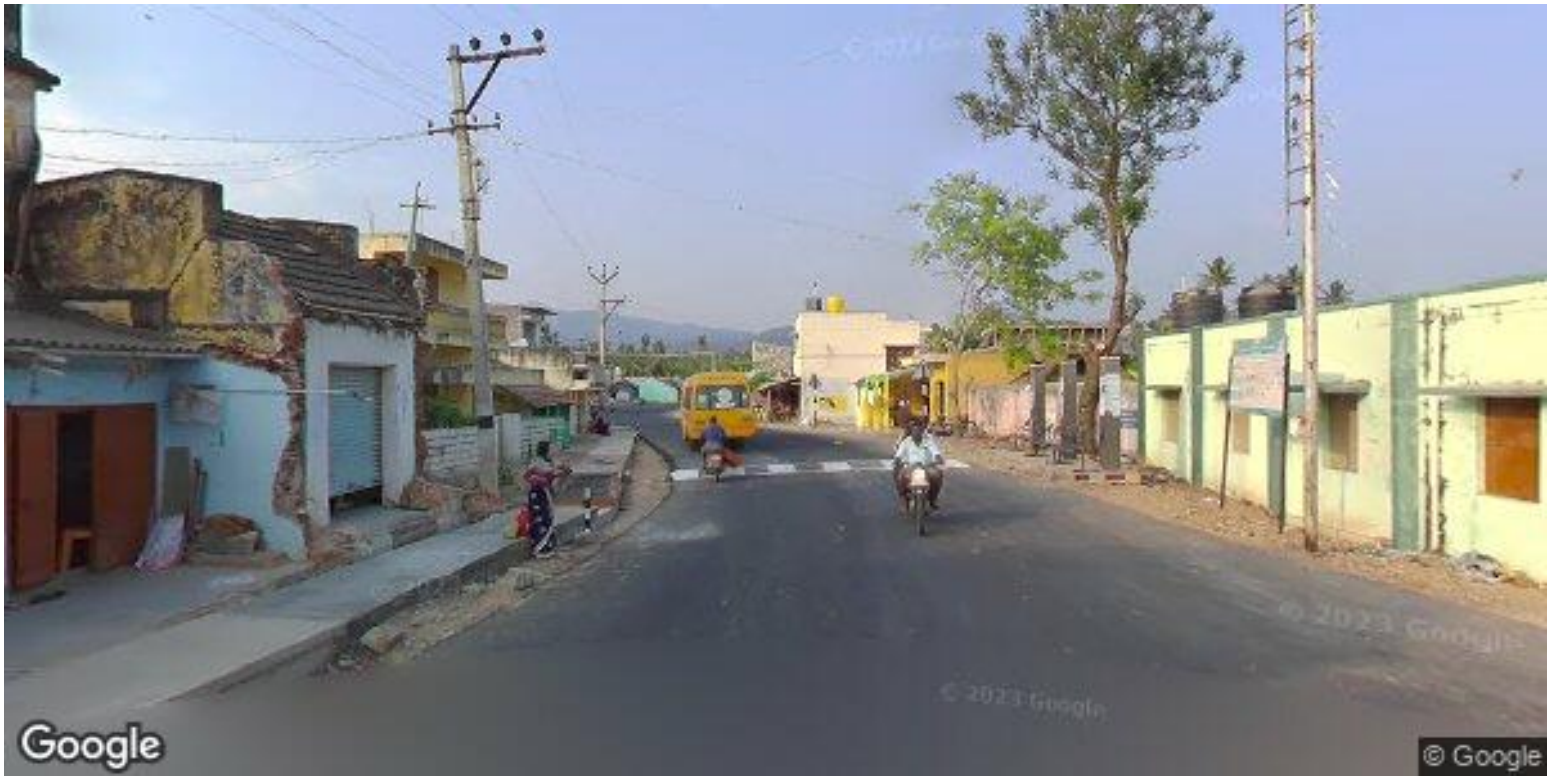
**Risk Type:** Turn  
**Risk Level:** Medium  
**Speed Limit:** 30 KM/Hr  
**Coordinates:** 11.72630, 78.45302

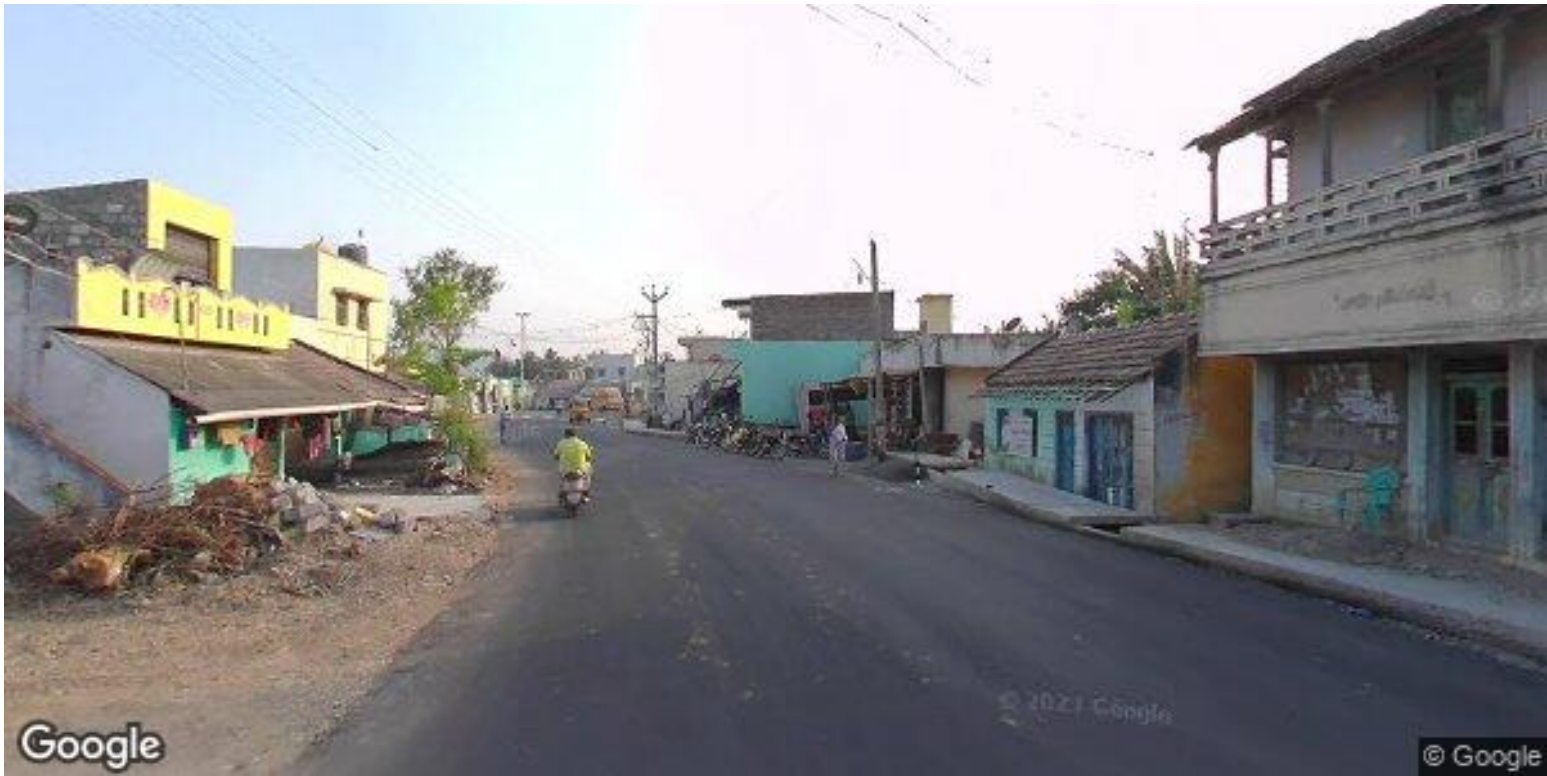
**Risk Type:** Turn  
**Risk Level:** Medium  
**Speed Limit:** 30 KM/Hr  
**Coordinates:** 11.72699, 78.45307

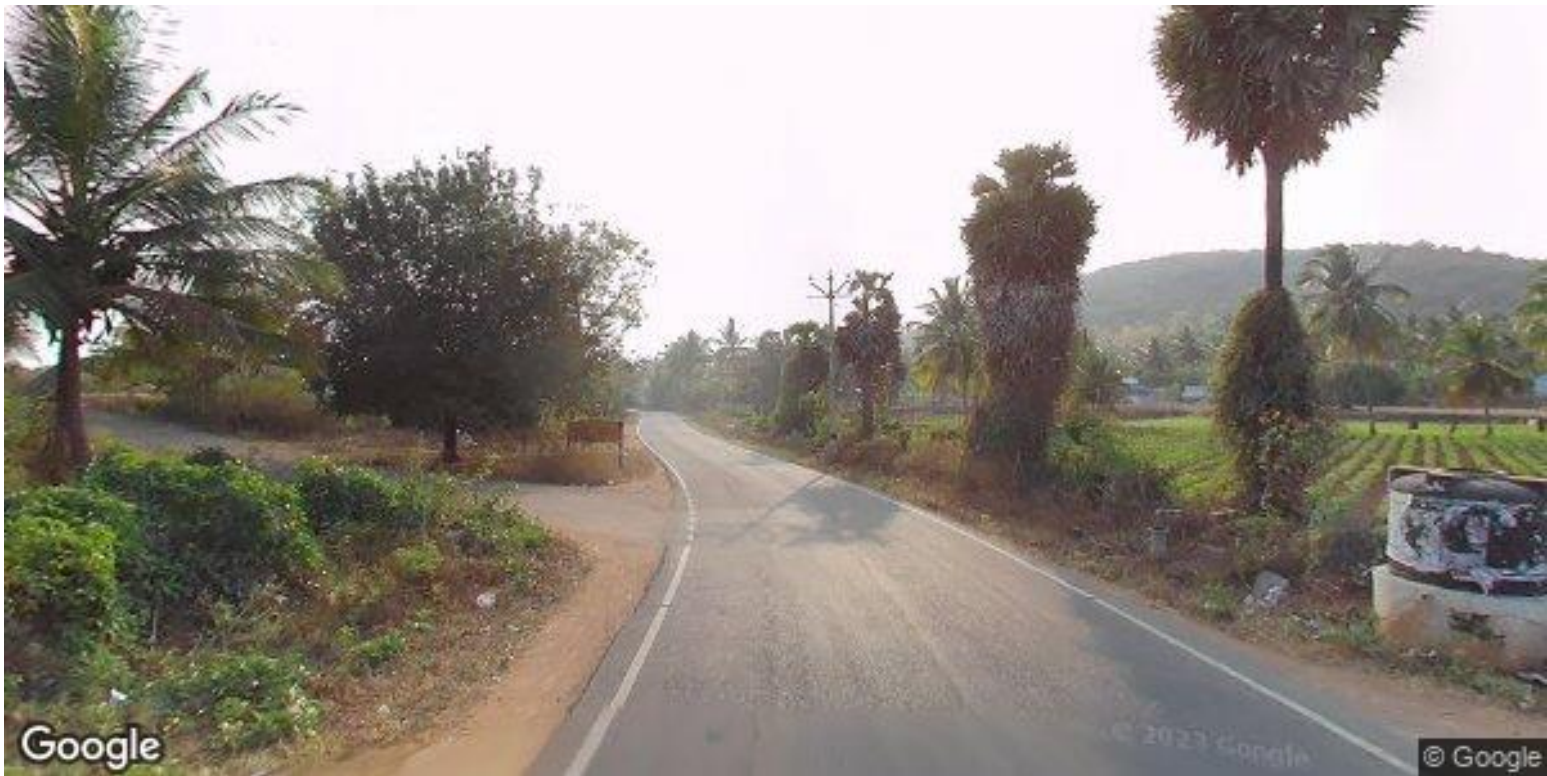
**Risk Type:** Turn  
**Risk Level:** Medium  
**Speed Limit:** 30 KM/Hr  
**Coordinates:** 11.74456, 78.46610

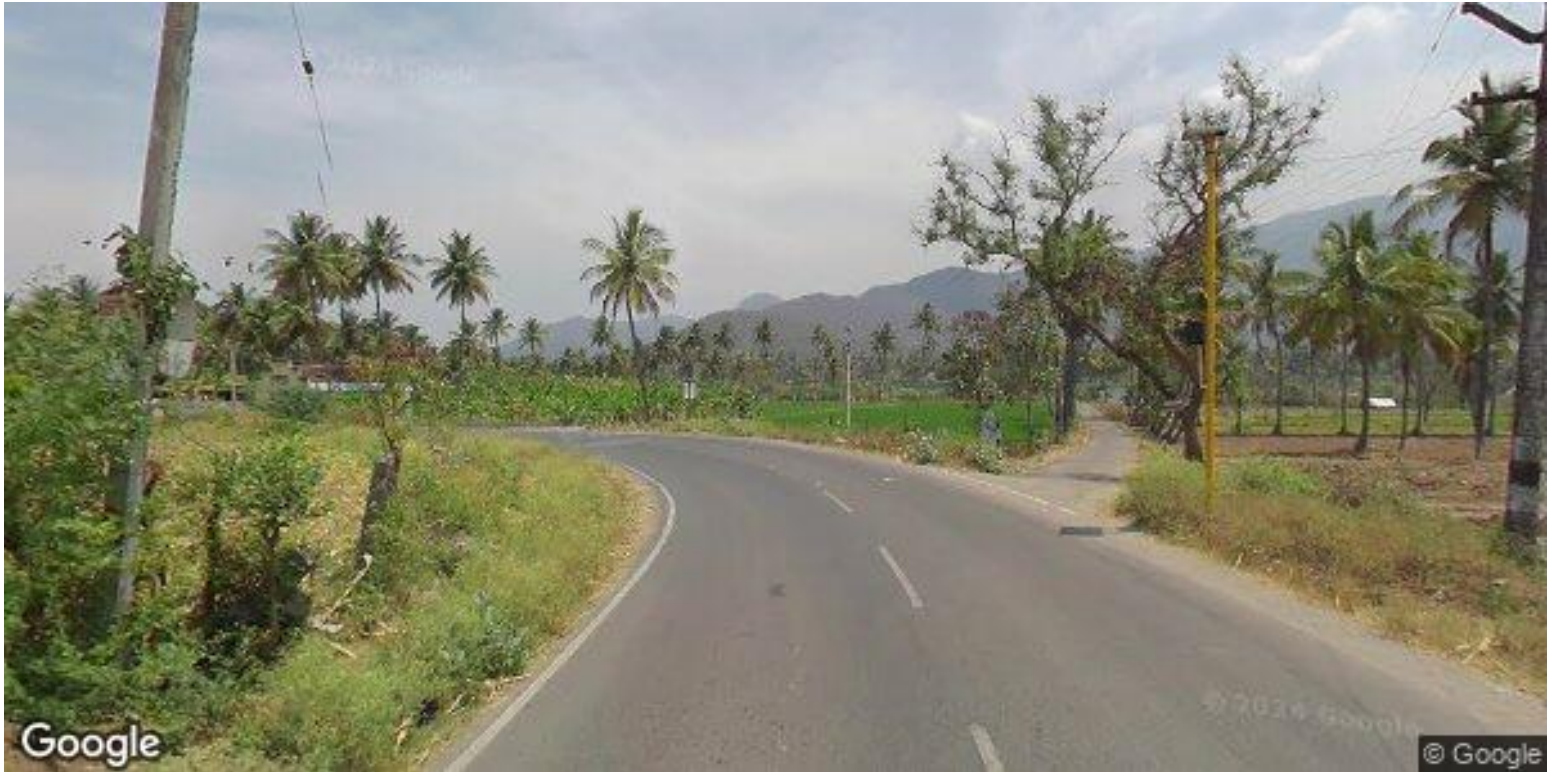
**Risk Type:** Turn  
**Risk Level:** Medium  
**Speed Limit:** 30 KM/Hr  
**Coordinates:** 11.74532, 78.48935

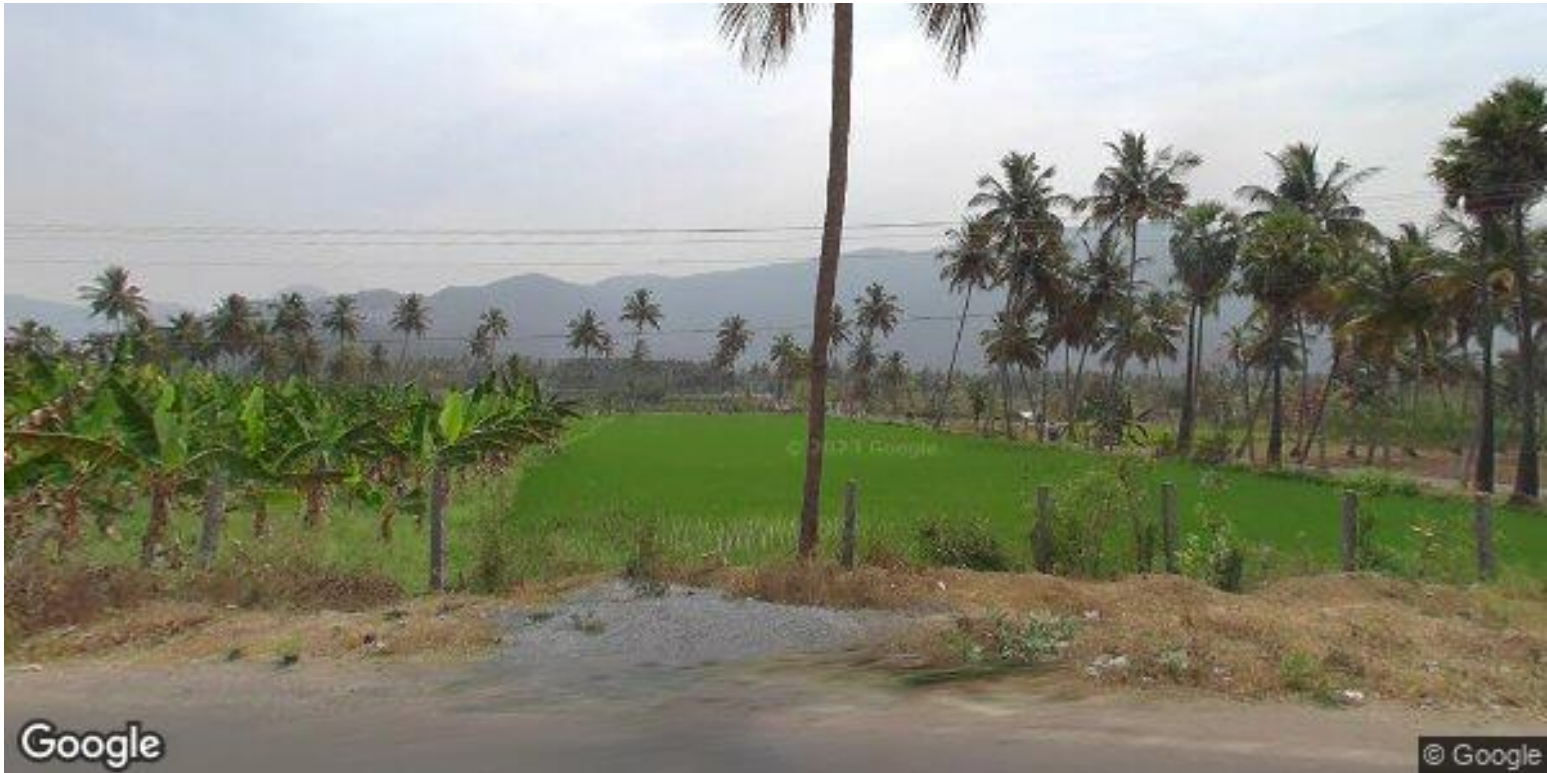
**Risk Type:** Turn  
**Risk Level:** Medium  
**Speed Limit:** 30 KM/Hr  
**Coordinates:** 11.74547, 78.48967

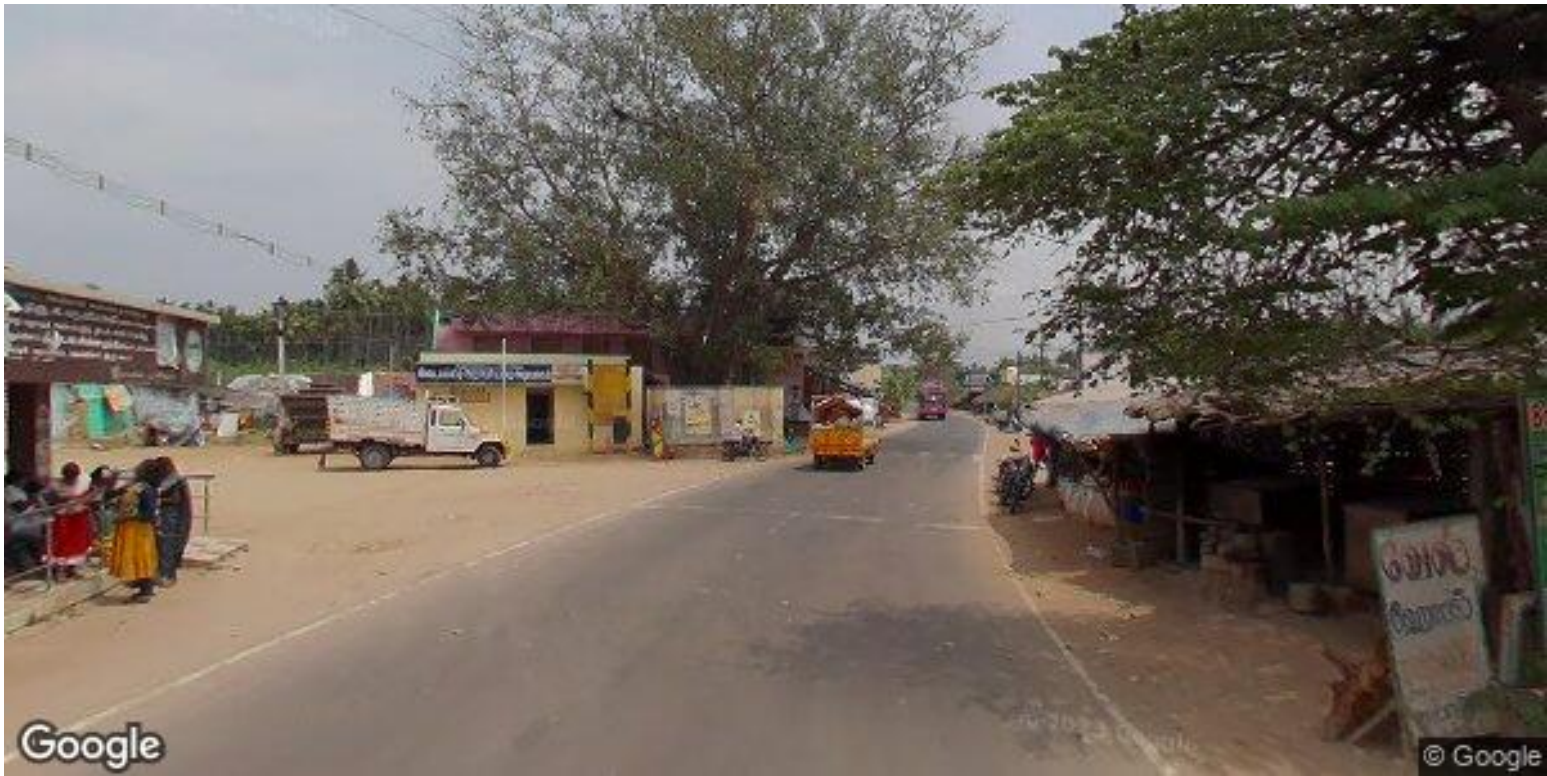
**Risk Type:** Turn

**Risk Level:** Medium

**Speed Limit:** 30 KM/Hr

**Coordinates:** 11.75365, 78.49176
