# IndianOil

## JOURNEY RISK MANAGEMENT (JRM) STUDY

### Salem Terminal TO SRI VENKATASWARA SERVICE STN.

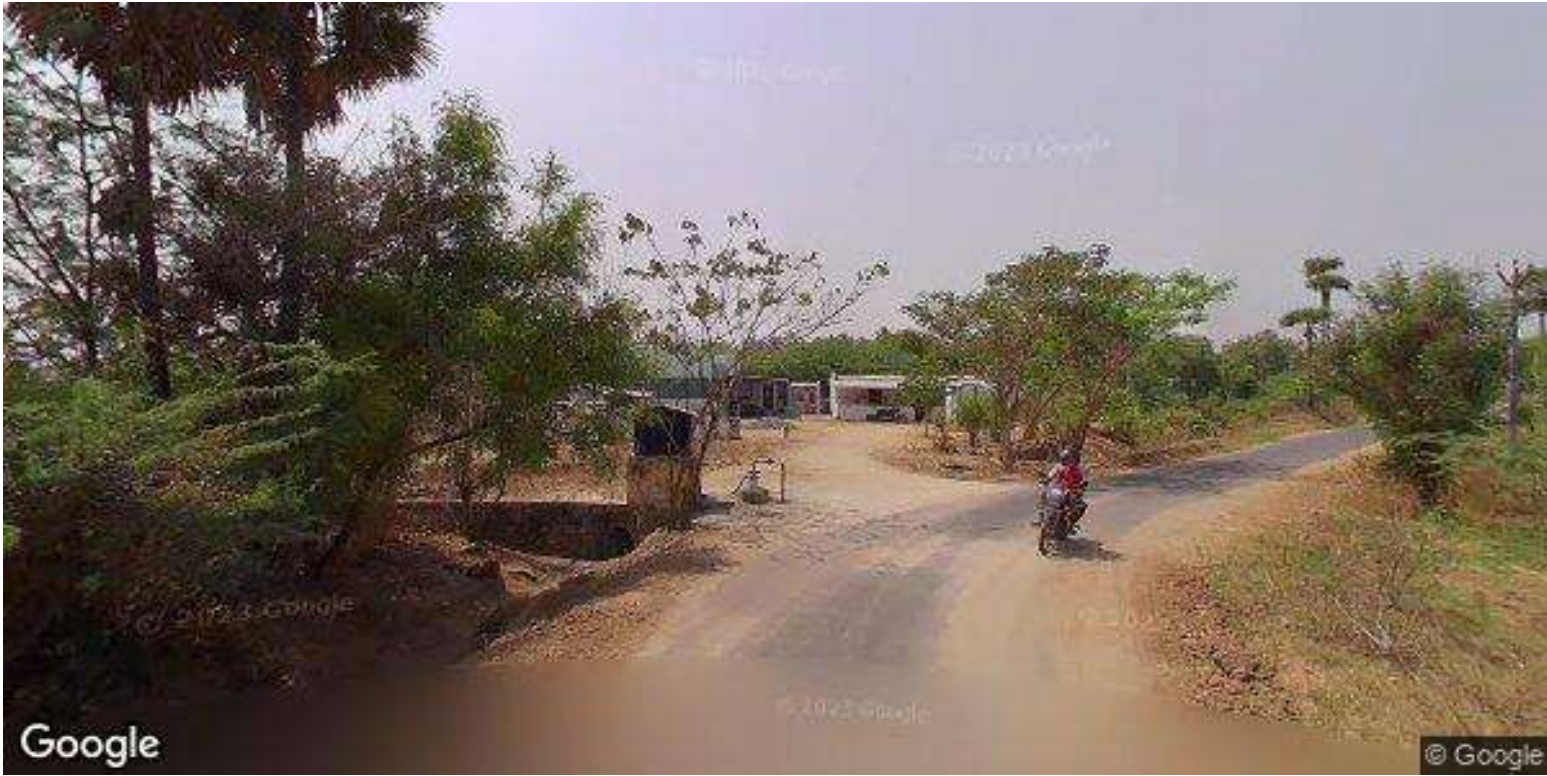
**Risk Type:** Turn  
**Risk Level:** Medium  
**Speed Limit:** 30 KM/Hr  
**Coordinates:** 11.41761, 77.88739

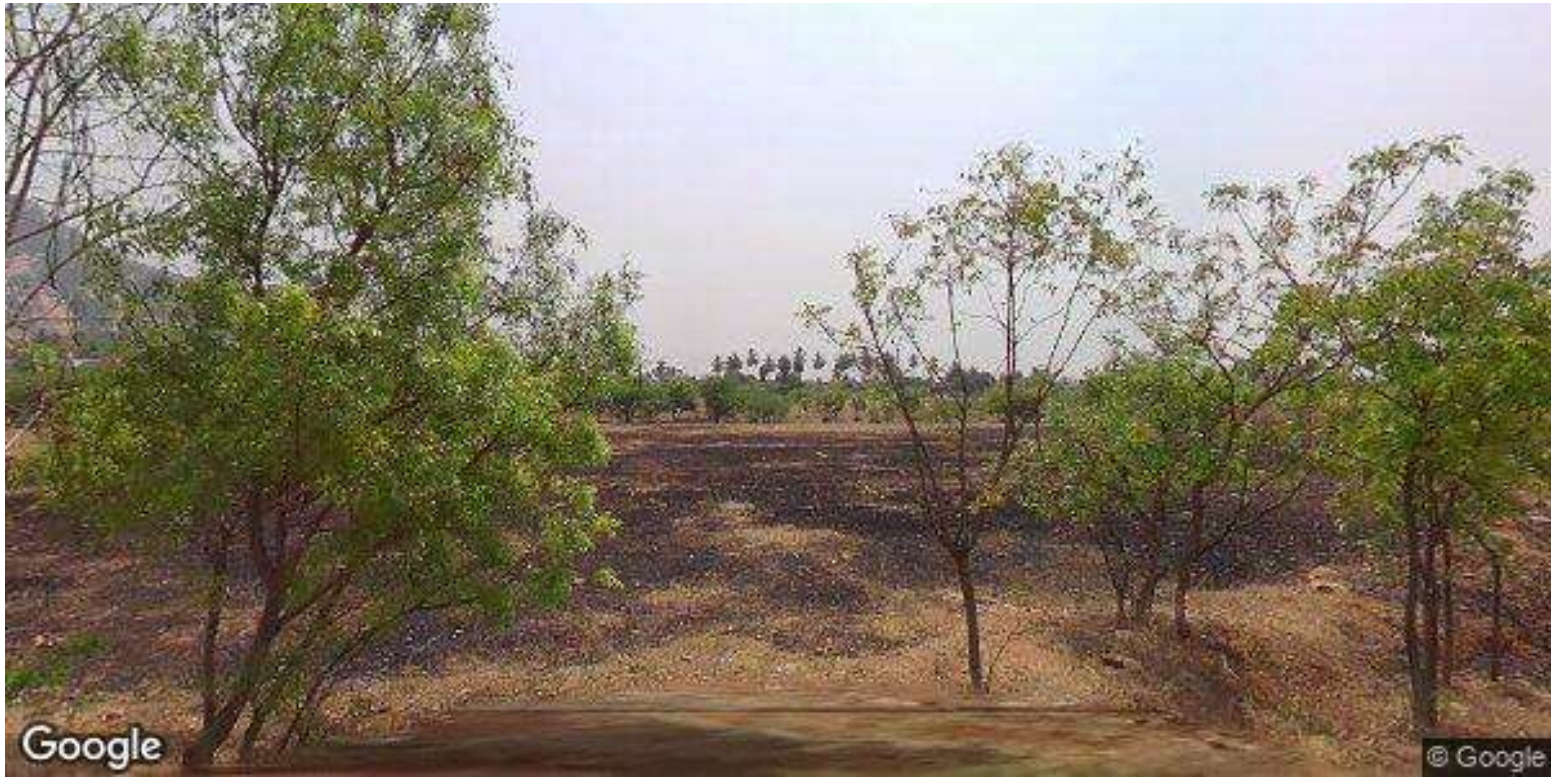
**Risk Type:** Turn  
**Risk Level:** Medium  
**Speed Limit:** 30 KM/Hr  
**Coordinates:** 11.41716, 77.88935

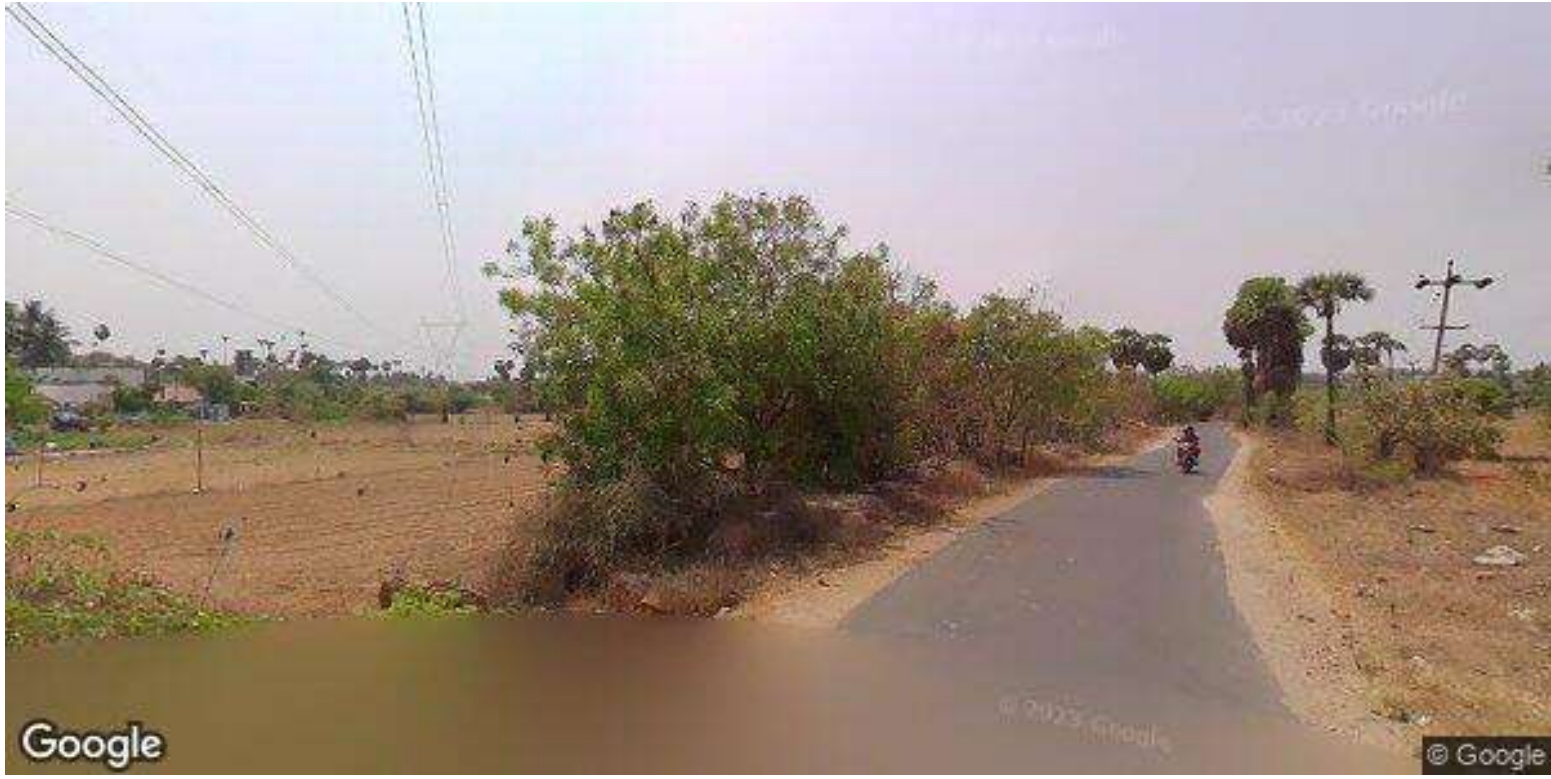
**Risk Type:** Turn  
**Risk Level:** Medium  
**Speed Limit:** 30 KM/Hr  
**Coordinates:** 11.41630, 77.89077

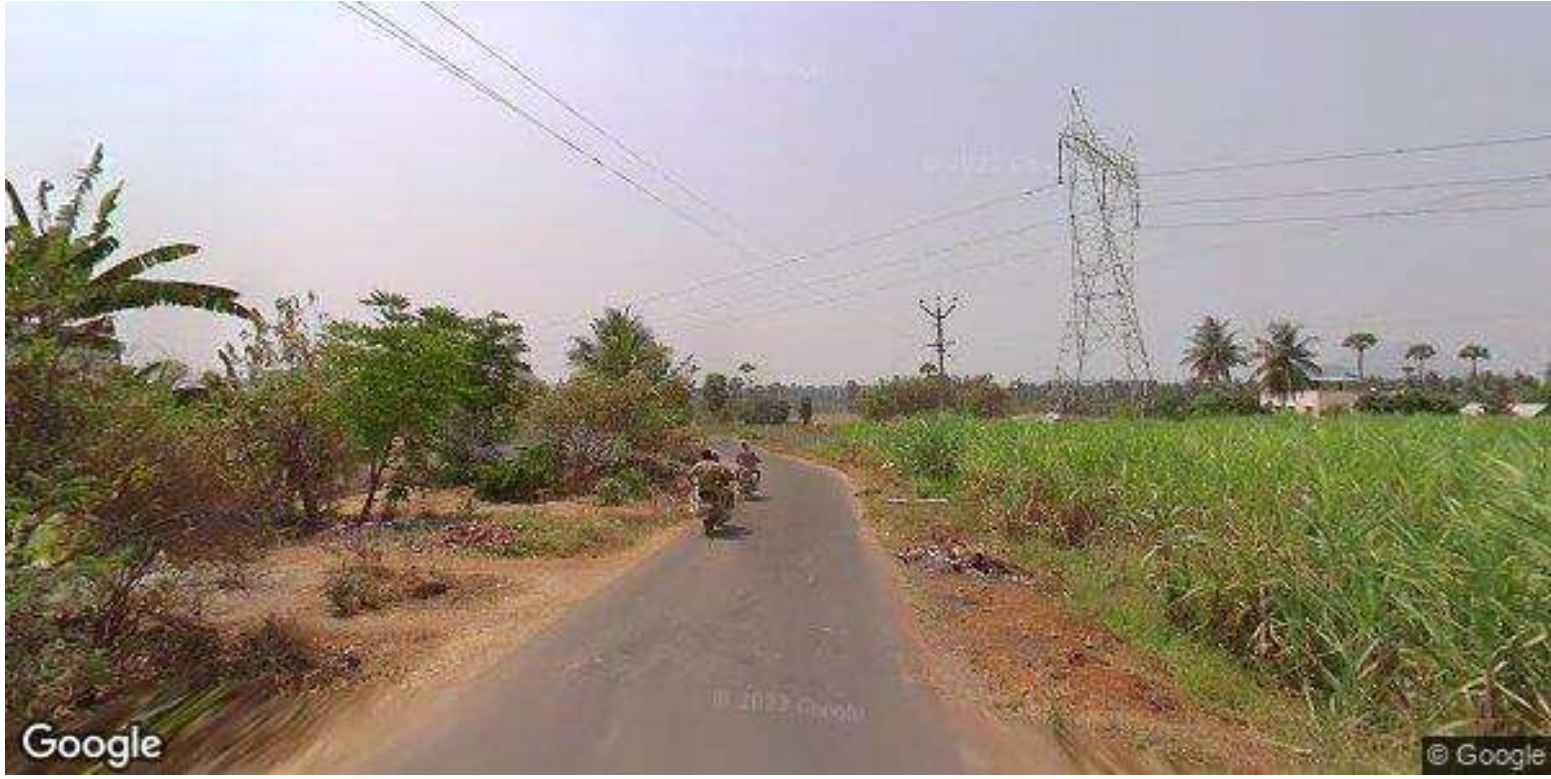
**Risk Type:** Turn  
**Risk Level:** Medium  
**Speed Limit:** 30 KM/Hr  
**Coordinates:** 11.41601, 77.89198

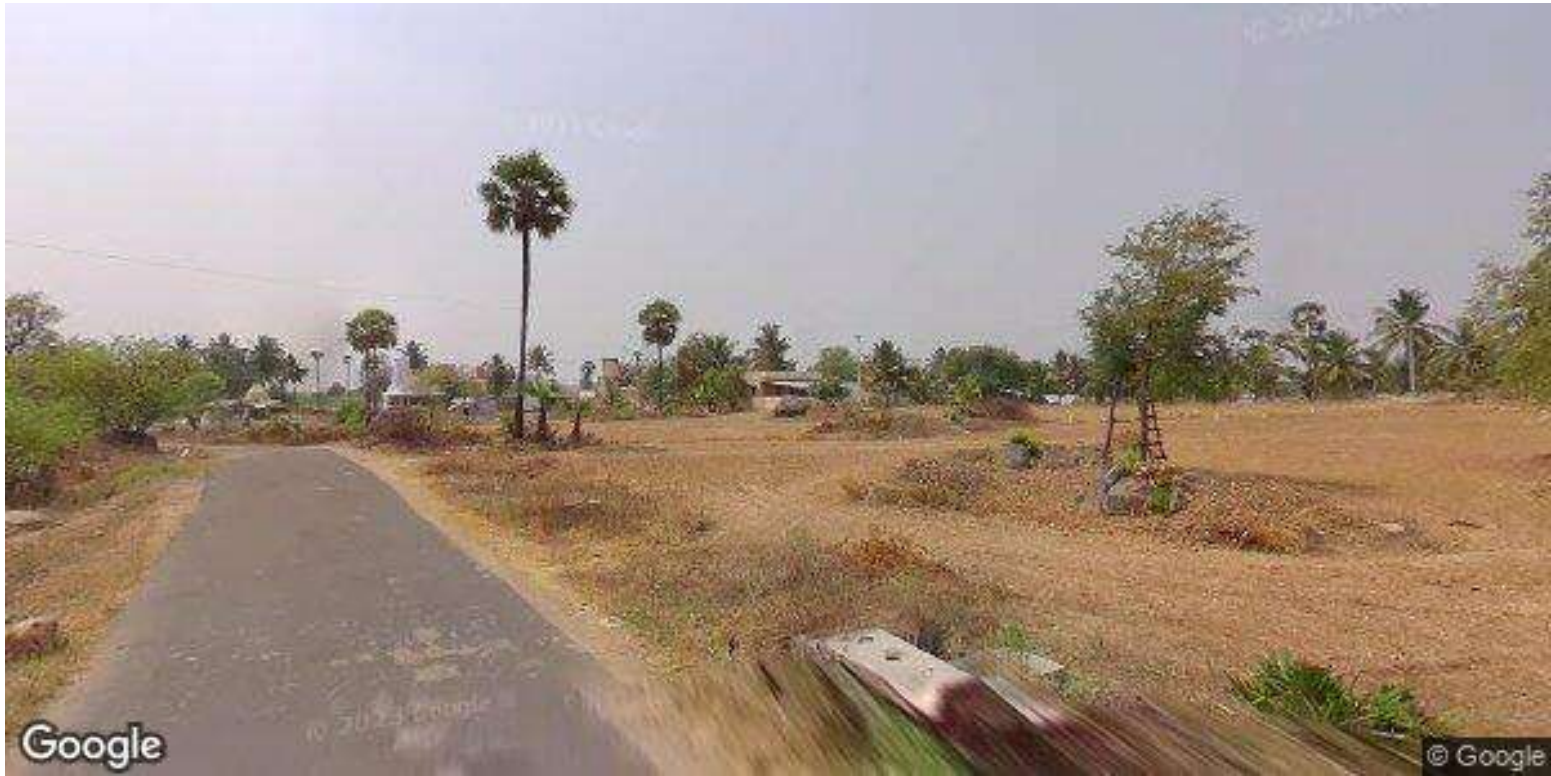
**Risk Type:** Turn  
**Risk Level:** Medium  
**Speed Limit:** 30 KM/Hr  
**Coordinates:** 11.41603, 77.89479

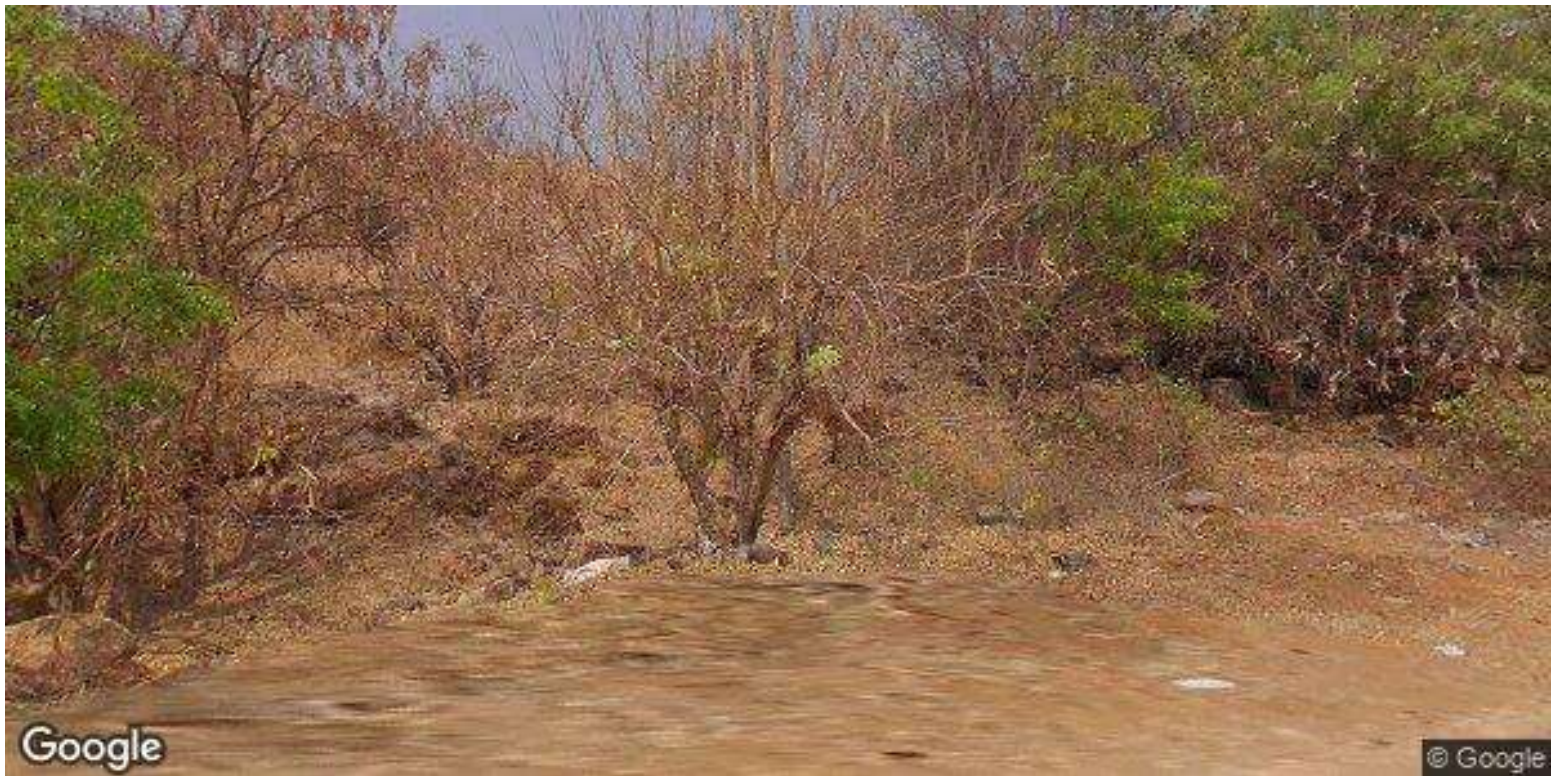
**Risk Type:** Turn  
**Risk Level:** Medium  
**Speed Limit:** 30 KM/Hr  
**Coordinates:** 11.41439, 77.90025

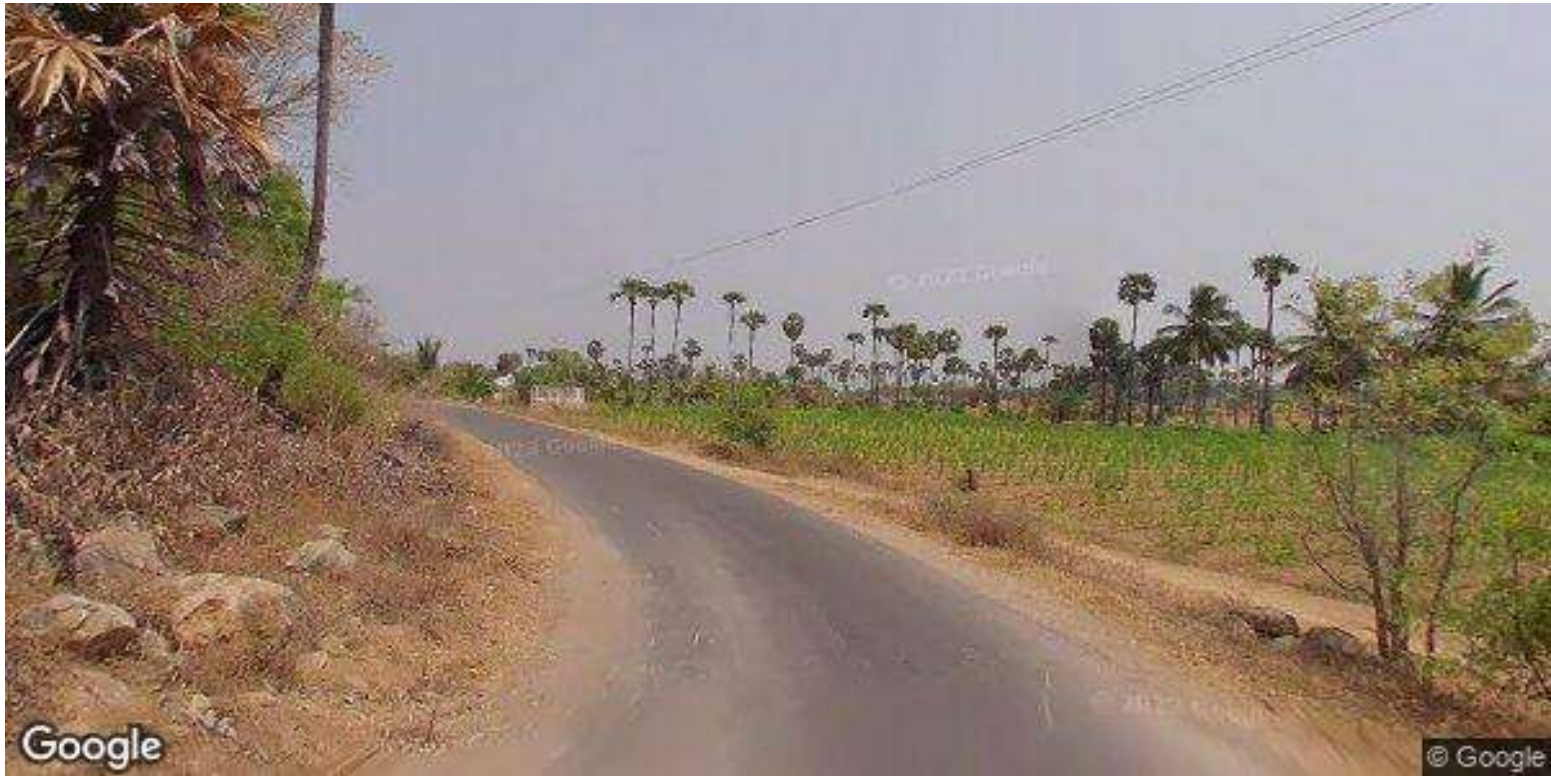
**Risk Type:** Turn  
**Risk Level:** High  
**Speed Limit:** 15 KM/Hr  
**Coordinates:** 11.41377, 77.90073

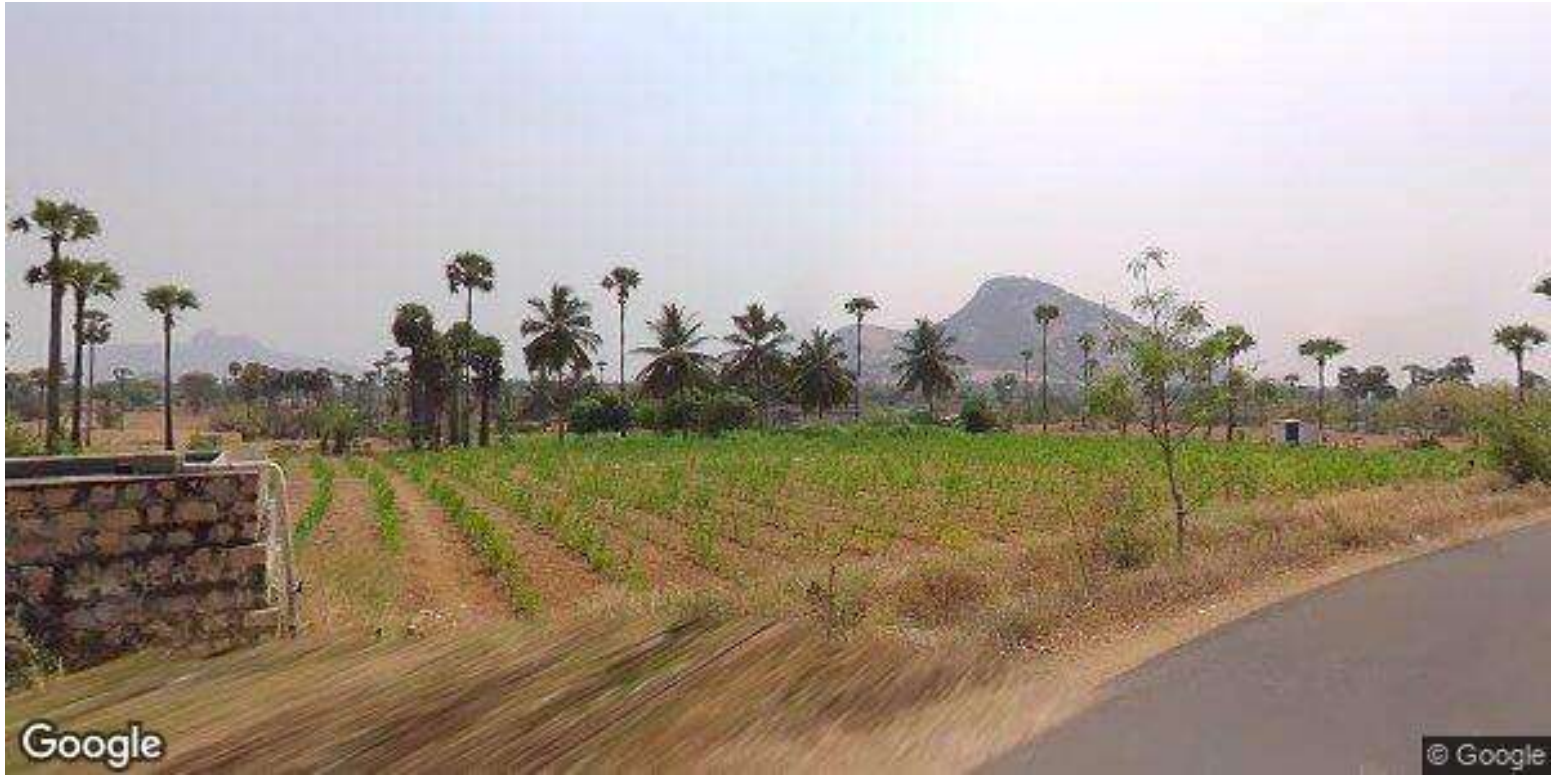
**Risk Type:** Turn  
**Risk Level:** Medium  
**Speed Limit:** 30 KM/Hr  
**Coordinates:** 11.41375, 77.90128

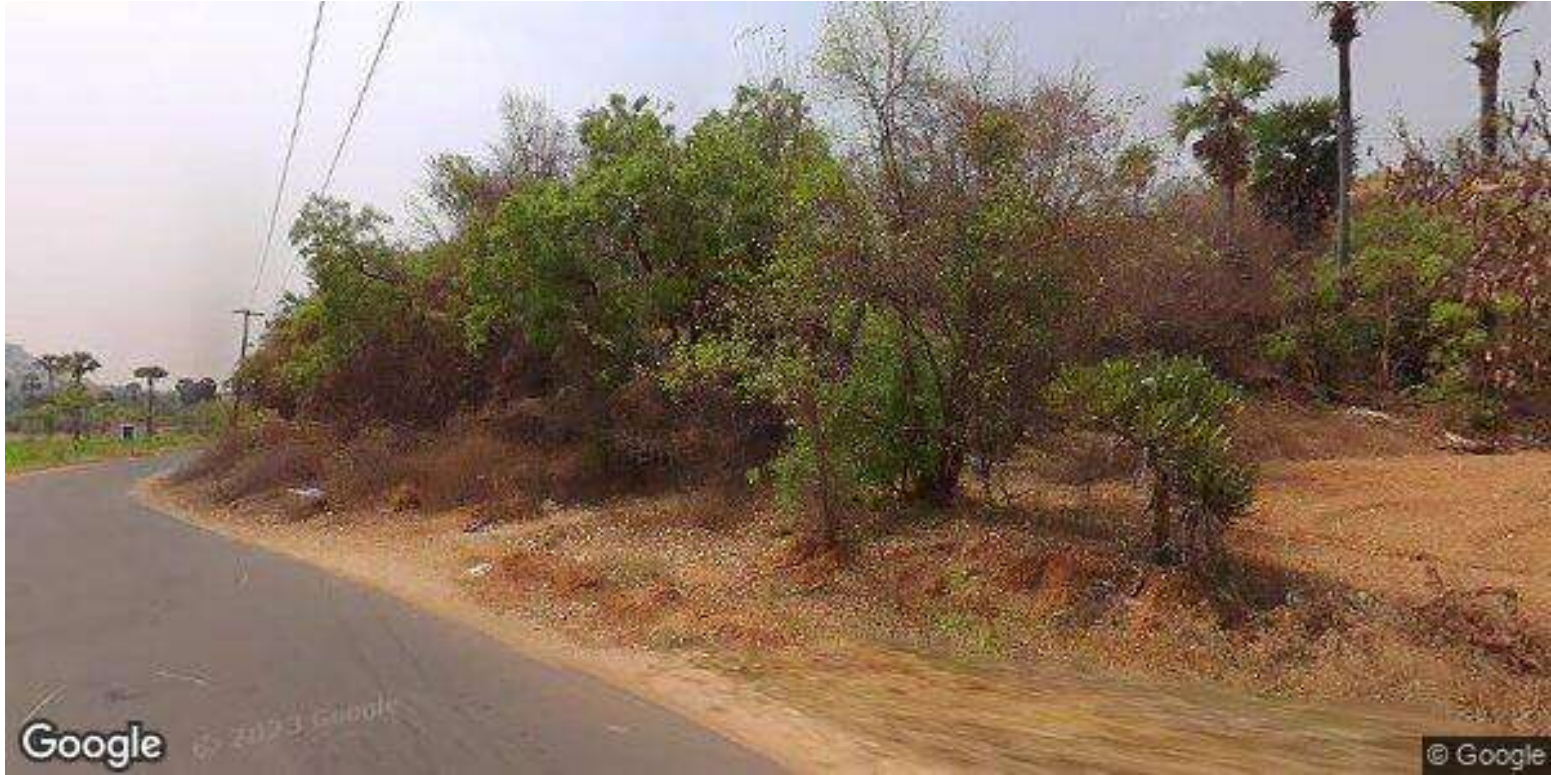
**Risk Type: Turn**

**Risk Level: Medium**

**Speed Limit: 30 KM/Hr**

**Coordinates: 11.41389, 77.90161**

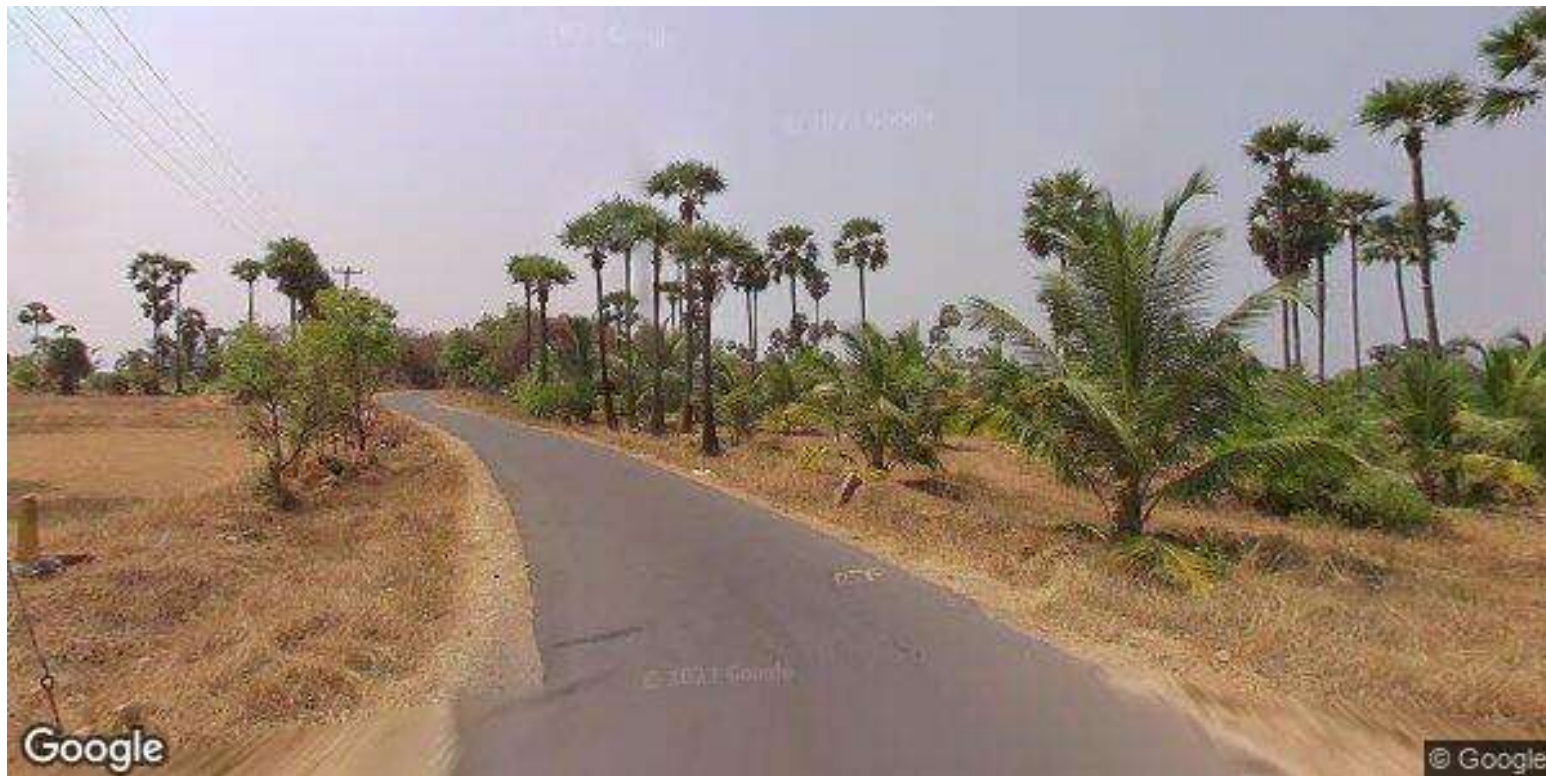
**Risk Type: Turn**

**Risk Level: Medium**

**Speed Limit: 30 KM/Hr**

**Coordinates: 11.41325, 77.90313**

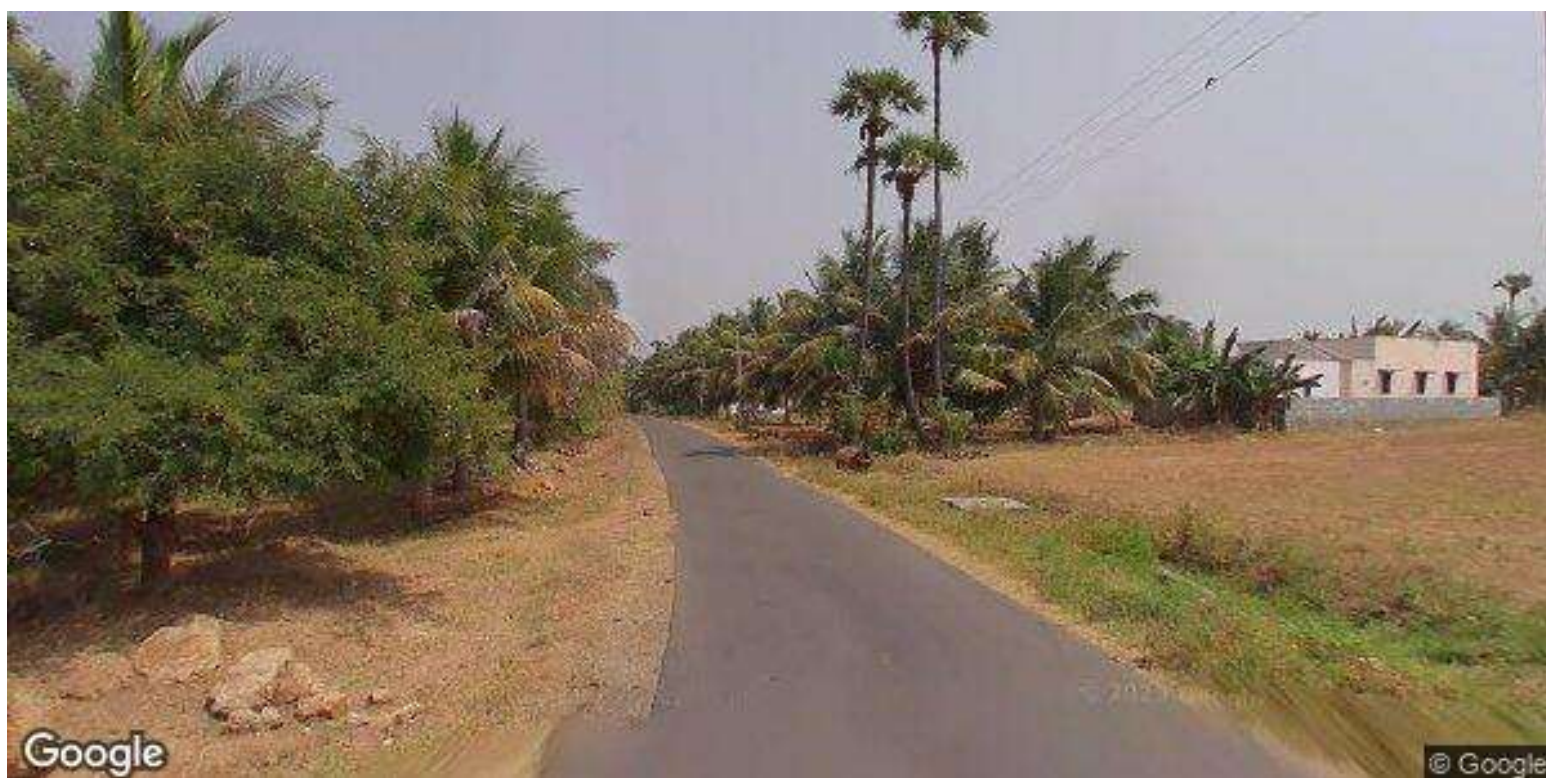
**Risk Type: Turn**

**Risk Level: Medium**

**Speed Limit: 30 KM/Hr**

**Coordinates: 11.41276, 77.90349**

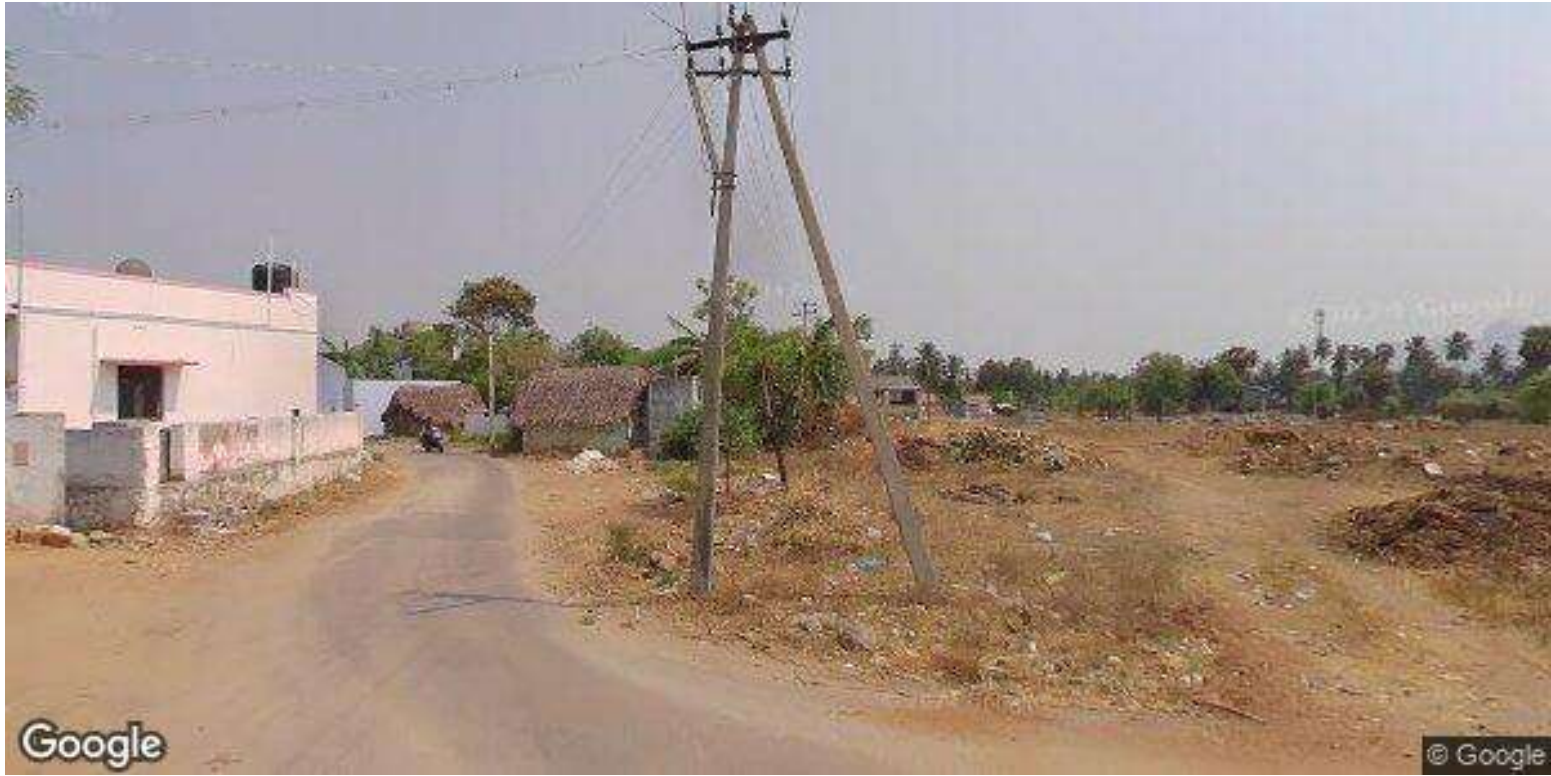
**Risk Type:** Turn  
**Risk Level:** High  
**Speed Limit:** 15 KM/Hr  
**Coordinates:** 11.41329, 77.90978

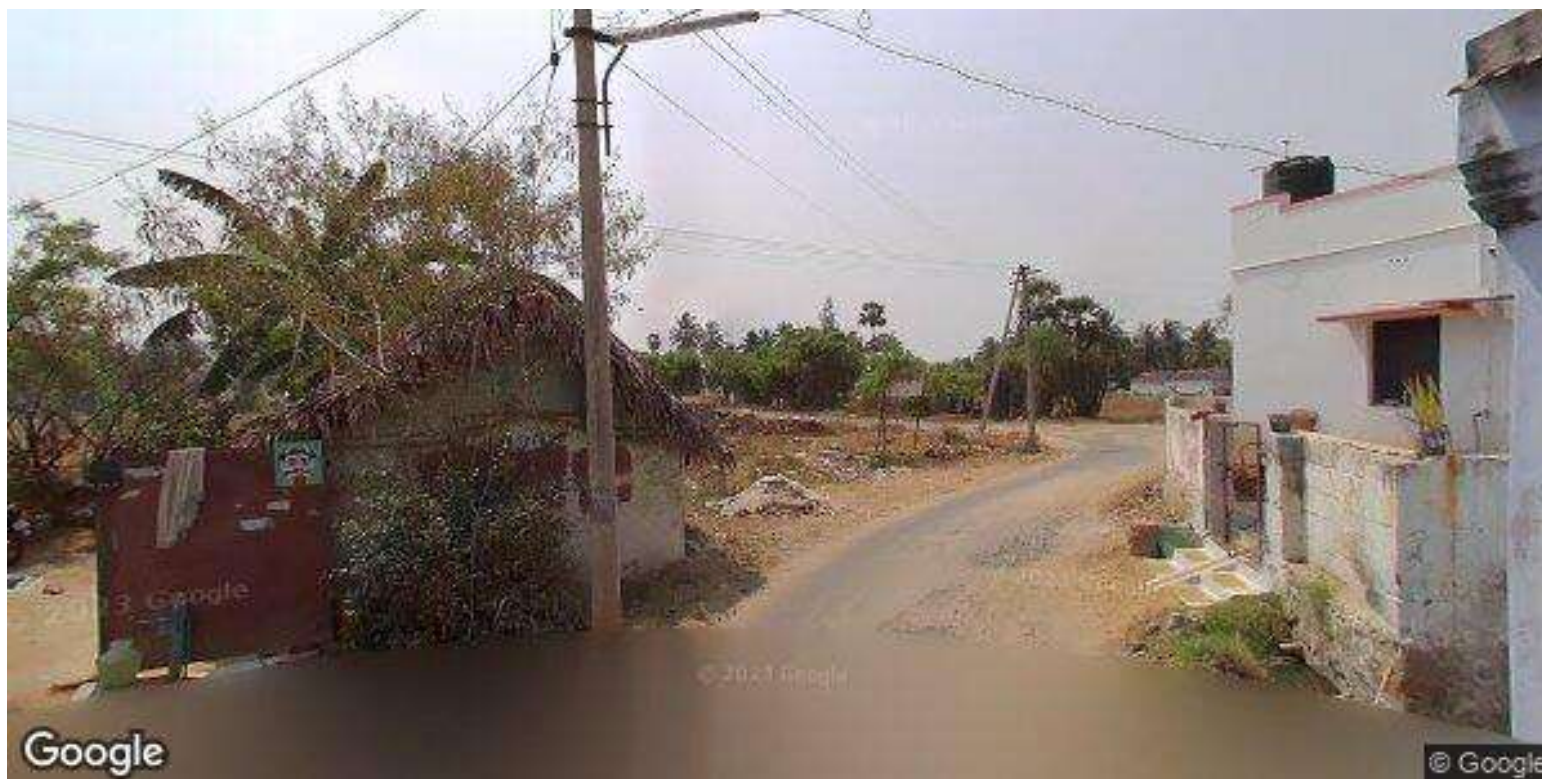
**Risk Type:** Turn

**Risk Level:** Medium

**Speed Limit:** 30 KM/Hr

**Coordinates:** 11.41314, 77.91006

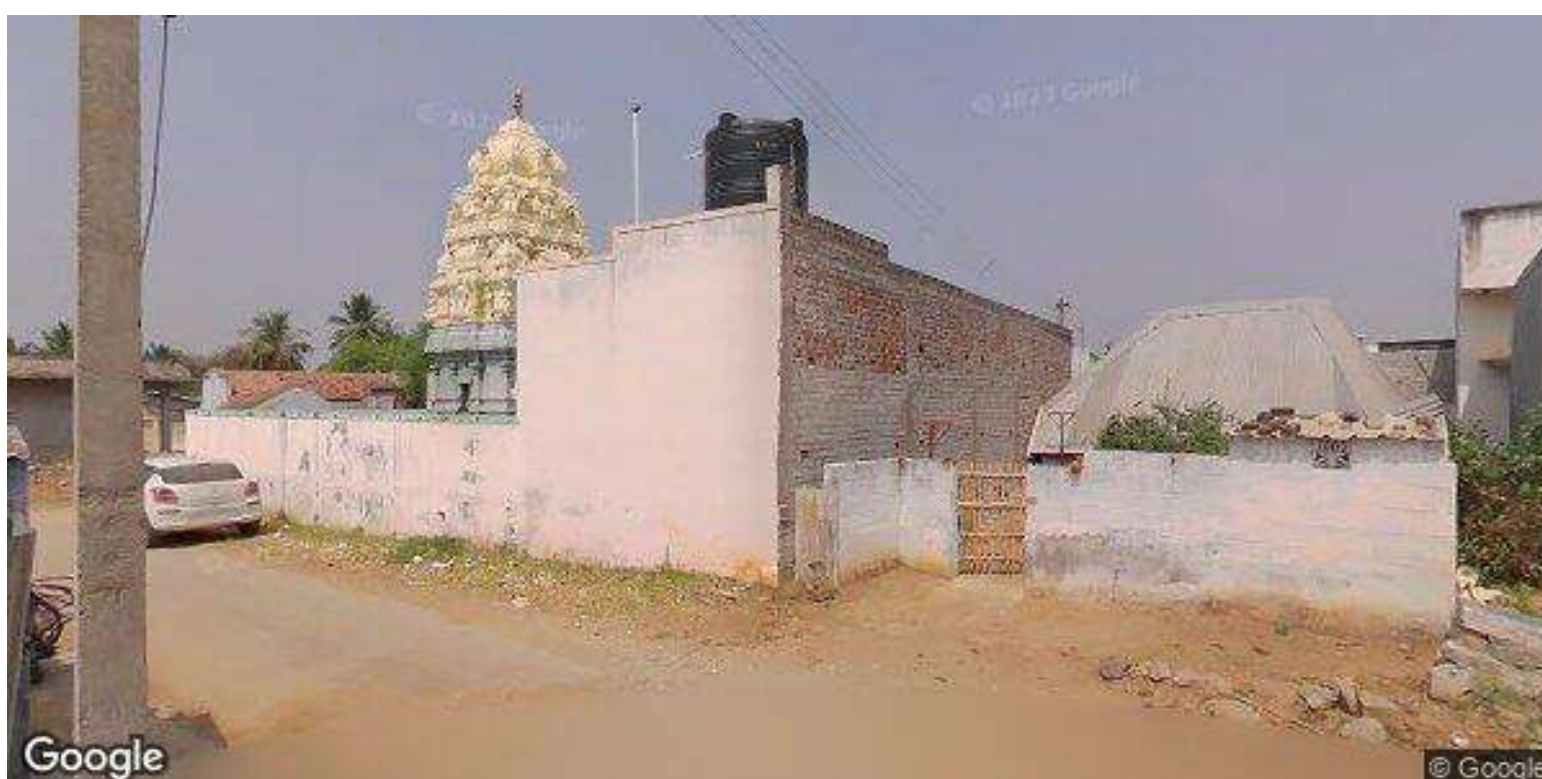
**Risk Type:** Turn

**Risk Level:** High

**Speed Limit:** 15 KM/Hr

**Coordinates:** 11.41313, 77.91057

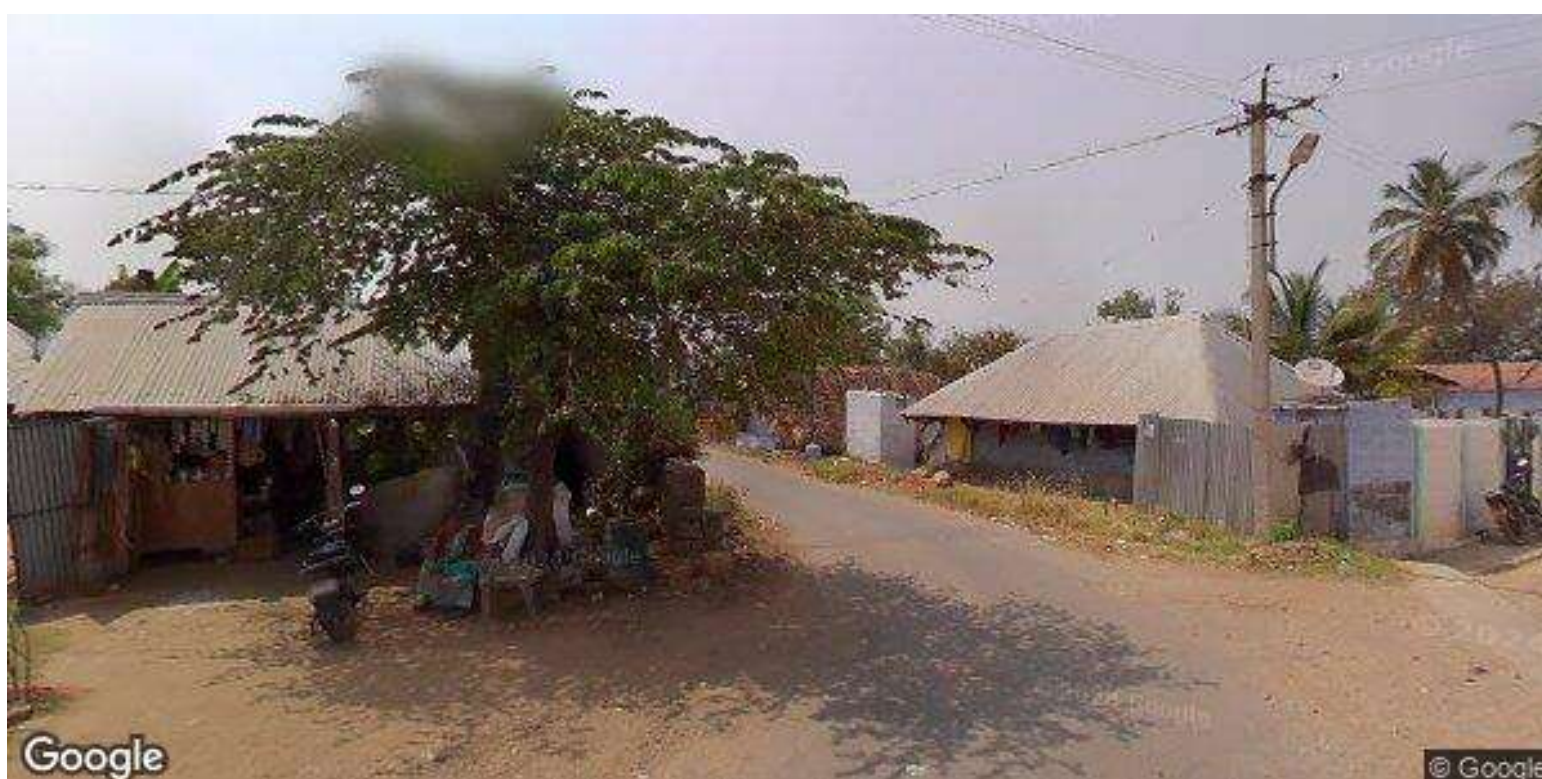
**Risk Type:** Turn  
**Risk Level:** High  
**Speed Limit:** 15 KM/Hr  
**Coordinates:** 11.41307, 77.91058

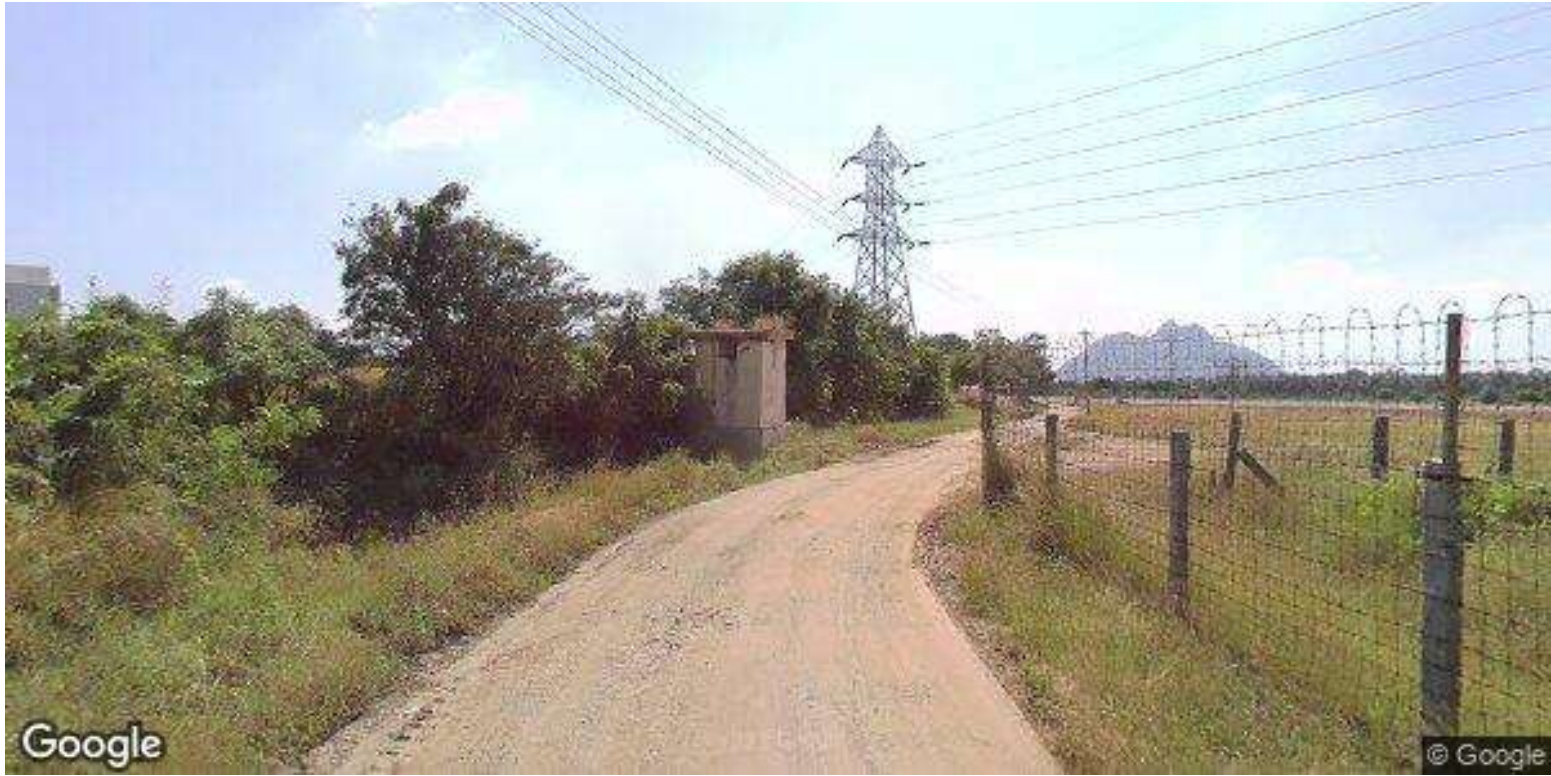
**Risk Type:** Turn  
**Risk Level:** Medium  
**Speed Limit:** 30 KM/Hr  
**Coordinates:** 11.40833, 77.92362

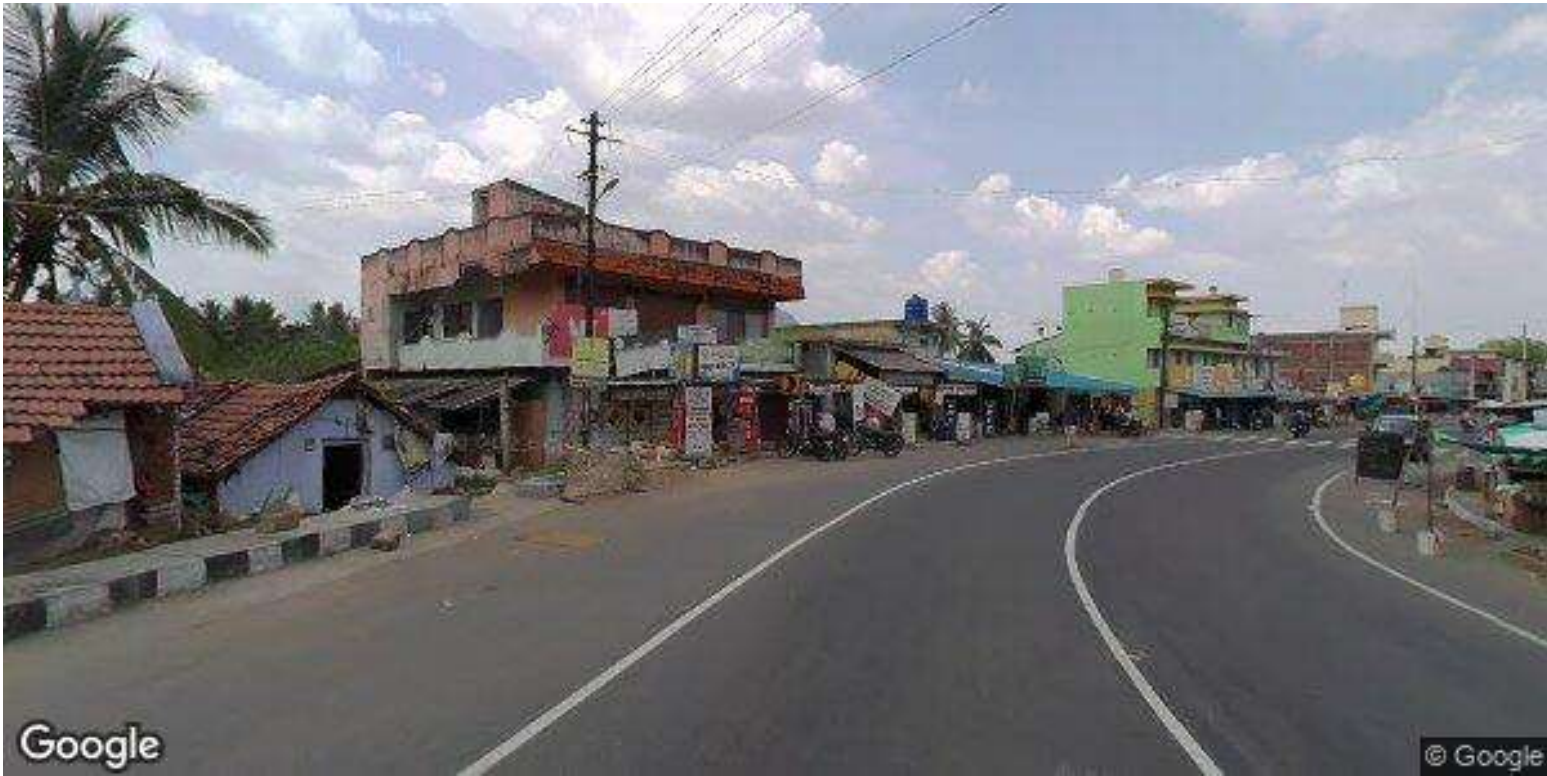
**Risk Type:** Turn  
**Risk Level:** High  
**Speed Limit:** 15 KM/Hr  
**Coordinates:** 11.41466, 78.08070

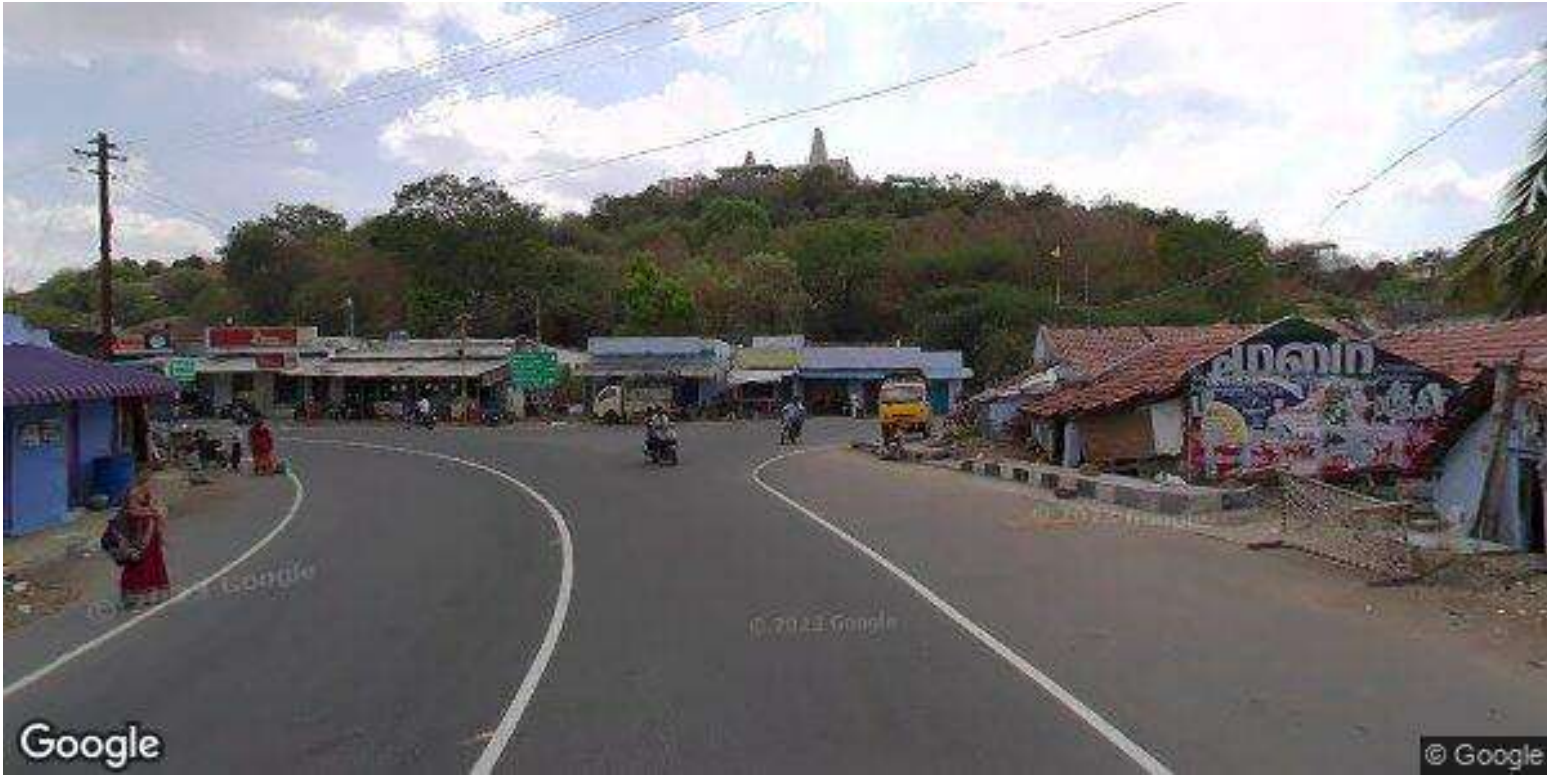
**Risk Type:** Turn  
**Risk Level:** Medium  
**Speed Limit:** 30 KM/Hr  
**Coordinates:** 11.41473, 78.08082
