# IndianOil

## JOURNEY RISK MANAGEMENT (JRM) STUDY

### Salem Terminal TO SRI VENKATASWARA SERVICE STN.

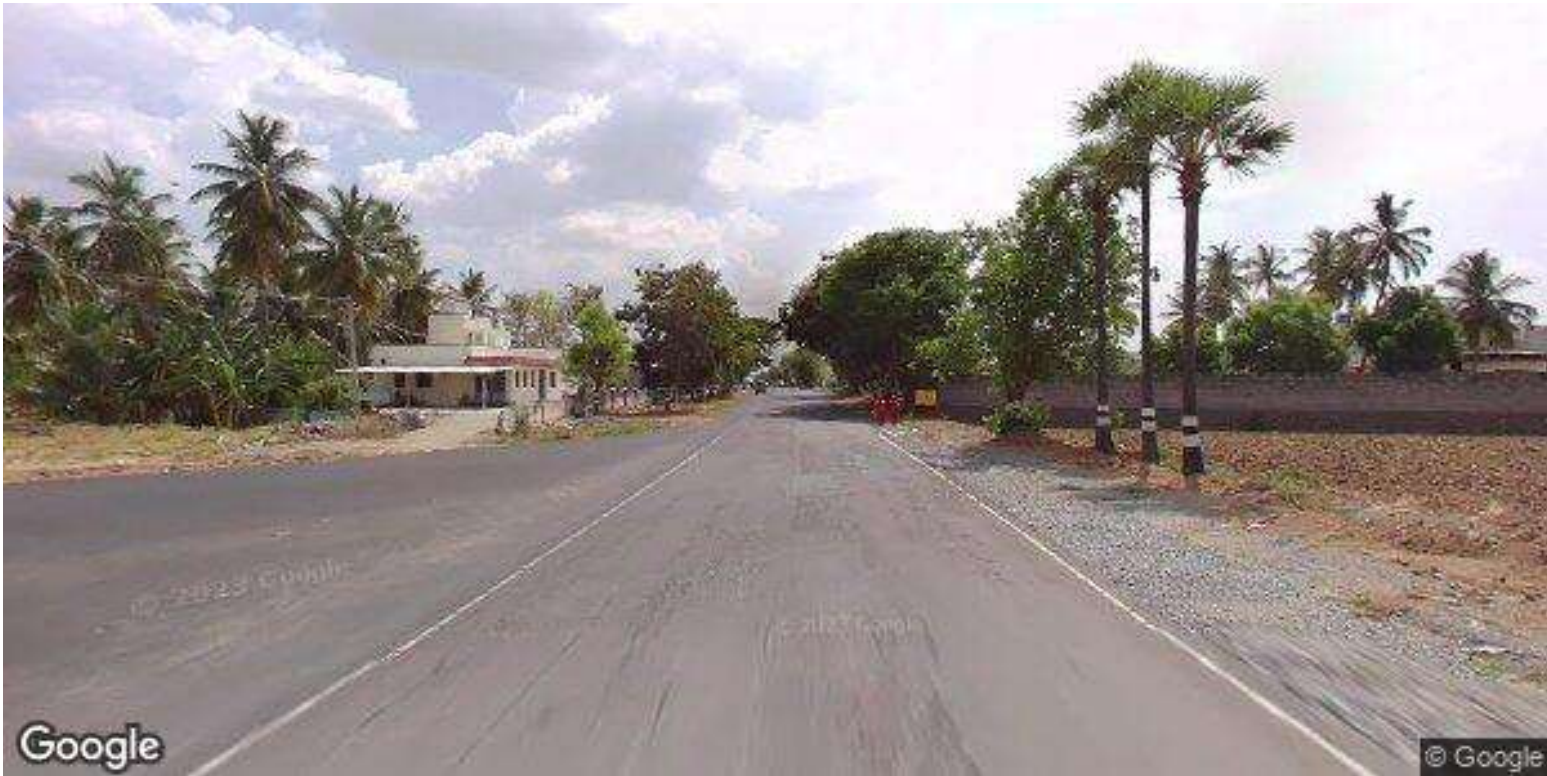
**Risk Type:** Turn  
**Risk Level:** High  
**Speed Limit:** 15 KM/Hr  
**Coordinates:** 11.42964, 78.11587

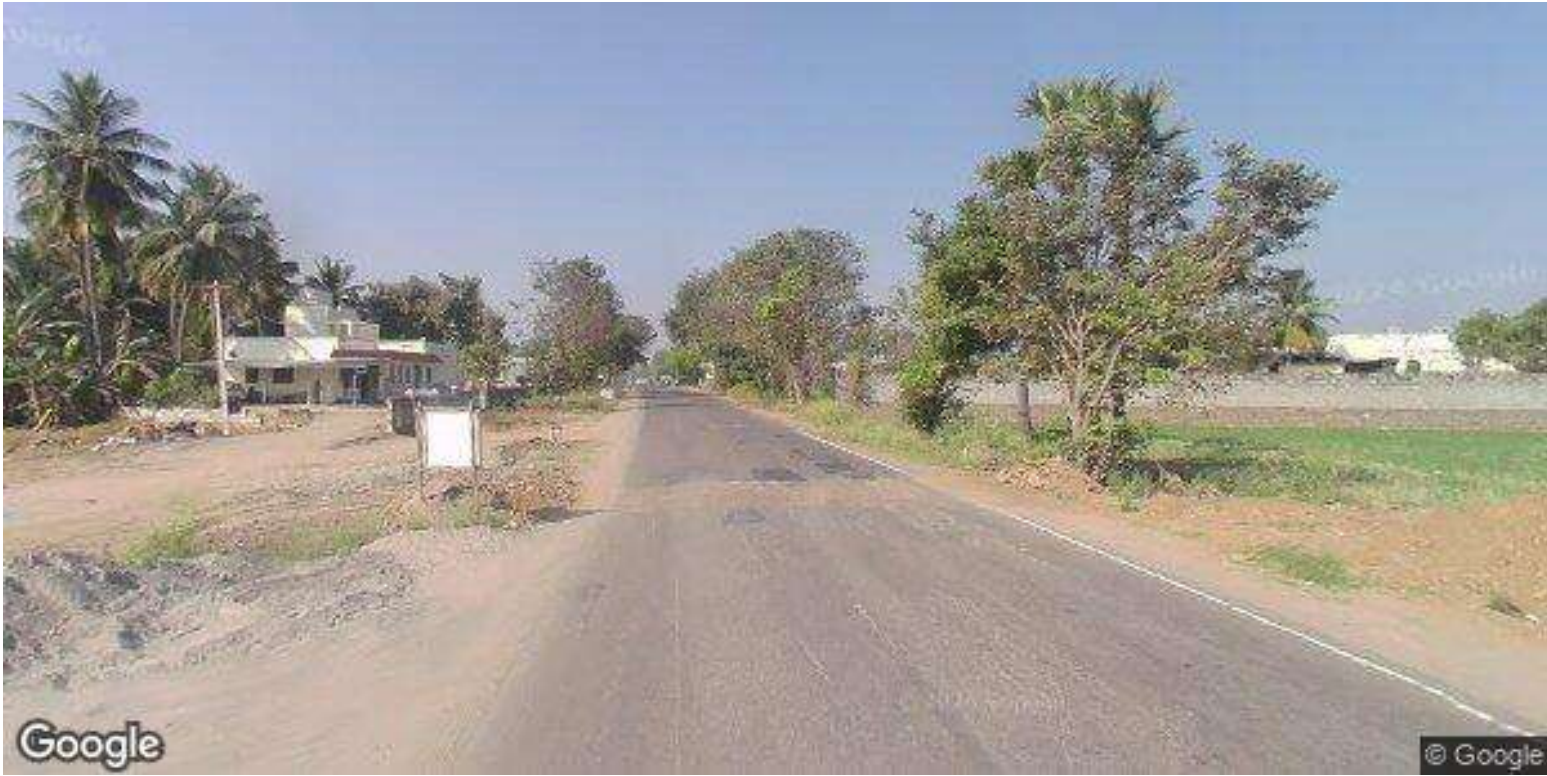
**Risk Type:** Turn  
**Risk Level:** Medium  
**Speed Limit:** 30 KM/Hr  
**Coordinates:** 11.42956, 78.11590

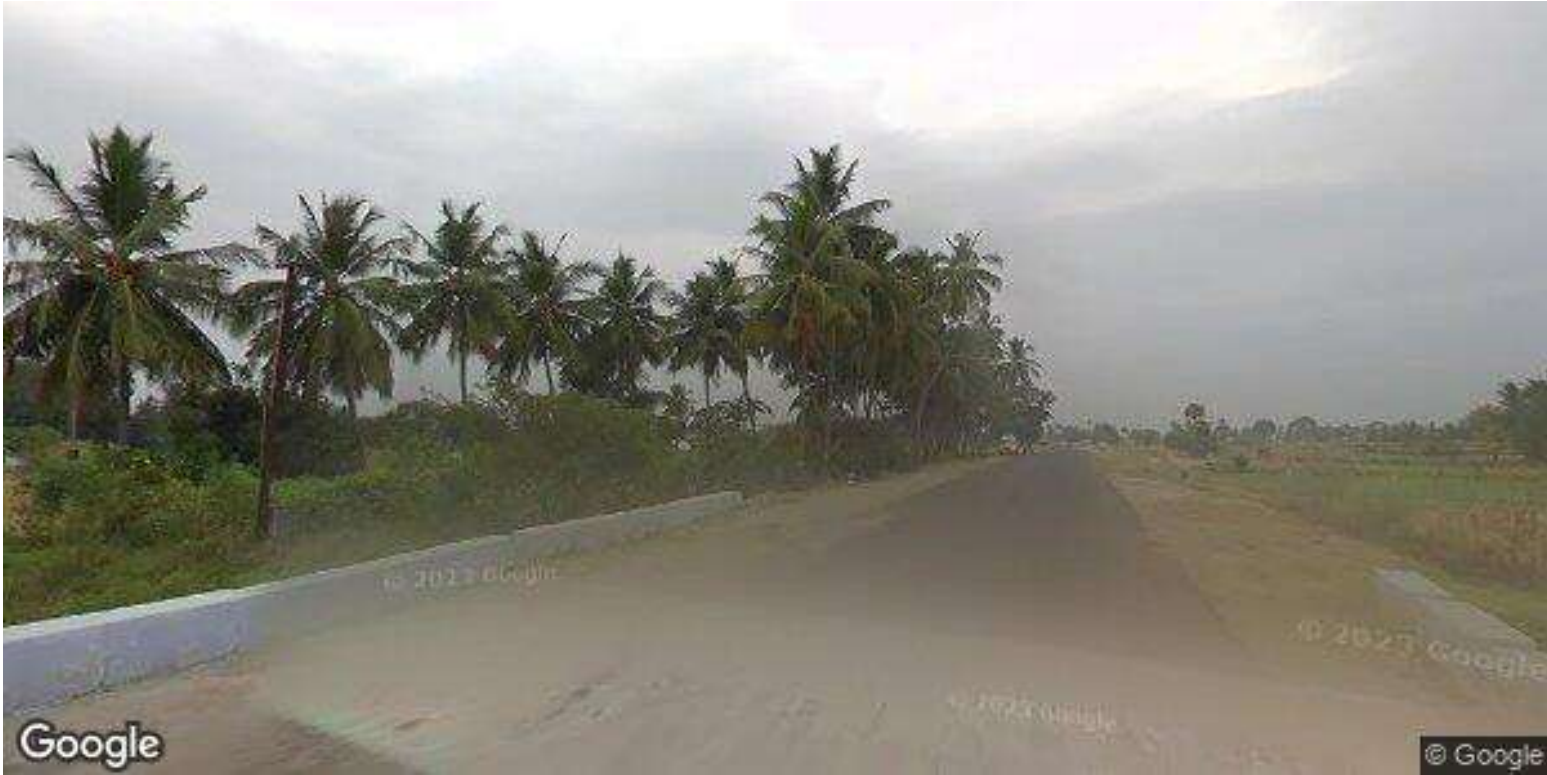
**Risk Type:** Turn  
**Risk Level:** Medium  
**Speed Limit:** 30 KM/Hr  
**Coordinates:** 11.42450, 78.15278

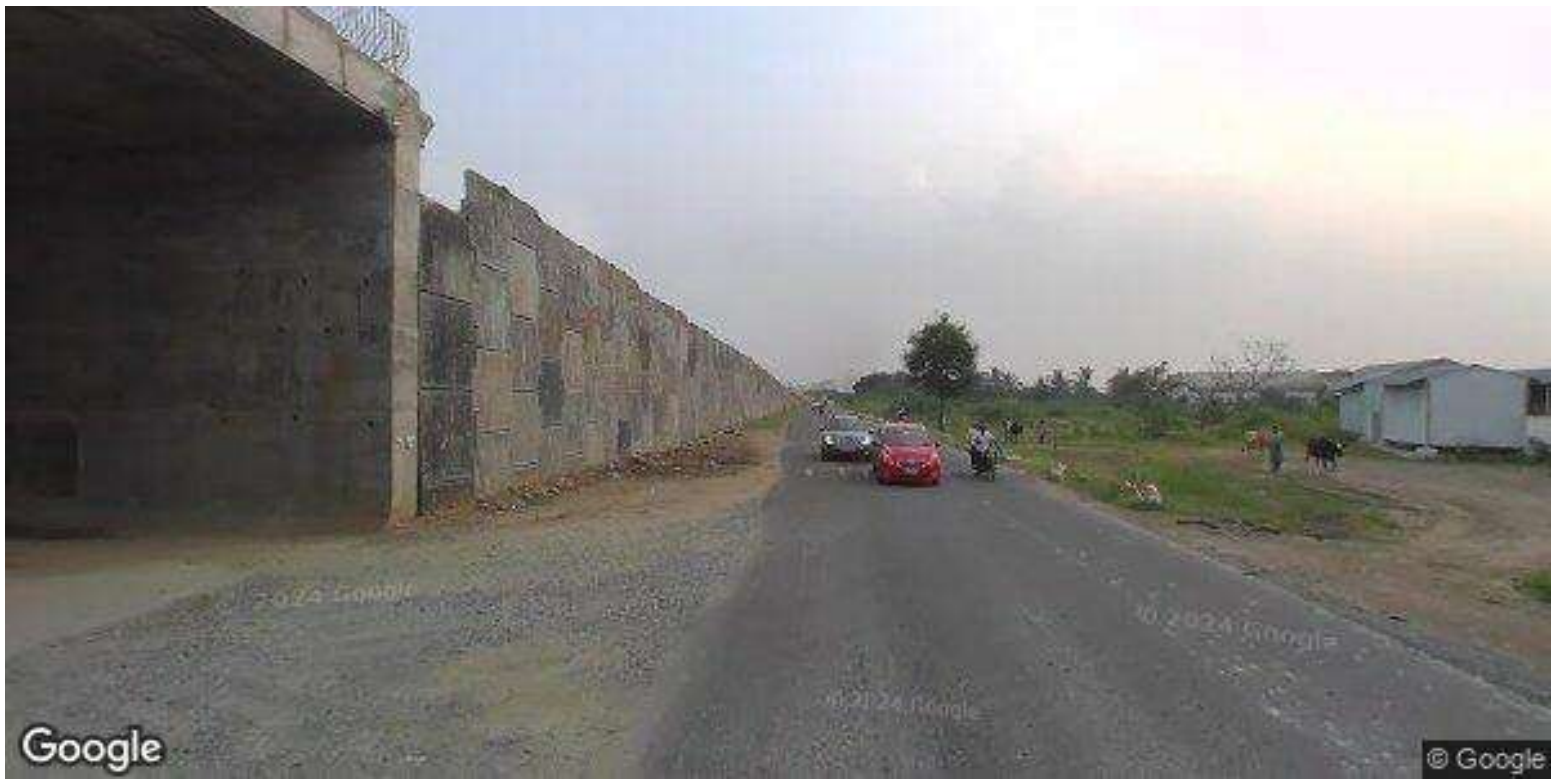
**Risk Type:** Turn  
**Risk Level:** High  
**Speed Limit:** 15 KM/Hr  
**Coordinates:** 11.42622, 78.15562

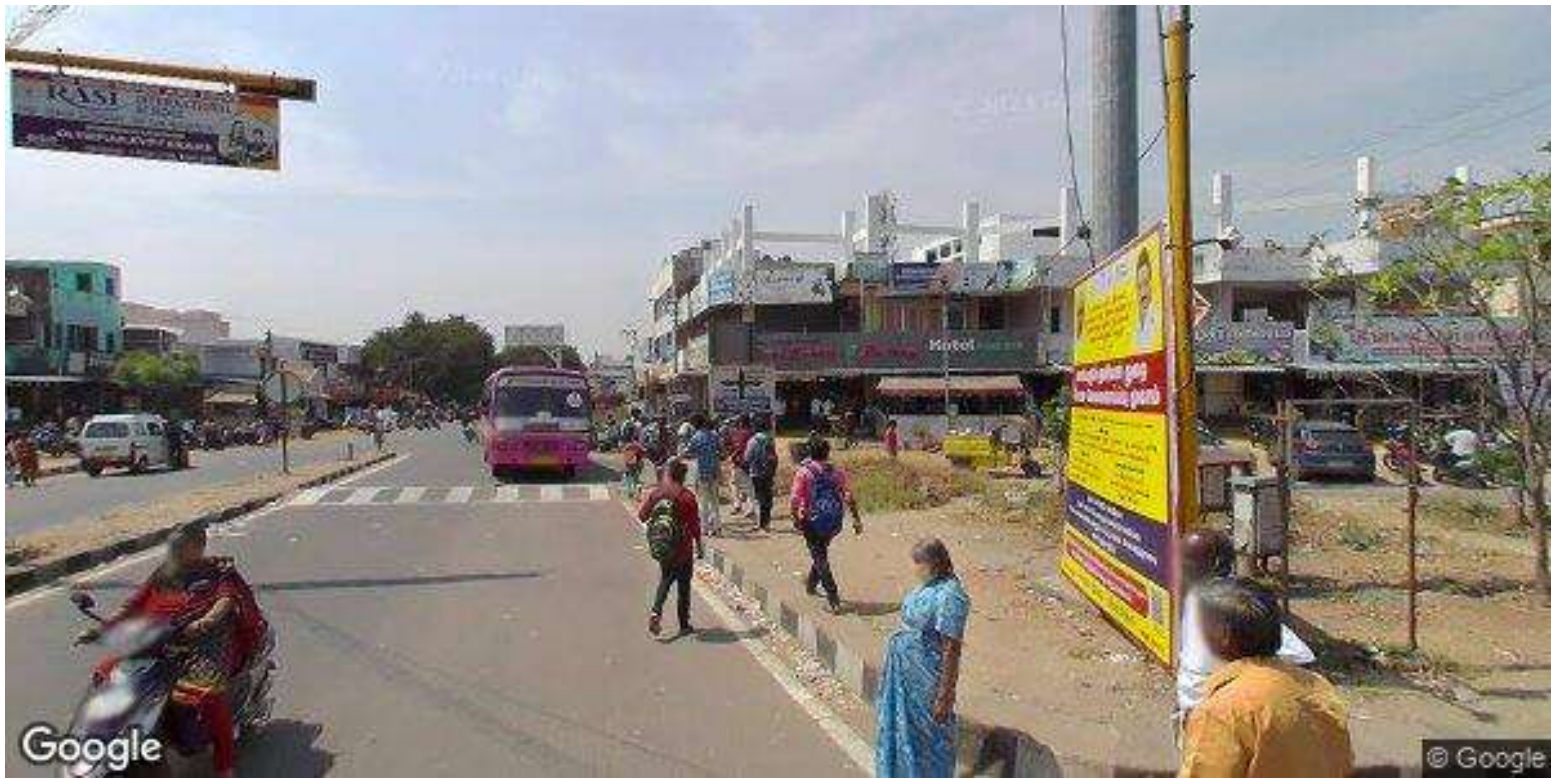
**Risk Type:** Turn  
**Risk Level:** High  
**Speed Limit:** 15 KM/Hr  
**Coordinates:** 11.44547, 78.15837
