# IndianOil

## JOURNEY RISK MANAGEMENT (JRM) STUDY

### Salem Terminal TO GUNA AGENCIES

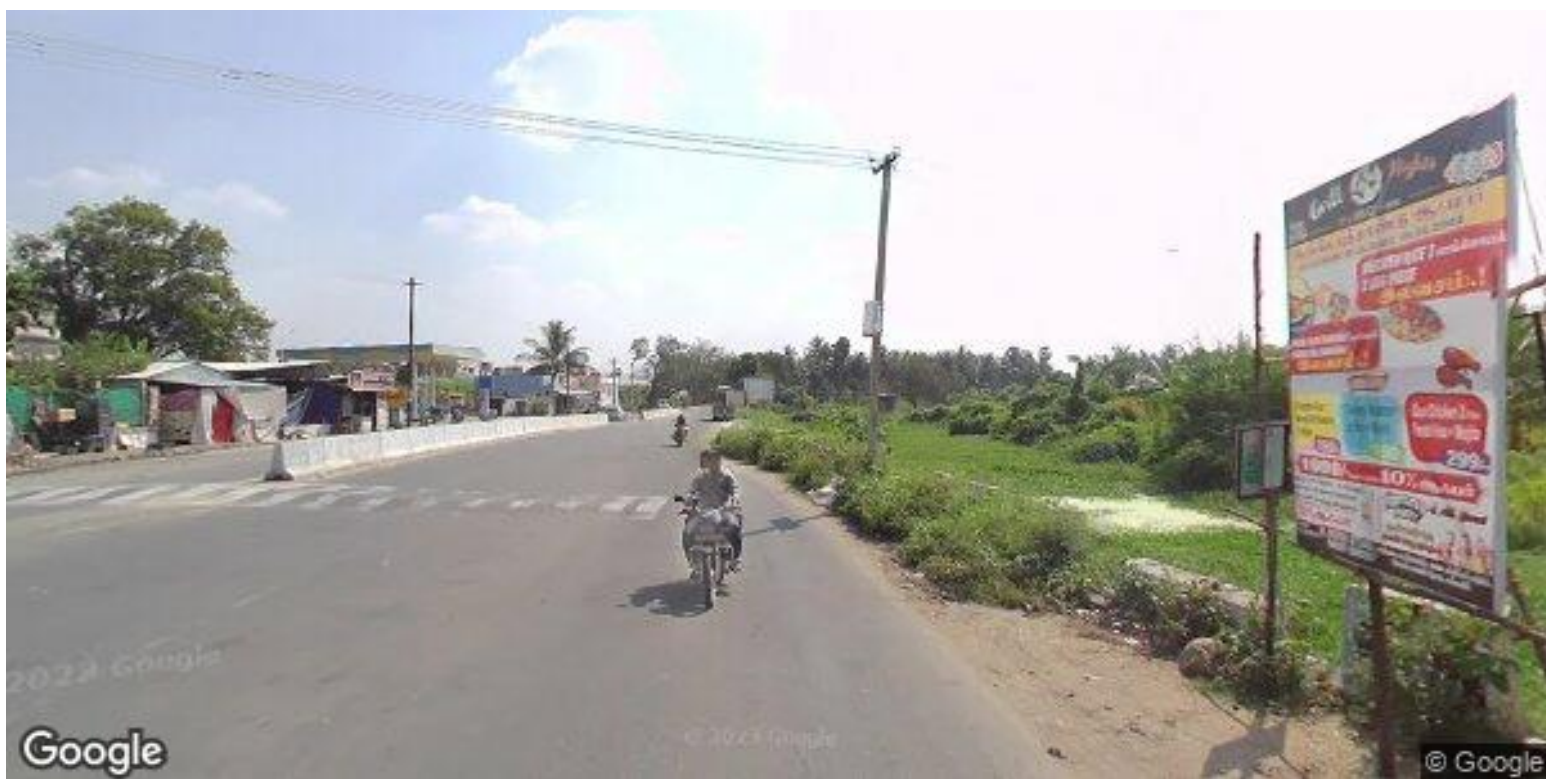
**Coordinates:** 11.44861, 77.87429

**Risk Type:** Turn

**Risk Level:** High

**Speed Limit:** 15 KM/Hr

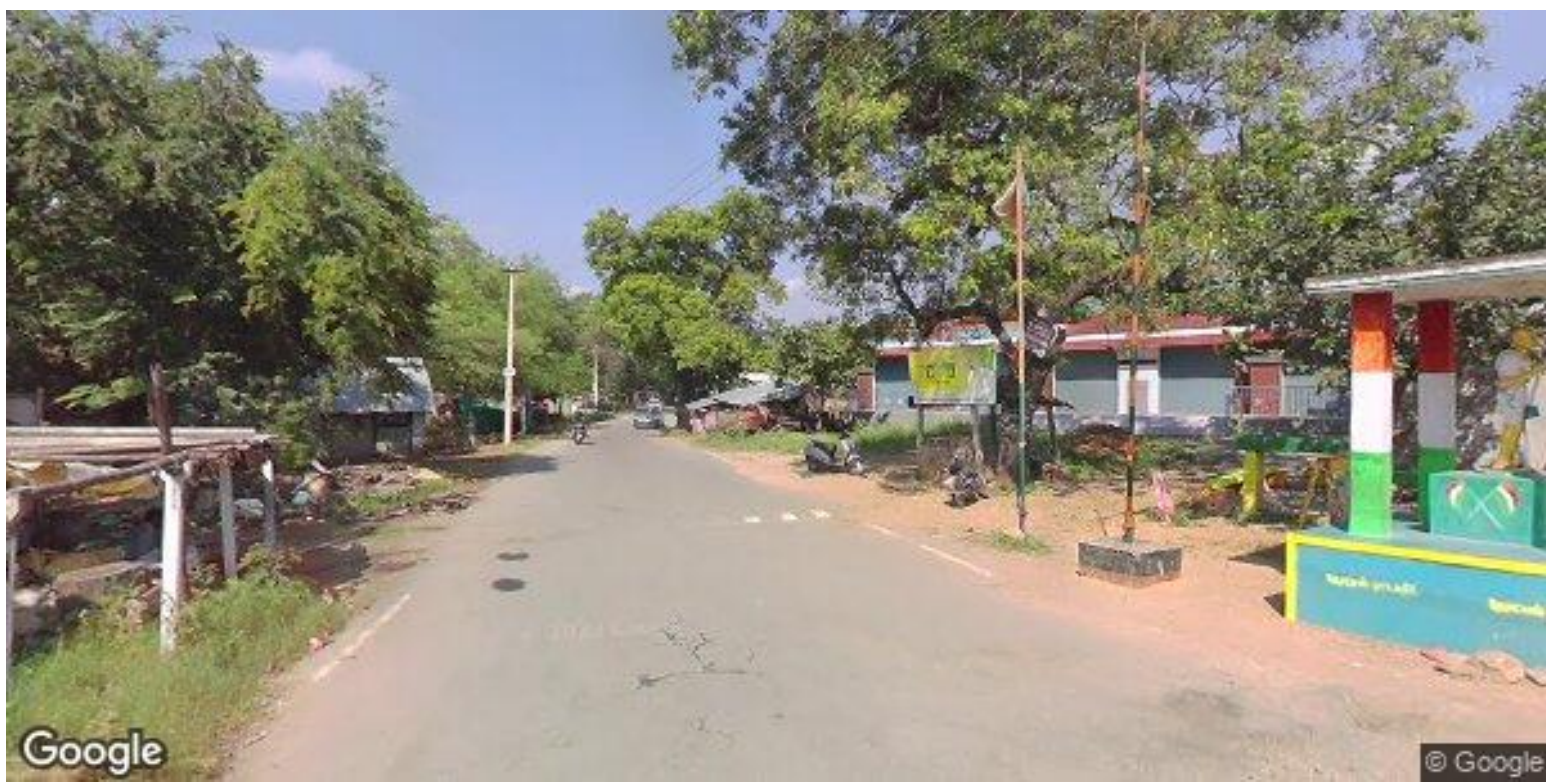
**Risk Type:** Blind Spot  
**Risk Level:** Blind Spot  
**Speed Limit:** 10 KM/Hr  
**Coordinates:** 11.43673, 77.91703

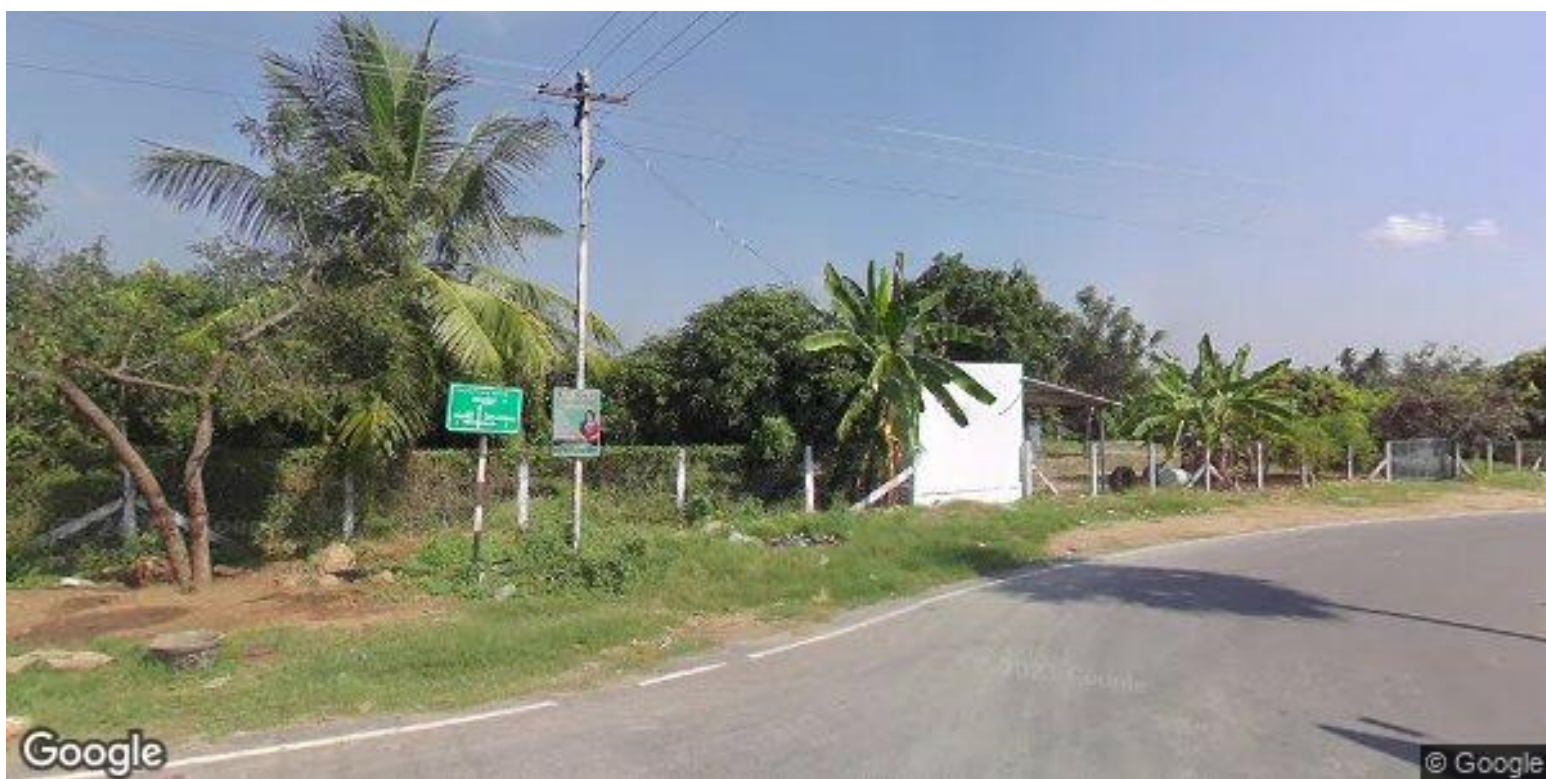
**Risk Type:** Turn  
**Risk Level:** High  
**Speed Limit:** 15 KM/Hr  
**Coordinates:** 11.43926, 77.91705

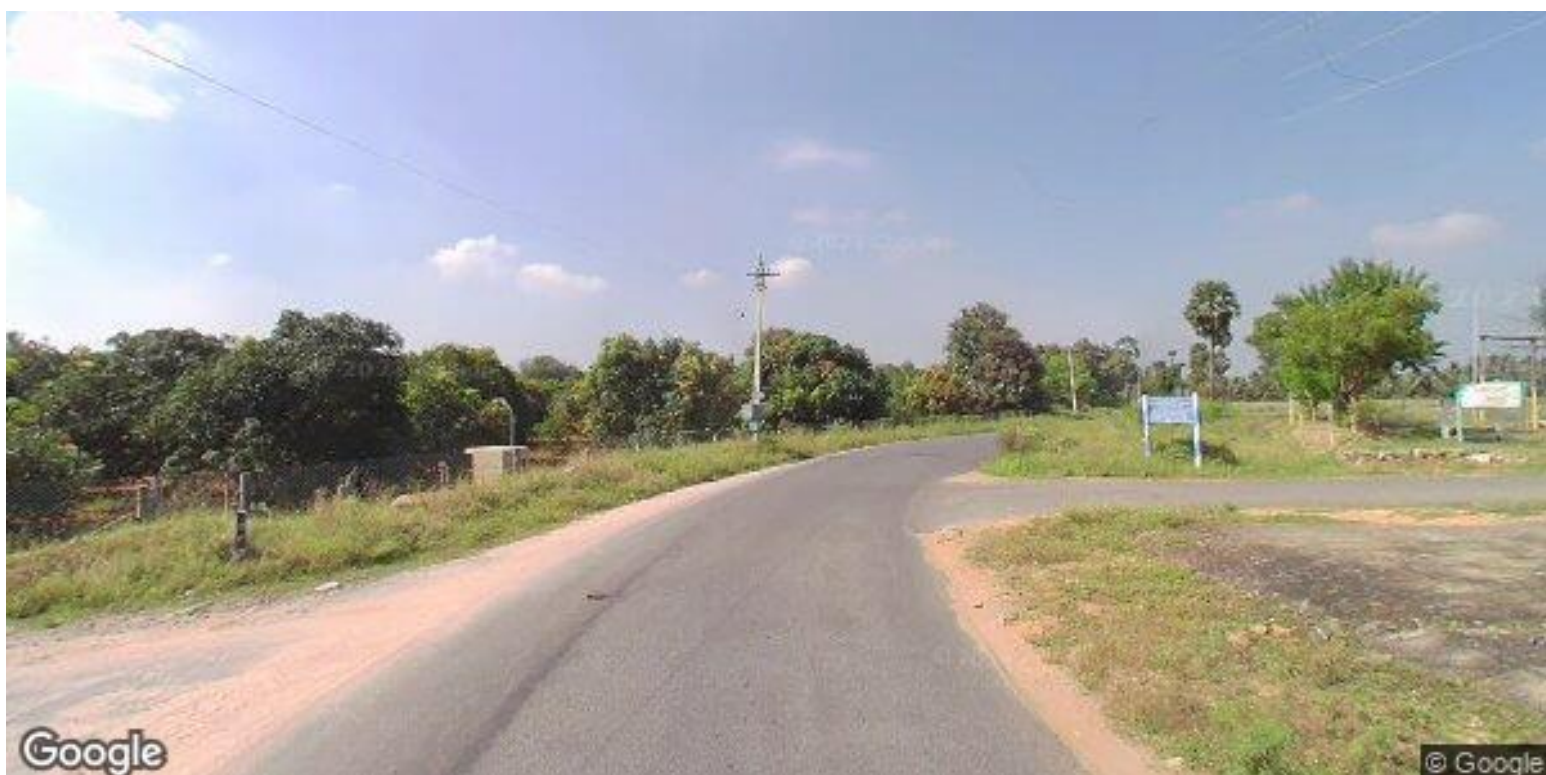
**Risk Type:** Turn  
**Risk Level:** Medium  
**Speed Limit:** 30 KM/Hr  
**Coordinates:** 11.43936, 77.92301

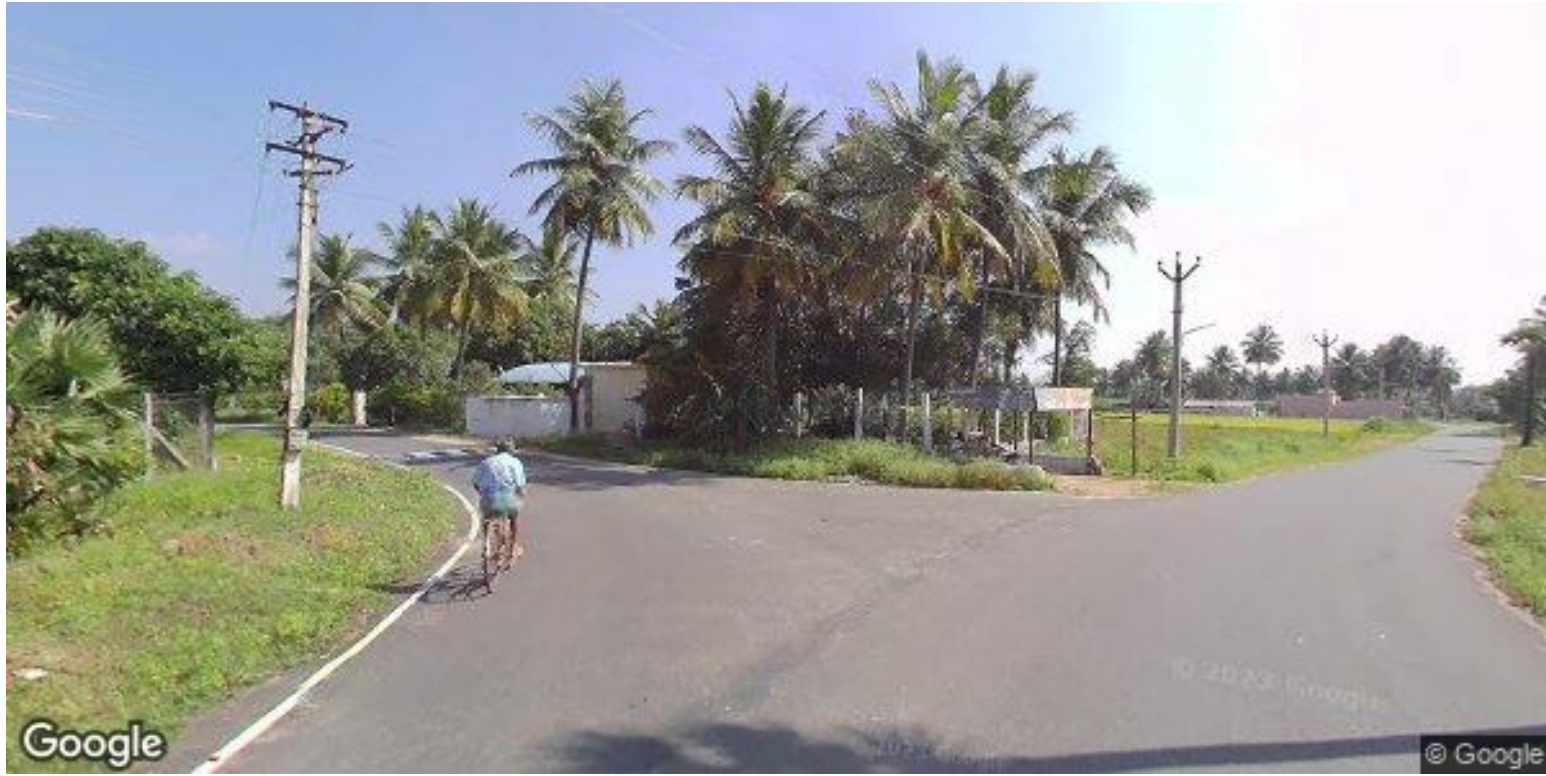
**Risk Type:** Turn  
**Risk Level:** Medium  
**Speed Limit:** 30 KM/Hr  
**Coordinates:** 11.43997, 77.92587

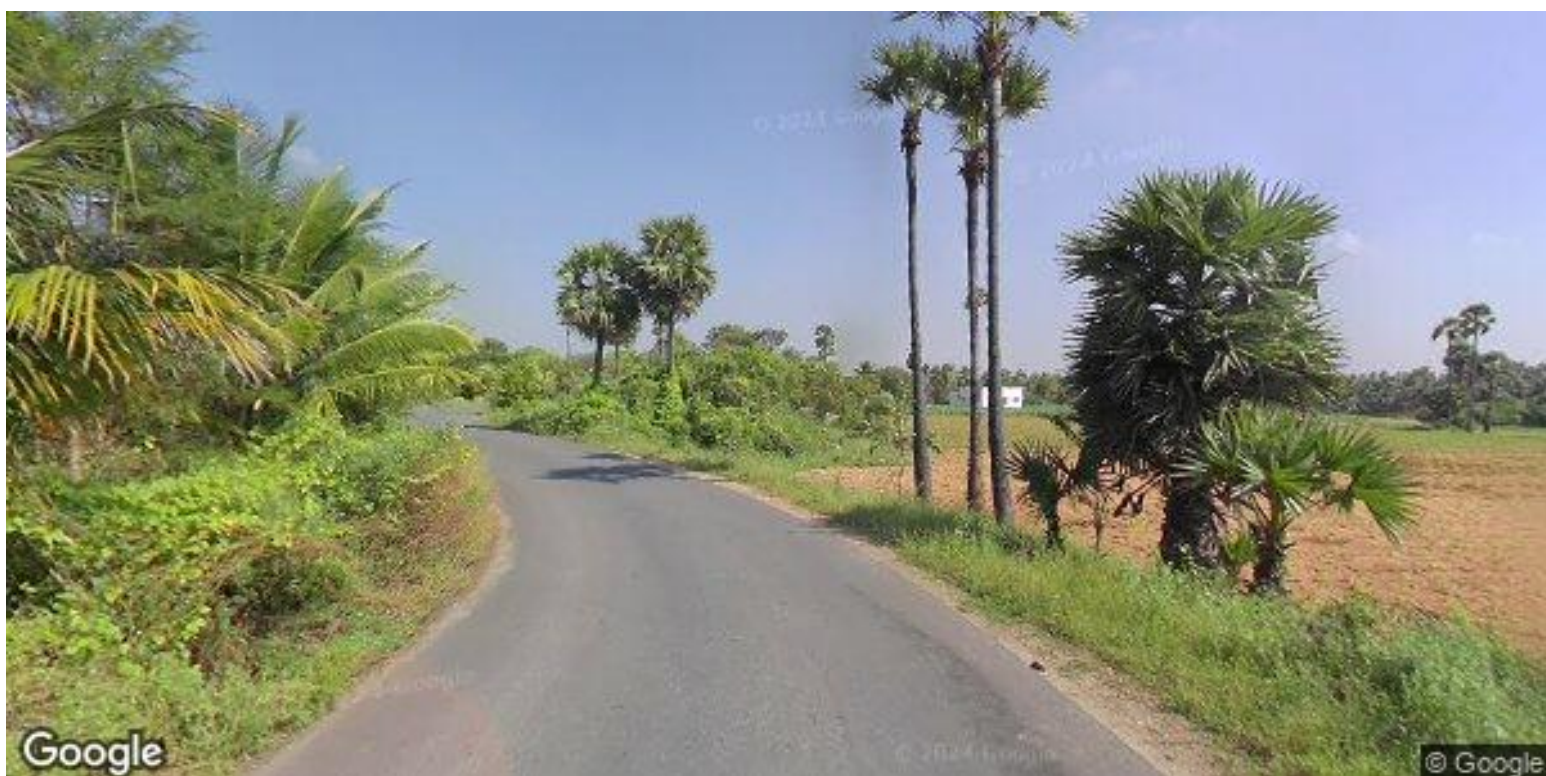
**Coordinates:** 11.44088, 77.93223

**Risk Type:** Turn

**Risk Level:** Medium

**Speed Limit:** 30 KM/Hr

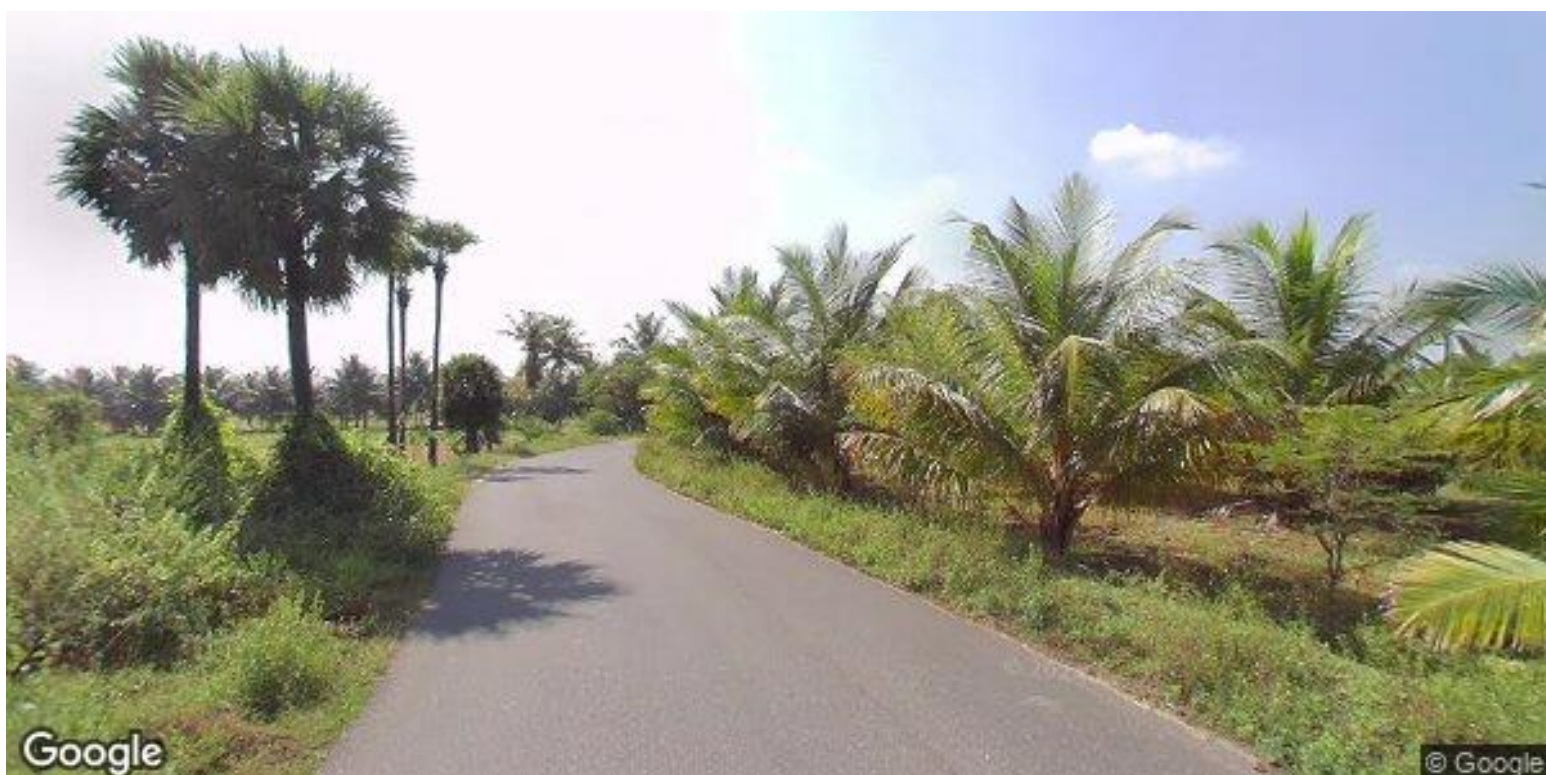
**Coordinates:** 11.44127, 77.93218

**Risk Type:** Turn

**Risk Level:** Medium

**Speed Limit:** 30 KM/Hr

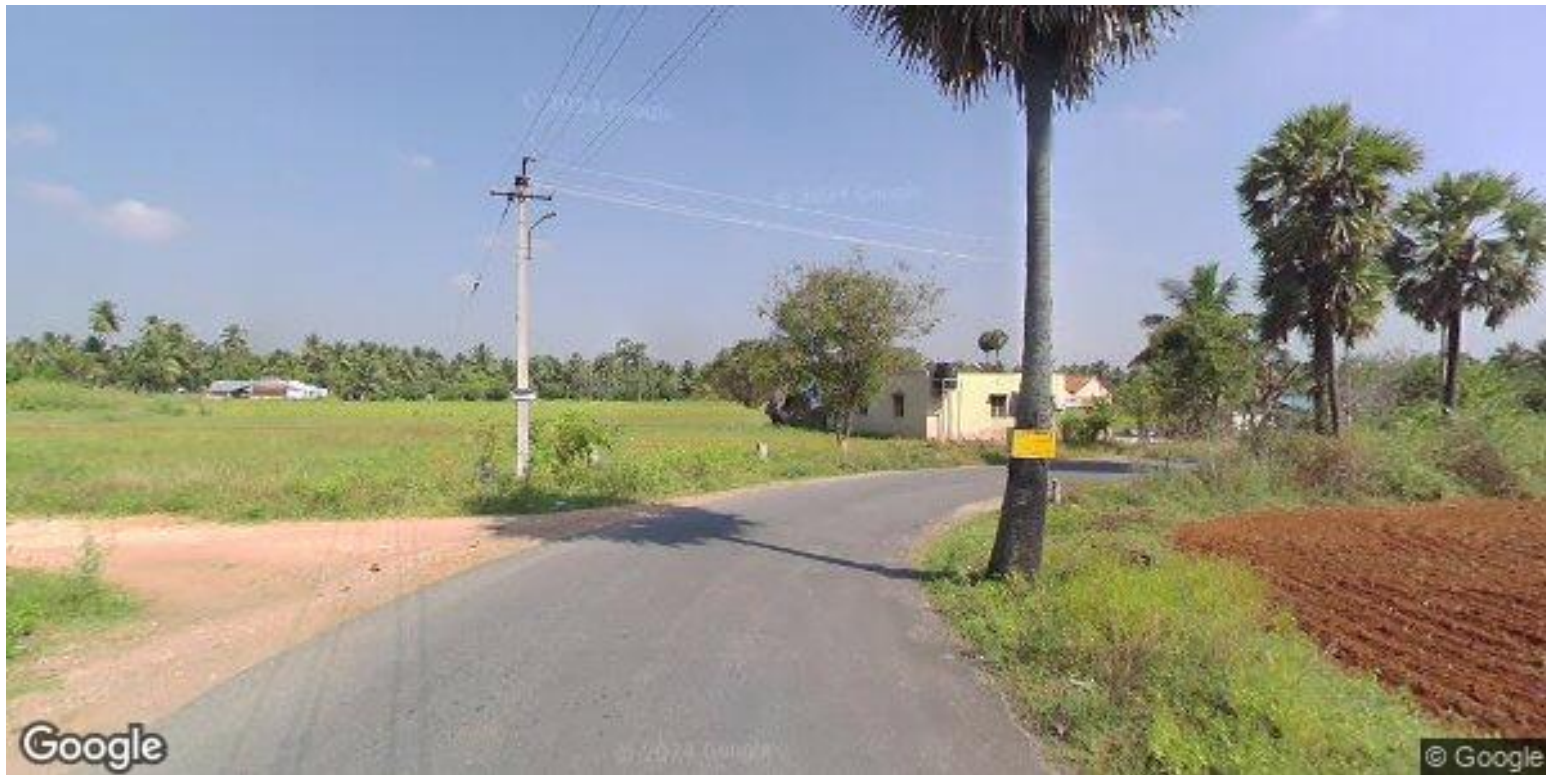
**Coordinates:** 11.44243, 77.93244

**Risk Type:** Turn

**Risk Level:** Medium

**Speed Limit:** 30 KM/Hr

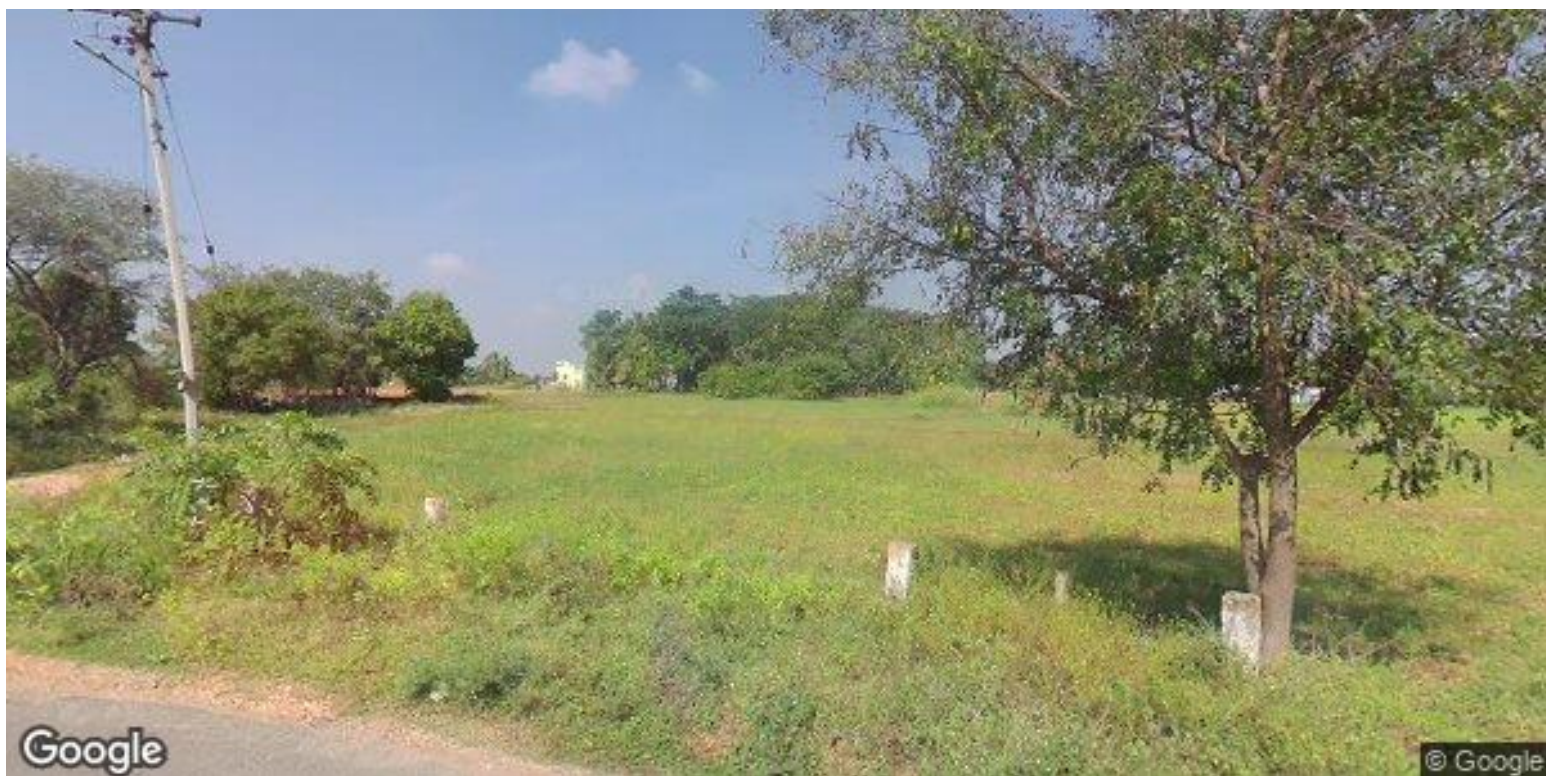
**Coordinates:** 11.44254, 77.93256

**Risk Type:** Turn

**Risk Level:** Medium

**Speed Limit:** 30 KM/Hr

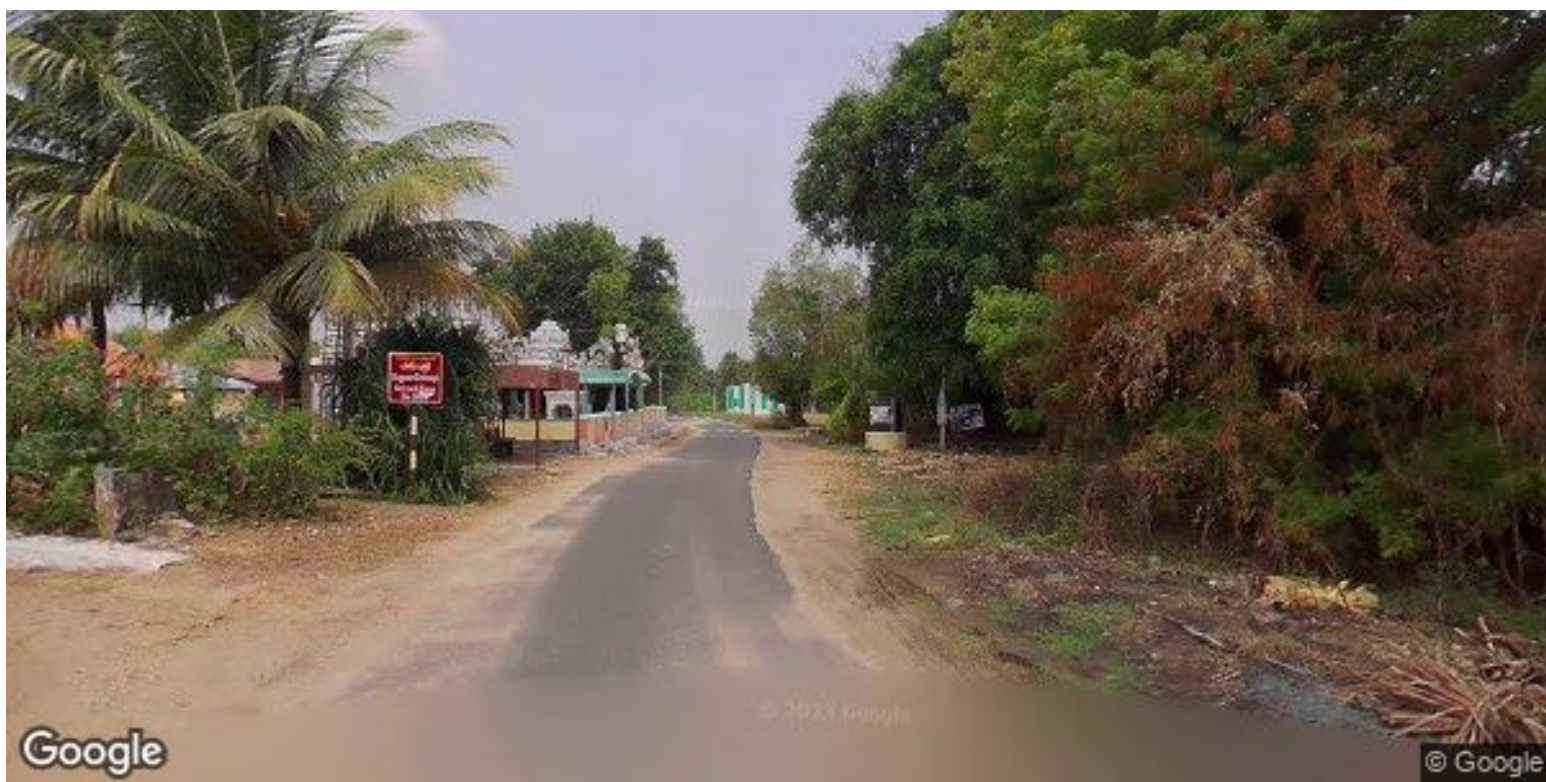
**Coordinates:** 11.44172, 77.94140

**Risk Type:** Turn

**Risk Level:** Medium

**Speed Limit:** 30 KM/Hr

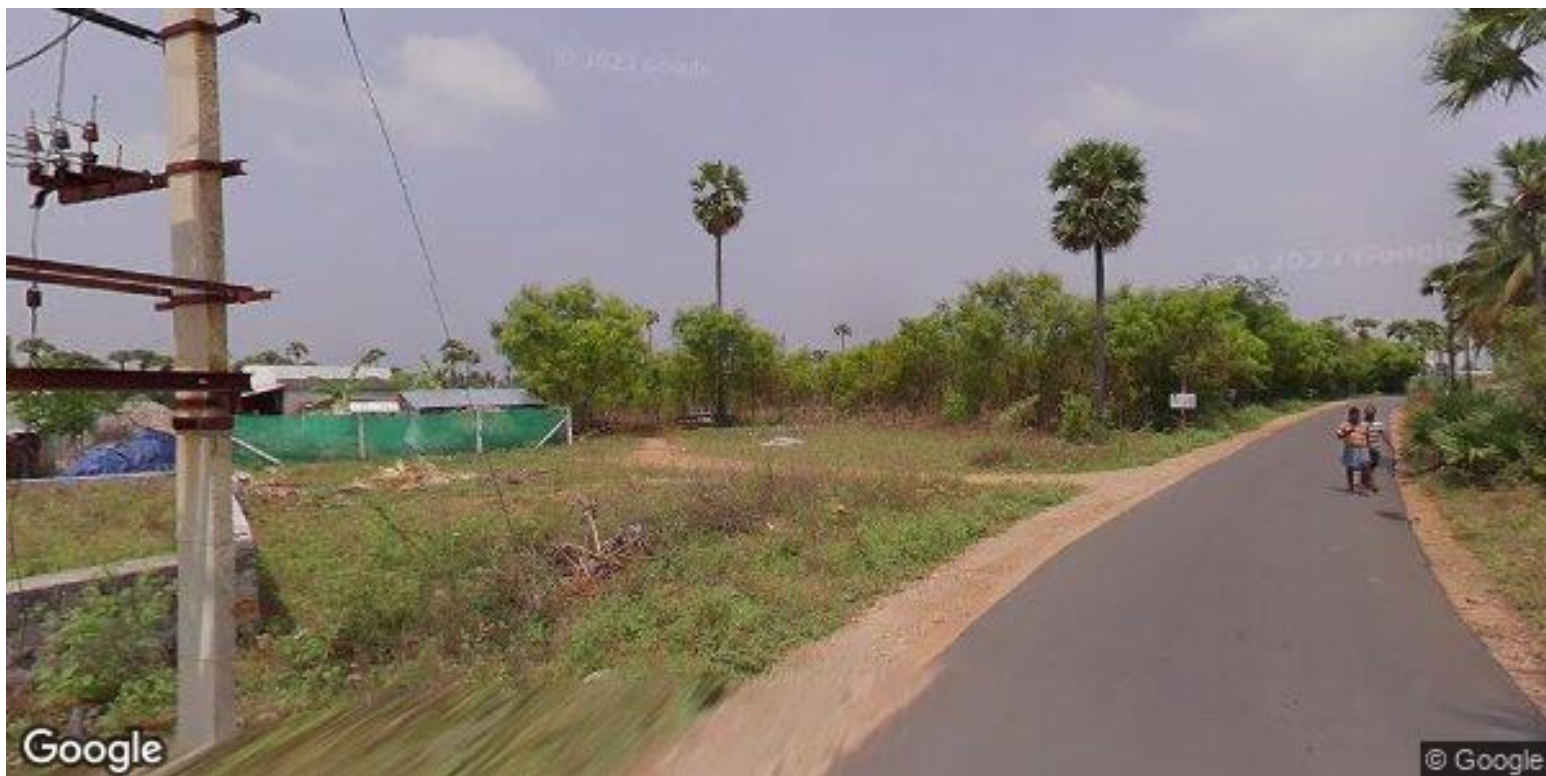
**Coordinates:** 11.44369, 77.96036

**Risk Type:** Turn

**Risk Level:** Medium

**Speed Limit:** 30 KM/Hr

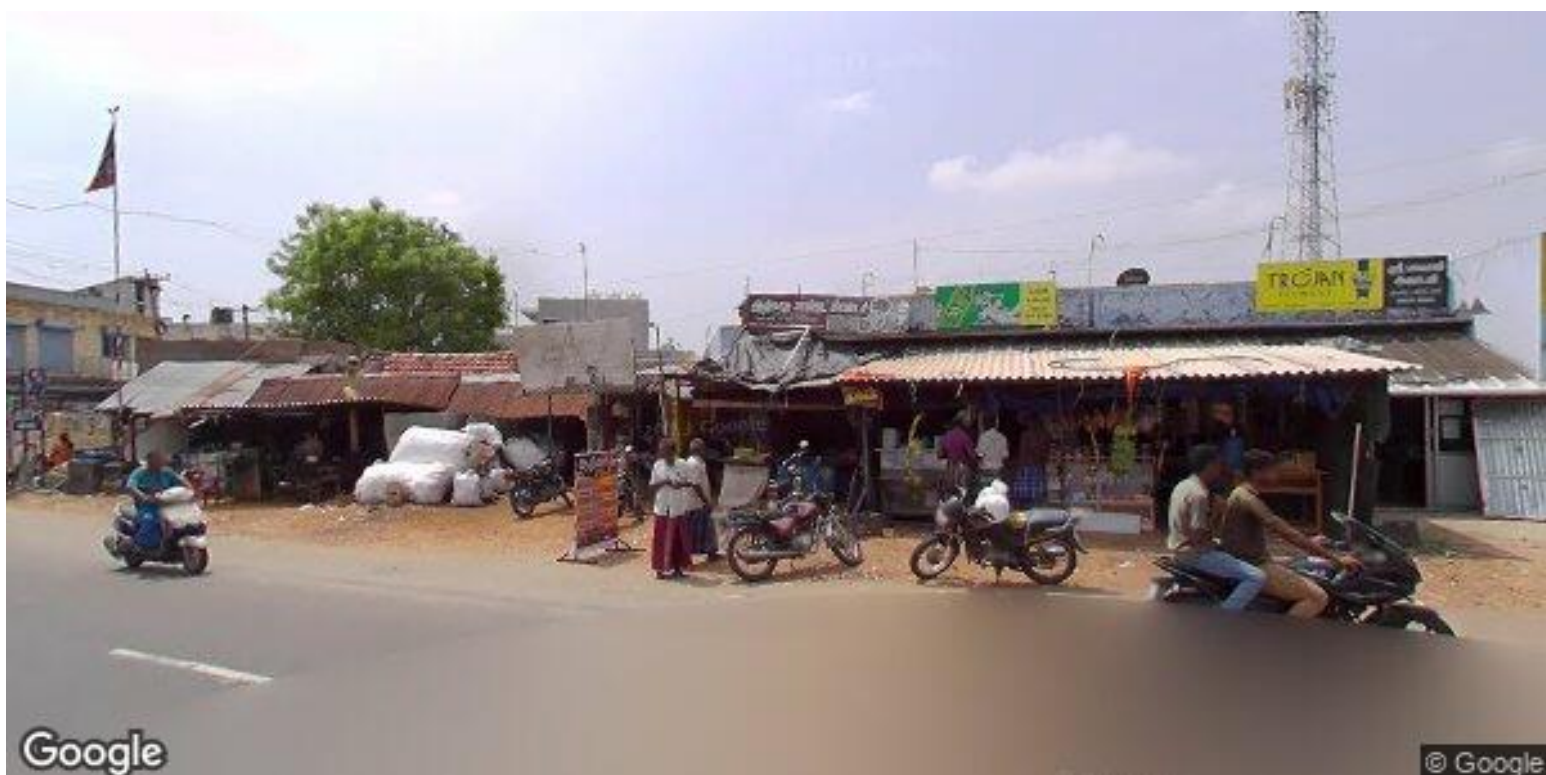
**Coordinates:** 11.44387, 77.96283

**Risk Type:** Turn

**Risk Level:** High

**Speed Limit:** 15 KM/Hr

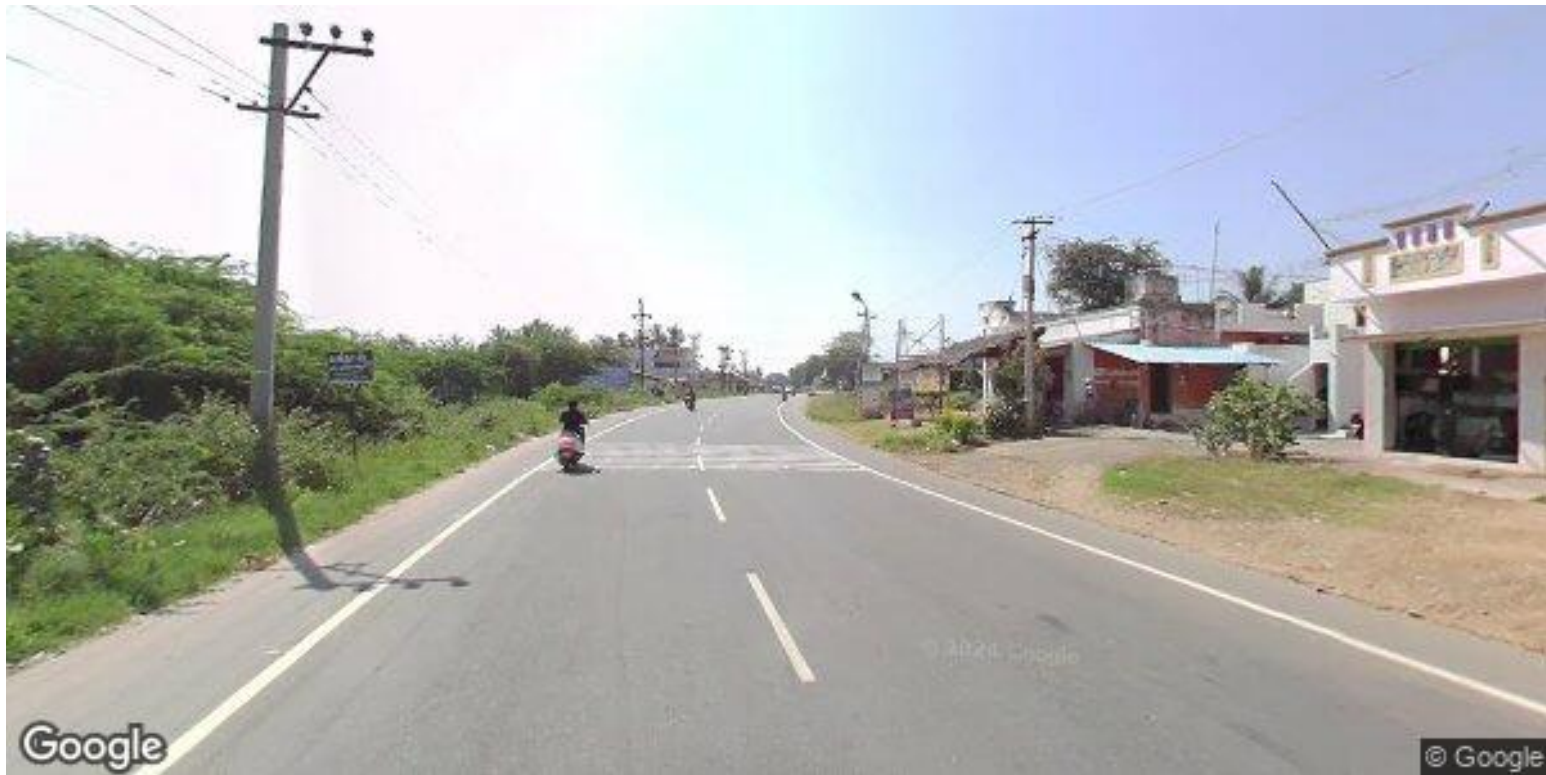
**Coordinates:** 11.52943, 78.04650

**Risk Type:** Blind Spot

**Risk Level:** Blind Spot

**Speed Limit:** 10 KM/Hr
