# Flanders Loft

## FY 2026 RESERVE STUDY AND MAINTENANCE SCHEDULE

**Flanders Loft Community  
Association  
c/o  
Bluestone Real Estate  
Services**

**November 4, 2025**

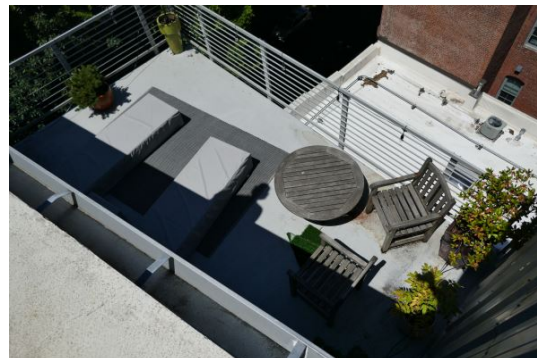
### Decks - Railings - Repair

| Code | Desc. | Service Date | Replace Date | Rem Life | Adj Life | Quantity | Current Cost | Future Cost |
|---|---|---|---|---|---|---|---|---|
| 910-000-0009 | | 01/01/1998 | 01/01/2034 | 8:00 | 36:00 | 1 | 5,299.34 | 6,292.94 |

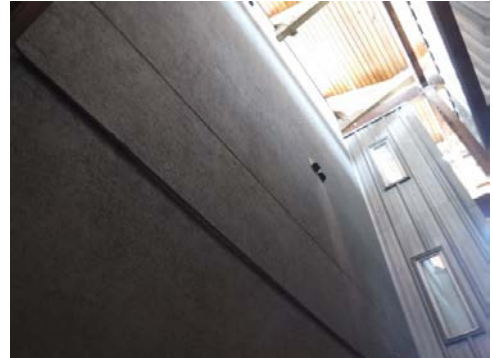
### Siding - Stucco/EIFS - Replacement

This component funds for the replacement of the stucco siding at the 4th floor (breezeway) and under the windows on the ground level of the building and includes hauling away of debris.

This item was observed to be in good condition by Forensic.
