## **Quality Assurance Management, Inc.**

## **Oxygen Test Report**

## **Moisture Test Report**

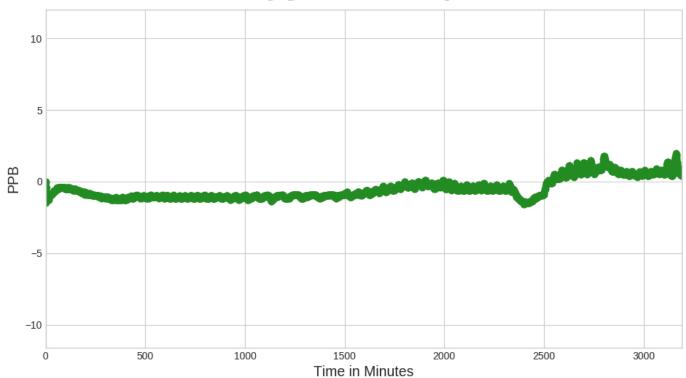
Client:	TEST CLIENT		Analyzer:	Delta F	
Facility:	QAM HQ		Serial Number:	PT-23473	-V6
Tool / Equipment ID:			Calibration Due:	Not calibra	ated
System:			Instrument Flow:	2.0	SCFH
Source ID:			Start Time/Date:	10:15 06/19/21	
Test Point ID:			Stop Time/Date:	15:24 06/21/21	
Test Gas:			Test Duration:	5 hours 9 minutes 6 seconds	
Test Flow:	4.3	SCFH	Average:	-0.5	PPB
Technician:			Final:	0.4	PPB
			Specification:	20	PPB

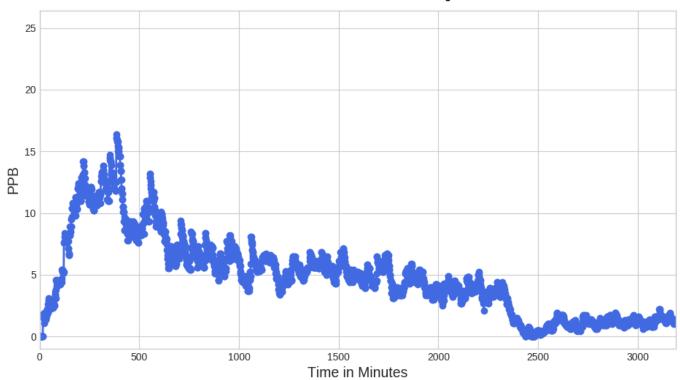
Client:	TEST CLIENT		Analyzer:	Tracer 2	
Facility:	QAM HQ		Serial Number:	17481-44-	1
Tool / Equipment ID:			Calibration Due:	02/23/202	3
System:			Instrument Flow:	2.3	SCFH
Source ID:			Start Time/Date:	10:15 06/1	9/21
Test Point ID:			Stop Time/Date:	15:24 06/2	21/21
Test Gas:			Test Duration:	5 hours 9	minutes 6 seconds
Test Flow:	4.3	SCFH	Average:	4.9	PPB
Technician:			Final:	1.1	PPB
			Specification:	20	PPB
