## **Oxygen Test Report**

## **Moisture Test Report**

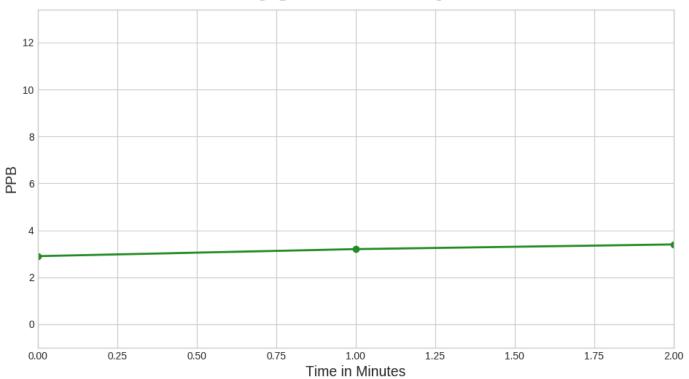
¬		
Client:	TEST CLIENT		Analyzer:	Delta F	
Facility:	QAM HQ		Serial Number:	PT-11058-V6	
Tool / Equipment ID:			Calibration Due:	08/06/2022	
System:			Instrument Flow:	2.0	SCFH
Source ID:			Start Time/Date:	12:59 09/13/21	
Test Point ID:			Stop Time/Date:	13:01 09/13/21	
Test Gas:			Test Duration:	2 minutes	
Test Flow:	4.3	SCFH	Average:	3.2	PPB
Technician:			Final:	3.4	PPB
			Specification:	20	PPB

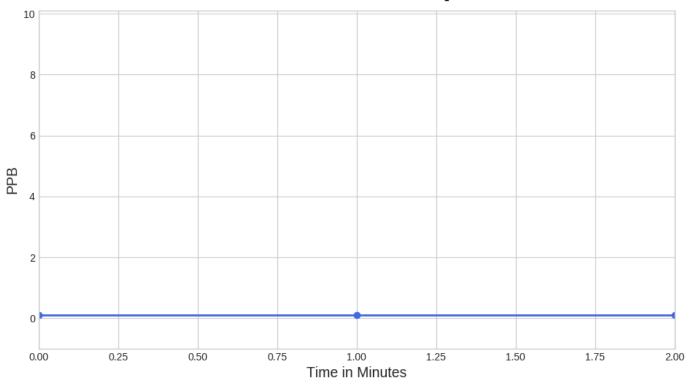
Client:	TEST CLIENT		Analyzer:	Tracer 2	
Facility:	QAM HQ		Serial Number:	17481-44-1	
Tool / Equipment ID:	D:		Calibration Due:	02/23/2023	
System:			Instrument Flow:	2.3	SCFH
Source ID:			Start Time/Date:	12:59 09/13/21	
Test Point ID:			Stop Time/Date:	13:01 09/13/21	
Test Gas:			Test Duration:	2 minutes	
Test Flow:	4.3	SCFH	Average:	0.1	PPB
Technician:			Final:	0.1	PPB
			Specification:	20	PPB
