## **Quality Assurance Management, Inc.**

## **Oxygen Test Report**

## **Moisture Test Report**

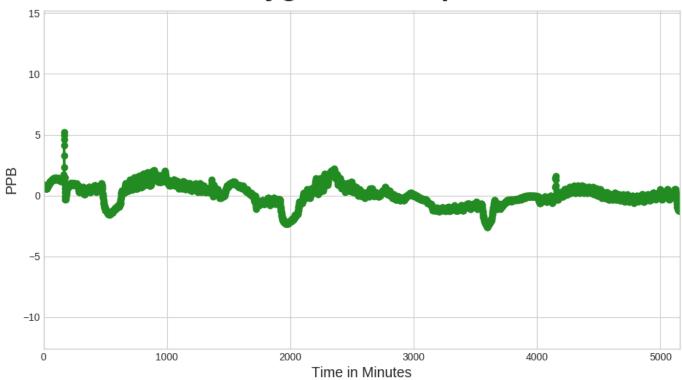
Client:	TEST CLIENT		Analyzer:	Delta F					
Facility:	QAM HQ		Serial Number:	PT-23473-V6					
Tool / Equipment ID:			Calibration Due:	Not calibrated					
System:			Instrument Flow:	2.0	SCFH				
Source ID:			Start Time/Date:	17:31 06/23/21					
Test Point ID:			Stop Time/Date:	07:25 06/27/21					
Test Gas:			Test Duration:	13 hours 53 minutes		48 seconds			
Test Flow:	4.3	SCFH	Average:	0.1	PPB				
Technician:			Final:	-1.3	PPB				
			Specification:	20	PPB

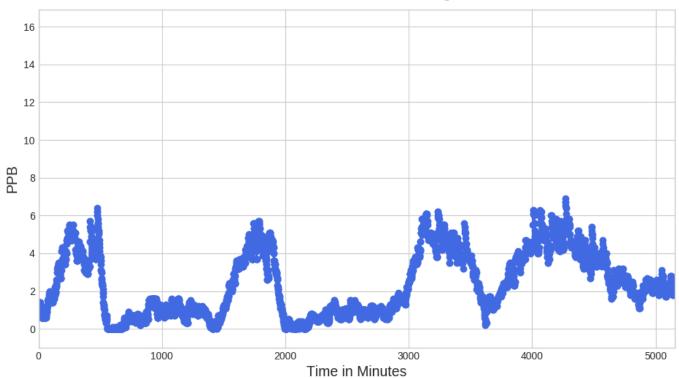
Client:	TEST CLIENT		Analyzer:	Tracer 2				
Facility:	QAM HQ		Serial Number:	17481-44-	1			
Tool / Equipment ID:			Calibration Due:	02/23/202	3			
System:			Instrument Flow:	2.3	SCFH			
Source ID:			Start Time/Date:	17:31 06/2	23/21			
Test Point ID:			Stop Time/Date:	07:25 06/2	27/21			
Test Gas:			Test Duration:	13 hours 5	3 minutes 48 seconds			
Test Flow:	4.3	SCFH	Average:	2.2	PPB			
Technician:			Final:	1.8	PPB			
			Specification:	20	PPB
