## Doolittle Construction, LLC

Re: Cherry Ridge Estates Chip Seal

# Limitations of Chip Seal - A Guide for Determining What Treatment is Needed

## **UPDATE: Proven Value from Double Chip Seal**

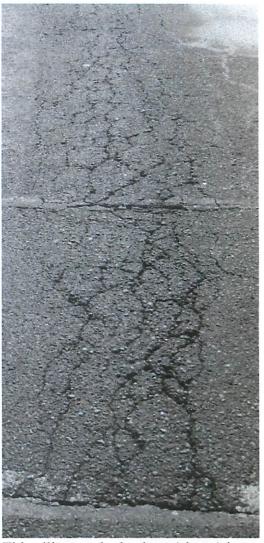
This alligatored wheel rut (above) is too far gone to be saved by crack seal with a single chip seal. It could be repaired by grinding it out, then patching with hot mix asphalt (HMA).

But if the rutting is not too severe, it would be more cost efficient to place a chip seal patch first, then chip seal full width. Unless there is a poor sub-grade, double chip seal or double bituminous surface treatment (DBST) is the most cost effective way to deal with asphalt pavement that has deteriorated too far to be saved by a single chip seal. The road shown below carries light to moderate traffic, and has not had any maintenance in over 30 years; an excellent candidate for double chip seal. This treatment will hold up better than a thin overlay because it bonds to the old pavement better, it seals better, it is much more flexible, and it will last longer.

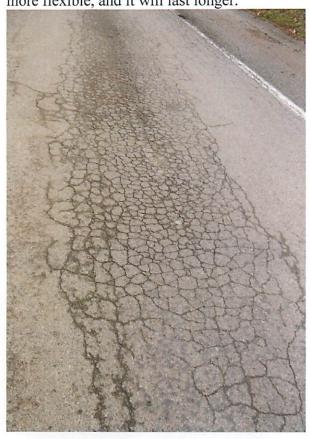
The crack sealing that was done in the past doesn't begin to cover the widespread alligatoring, below. This street is a good candidate for double chip seal. That would bring this distressed pavement up to an acceptable pavement condition, which will last beyond the next maintenance cycle.

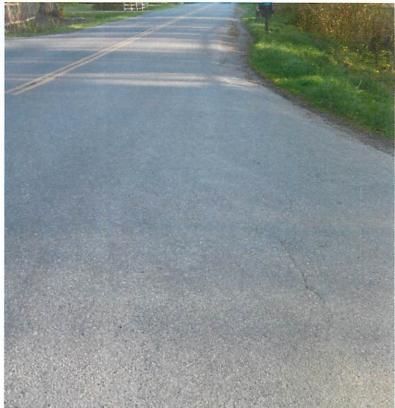
April 2016 - **16 years** after double chip seal A few cracks have started, but it is in **much** better condition than it was.

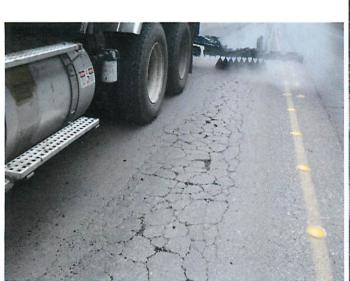
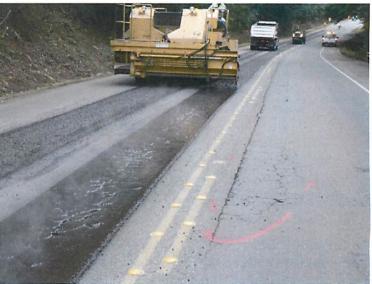
**Auburn - Kersey Road SE, from SE 53rd to south city limits** - In 2006 this major arterial, between Auburn and Lake Tapps / Bonney Lake area, received chip seal patches in the wheel ruts, before applying a double chip seal using CRS-2P. The chip seal patches and first lift were installed using 1/2"-1/4" aggregate. The second lift used 3/8"-#10 aggregate, then fog sealed using CSS-1H, (mixed 60:40 with water).

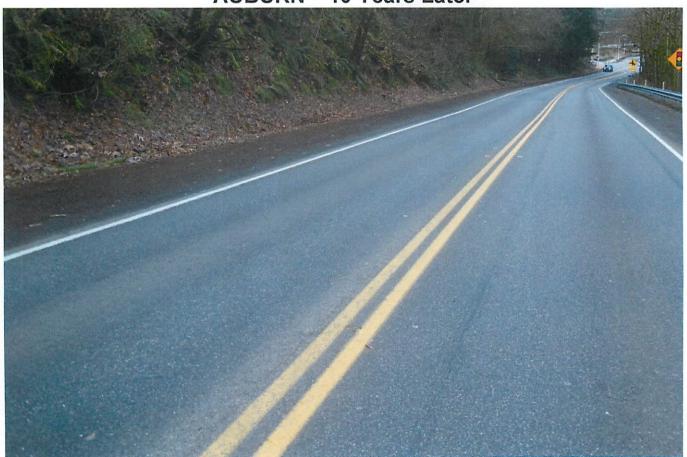
AUBURN - 10 Years Later

March 2016 - Ten years after wheel rut patching and double chip seal. The road surface looks good, considering the traffic and age. It needs a new chip seal, as a few hairline cracks have started.

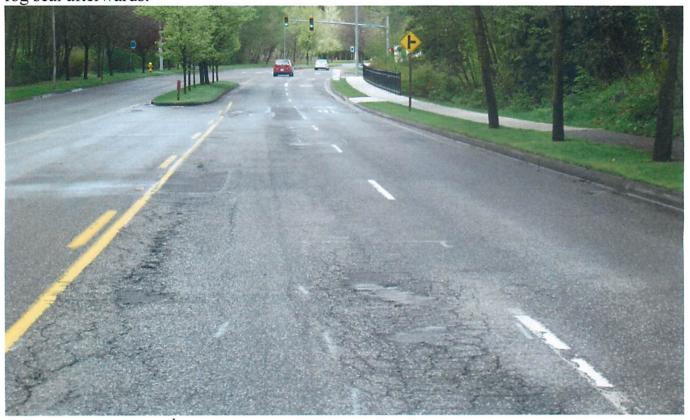
2011 Single Chip Seal, with chip seal patches in the areas of deteriorated pavement. 1/2"-#4 chips were used for the chip seal patches, then 3/8"-#10 chips were placed full width, with a fog seal afterwards.

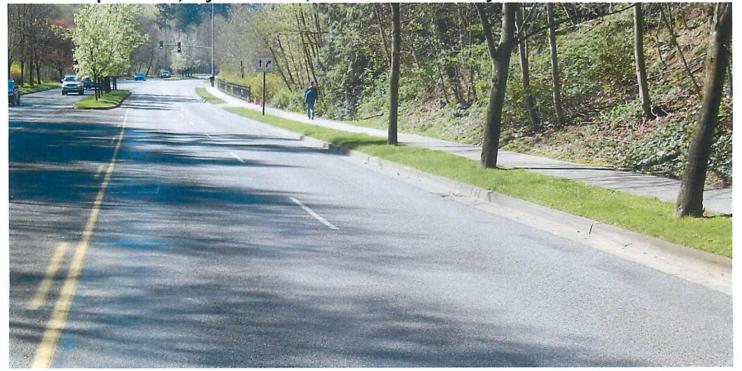
April 2016, 5 years later, No evidence of any cracks
