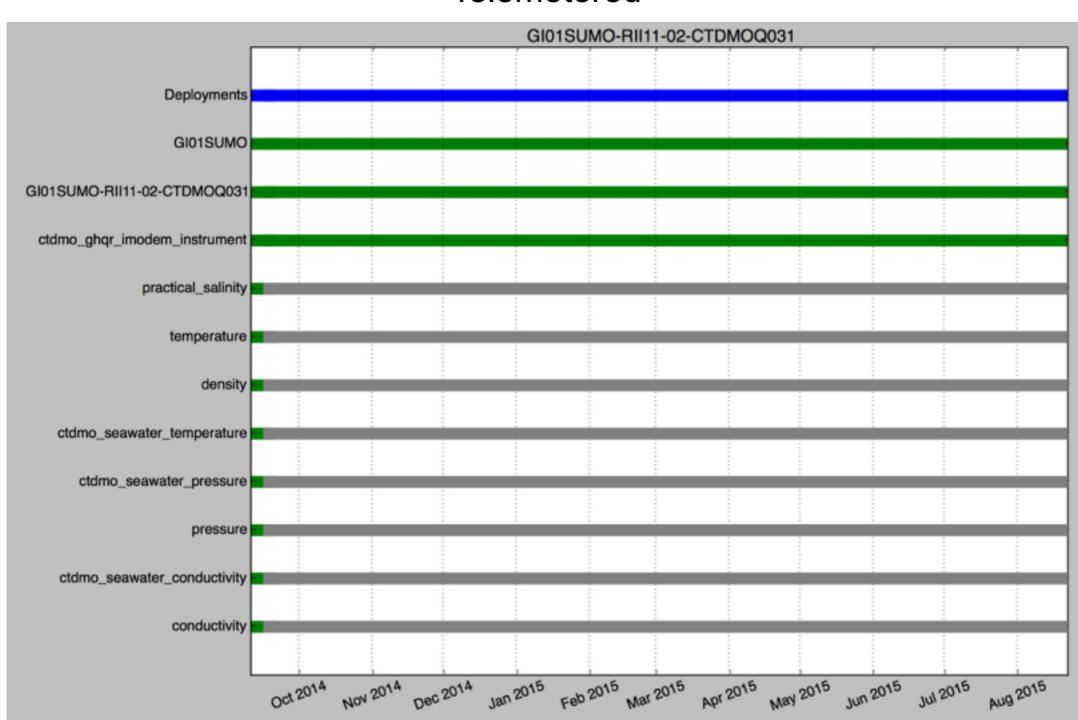
## **Telemetered**

Level	Deployment	StartTime	EndTime	Annotation	Status	Redmine#	Todo
GI01SUMO	D00001	2015-02-15T00:00:00Z	2015-08-22T11:00:00Z	Status data sent from the buoy included leak detects in the buoy well, drop in battery voltage, and loss of wind turbine input. Upon recovery, the buoy was primarily intact but several instruments were damaged and/or missing. Ice build-up on the tower is speculated to be the cause for much of the damage. No telemetered or recovered_host data expected from this platform . Functional instruments could continue to collect data using internal battery power and storage cards.			
GI01SUMO	D00002	2016-01-27T00:00:00Z	2016-07-19T00:00:00Z	A period of violent weather caused power outages on multiple instruments. No telemetered or recovered_host data expected from this platform. Functional instruments could continue to collect data using internal battery power and storage cards. Upon recovery, the buoy well was flooded.		9583

GI01SUMO	D00003	2016-12-27T00:00:00Z	2017-04-07T00:00:00Z	There is evidence of ice build-up on the surface buoy tower. Wind turbines are disabled and the battery charge state has been declining steadily. As of 2017-01-15, all DCLs have been shut down and the telemetry schedule has been reduced to conserve power. Battery-powered instruments will continue to collect data. UPDATE 2017-04-07: With increasing daylight at this location, there is now sufficient power available from PV panels to re-establish limited high-bandwidth telemetry and data transmission. Instruments on DCL11 are sending data to shore. The backlog of data stored on instruments with batteries may slowly backfill over time.		11758	Update end time as the deployment progresses
ctdmo_ghqr_imodem_instrument	D00001	2014-09-10T18:52:31Z	2014-09-18T14:07:31Z		AVAILABLE		
ctdmo_ghqr_imodem_instrument	D00001	2014-09-18T14:07:31Z	2015-08-22T11:00:00Z	Telemetry was lost in Sept-2014, and surface buoy suffered damage in Feb-2015. See platform-level	NOT_AVAILABLE

annotation for details.

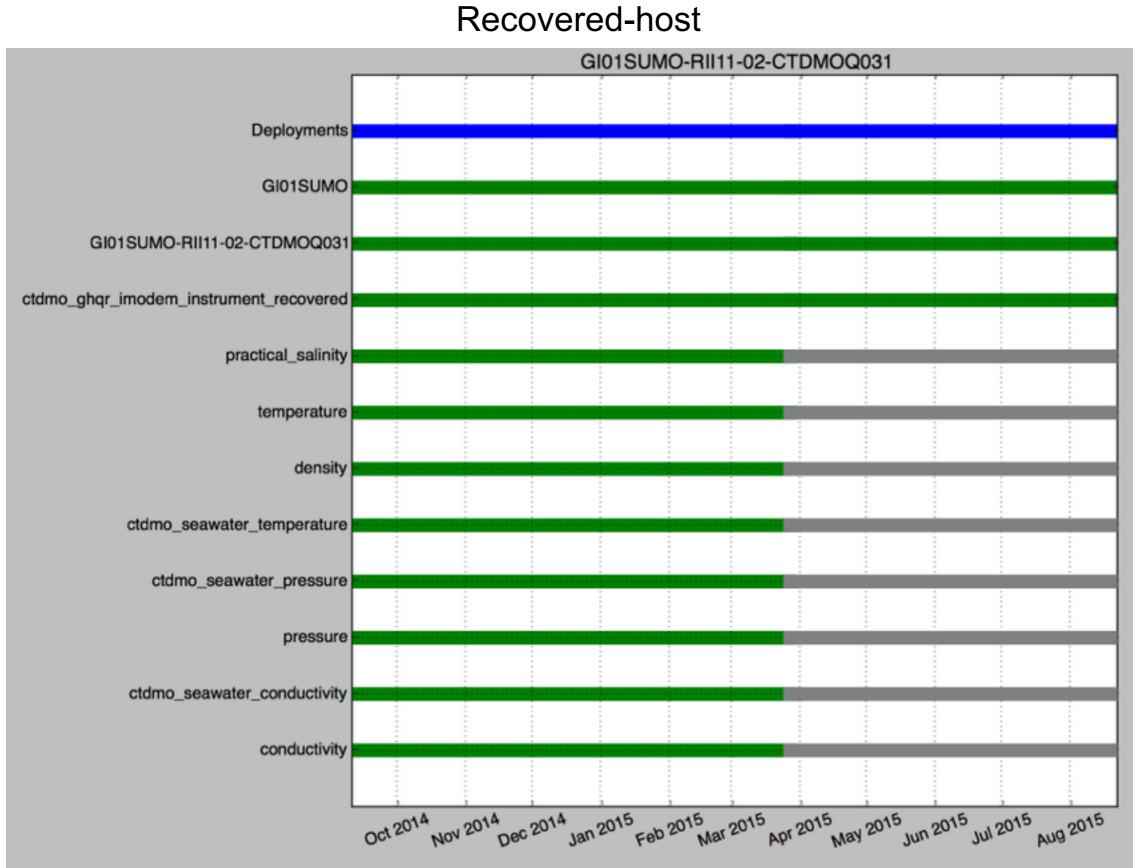
Level	Deployment	StartTime	EndTime	Annotation	Status	Redmine#
ctdmo_ghqr_imodem_instrument_recovered	D00001	2014-09-10T18:52:31Z	2015-03-27T16:07:31Z		AVAILABLE	
ctdmo_ghqr_imodem_instrument_recovered	D00001	2015-03-27T16:07:31Z	2015-08-22T11:00:00Z	The surface buoy suffered damage in Feb-2015. See platform-level annotation for details.	NOT_AVAILABLE
