DEPARTMENT OF ENVIRONMENTAL SERVICES  
**CITY AND COUNTY OF HONOLULU**

**SUBJECT:** Draft Environmental Assessment and Anticipated  
Finding of No Significant Impact for the  
Ahuimanu Wastewater Pre-Treatment Facility Improvements and  
Equalization Facility  
Koolaupoko District, Island of Oahu, Hawaii  
Tax Map Key: (1) 4-7-004:006 (por.)

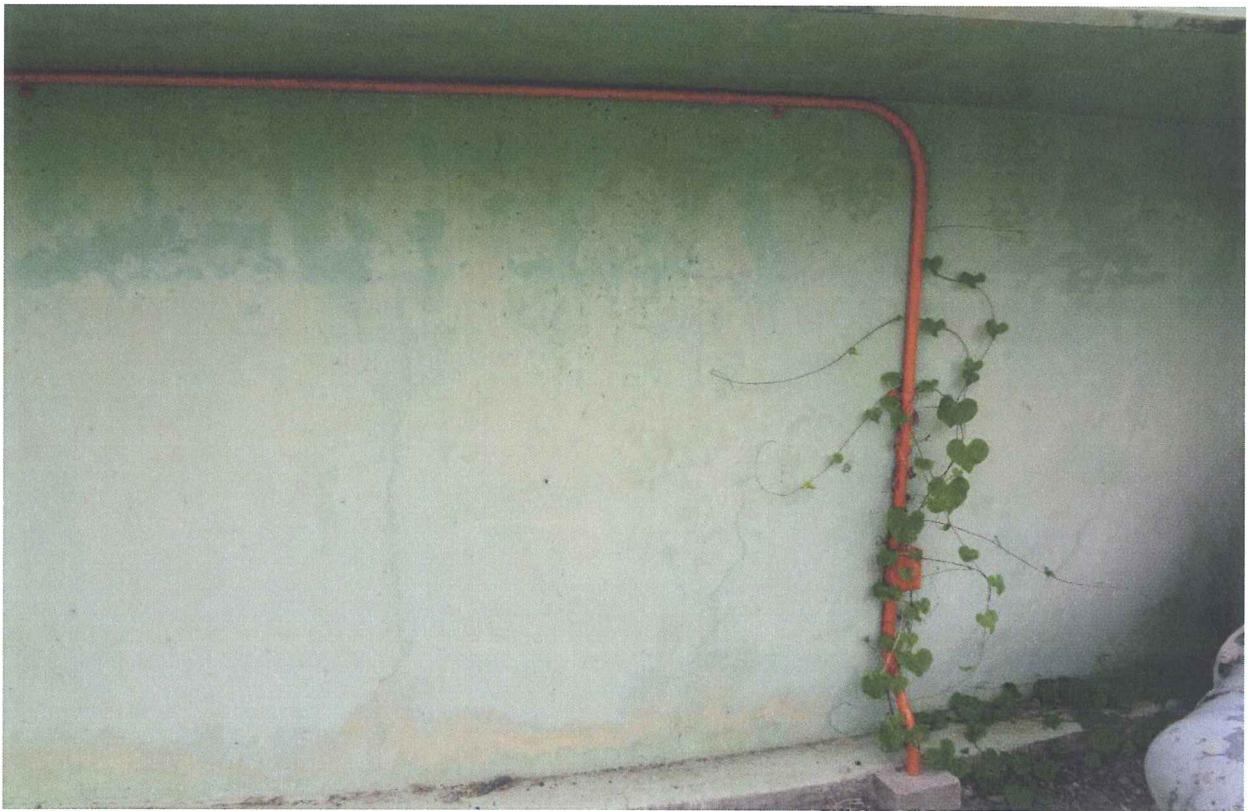
PHOTO 2.2 – EXTERIOR CRACKS

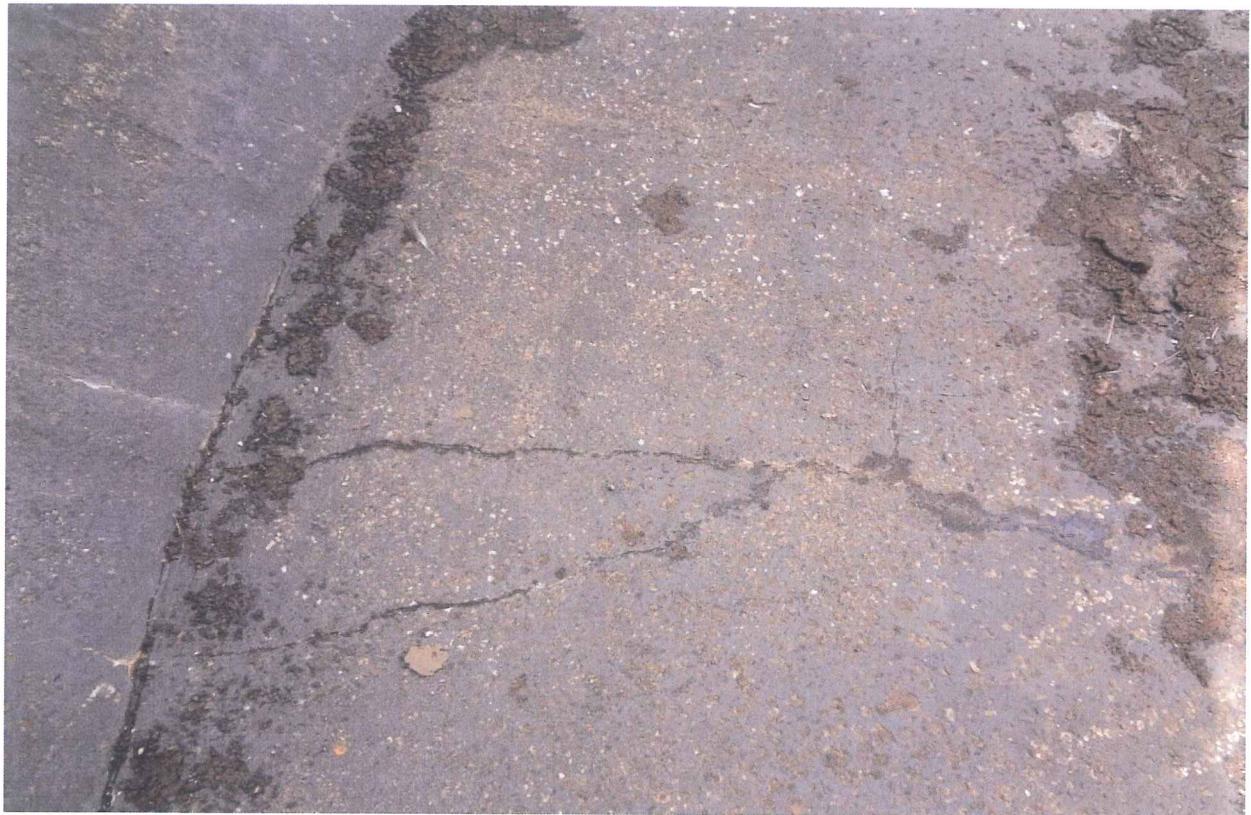
PHOTO 3.3 – CRACKS ON WALL BASE

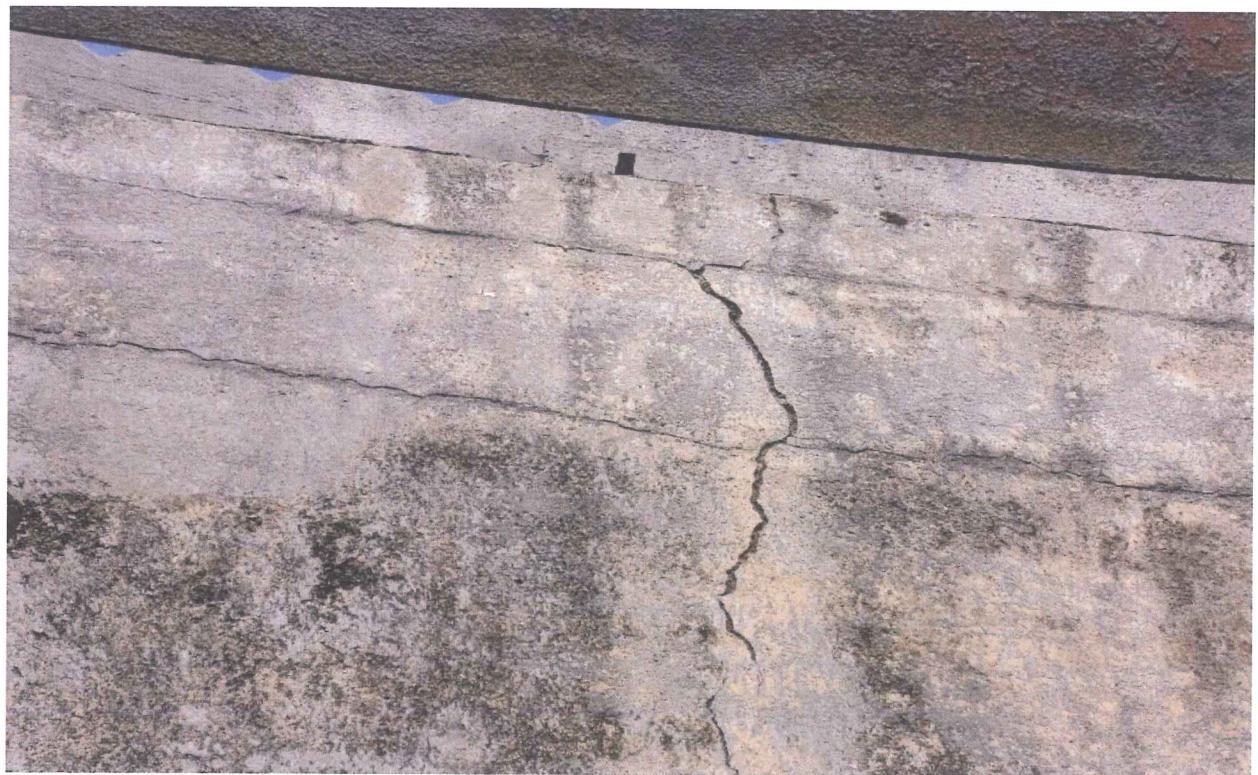
PHOTO 3.4 – SEVERE CRACKS ON TOP OF WALL

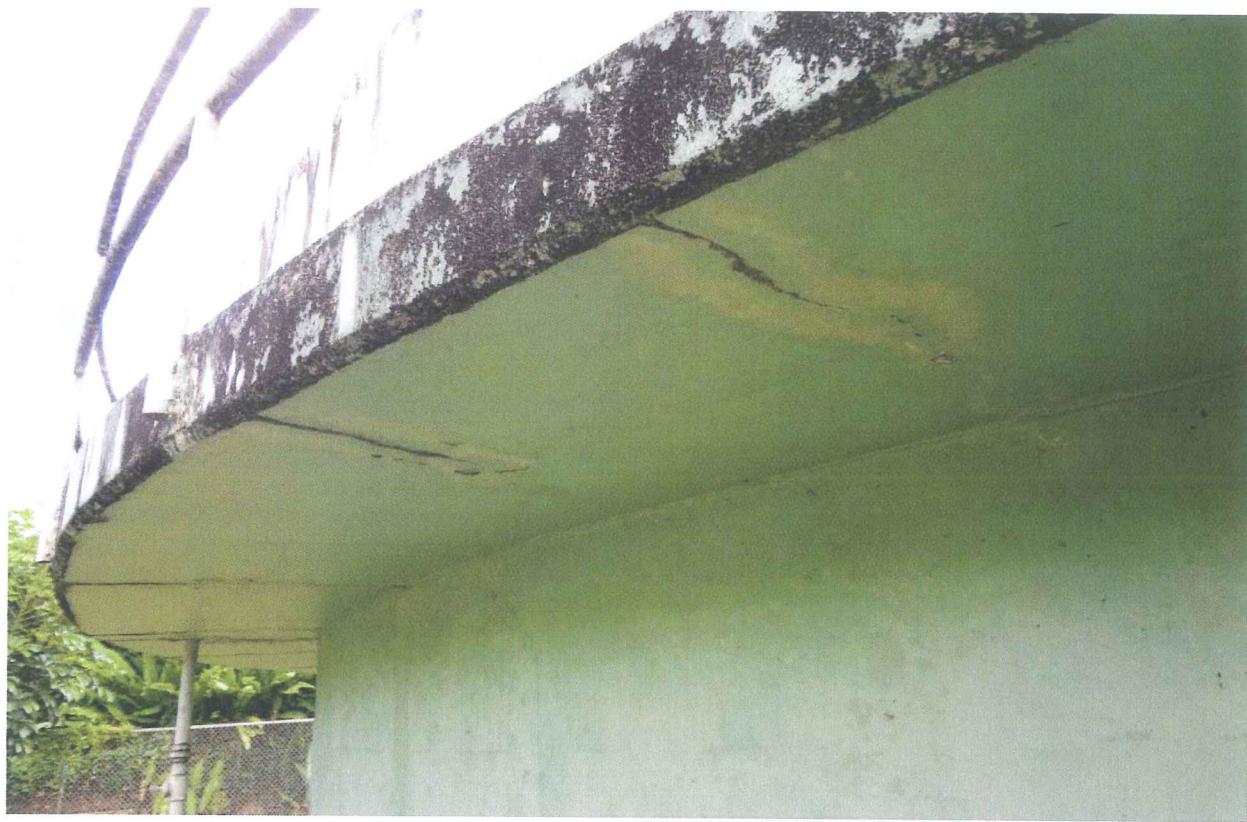
PHOTO 3.5 – CRACKS ON OVERHANG SOFFIT

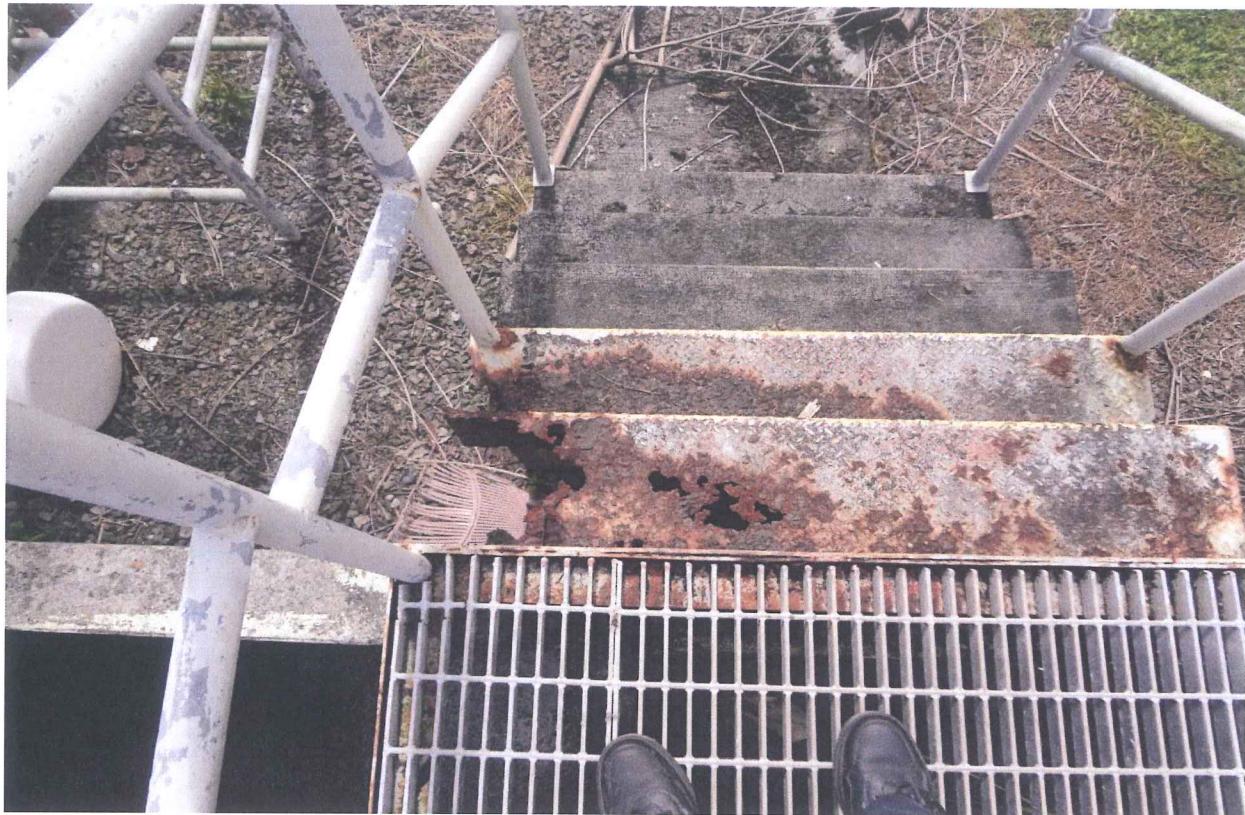
PHOTO 4.3 – CORRODED STEEL STEPS

1. The existing RBU structure is at workable condition with reliable structural integrity. To maintain a good and long useful life, the structure needs minor repairs, which includes sealing of cracks, repair of spalls and recoating of interior concrete surfaces. We estimate that the structural capacity at the current condition can still serve its original design load.
2. The minor repair and recoating is estimated to cost approximately \$ 250,000.00

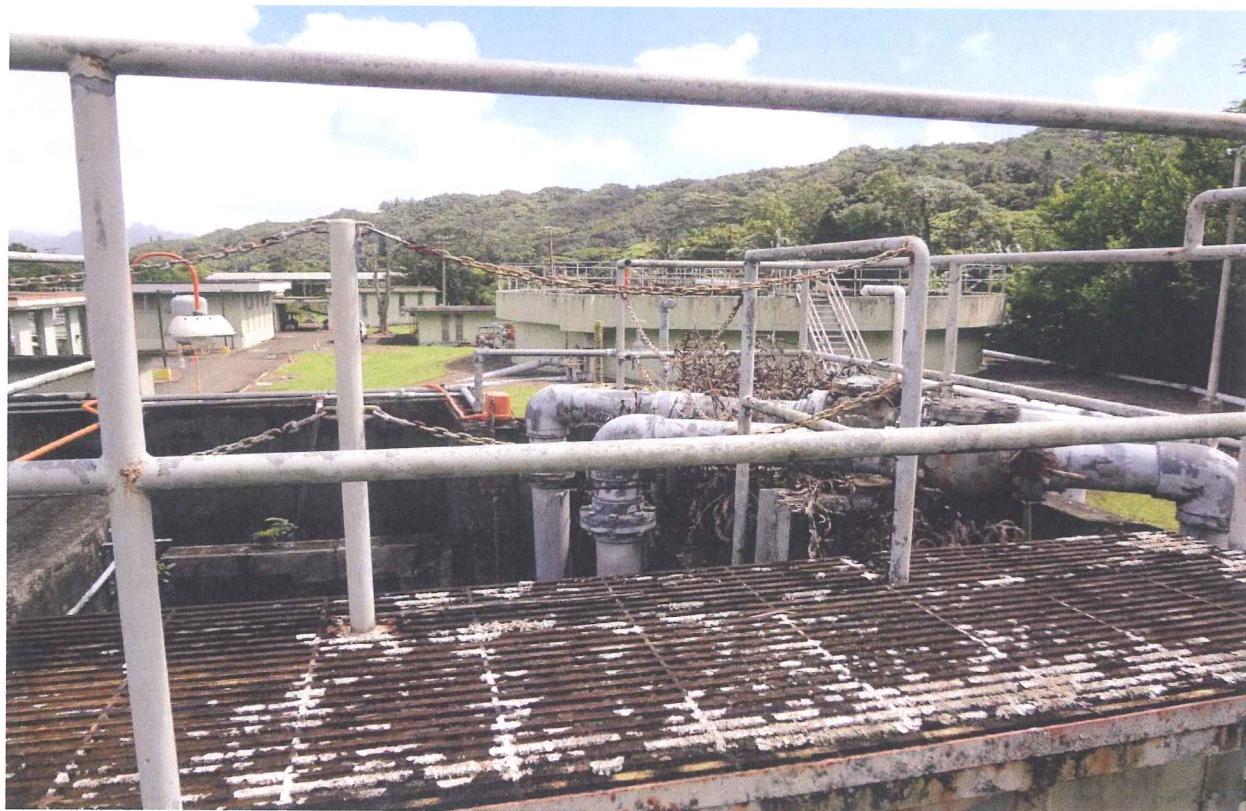
PHOTO 4.4 – CORRODED GRATING

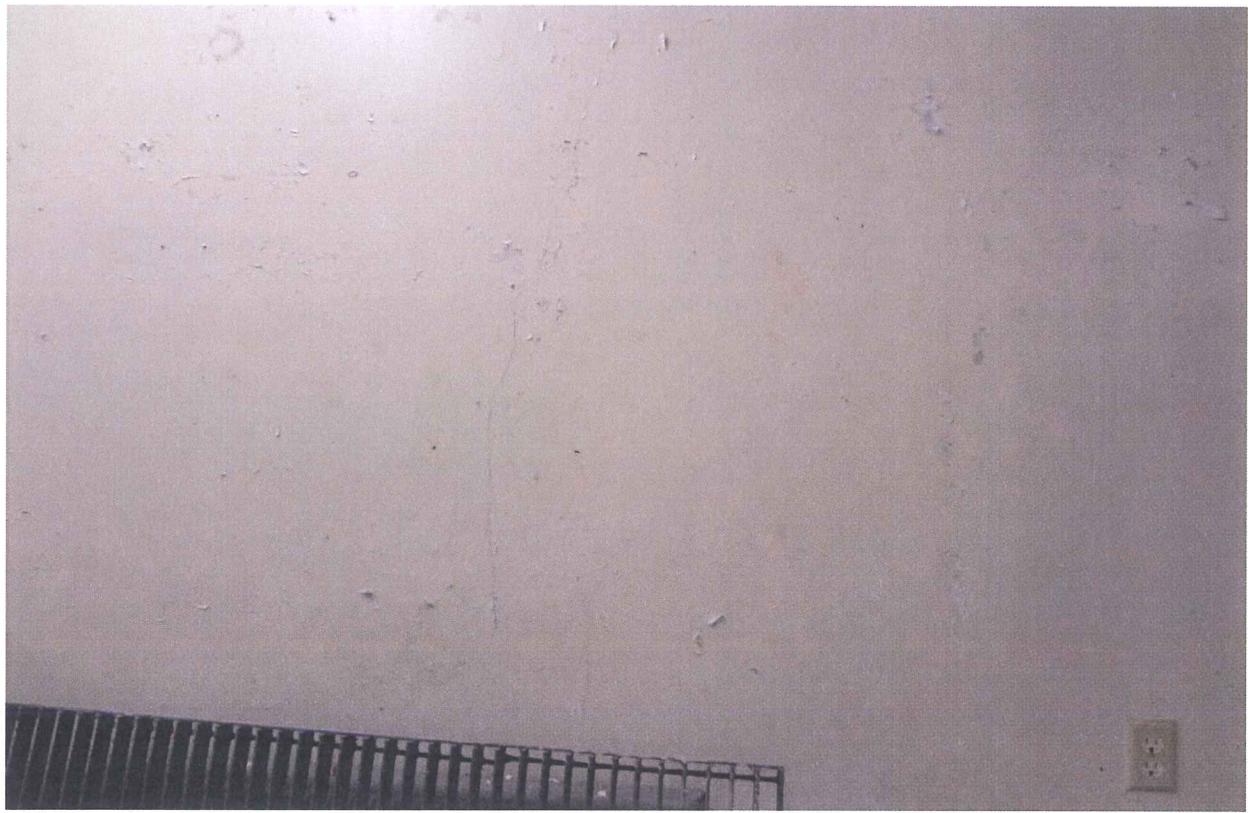
PHOTO 6.2 – WALL CRACK ON PUMP ROOM WALL

2. The minor repair is estimated to cost approximately \$50,000.00

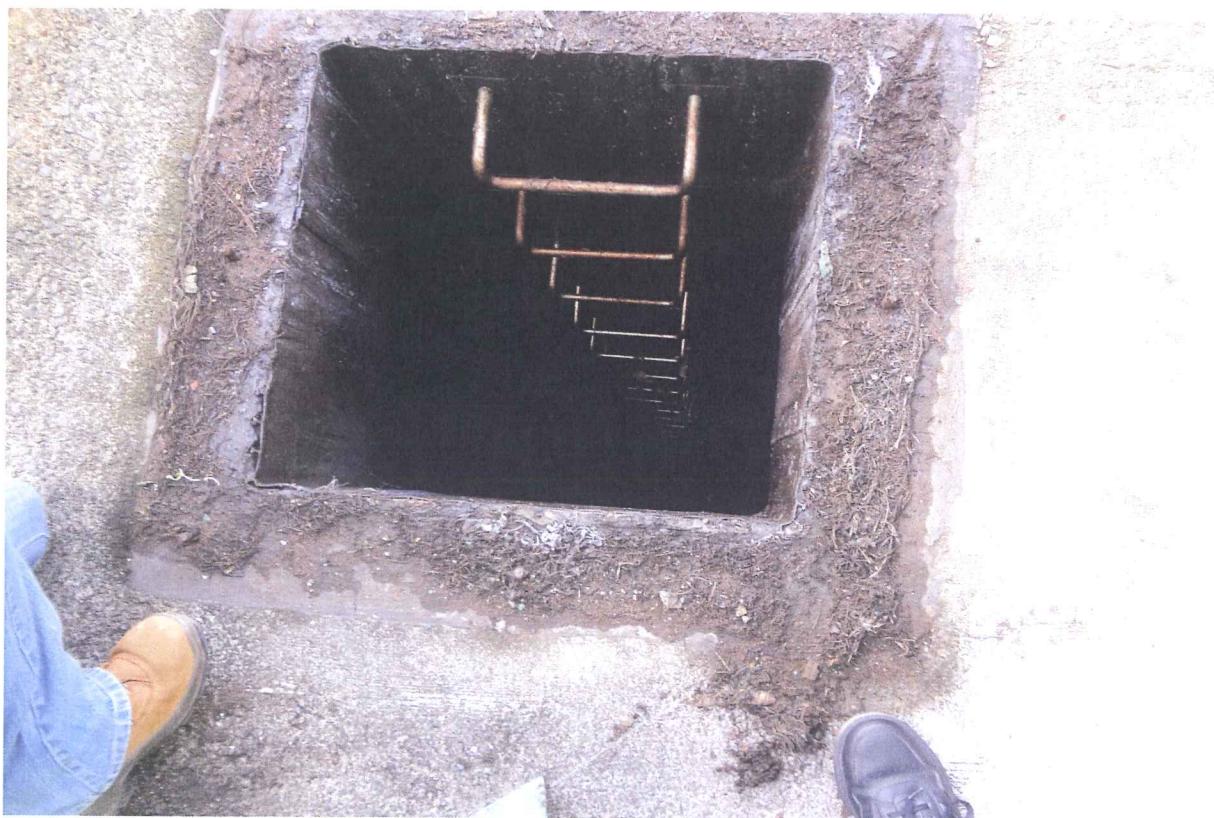
1. Except for the corroded steel covers the concrete of the Wet Well entries appeared in good condition. Judging from the condition of the entries the main body of the Wet Well would most likely be in fairly good condition. It seems unnecessary to do extensive repair work to the Wet Well structure except cleaning or small tough up repairing.
2. For budgetary purpose the cost for minor repair is estimated to be \$10,000.00

PHOTO 7.1 – WET WELL ENTRY NO. 1

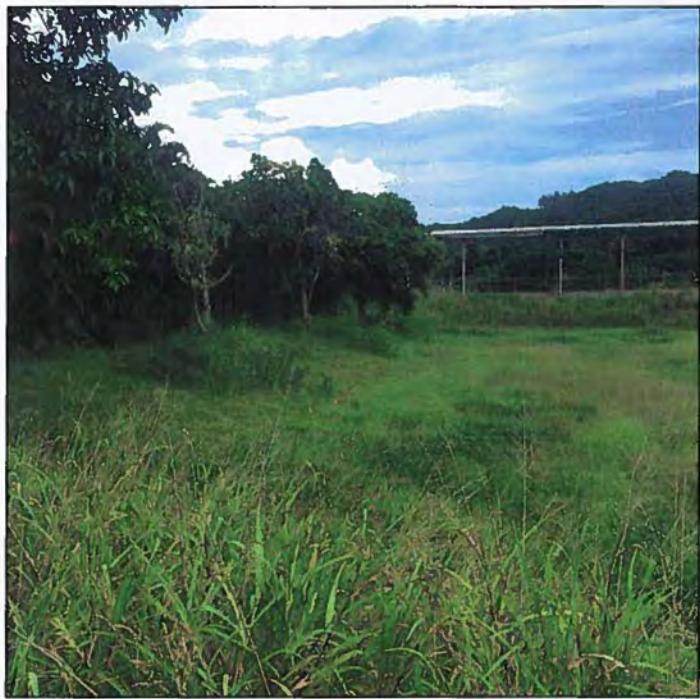
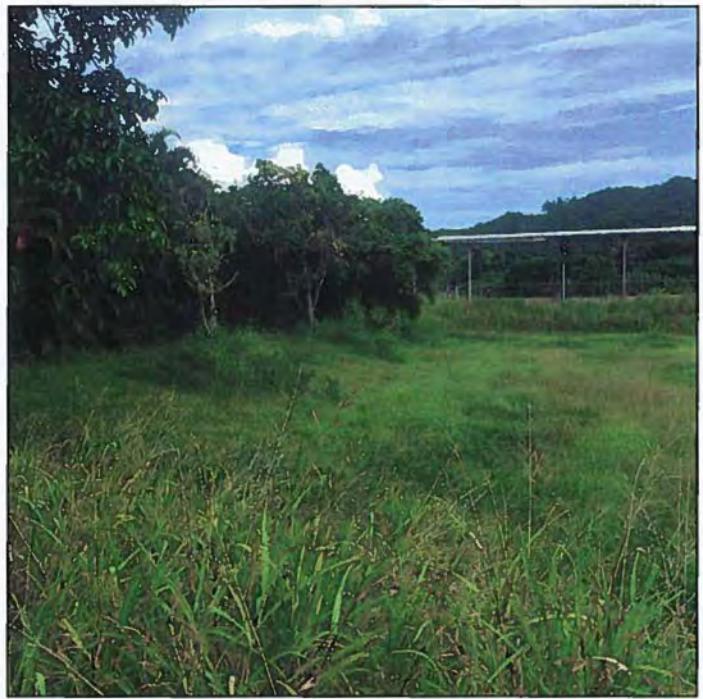
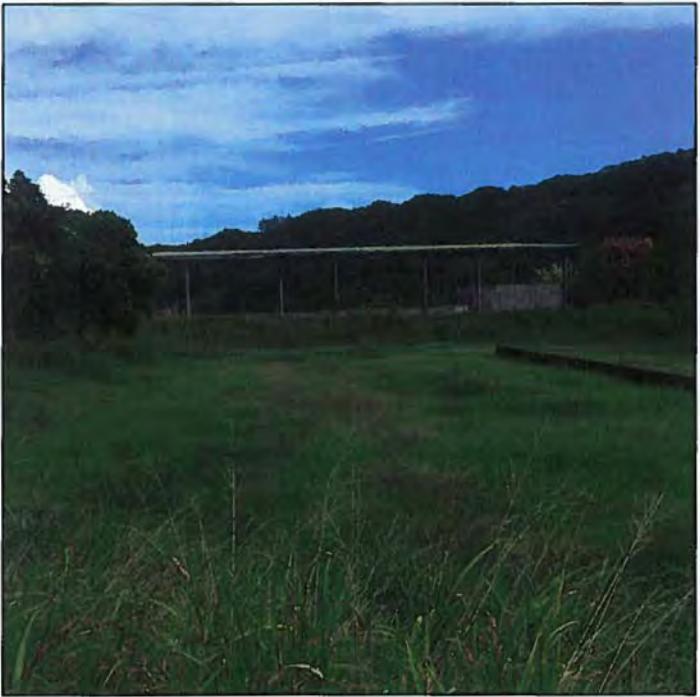
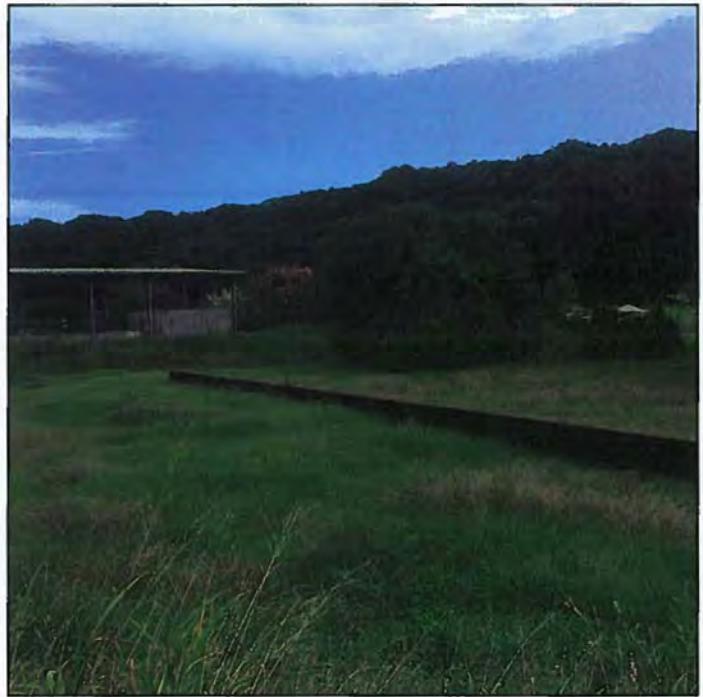
**Figure 5A**  
**Photographs of Project Site**  
**‘Āhuimanu Wastewater Pre-Treatment Facility**  
**Kāne‘ohe, Island of O‘ahu, Hawai‘i**

The drainage basin is currently grassed with narrow-leaved carpet grass (*Axonopus fissifolius*) and Hilo grass (*Paspalum conjugatum*). Various trees, shrubs and palms grow along the tops and outer sides of the eastern and western berms. The grass and vegetation are routinely mowed and trimmed. See attached **Figures 5A** and **5B** for photographs taken on July 22, 2015.

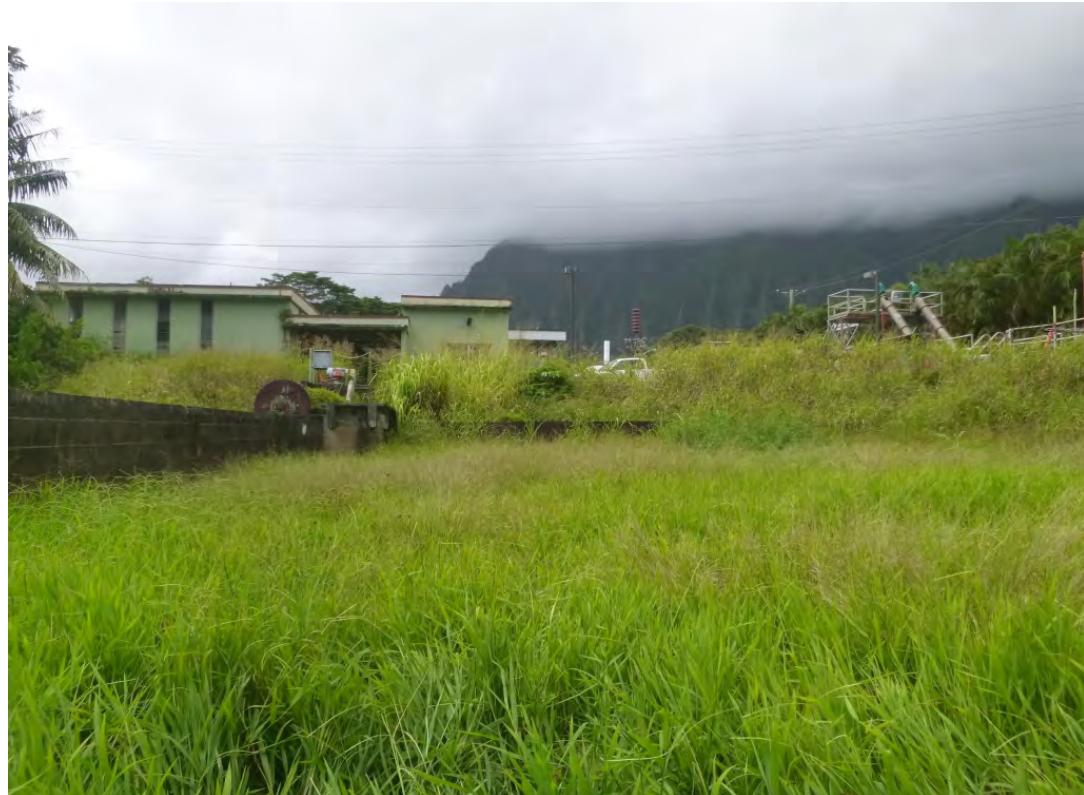
**Vegetation** - The National Wetland Plant List (NWPL), administered by the USACE, assigns a regional wetland indicator status to each species of plant (USACE, 2012b, Lichvar, et al., 2014). Table 1 provides descriptions of each status indicator. Only plant species that are designated obligate (OBL), facultative wetland (FACW), or facultative (FAC) are considered as indicators of wetlands. The basin has hydric vegetation, as the two dominant plants are facultative grasses (Figure 3): *Axonopus fissifolius* (narrow-leaved carpet grass) and *Paspalum conjugatum* (Hilo grass).

Figure 3. Facultative plants are dominant in the basin.

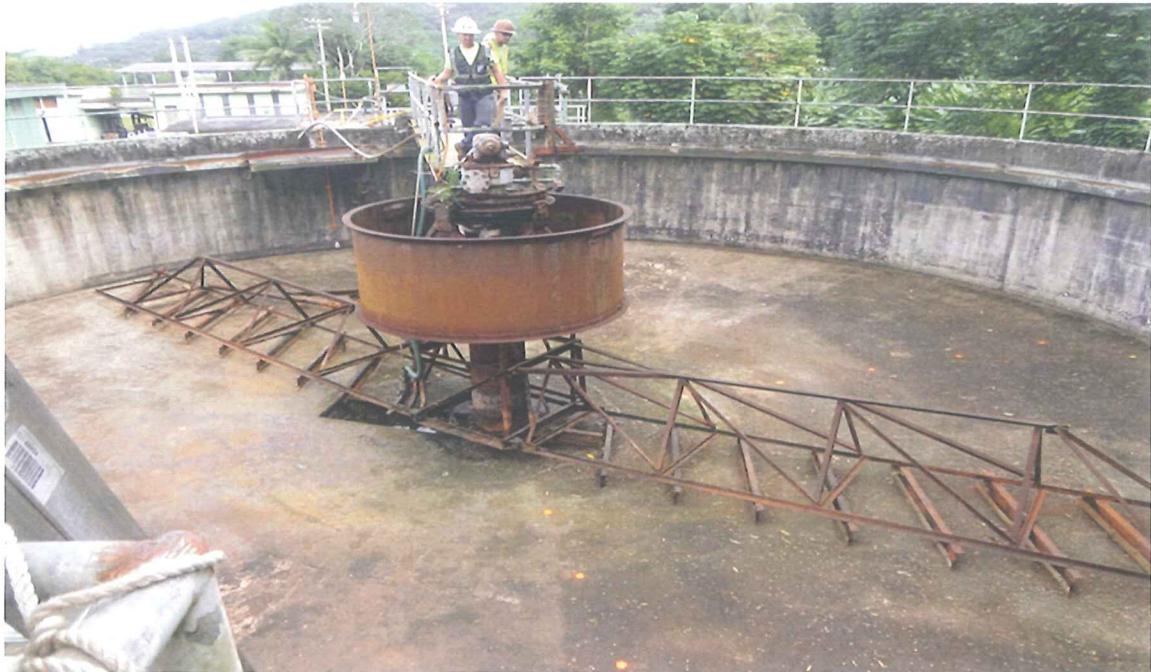
PHOTO 2.1 - PRIMARY CLARIFIER BOTTOM SLAB

5. Interior tank wall surface was noted to have random 1/16" vertical and horizontal cracks. No concrete spalls were noted. A certain areas on the interior wall surfaces appeared having minor delamination but should not affect the structural integrity of the wall. No protective coating on the concrete surface was noted. (SK-2.6 , Photo 2.1)

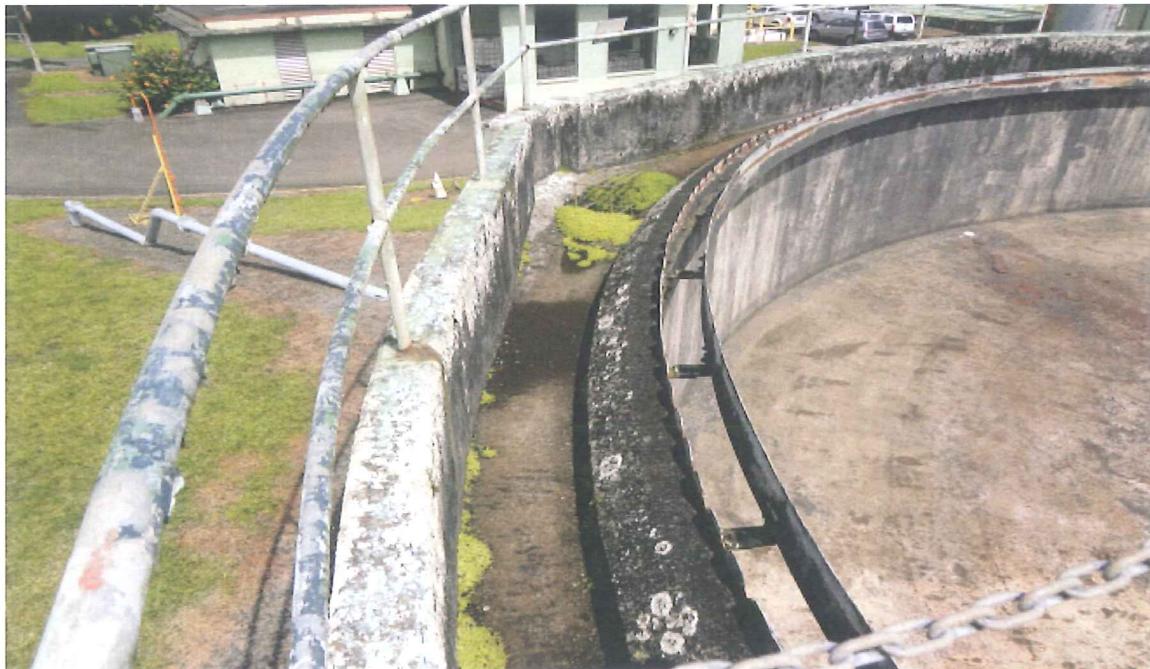
4. The effluent launder channel walls and slab appeared in working condition. Very few defects were noted (SK-2.4). Horizontal cracks between 1/16" and 1/8" wide were noted constantly on top of the launder wall.(Sk-2.1,2.4, Photo 2.6))

PHOTO 2.6 - EFFLUENT CHANNEL WITH VEGETATION GROWTH AND CONCRETE WALL SURFACE DETERIORATED. METAL RAILING ON CHANNEL HAVE PAINT PEELING AND CORROSION

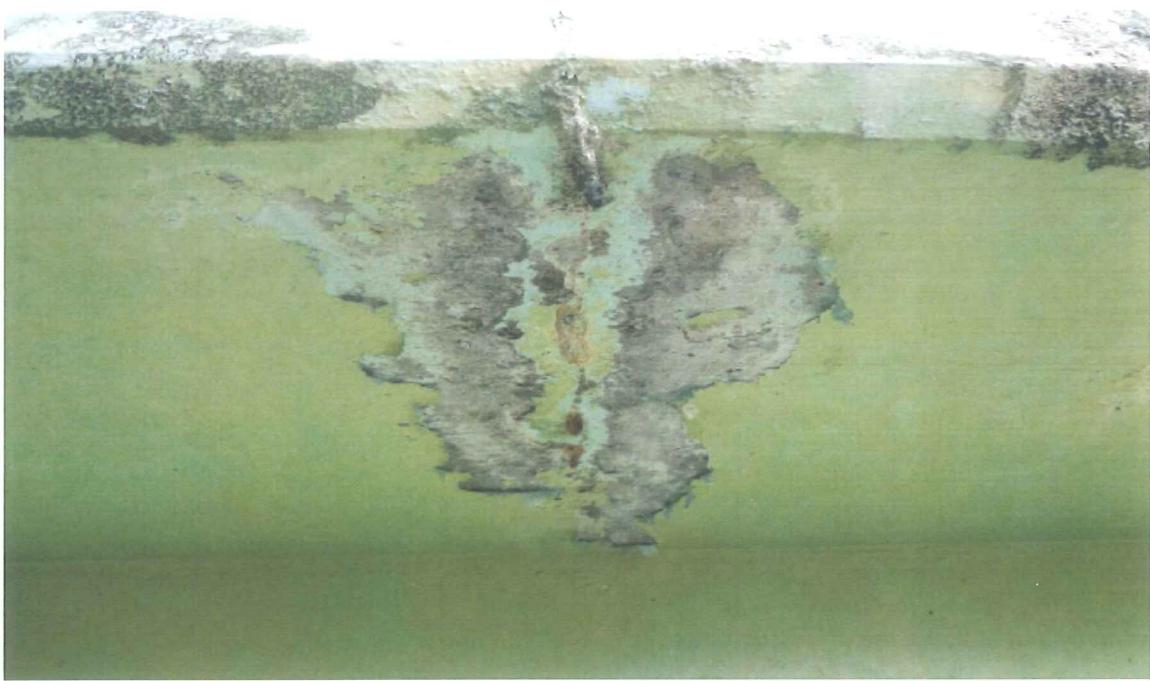
8. The soffit surface of the launder channel slab was noted to have numerous surface cracks up 1/16" wide and random spalls. (SK-2.3, Photo 2.7)
9. The steel stairs on both South and North sides of the tanks appeared in working conditions with minor rusts. (Photo 2.2 & 2.3)
10. The catwalk appeared severely rusted.

**PHOTO 2.7 - PRIMARY CLARIFIER EFFLUENT CHANNEL BOTTOM SLAB WITH CRACK AND PAINT PEEL DUE TO WATER LEAKAGE**

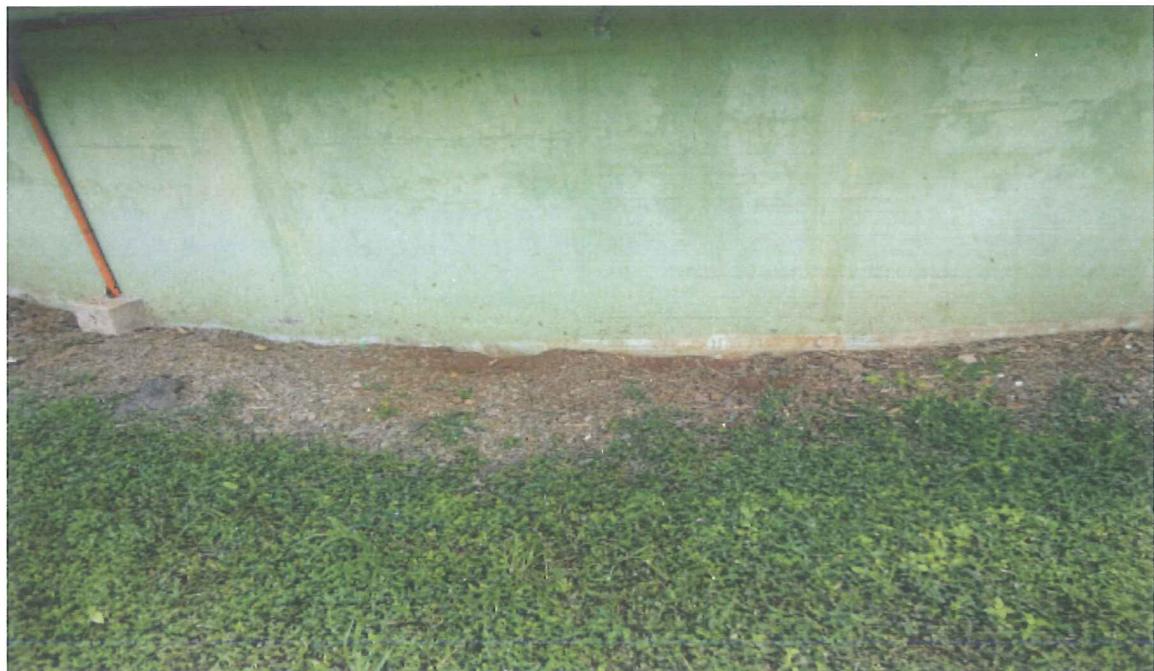
**PHOTO 2.8 - PRIMARY CLARIFIER SOIL SETTLEMENT ON EXISTING GRADE MAINLY AROUND THE WEST SIDE OF THE CLARIFIER**

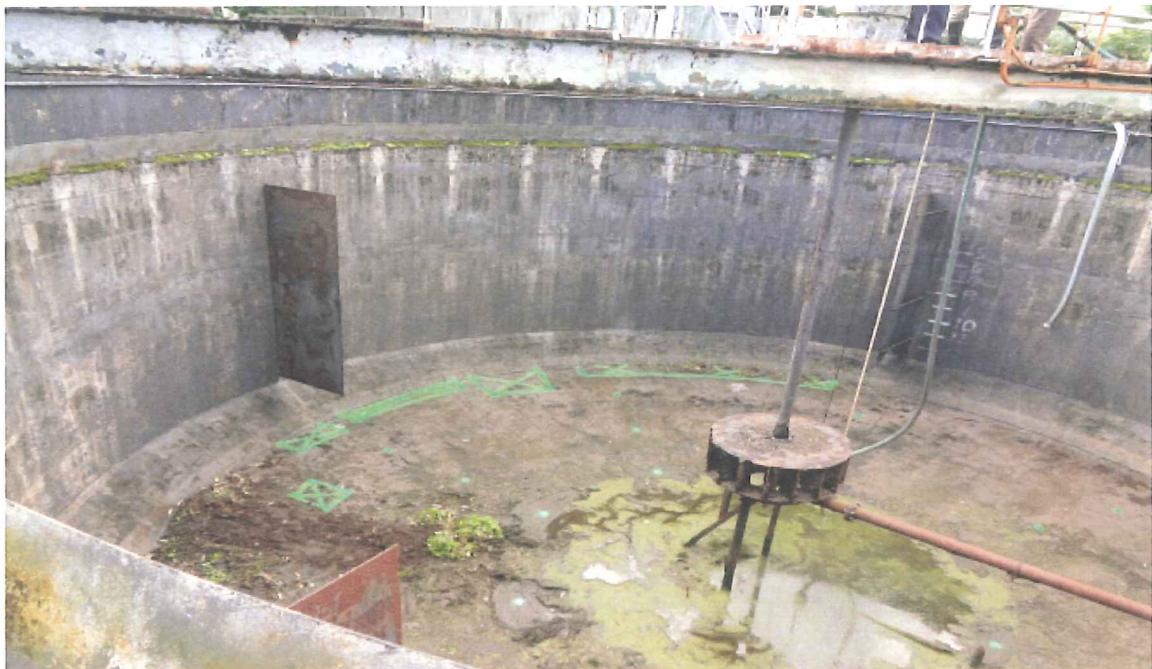
2. The residual coating on the base slab and the interior wall surface, which was noted in the last field observation, was completely gone this time.
3. Weeds and vegetation growth was observed on most of the launder channel slab and the overhand eave slab. Random vegetation was noted on the base slab. (SK-3.1 3.2, Photo 3.2)

5. The effluent launder channel walls and slab appeared in working condition. Very few defects were noted (SK-3.9).
6. Interior tank wall surfaces were noted to have continuous horizontal cracks with crack widths ranging from 1/32" to 1/8". There were no concrete spalls. A certain areas on the interior wall surfaces appeared having minor delamination but should not affect the structural integrity of the wall.(SK-3.7, 3.8, Photo 3.2))

**PHOTO 3.2 - AEROBIC DIGESTOR TANK BOTTOM SLAB. NOTE AREA OF  
VEGETATION GROWTH AND DELAMINATION OF SLAB**

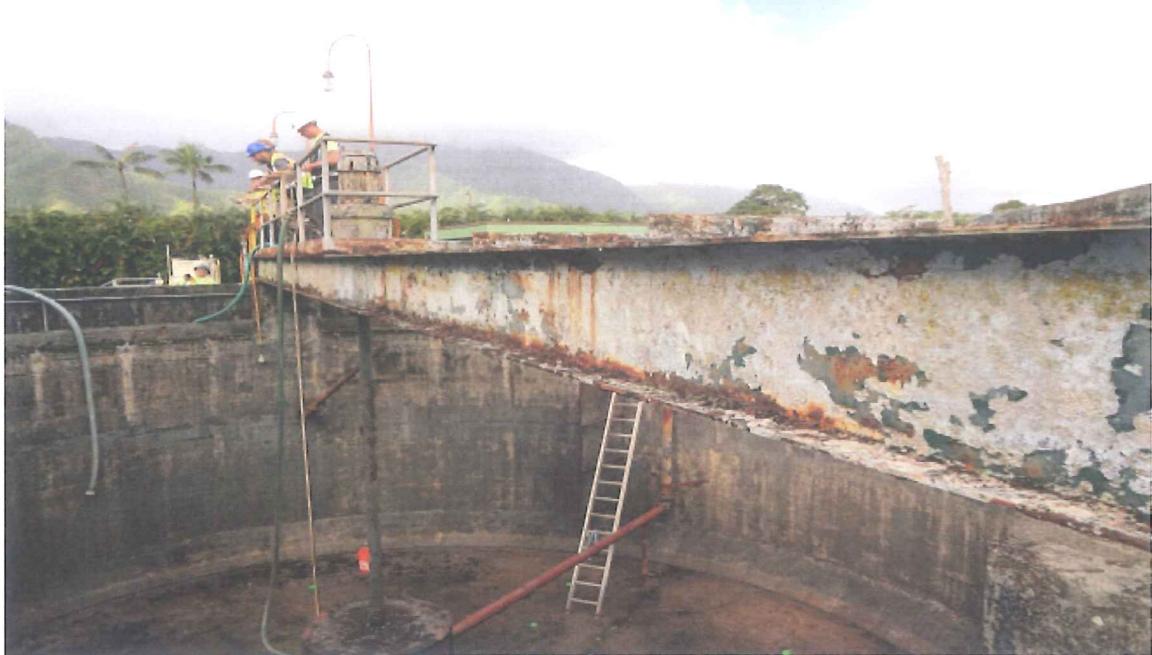
10. The catwalk was severely corroded. (photo 3.3, 3.4,3.5)
11. Rusting was noted on the surfaces of all metal railing. (Photo 3.3.6)

**PHOTO 3.3 - EXISTING CATWALK, SEVERELY RUSTED AND PAINT PEELED OFF**

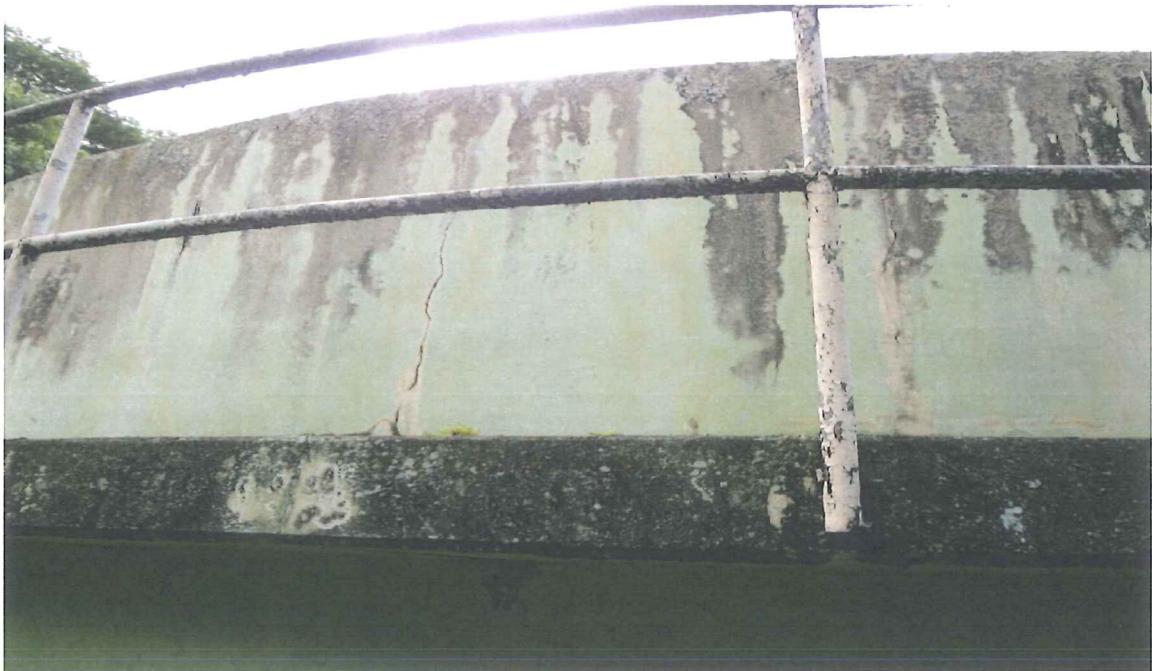
PHOTO 3.6 - AEROBIC DIGESTER EFFLUENT LAUNDER WALL AND METAL RAILING WITH CORROSION AND PAINT PEELING

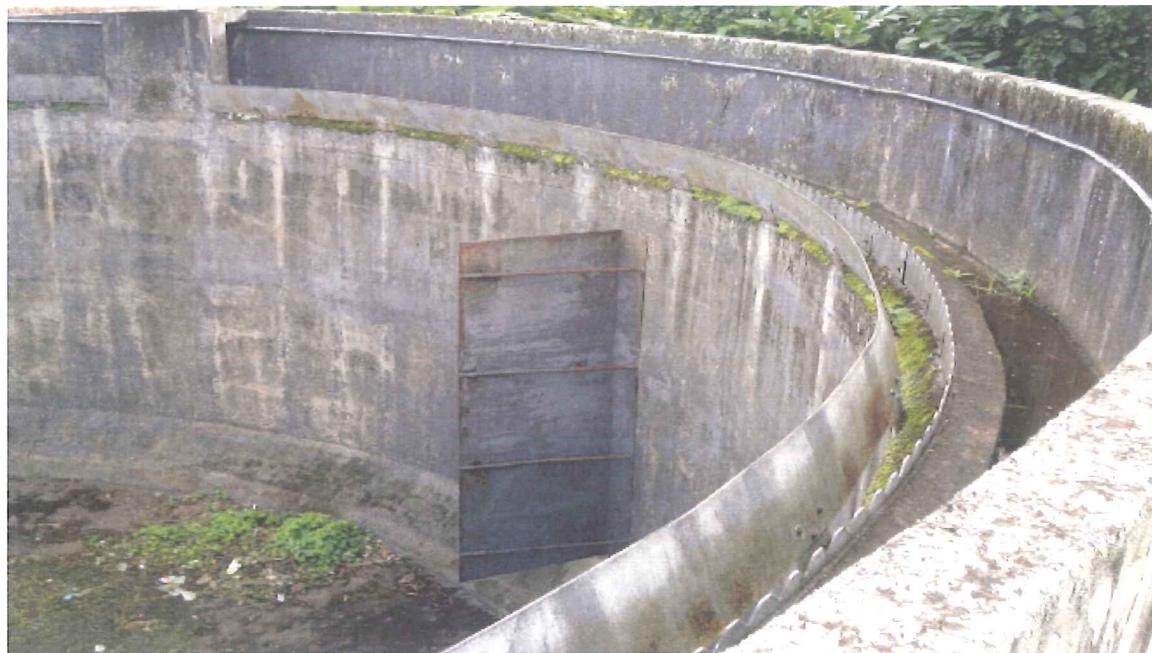
**PHOTO 3.8 – DIGESTER INTERIOR CONC. WLL AND EFFLUENT CHANNEL WALL. NOTE DETERIORATOIN AND MISSING COATING. VEGETATION GROWTH AT BOTTOM SLAB OF LAUNDER CHANNEL, SCUM BAFFLE, AND WEIR**

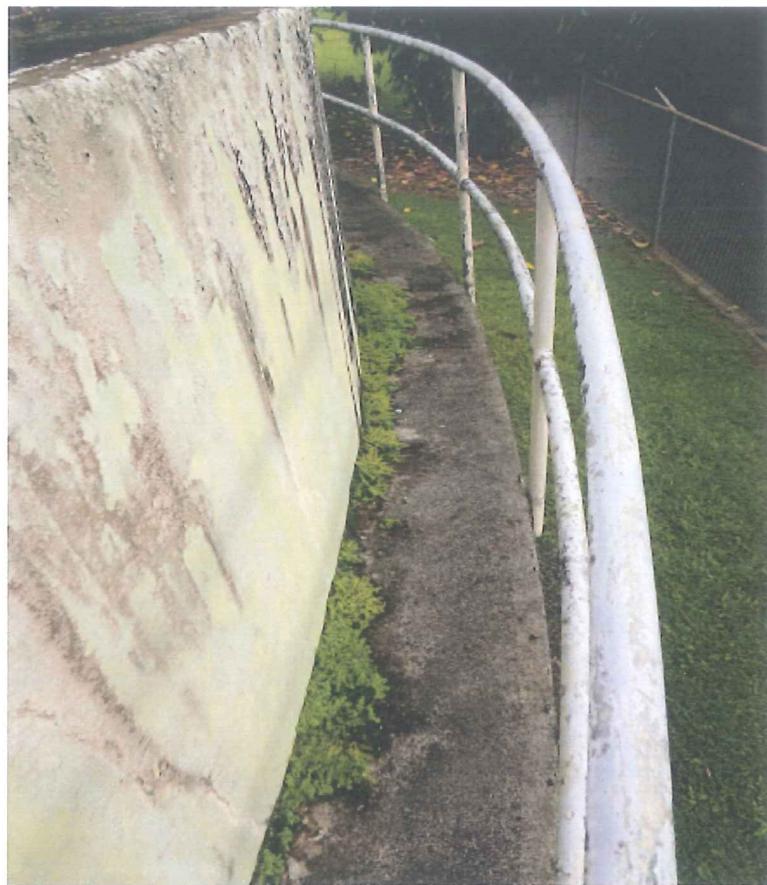
**PHOTO 3.9 - DIGESTER EFFLUENT LAUNDER CHANNEL  
WALL AND OVERHANG SLAB WITH VEGETATION GROWTH**

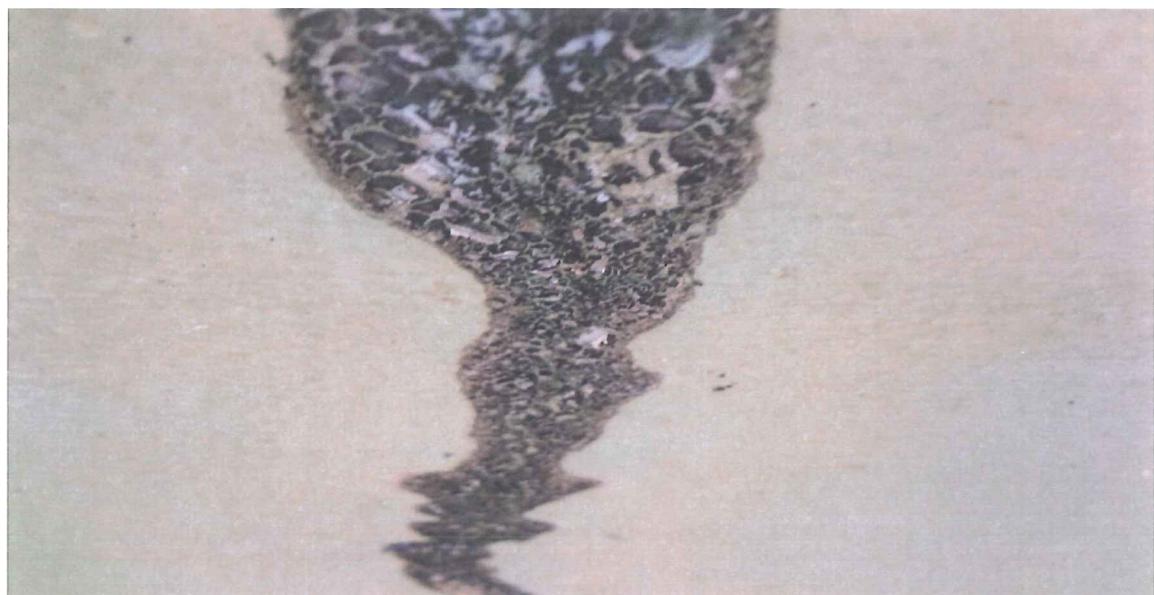
**PHOTO 3.10 - SPALLING OF CONCRETE ON OVERHANG SLAB SOFFIT  
OF EFFLUENT CHANNEL**

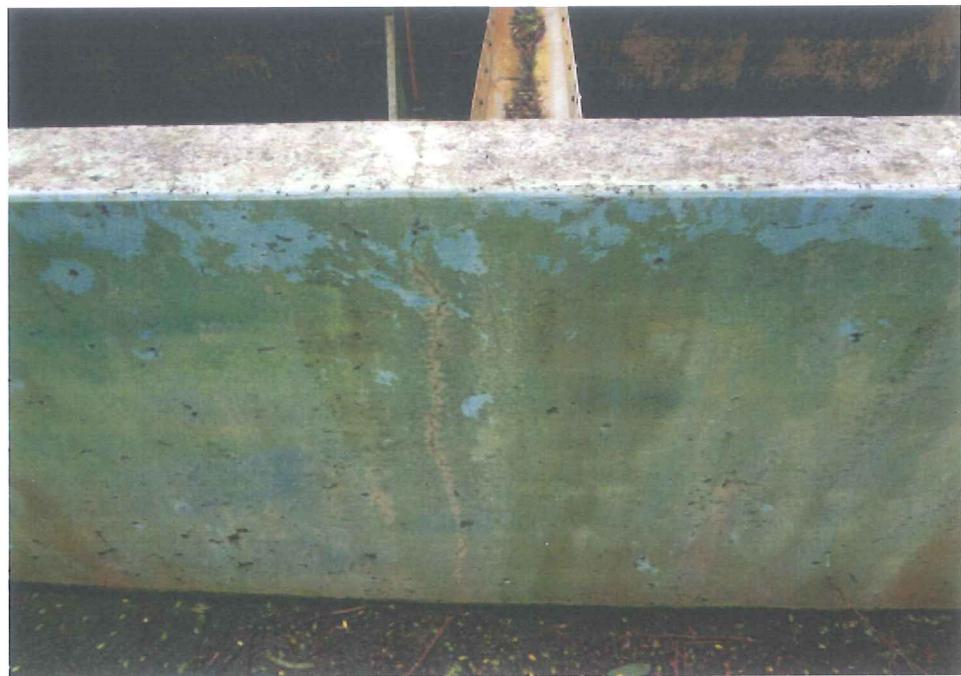
PHOTO 4.3 – CRACK ON OUTLET CHANNEL WALL SURFACE

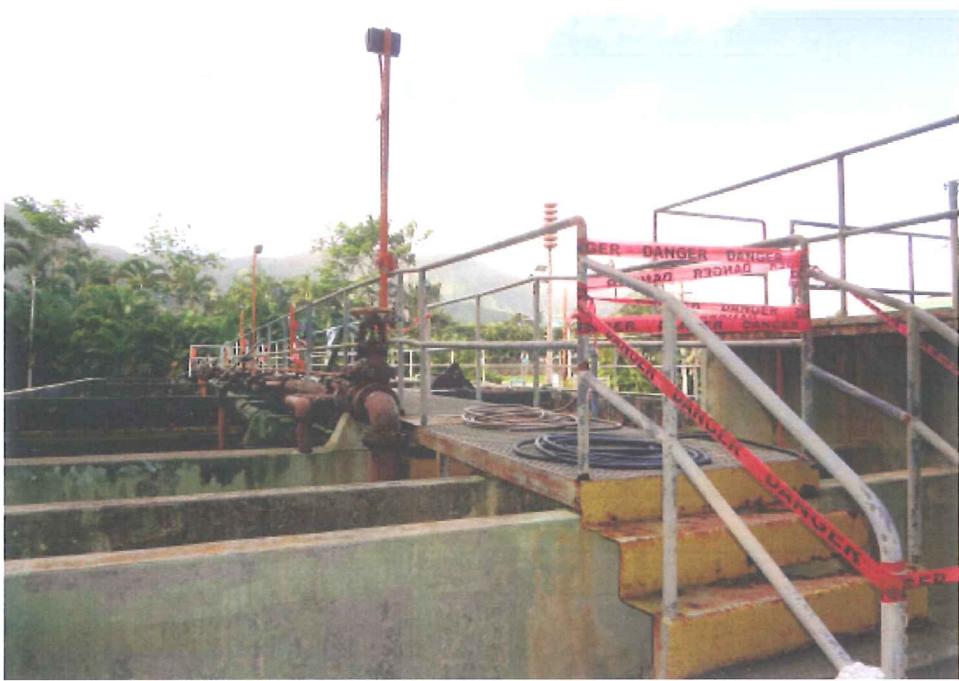
5. The inner channel slab was noted to have random hollow spots underneath the concrete (Photo 4.17)
6. Some weir inlet plates were rusted. One weir plate was broken. See Sk-4.6 and Photo 4.6.

PHOTO 4.6 - WEIR PLATES. NOTE DAMAGE ON ONE OF WEIR

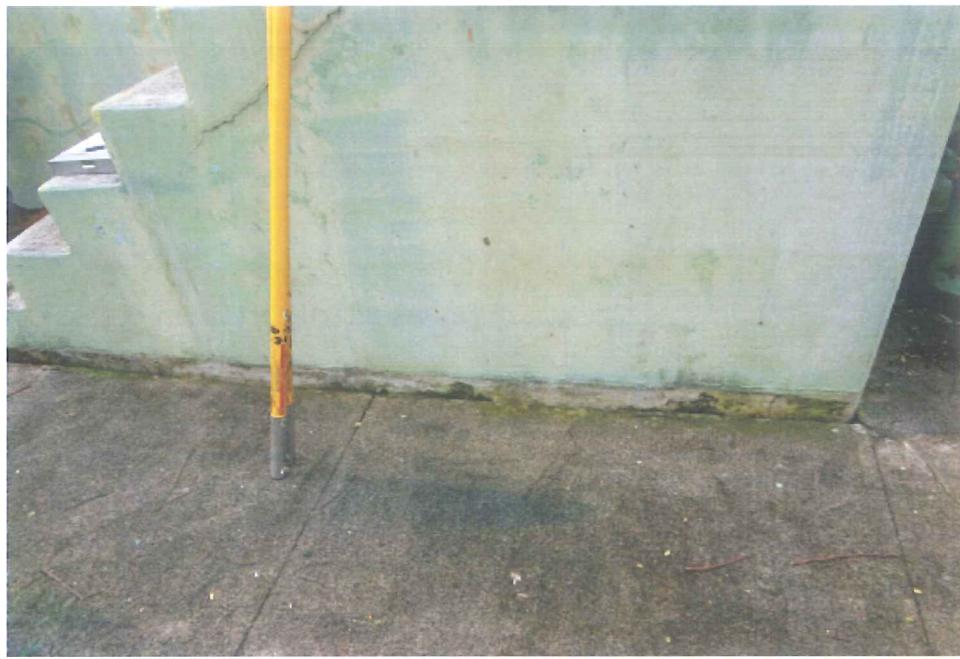
4. Surrounding soil settlement and erosion along North and West exterior walls were noted. A certain section of existing sidewalk slab cracked. See Sk-4.1, 4.3, and 4.4, and Photo 4.8, 4.9,4.10, 4.16

PHOTO 4.8 – WEST/SOUTH CORNER. NOTE GROUND SETTLEMENT

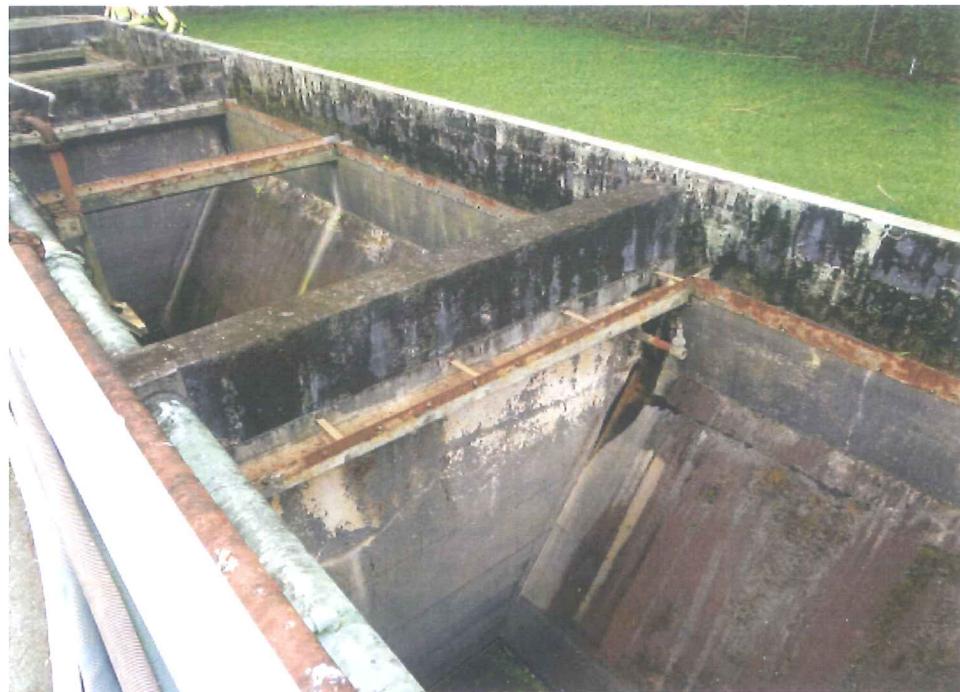
7. Overflow troughs across settling tanks were corroded. (Photo 4.12)

**PHOTO 4.12 – OVERFLOW TROUGH ON TOP OF SETTLING TANK**
