DEPARTMENT OF ENVIRONMENTAL SERVICES  
**CITY AND COUNTY OF HONOLULU**

**SUBJECT:** Draft Environmental Assessment and Anticipated  
Finding of No Significant Impact for the  
Ahuimanu Wastewater Pre-Treatment Facility Improvements and  
Equalization Facility  
Koolaupoko District, Island of Oahu, Hawaii  
Tax Map Key: (1) 4-7-004:006 (por.)

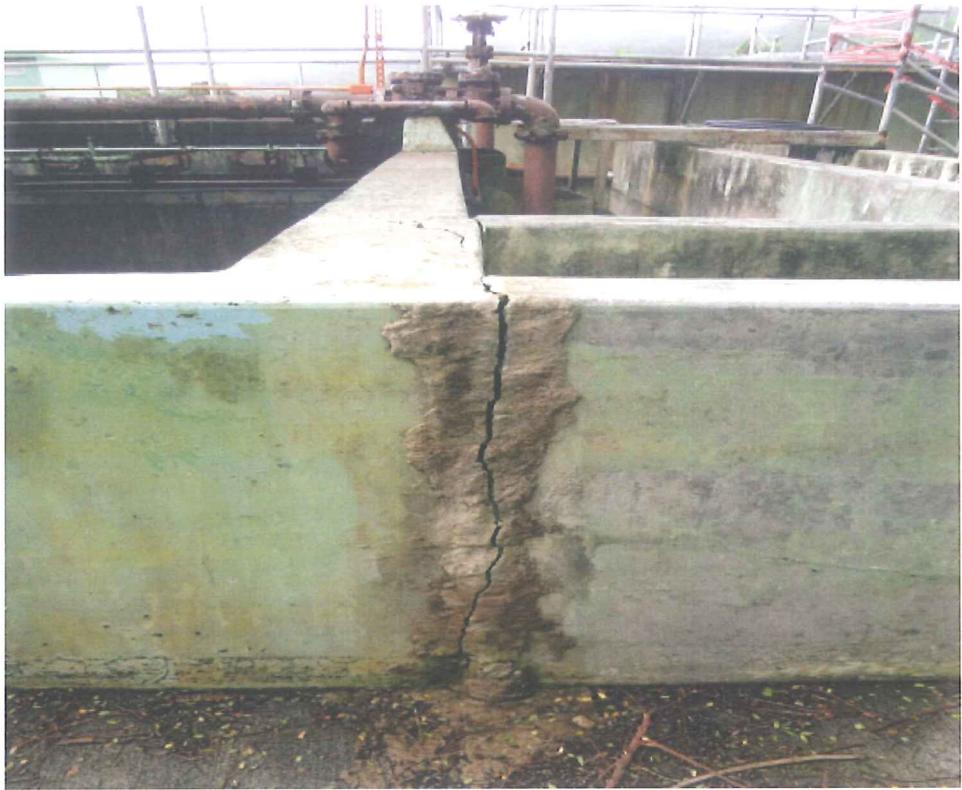
PHOTO 4.14 – CRACKS/PENETRATION TOP OF OUTLET CHANNEL  
WALL/SETTLING TANK No. 1 CRACK CONTINUES TO PHOTO 4.15

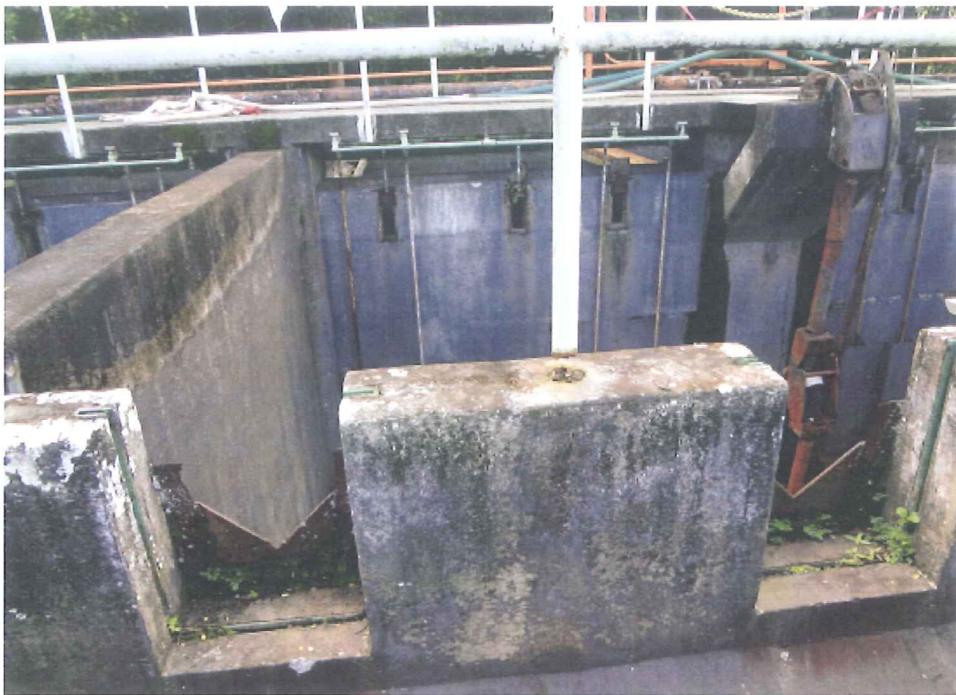
Due to the requirement of the operation and retrain of weather condition only Aeration Tank No.1 (SK-4.1, Photo 4.Photo 4.18) was cleaned out to open for observation of the base slab and surrounding walls. The existing conditions of all other tanks were presumed to be similar. The results of observation are summarized as follows.

**PHOTO 4.18 – STANDING AT CATWALK TO VIEW AERATION TANK (LEFT) AND CORRODED GRATING ON AERATION TANK (RIGHT)**

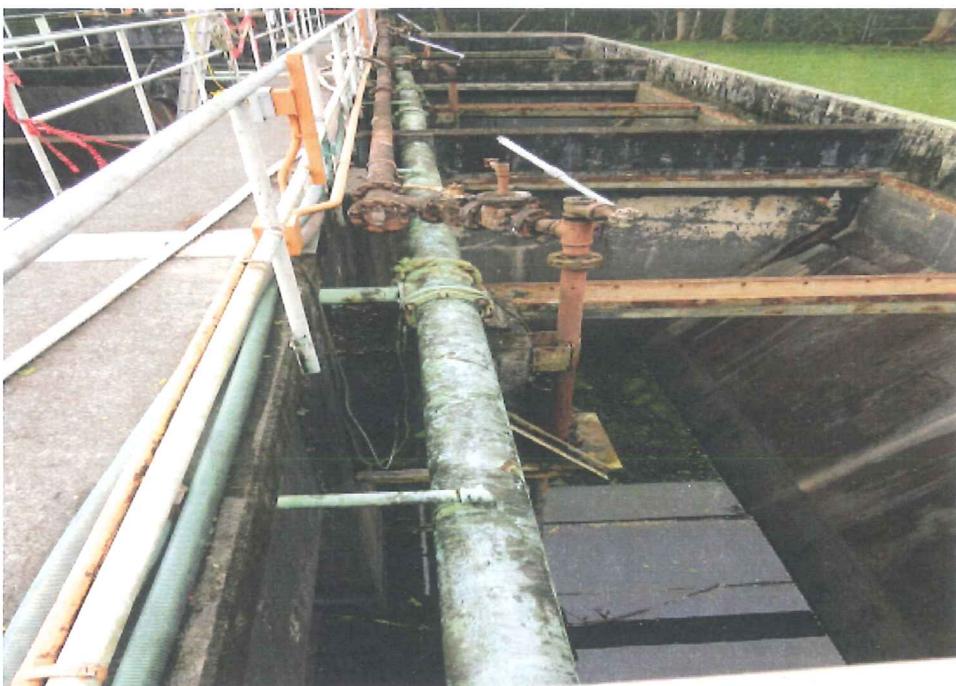
2. The metal railing appeared severely rusted See SK-4.3 and Photo 4.19
3. All Exterior wall surfaces showed random vertical cracks ranging from 1/16" to 1/8" wide. Existing paint on walls peeled off. See Sk-4.4, 4.5. One (1) large vertical wall crack of 1/2" wide at South/East corner of Settling Tank No.1 was observed.

PHOTO 4.19 – CORRODED END OF RAILLING POST

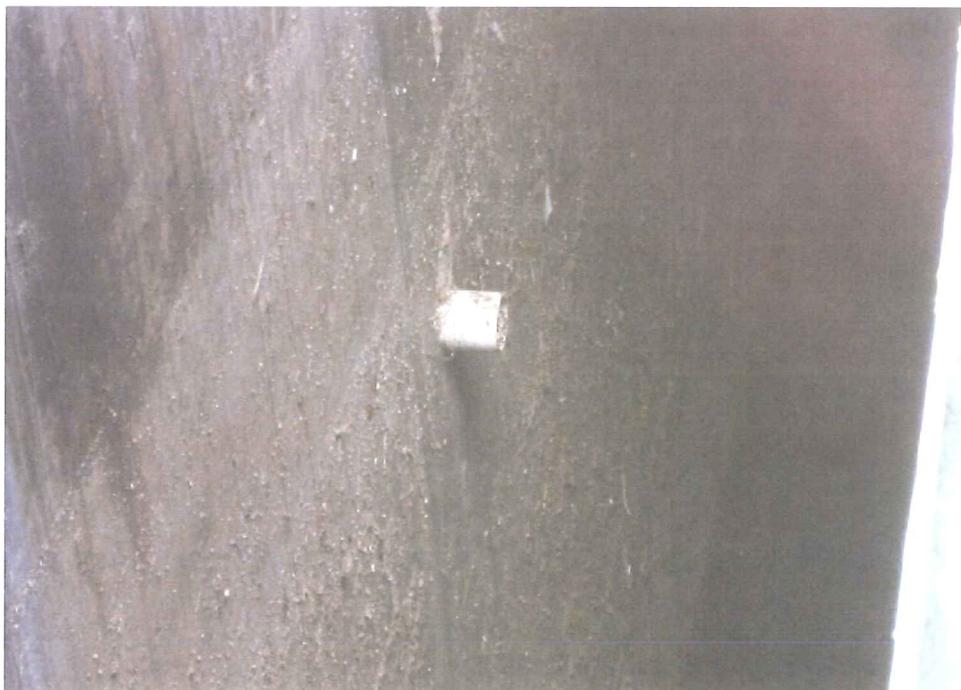
**PHOTO 5.2 PIPE PENETRATION ON WALL**

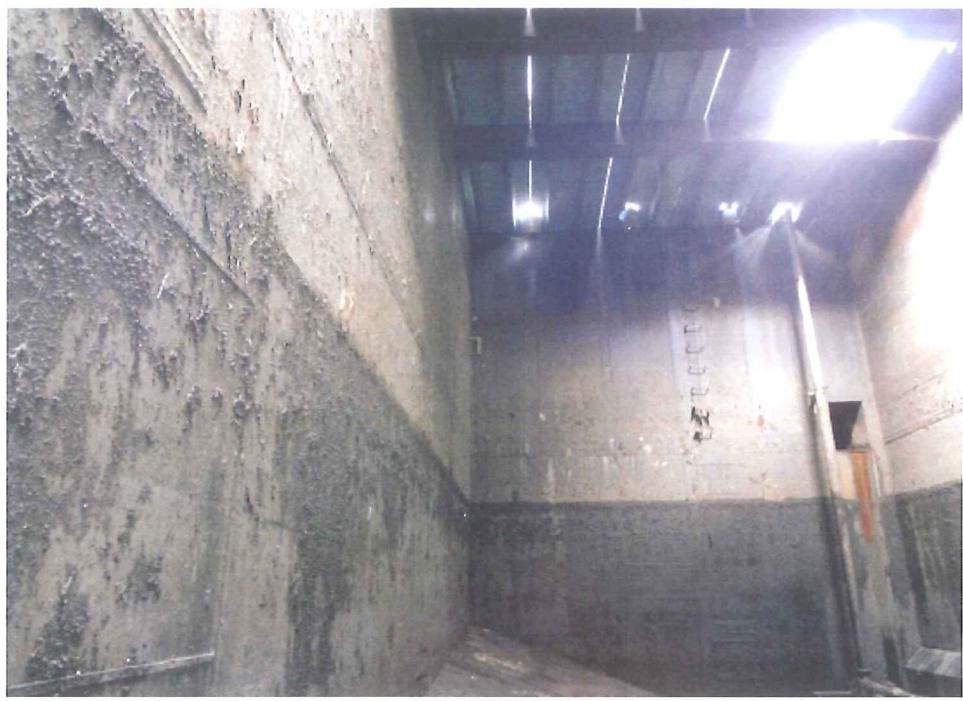
**PHOTO 5.3 - BOTTOM OF WALL SHOWING T-LOCK & EPOXY COATING**

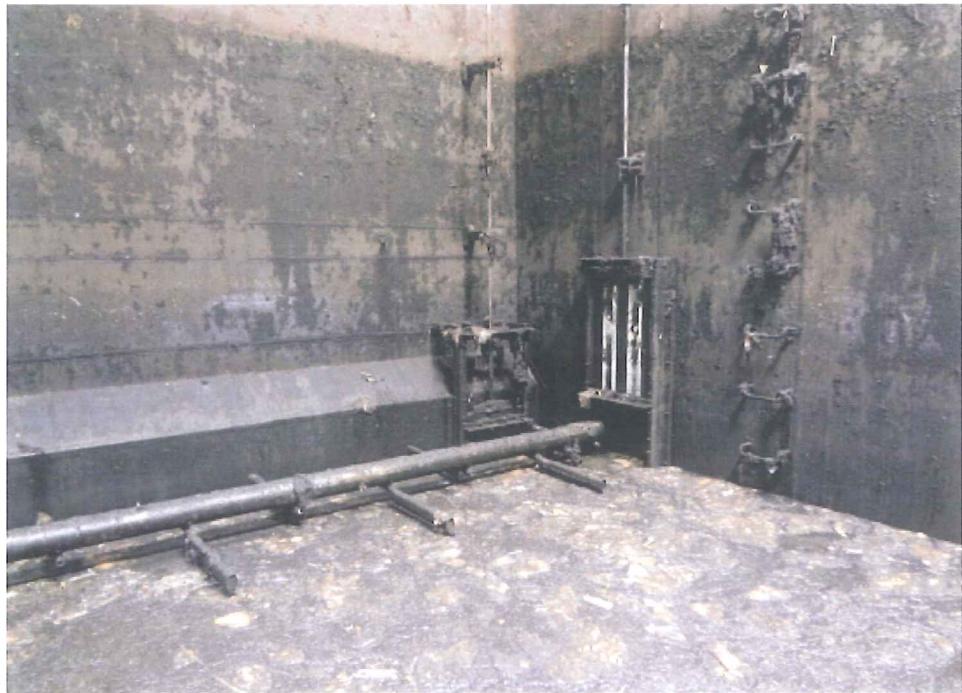
**PHOTO 5.5 – PIPE ON BOTTOM SLAB AND GATE. NOTE RUNGS DAMAGE AND BLISTERING/BUBBLES ON T-LOCK**

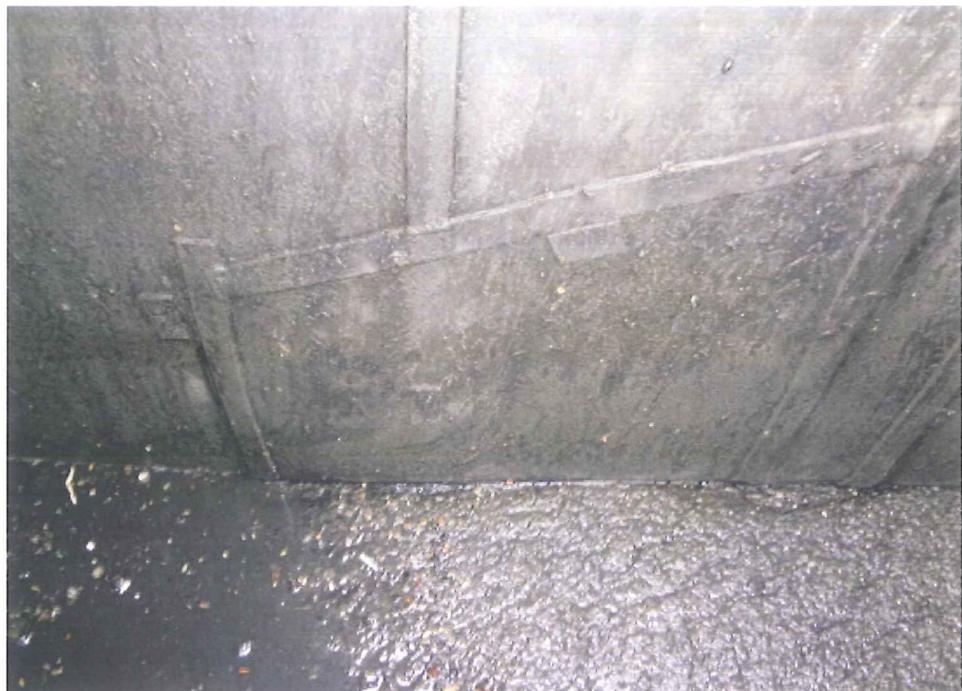
**PHOTO 5.7 – T-LOCK JOINTS/SPLICE**

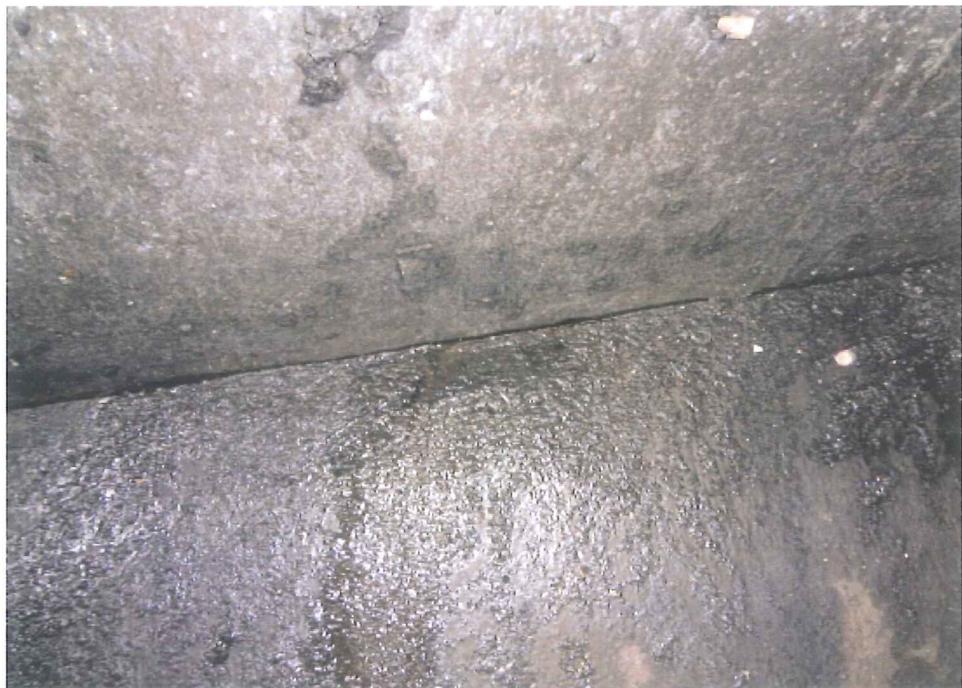
1. The tank structure appeared in fairly good condition. The thick walls and mat footing created an impression that the structure looked strong and sturdy. Concrete surfaces generally appeared sound. However, some damages were noted.
2. T-lock lining had bubbles, blistering, and was randomly delaminated from the concrete. Water existed between the T-lock and the concrete surface as dripping at the bottom of the lining was noted and water could be squeezed out from the T-lock joints. See photo 5.8,
3. Epoxy coating over the bottom portion of the T-lock was damaged and peeled off. Blistering was noted on the coating surfaces

**PHOTO 5.8 – BLISTERING AND BUBBLE ON T-LOCK AND  
BLISTERING FROM JOINT**

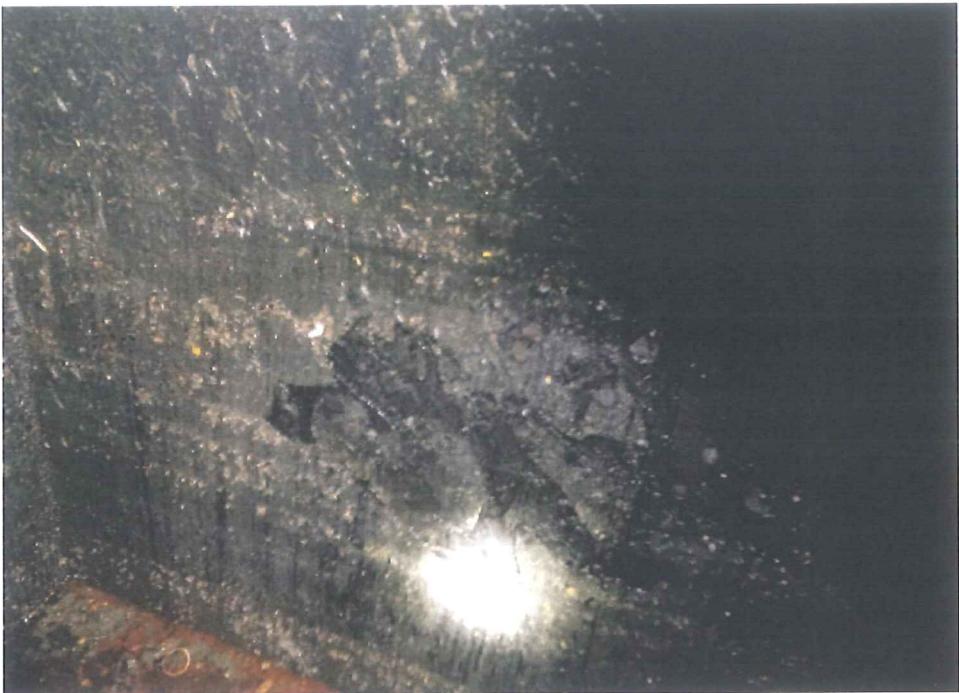
4. Water infiltration was noted at a couple of spots on the floor slab and wall surfaces. See Photo 5.9, 5.10.
5. Corroded concrete and reinforcing bars were observed at gate opening.

**PHOTO 5.9 – WATER PENETRATION ON WALL**

- B. Repair all corroded concrete surfaces and cracks after the coatings are removed.
  - C. water infiltration on the walls and slab shall be sealed
  - C. Rusted reinforcing bars shall be either repaired or replaced.

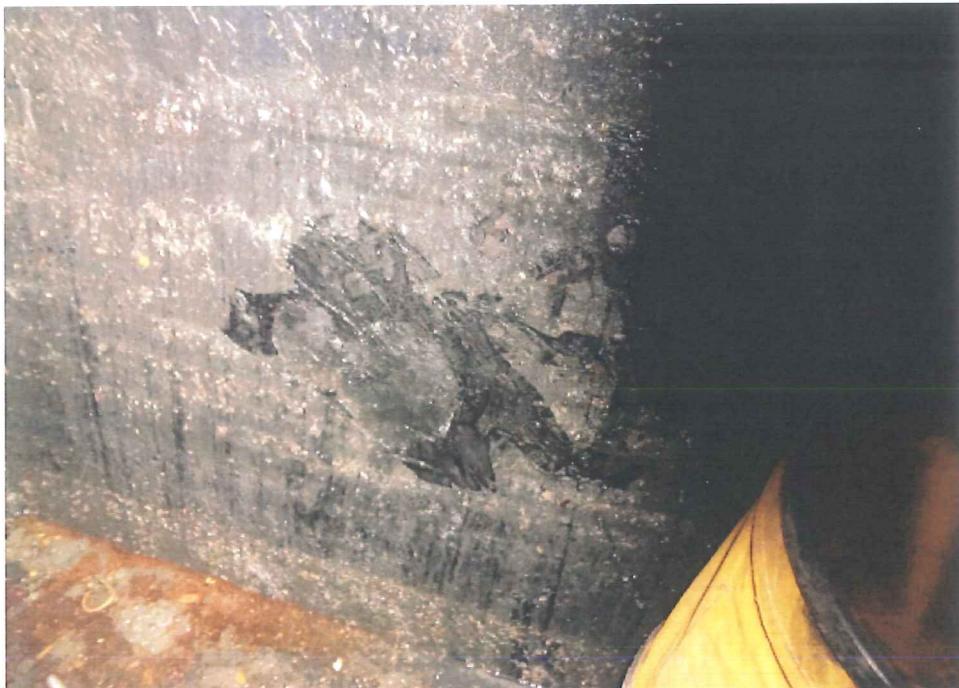
**PHOTO 5.10 – WATER PENETRATION**

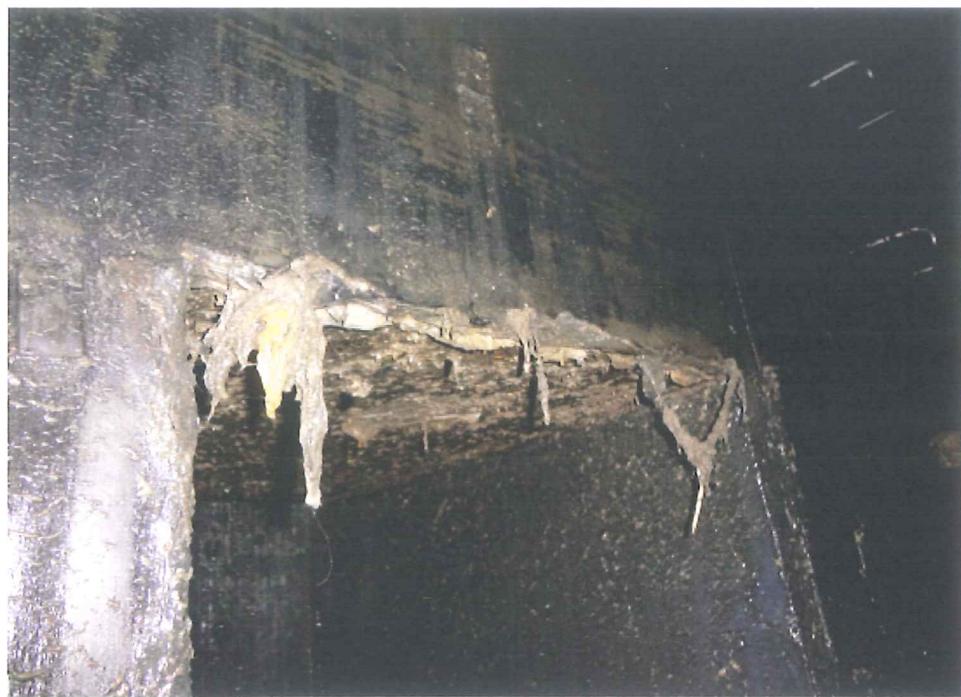
**PHOTO 5.11 – CONCRETE DAMAGES AROUND GATE OPENING**

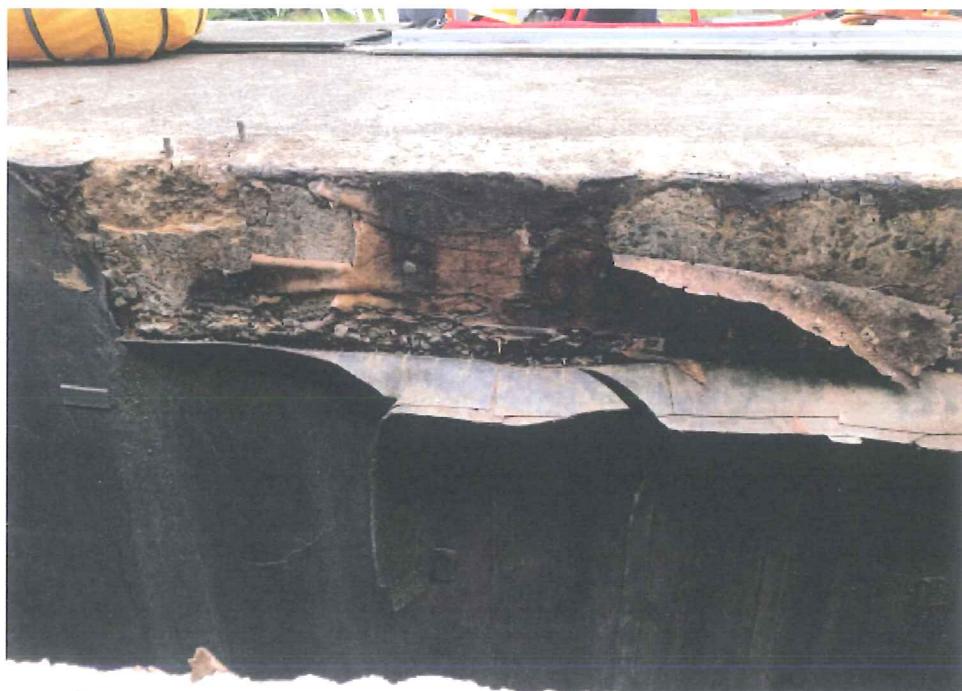
PHOTO 6.4 – CONCRETE DAMAGED AND COATING PEELED OFF

4. Repair all cracks, spalls, rusted rebars, and water infiltrations where occur on existing exterior walls and slabs.
5. Repair or re-construct all top panels.
6. Repair or reconstruct damaged/rusted metal railings, gratings, and steel stairs.
7. For the items of renovations and upgrading as aforementioned, the estimated structural cost is \$1,600,000.
8. Prior to proceeding the final design an in-depth field observation to the Headworks structure shall be conducted to verify the updated conditions and the applicability of these recommendations.

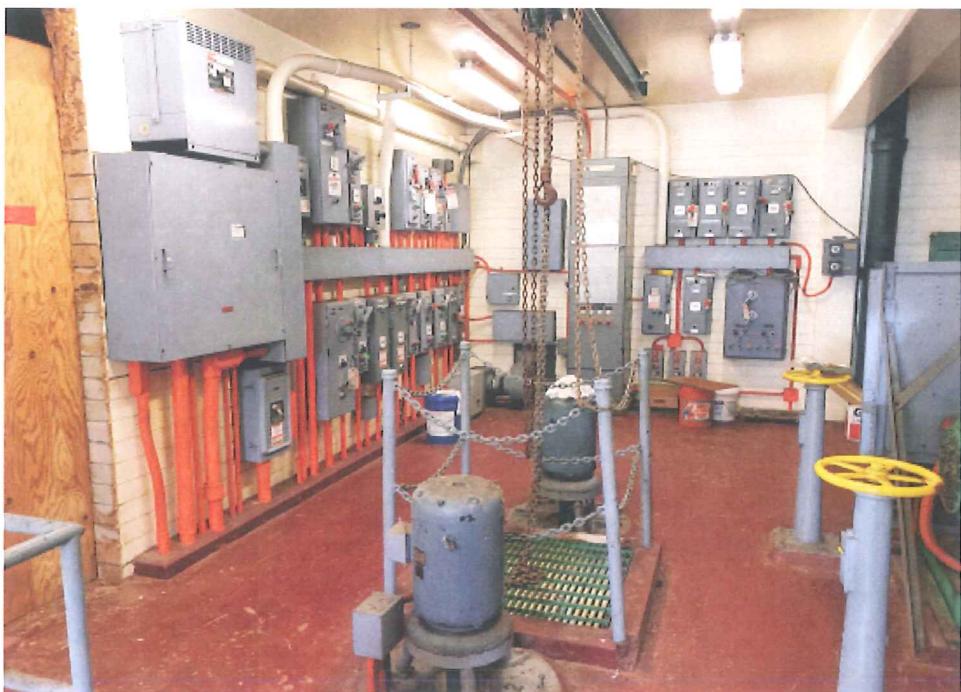
There was no structural field observation and investigation conducted for IPS building. Existing condition of the IPS floor was observed by RMTC and briefly described below. However, the condition of Wet well was discussed in the previous field observation report. Photos 7.1 through photo 7.4.

**PHOTO 7.2 – PARTIAL EAST INTERIOR ELEVATION AT GROUND FLOOR PLAN**

1. The existing IPS floor is in operable condition without special repair.
2. The structure of existing roof over IPS station floor can be salvaged with some repair and paint, However, the existing roofing shall be completely replaced or reconstructed.
3. The added room and open shed super structure shall be completely removed. However, the existing slabs on grade can be salvaged
4. Considering the potential high flood level, which may be 3 to 4 feet higher than the surrounding grade we recommend building a 6 feet tall CMU protection walls on the North side of the building. SK-7.1 and SK-7.2. This wall can be founded on the existing slab on grade.
5. For the aforementioned work we estimate a structural cost of \$100,000

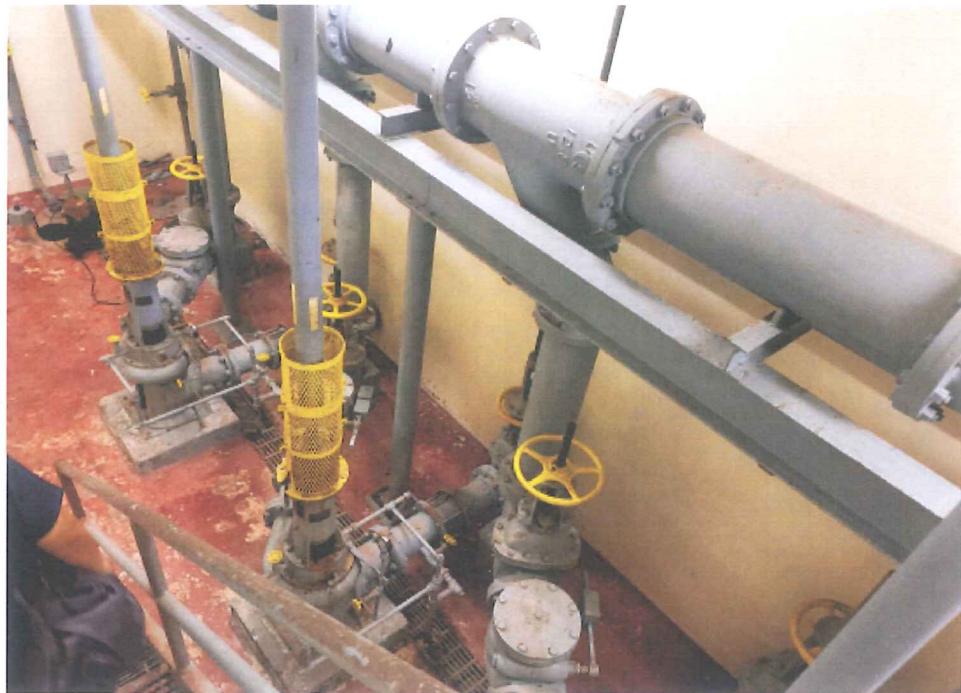
**PHOTO 7.3 – BOTTOM PLAN**

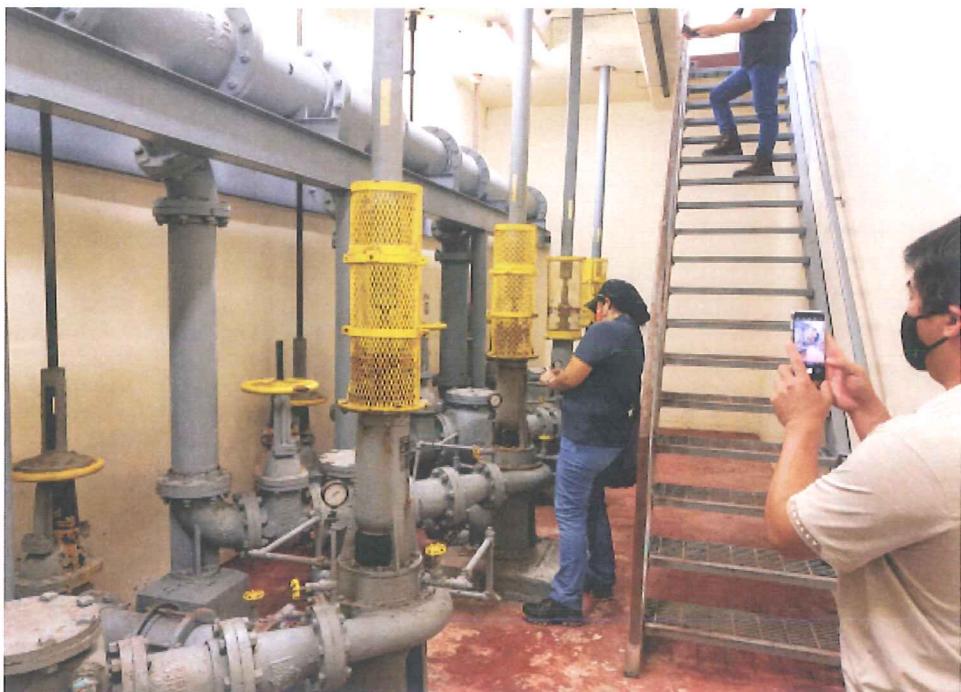
**PHOTO 7.4 – BOTTOM PLAN**
