DEPARTMENT OF ENVIRONMENTAL SERVICES
CITY AND COUNTY OF HONOLULU

SUBJECT: Waianae Wastewater Treatment Plant Outfall Improvements
and Rehabilitation
Tax Map Key: (1) 8-6-001:007 (POR.)

The City & County of Honolulu (CCH) Department of Environmental Services (ENV), Wastewater Engineering and Construction Division, proposes to install a concrete encasement structure over the existing Waianae Wastewater Treatment Plant (WWTP) outfall and cap three manholes on the existing outfall pipe in response to a 2018 inspection report that identified advancing shoreline erosion as a threat to the stability of the outfall and actively corroding cast iron manhole covers at an elevated risk of failure. The proposed project includes the following actions:

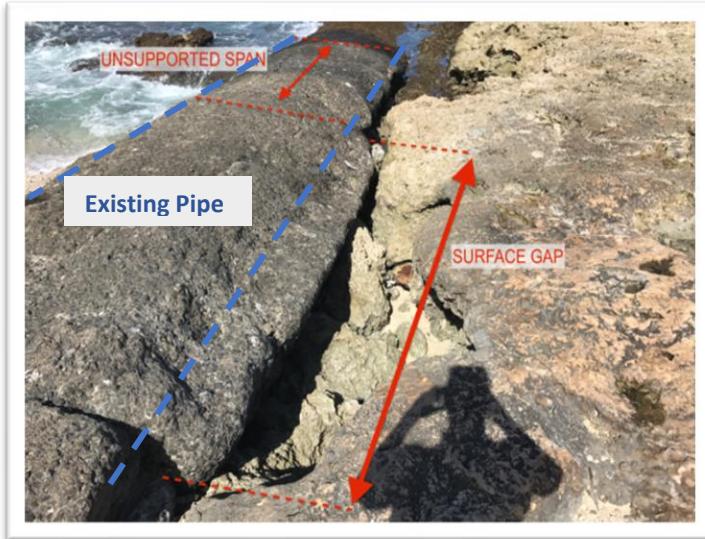
Sea Engineering, Inc., (SEI) conducted visual inspections of the outfall pipe's landfall and shoreline location on three separate visits: August 2015, June 2017, and July 2017. These observations revealed that an approximate 20-foot-long section of the 36-inch pipe was unsupported with a gap of up to one foot from the bottom of the pipe to the substrate. Approximately 20 to 30 feet landward, on the north flank of the pipeline, a gap or void space between the existing trench wall and grout jacket was also observed. Additional void spaces were observed seaward on the north flank of the pipeline.

Surface gap and voids along north flank of outfall pipe

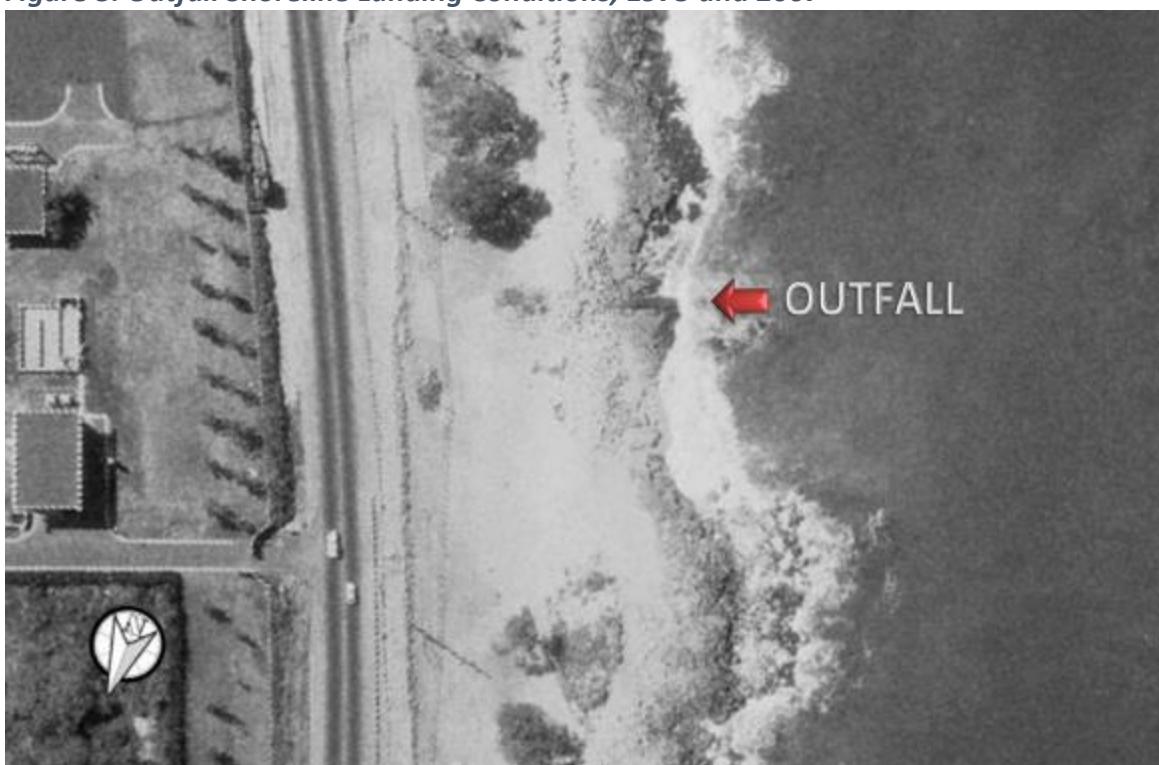
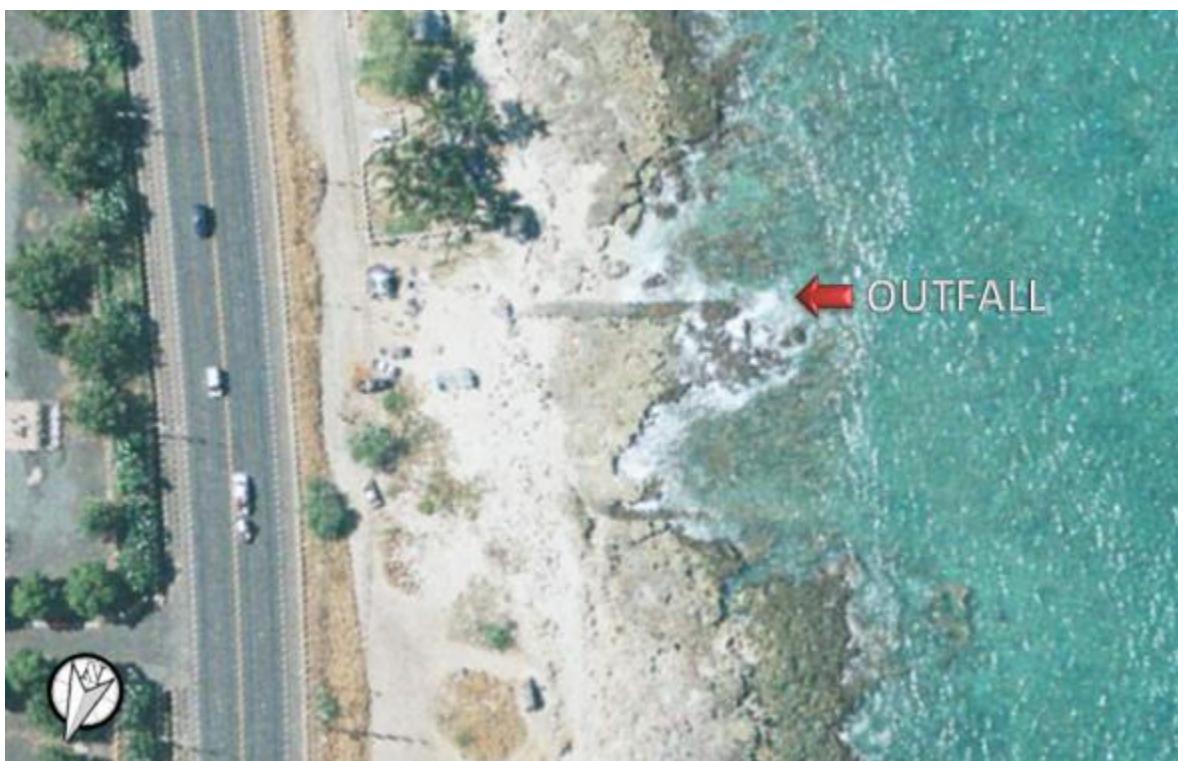
Figure 3. Outfall Shoreline Landing Conditions, 1975 and 2007

Since the construction of the outfall in 1965, it is estimated that the shoreline south of the pipe has retreated (i.e., eroded) approximately 25 to 30 feet. The existing shoreline adjacent to the outfall pipe has experienced significant erosion since its original construction, as shown in . The entire mass of rock adjacent to the waterline along the southern flank of the outfall pipe has been fractured, broken up, and eroded away from the pipe.

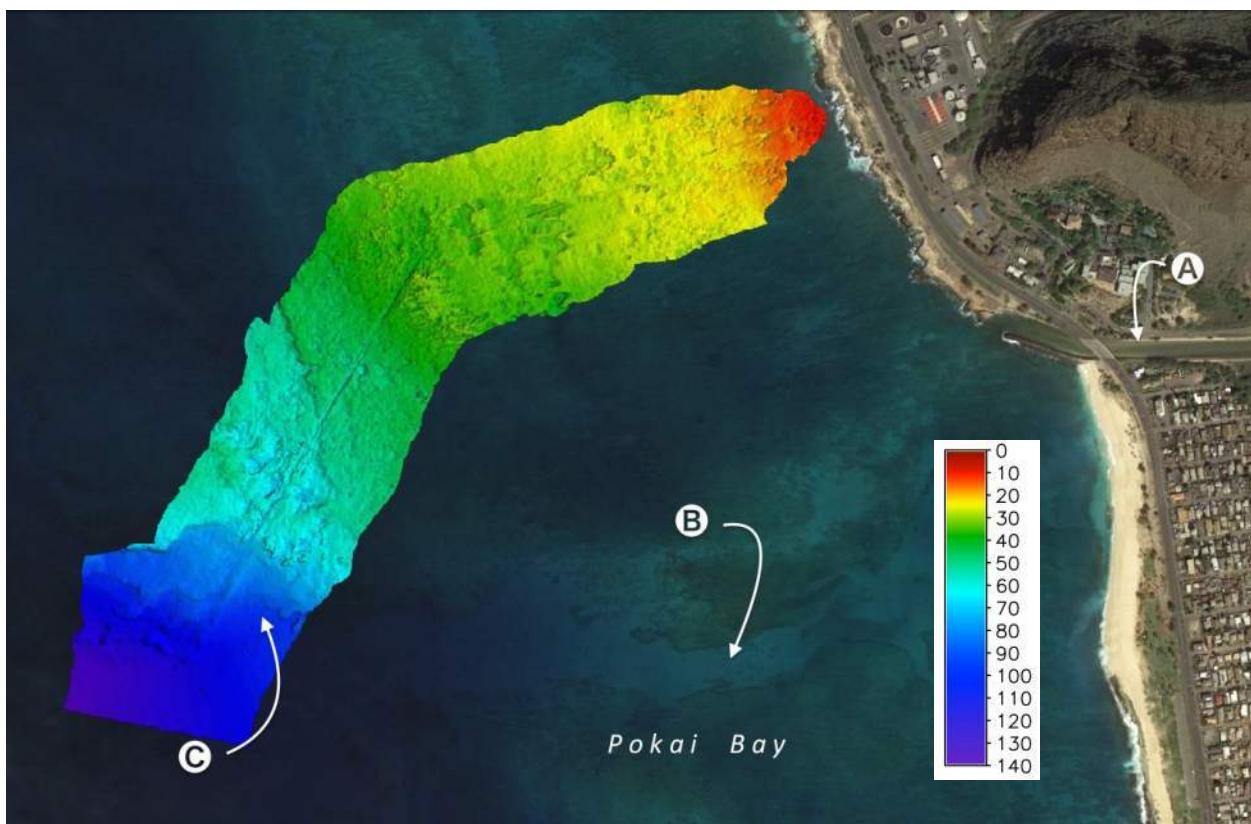
In general, the multibeam results clearly resolve the outfall along much of the surveyed corridor, where the surrounding seafloor is characteristically irregular, hard bottom substrate, as illustrated in the overview bathymetric DTM presented in Figure 3-6 below. The deeper diffuser section is the exception, which appears to just intersect the sand channel created by Mailili Stream (A), with the submerged expression of what is likely the stream's prehistoric alignment given by the sand channel clearly visible (B) at image lower center, which runs east-west bisecting Pokai Bay. The northern boundary of the sand channel appears to run just north of the diffuser section (C), suggesting that the diffuser leg may rest on at least partial sand bottom, or is partially covered by the northern fringe of this deposit.

Figure 3-6. Overview of surveyed outfall corridor. Depth in feet above MLLW.

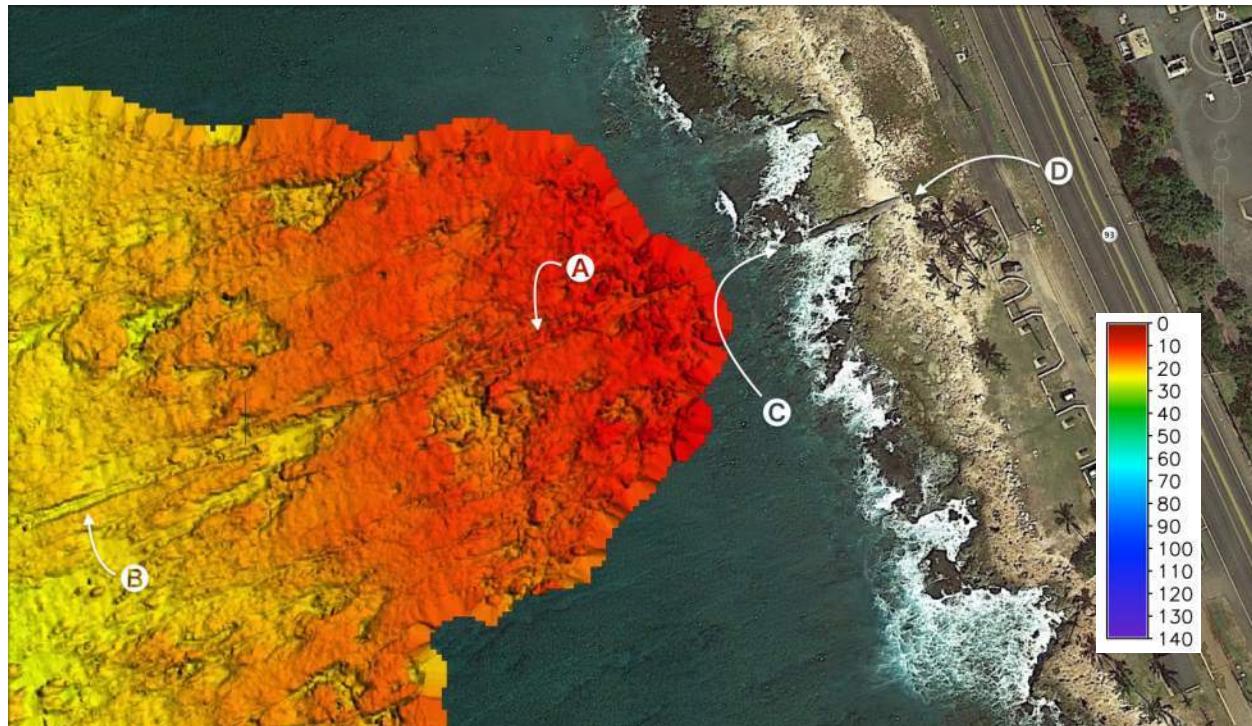
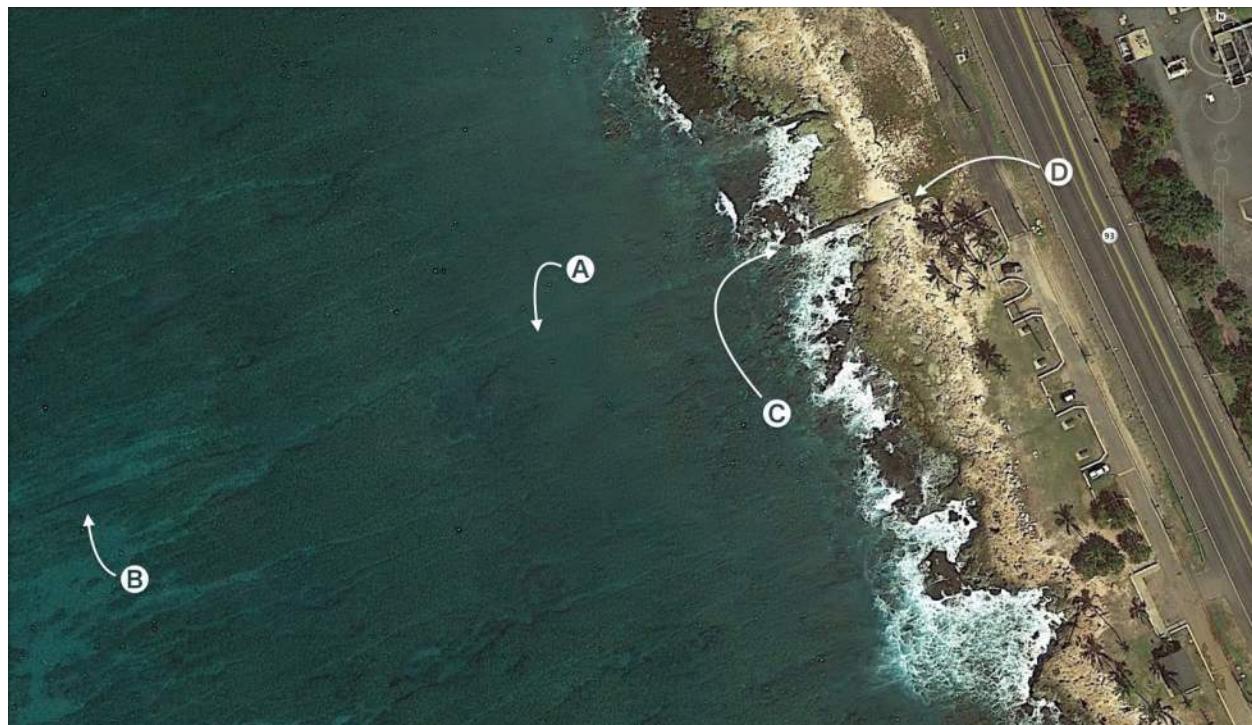
A closeup view of the nearshore section of outfall corridor, including landfall, between the shoreline valve-box and approximately 20-foot water depth (red to yellow shaded bathymetry in Figure 3-7, top panel) suggests that the seafloor is largely composed of spur-and-groove type coral/limestone formations, with the groove features apparently accumulating some limited sand veins and sand patches, as indicated in the corresponding aerial imagery in Figure 3-7 (bottom panel). Also in Figure 3-7, the outfall with concrete

Figure 3-7. Outfall landing with DTM (top) and without DTM (bottom) over aerial image, dated 29 Jan 2013. *Image Source: Google Earth, 2017*

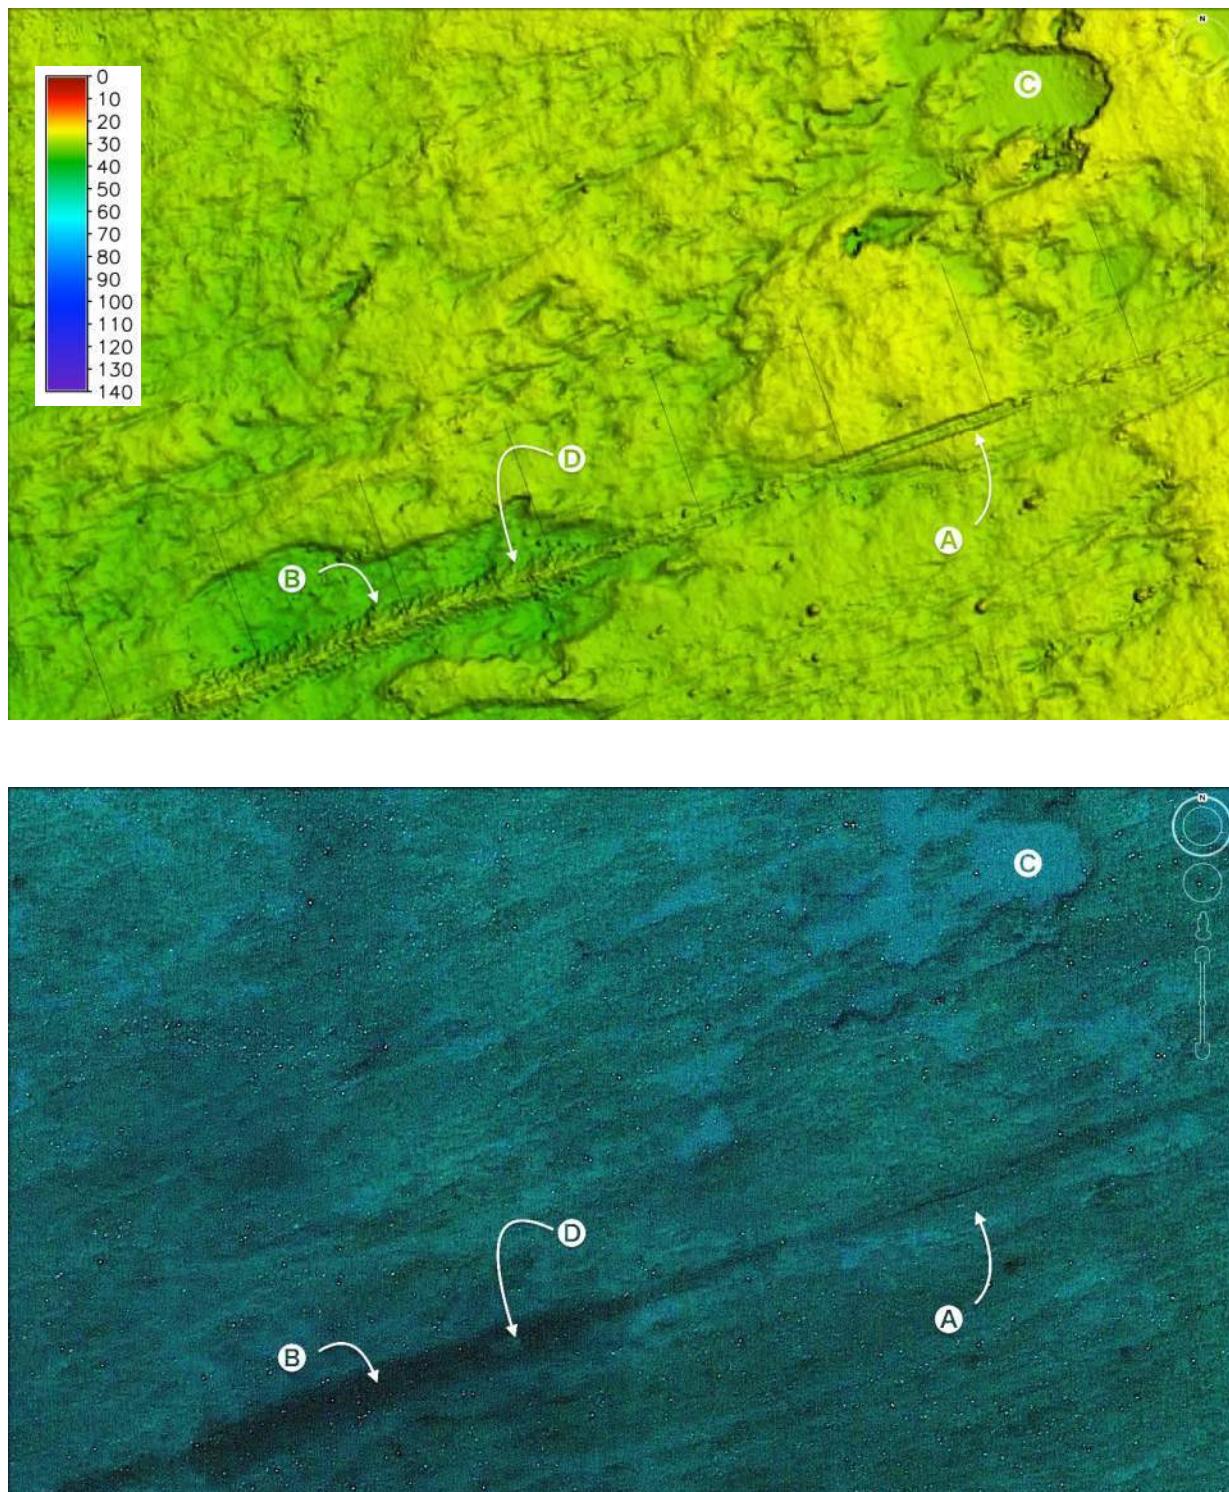
Further out, approximately between the 20 and 30-foot depth contours (yellow to green shaded bathymetry), the seafloor is relatively flat and smooth, but marked with steep-walled potholes and other deep scarring, as shown in Figure 3-8. Continuing offshore, in roughly 30 to 40-foot water depths, the outfall trench is visible (A) at approximately Station 17+00. A ballasted (rocked) section of pipe (B) is seen between Stations 20+00 to 23+00, with individual ballast stones discernable along the ballast pile. A relatively large and apparently sand-filled pothole (C) lies to the north (aerial image, bottom panel). Pressure Manhole 3 (D) is almost perceptible along the ballast pile, suggested by the saddle shaped depression in the pile at this location.

Figure 3-8. Shallow outfall corridor with DTM (top) and aerial image (bottom), dated 29 Jan 2013. *Image Source: Google Earth, 2017*

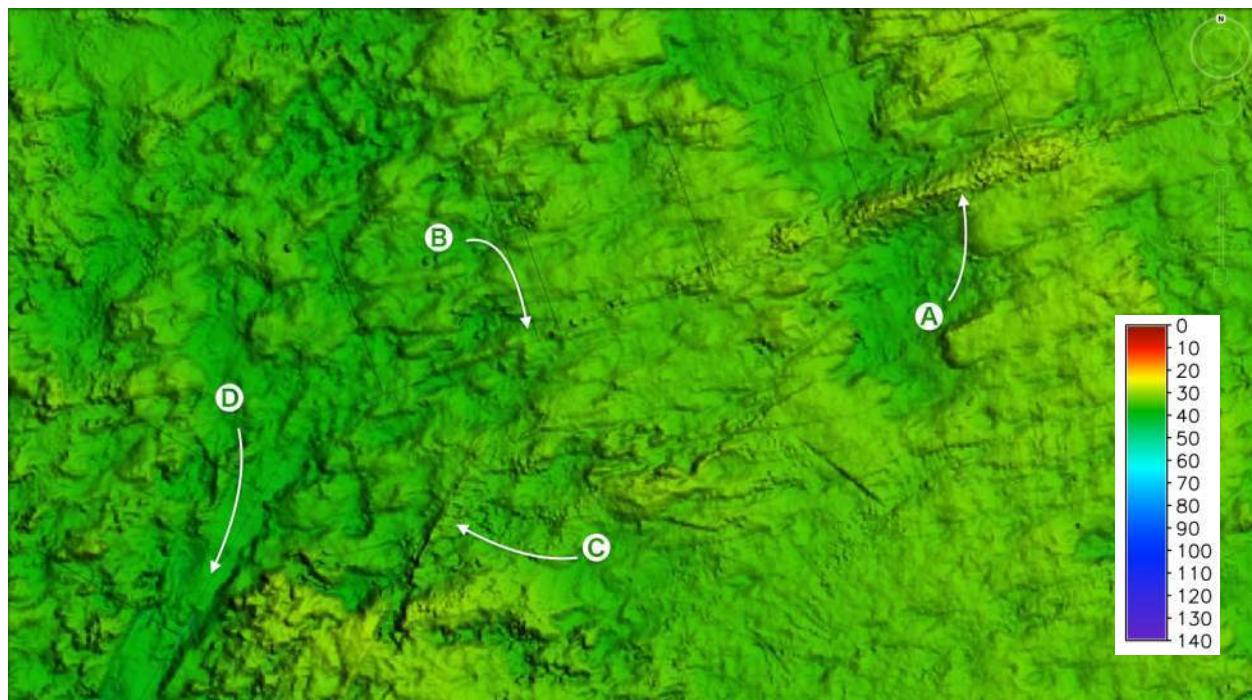
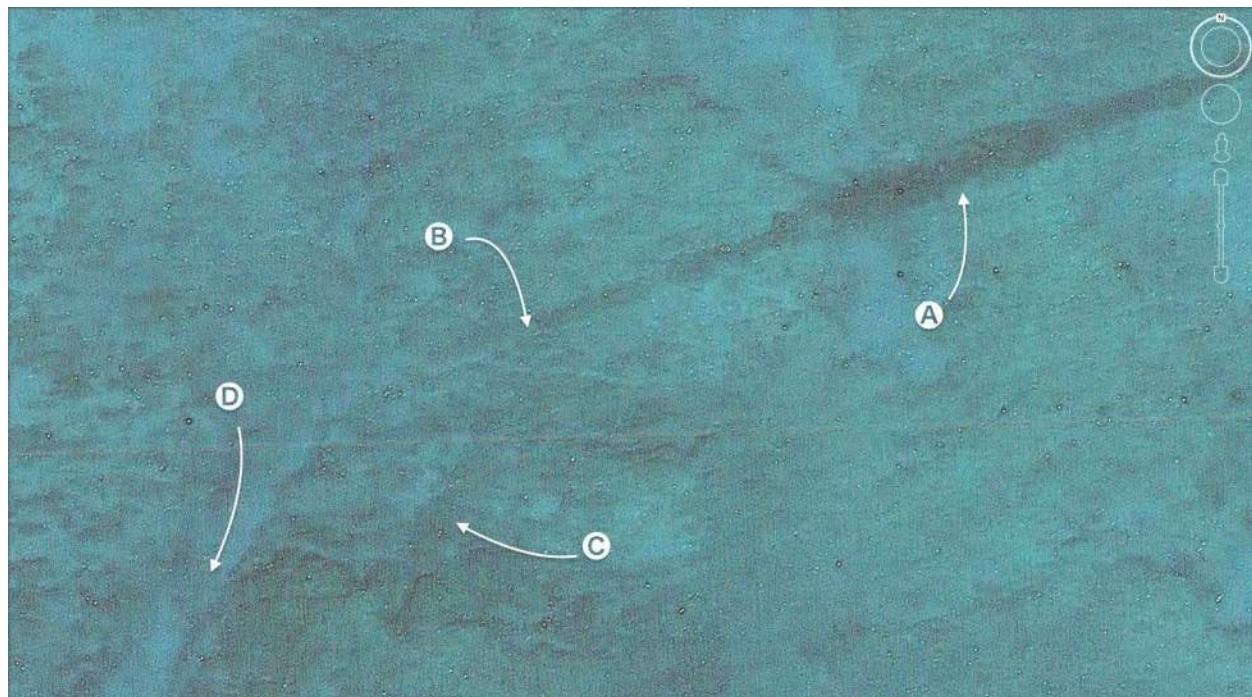
In the vicinity of the offshore wye structure, Figure 3-9 reveals a section of ballasted pipe (A) that is clearly visible at approximately Station 25+00 to 26+00. The wye junction itself (B) is vaguely discernable at Station 28+00, where the abandoned original diffuser leg (C) is visible extending approximately 170 ft from the wye. The 42-inch extension begins at the wye, makes a 39° bend, and continues offshore in a trench (D). At this point, the general seafloor slope breaks and falls more steeply to a scarp line that runs basically north-south at approximately 50 to 60 ft depth (green to cyan shaded bathymetry). Between this scarp line and the Mailiili sand channel (C), the bottom is broken and irregular with pits and scars, likely filled with sand. The remaining corridor sloping down to 100 ft or greater appears to transition from hard bottom to sand or a combination of the two.

Figure 3-9. Wye junction structure with DTM (top) and aerial image (bottom), dated 29 Jan 2013. Image Source: Google Earth, 2017

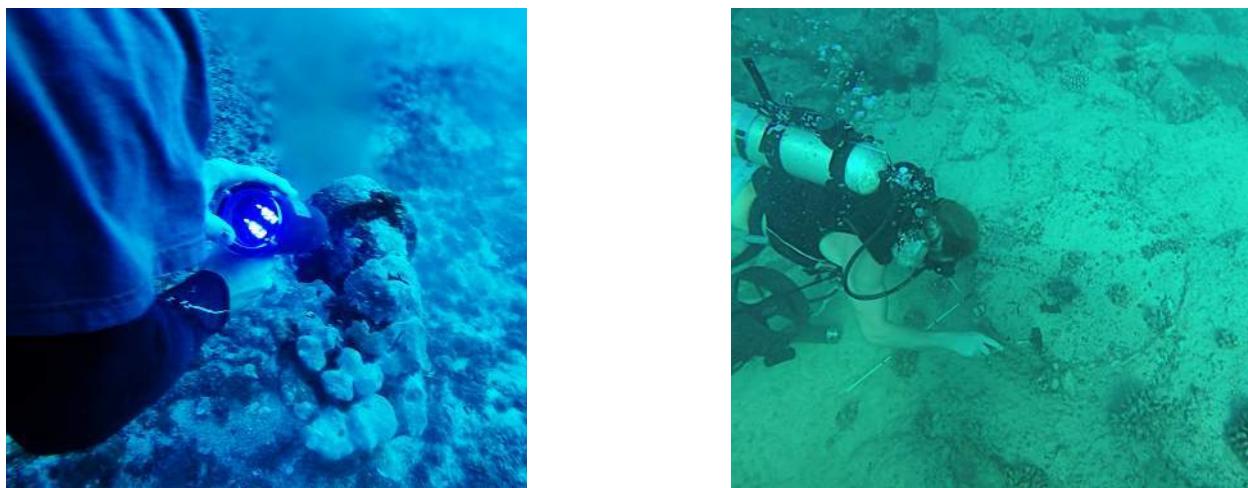
Figure 4-9. CP-gun measurements on monel diffuser bolts (left); surface cleaning, cast iron cover, MH3 (right)

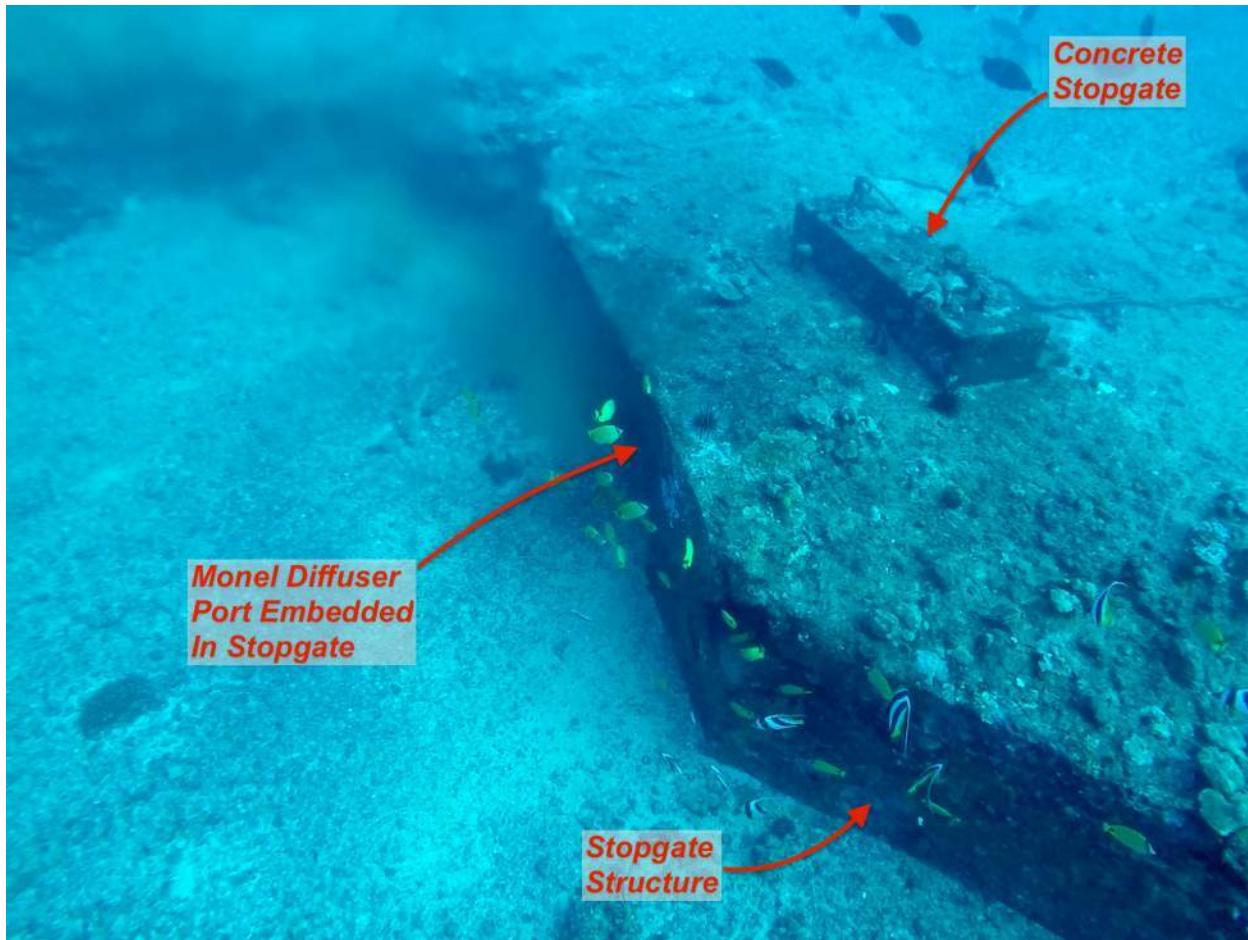
- At no point during the inspection were the actual 36-inch or 42-inch RCP joints visible. This is a good indication, as it is consistent with design and implies stability.
- The stopgate structure, special wye structure, and manhole risers visibly appeared to be in good operating condition, with no significant cracks or spalls evident to inspectors. A majority of the mass of most structures were embedded in the ocean floor and appeared well supported with no significant evidence of scour or failure of supporting trench walls. Representative photographs of the stopgate structure and special wye structure are provided in Figure 4-10 and Figure 4-11, respectively.

Figure 4-10. Stopgate structure, located at end of diffuser leg, which is also the outfall terminus.

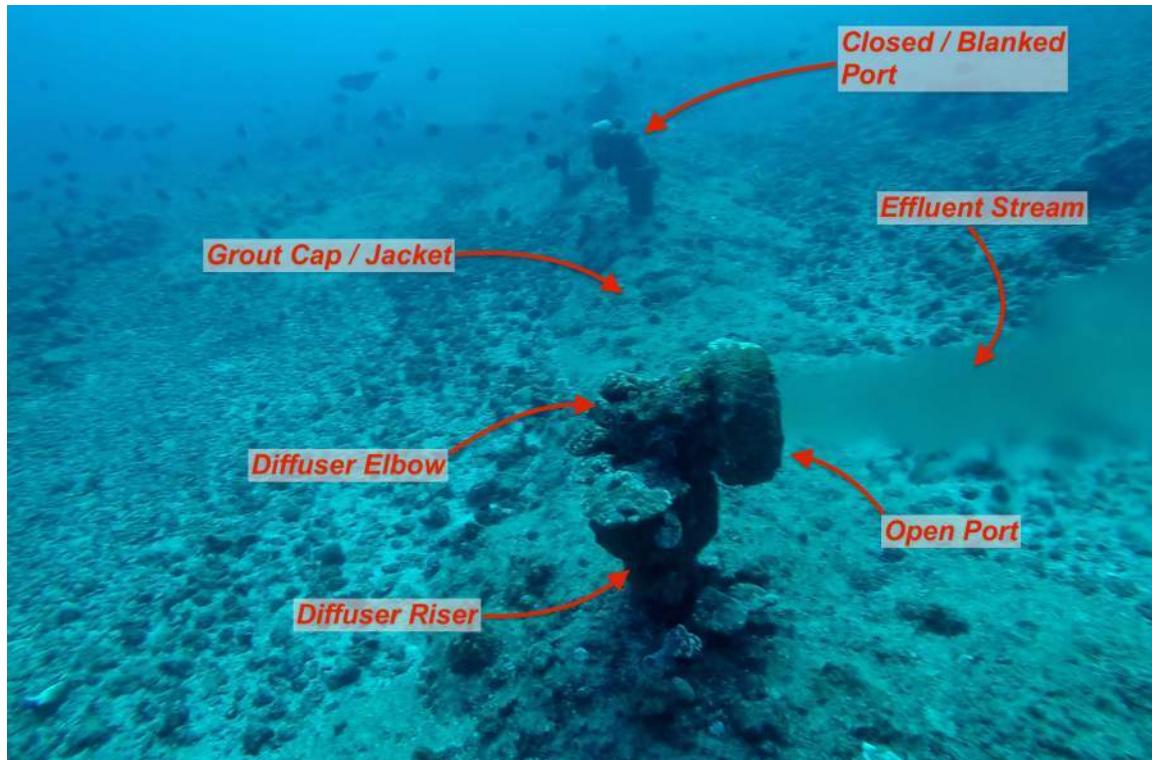
Figure 4-12. Looking northward along the diffuser leg, with open diffuser in foreground, blanked diffuser behind.

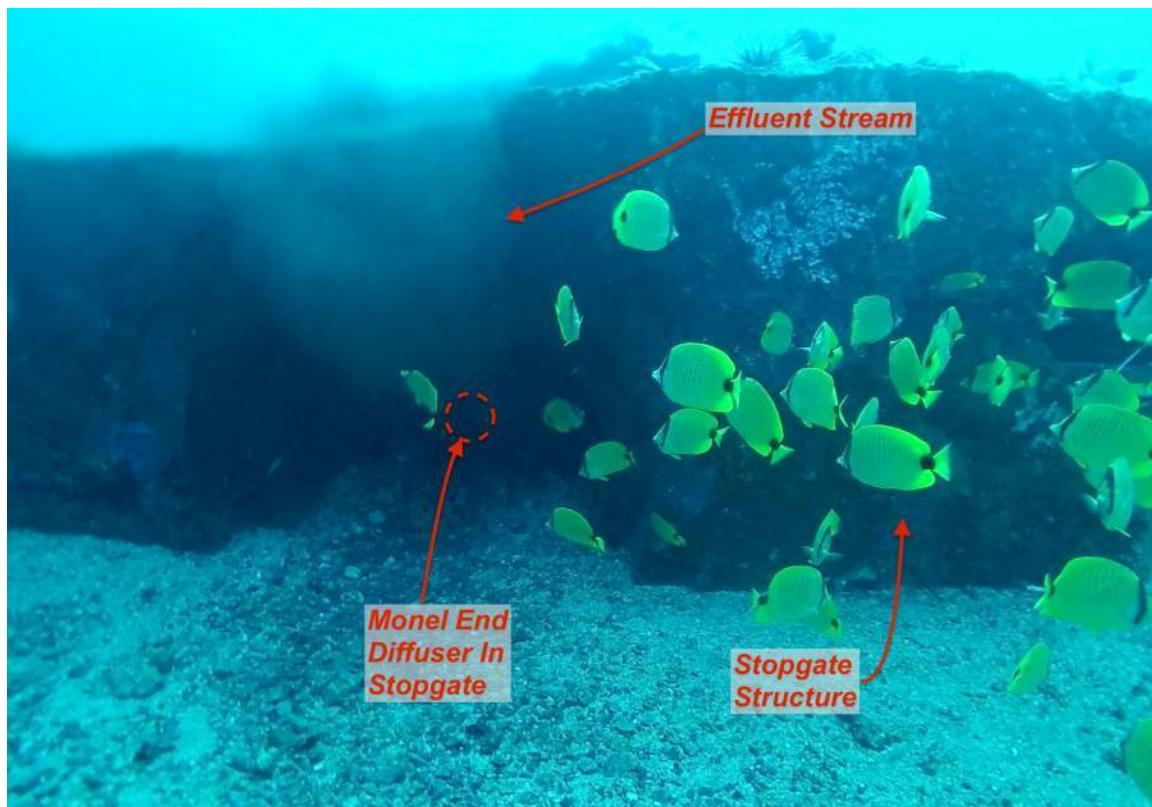
Figure 4-13. Stopgate structure, with single monel diffuser port

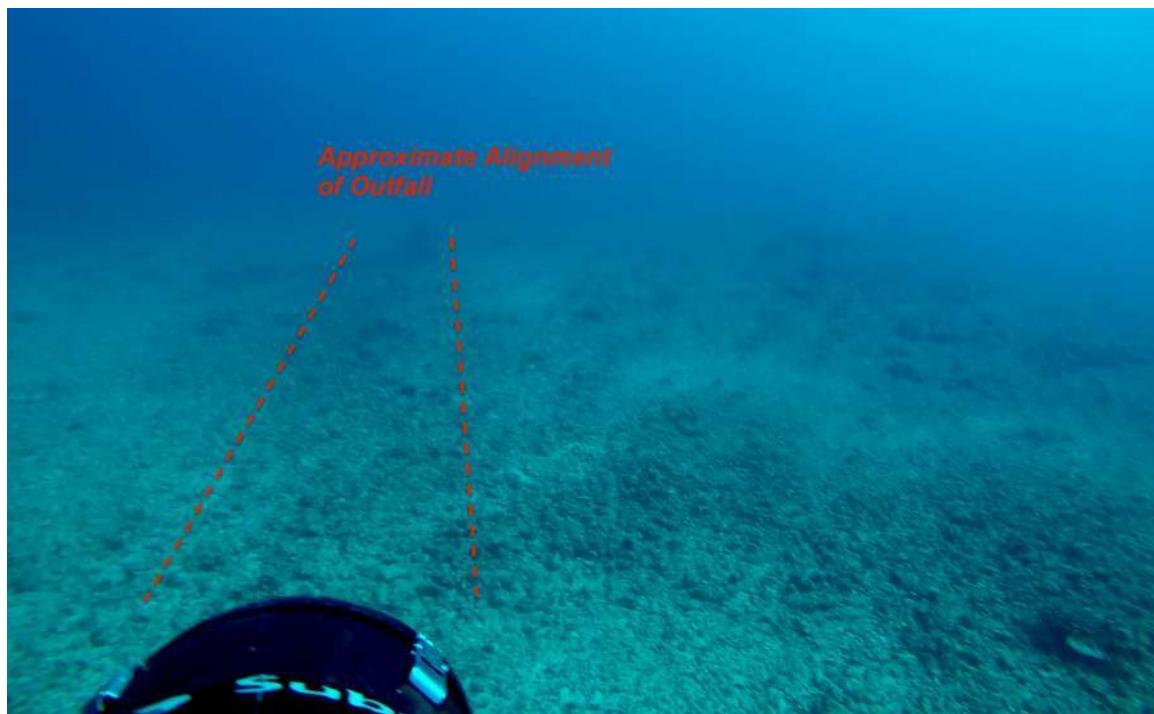
Figure 4-14. Outfall completely hidden, approximately between station 23+00 E and 26+00 E

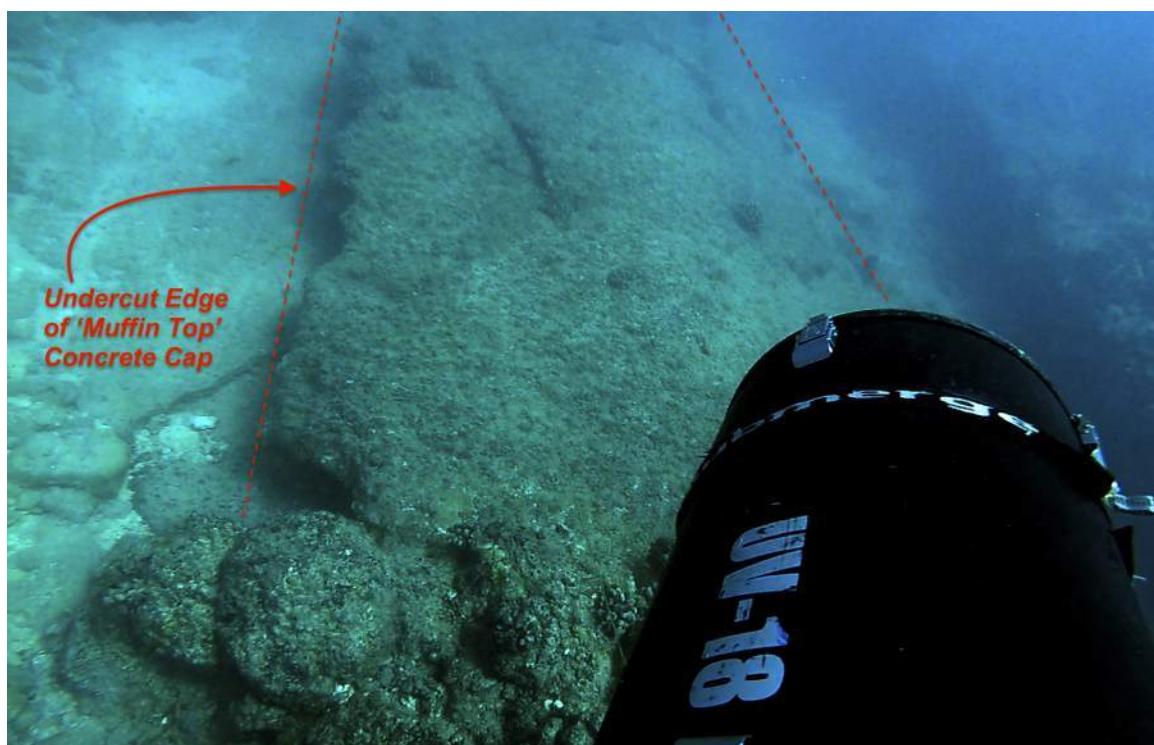
- During earlier visual inspections of the shoreline landing and above-water portions of the outfall conducted in August 2015 and July 2017, an area of partial erosion and scour of the shoreline limestone, sandy sediments and sedimentary rock was noted. The erosion resulted in a collapse of approximately 50 to 75 ft of the south trench wall seaward of the valve box, in the intertidal zone. Loss of the section of supporting south trench wall resulted in undermining of the pipe and development of a void space below the pipe. An unsupported span of approximately 20 ft currently affects the pipe. This condition was previously noted in an SEI memorandum, dated 26 June 2017. Emergency repair of this area by injecting tremie concrete under the pipe has been scheduled. Several locations along the outfall were noted where the concrete jacket or cap formed a mushroom-shaped profile or "muffin top" that appeared to have a slight undercut along the edge of the pour. This appeared to be the result of construction methodology and concrete form over-pour, and did not appear to be a sign of active erosion, undermining or instability. An example of this condition can be seen in Figure 4-15.

Figure 4-15. Concrete jacket/cap with edge voids creating a “muffin top” profile

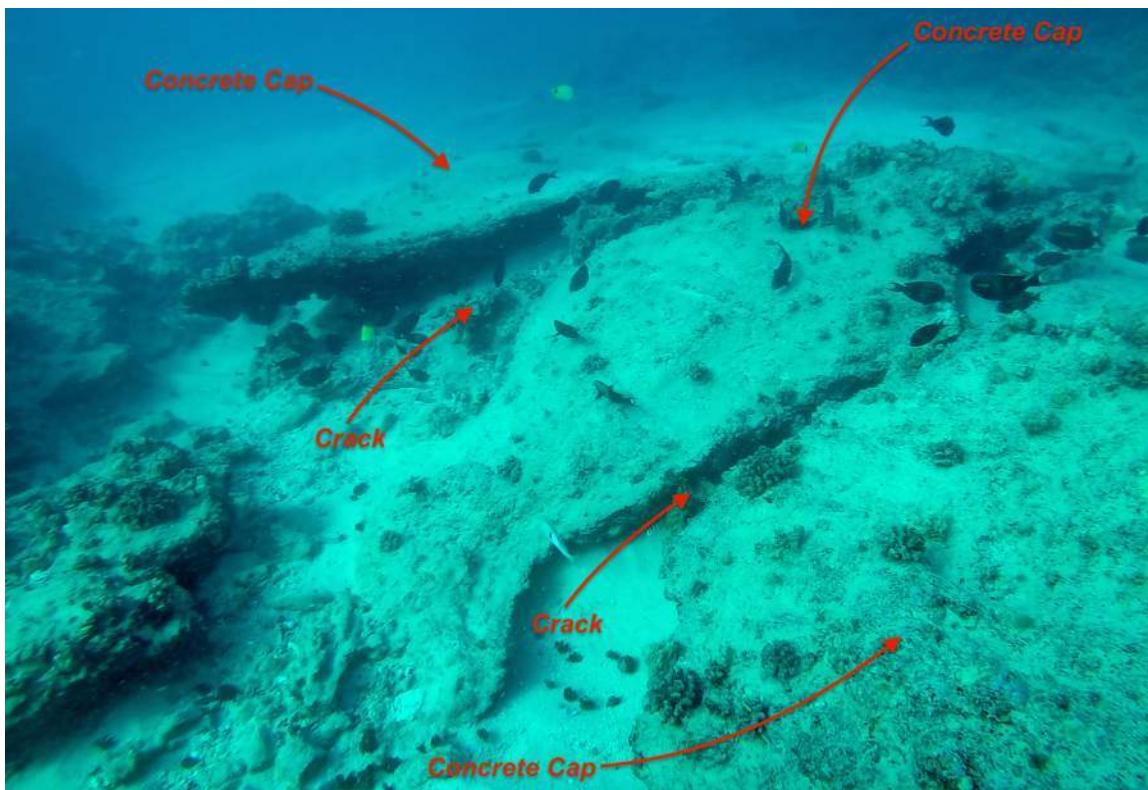
- Near station 02+50 E, the concrete cap was found broken into several large masses with large visible voids underneath the edges of the breaks. No underlying gravel, stone or RCP joint was visible at this location, and it appears the damage was limited to the concrete cap. A photograph of this location is presented in Figure 4-16.

Figure 4-16. Concrete jacket/cap broken into three massive pieces

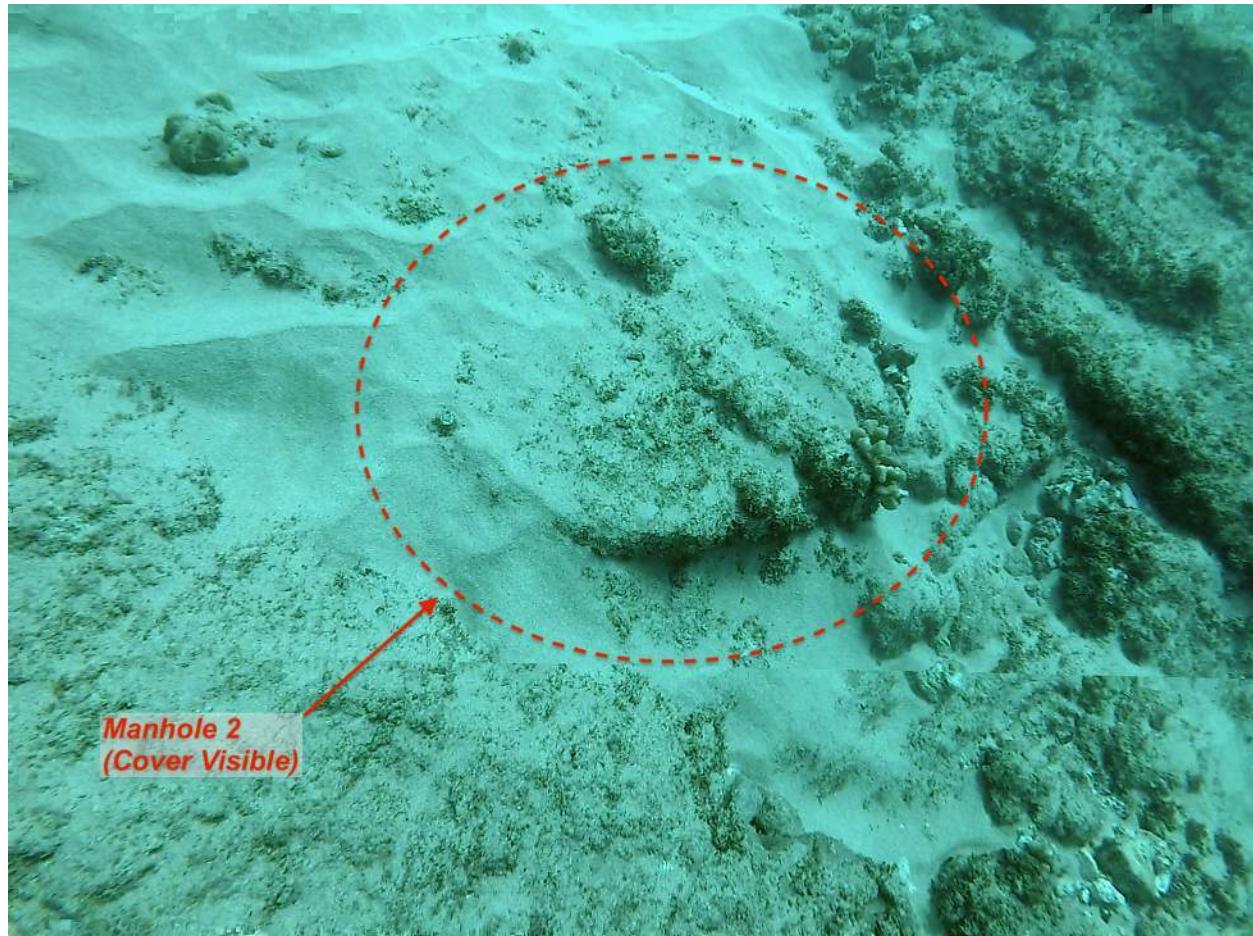
- All seven of the underwater manholes were located (Manhole 1 is located on the valve box at station 00+00, which is onshore), and showed no visible signs of leakage or significant damage to the manhole riser, gasket, or cover. Manhole 2, the shallowest manhole on the outfall, was found nearly completely buried within the sand and seafloor sediments, and required partial excavation for inspection. Conditions of the metallic manhole covers varied depending on the type of metal used, and is discussed in more detail in the hardware section. Photographs of each manhole are illustrated in Figure 4-17 through Figure 4-23, where they are presented in sequential order starting from the shallowest (inshore) manhole and proceeding in the offshore direction to the deepest.

Figure 4-17. Manhole 2, first underwater manhole on the original 36-inch pipeline

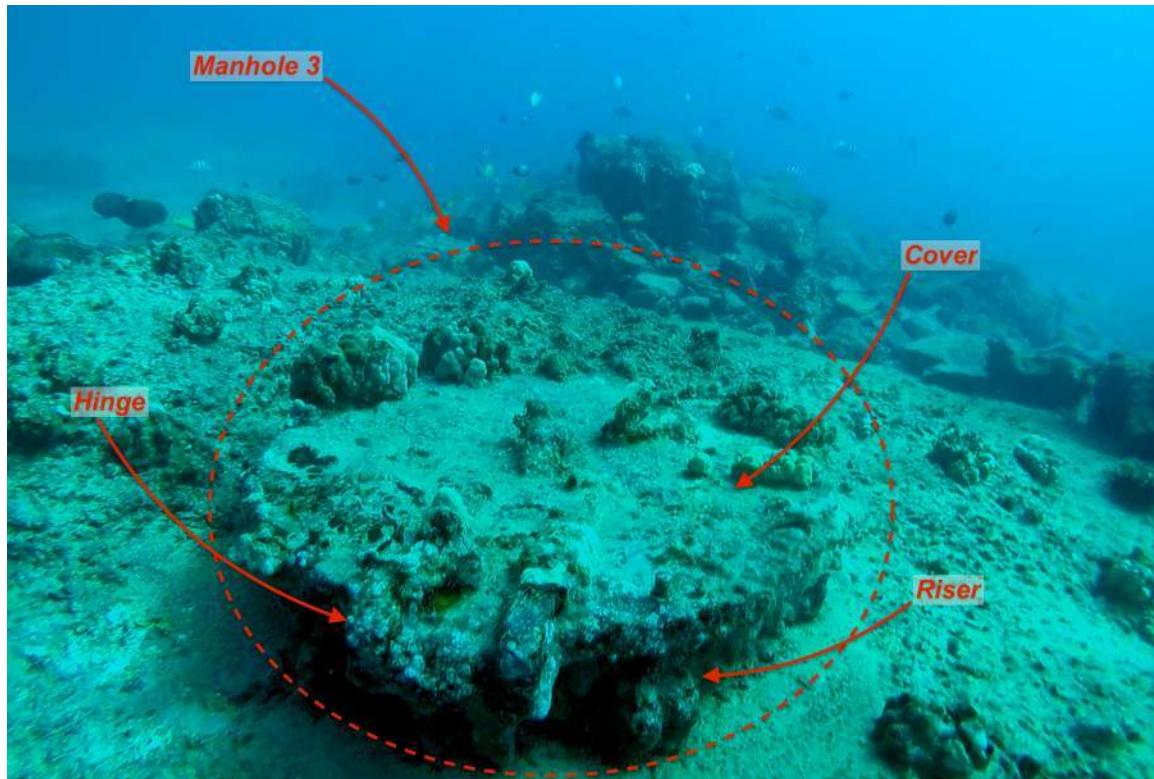
Figure 4-18. Manhole 3, on the original 36-inch pipeline

- The cast iron manhole covers (MH 2 through MH 4), located along the original 36-inch pipeline, all displayed signs of advanced corrosion. The metal surfaces were readily eroded when scraped or struck with a rock hammer during the cleaning process for cathodic protection measurements. This suggests that a significant fraction of the cover's cross section has been corroded and transformed into corrosion byproducts such as ferric oxide (rust). Therefore, the effective structural cross section of the cover has likely been reduced. The lack of provision for any cathodic protection, such as sacrificial anodes, in combination with the locations' shallow and well-oxygenated waters, have exposed the unprotected and susceptible cast iron covers to a highly corrosive environment, likely explaining their advanced state of corrosion that was observed.

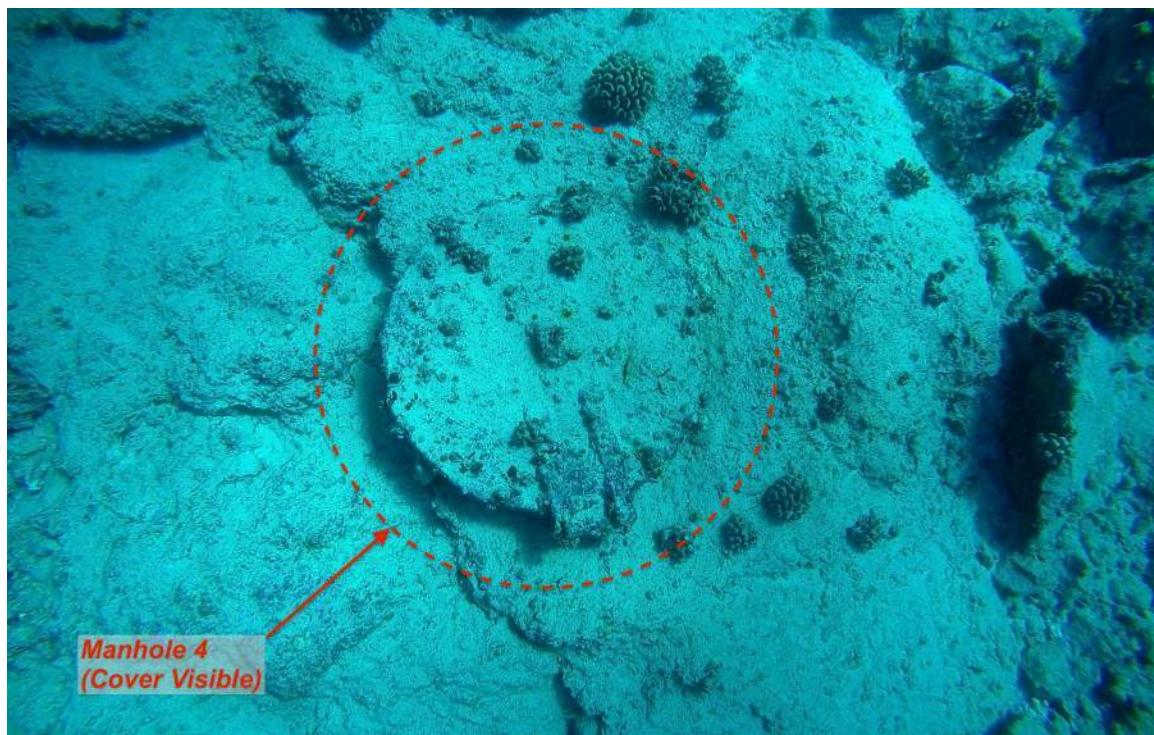
Figure 4-19. Manhole 4, deepest manhole on the original 36-inch pipeline

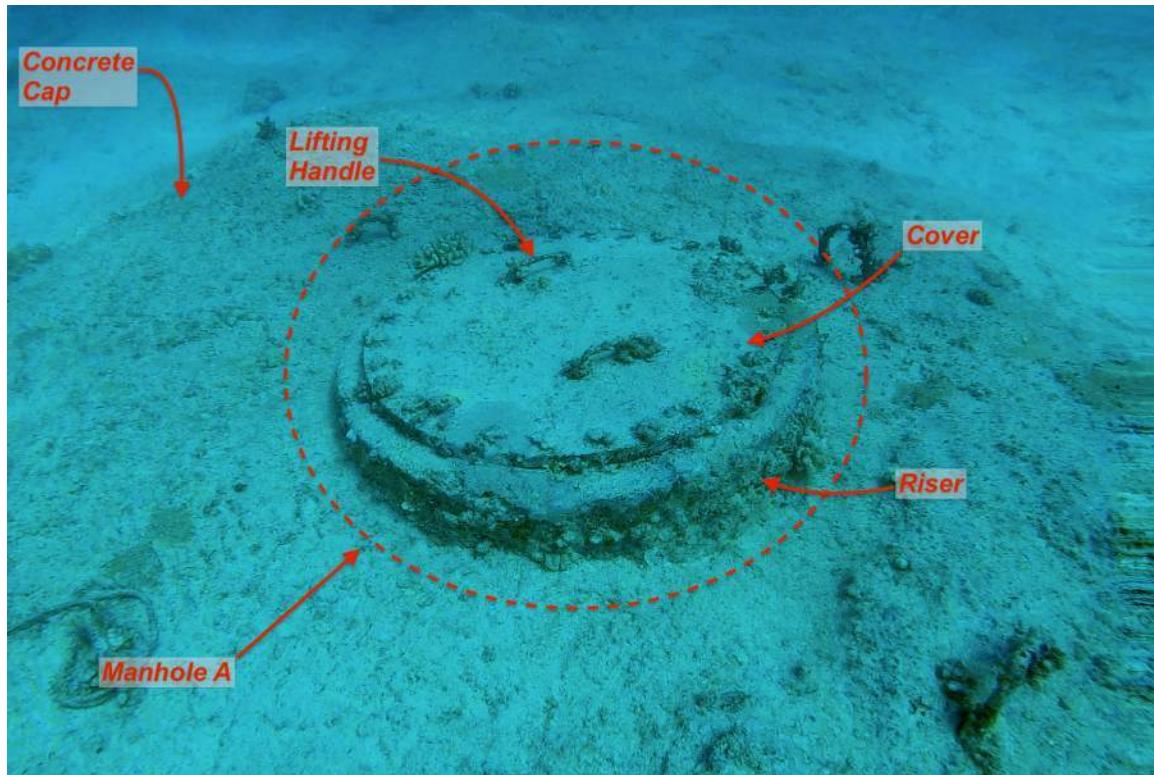
Figure 4-20. Manhole A, shallowest manhole on the 42-inch extension

- The 316 stainless steel manholes on the 42-inch outfall extension (MH A though MH D), as well as the slot covers on the special wye structure, appeared to be in good condition. All gaskets and seals also appeared to be in good condition, with no visible leakage. In areas where marine growth was removed, the newly exposed metal surfaces were bright, shiny, and exhibiting no visual signs of corrosion.

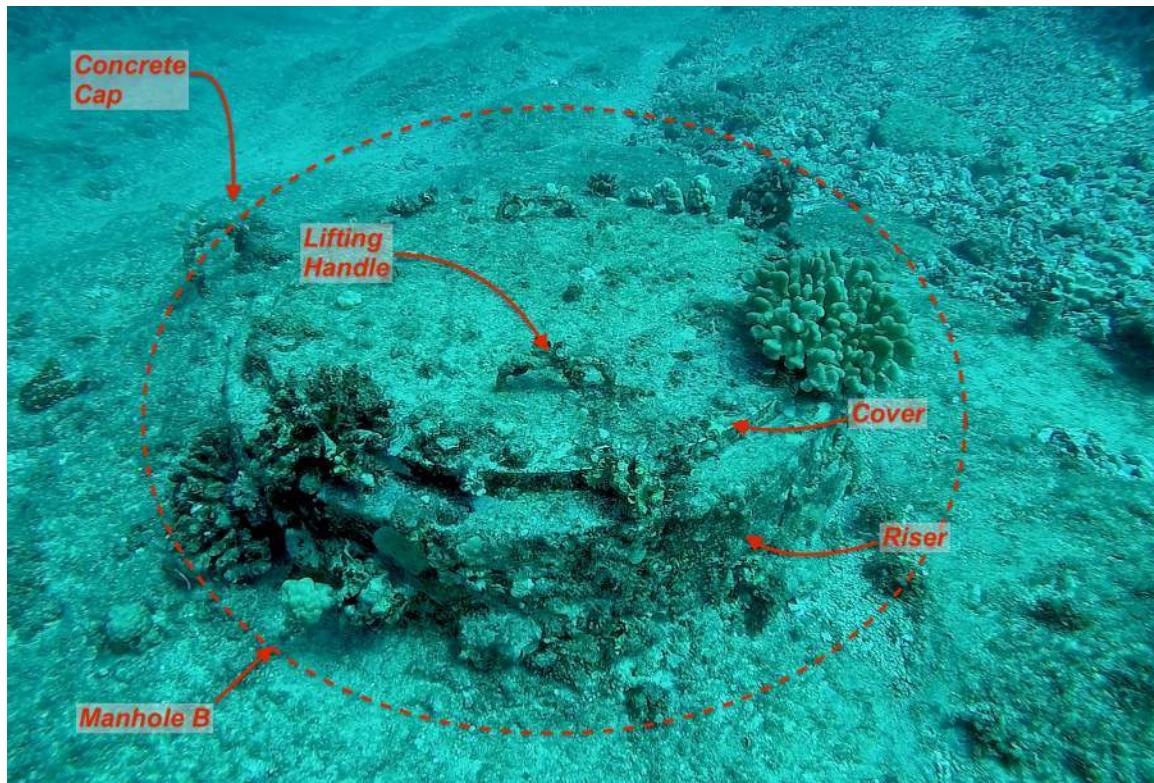
Figure 4-21. Manhole B, on the 42-inch extension
