DEPARTMENT OF ENVIRONMENTAL SERVICES
CITY AND COUNTY OF HONOLULU

SUBJECT: Waianae Wastewater Treatment Plant Outfall Improvements
and Rehabilitation
Tax Map Key: (1) 8-6-001:007 (POR.)

The City & County of Honolulu (CCH) Department of Environmental Services (ENV), Wastewater Engineering and Construction Division, proposes to install a concrete encasement structure over the existing Waianae Wastewater Treatment Plant (WWTP) outfall and cap three manholes on the existing outfall pipe in response to a 2018 inspection report that identified advancing shoreline erosion as a threat to the stability of the outfall and actively corroding cast iron manhole covers at an elevated risk of failure. The proposed project includes the following actions:

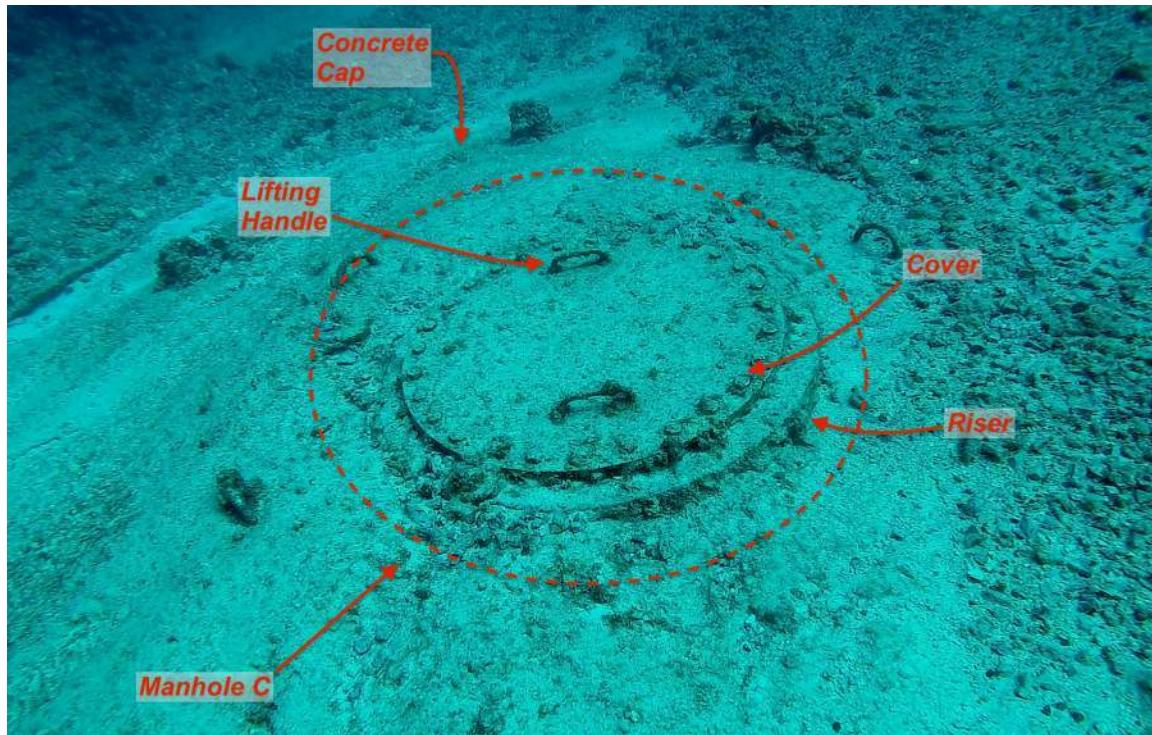
Figure 4-22. Manhole C, on the 42-inch extension

- The 316 stainless steel manholes on the 42-inch outfall extension (MH A though MH D), as well as the slot covers on the special wye structure, appeared to be in good condition. All gaskets and seals also appeared to be in good condition, with no visible leakage. In areas where marine growth was removed, the newly exposed metal surfaces were bright, shiny, and exhibiting no visual signs of corrosion.

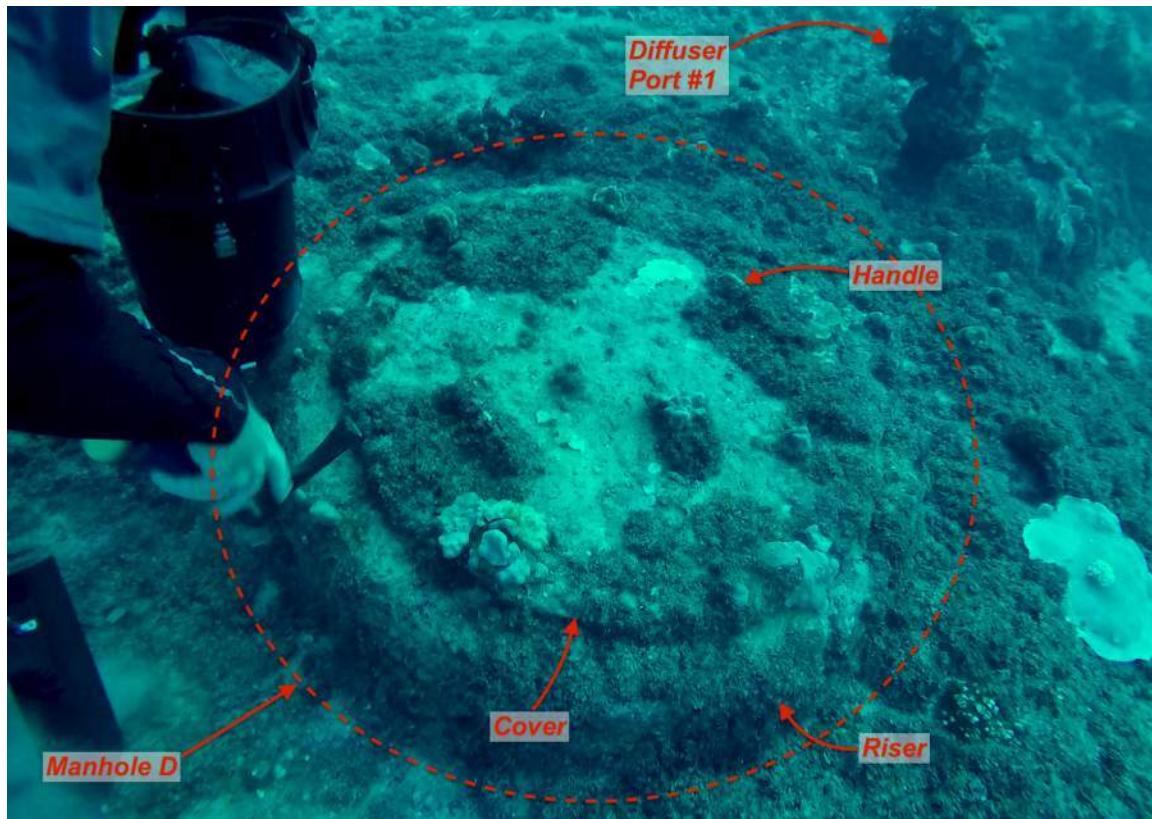
Figure 4-23. Manhole D, deepest manhole on the outfall

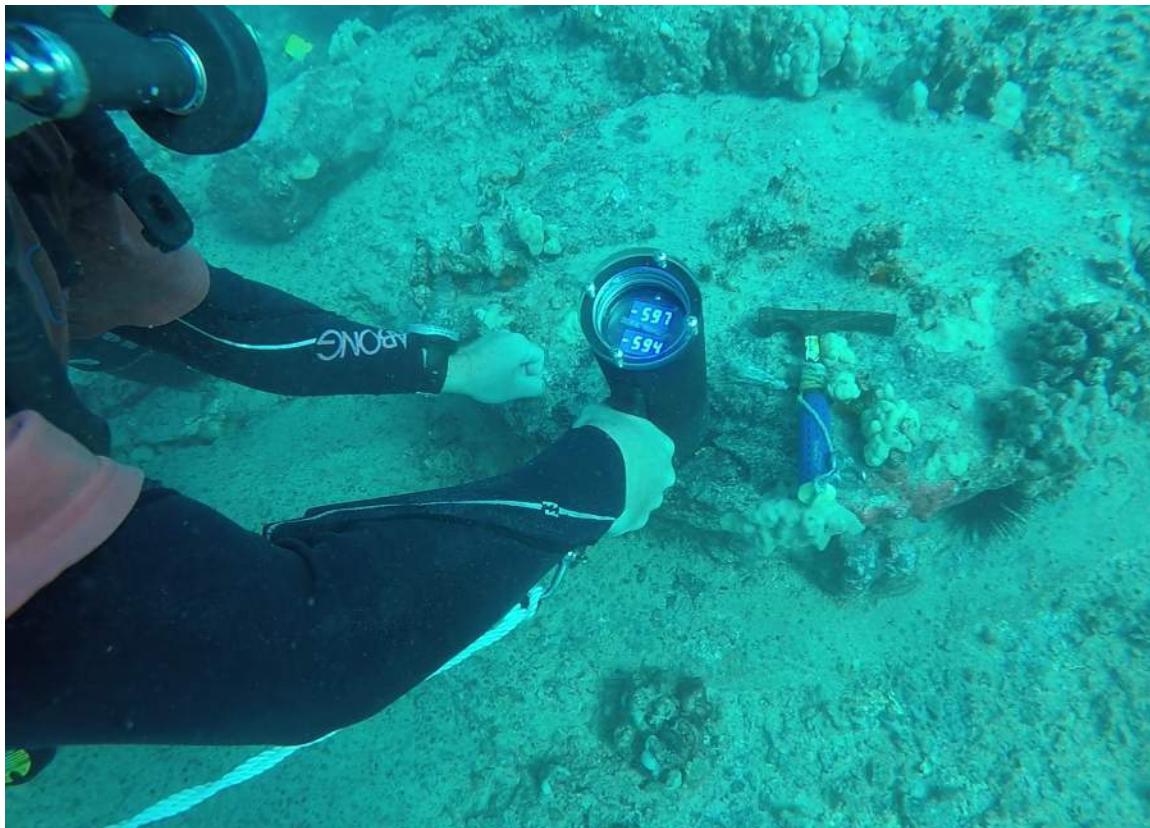
Manhole 4 - bolt	-594/-597	Not corroding	stainless steel
Manhole 3 - lid	-593/-589	No protection, corroding	Cast Iron
Manhole 2 - lid	-597/-594	No protection, corroding	Cast Iron
Manhole 2 - bolt	-594/-590	Not corroding	stainless steel
Manhole 2 - side	-597/-593	No protection, corroding	Cast Iron

Figure 4-25. Inspector shown obtaining galvanic potential measurements with CP-gun at MH 4.

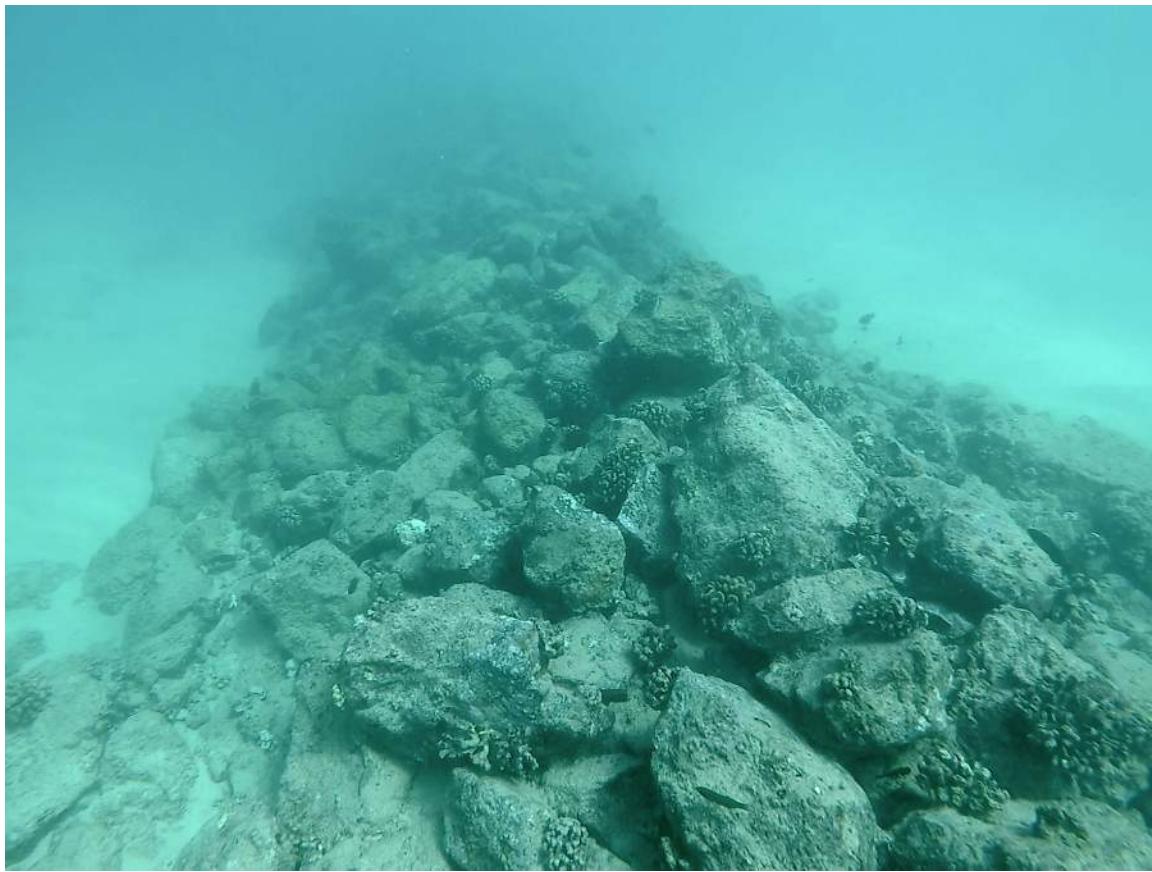
Figure 4-27. Typical ballast pile condition, near station 10+00

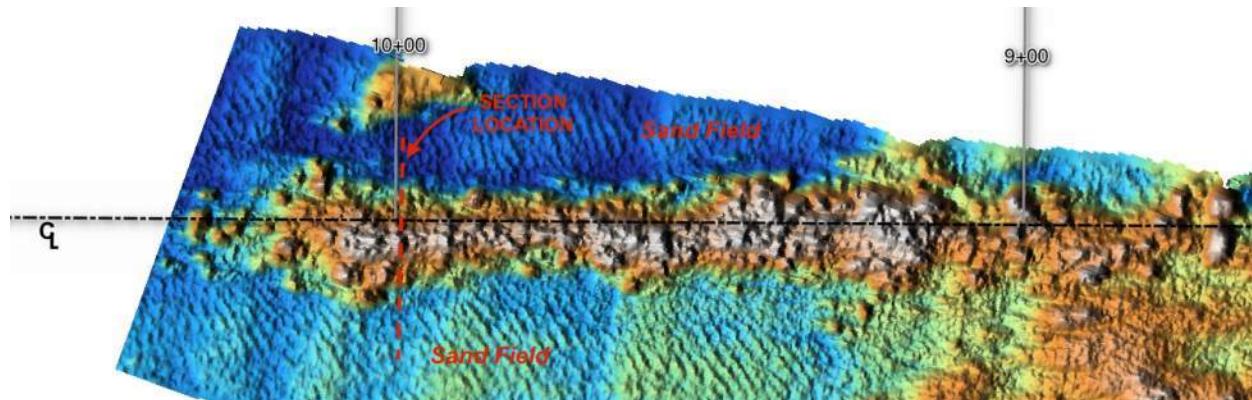
The ballast pile near station 10+00 appears to be 1-½ ft lower than that called for by the plans (refer to Figure 4-29), however, this location could be a low spot along the pile crest. Additionally, the DTM in Figure 4-28 does show an undulating crest height along the pile, with numerous peaks and saddles, both higher and lower than the peak at 10+00. Conversely, the shallow depth and increased exposure to wave energy at this nearshore location may have accelerated settlement of the ballast stone downward into the surrounding sand field, accounting for the lower peak. Furthermore, the exact depth of the pipe under the pile at this location is unknown, and therefore the vertical alignment of the two sections may be offset, but cannot be readily determined.

Figure 4-28. Close up of MBES bathymetry, ballast pile near station 10+00

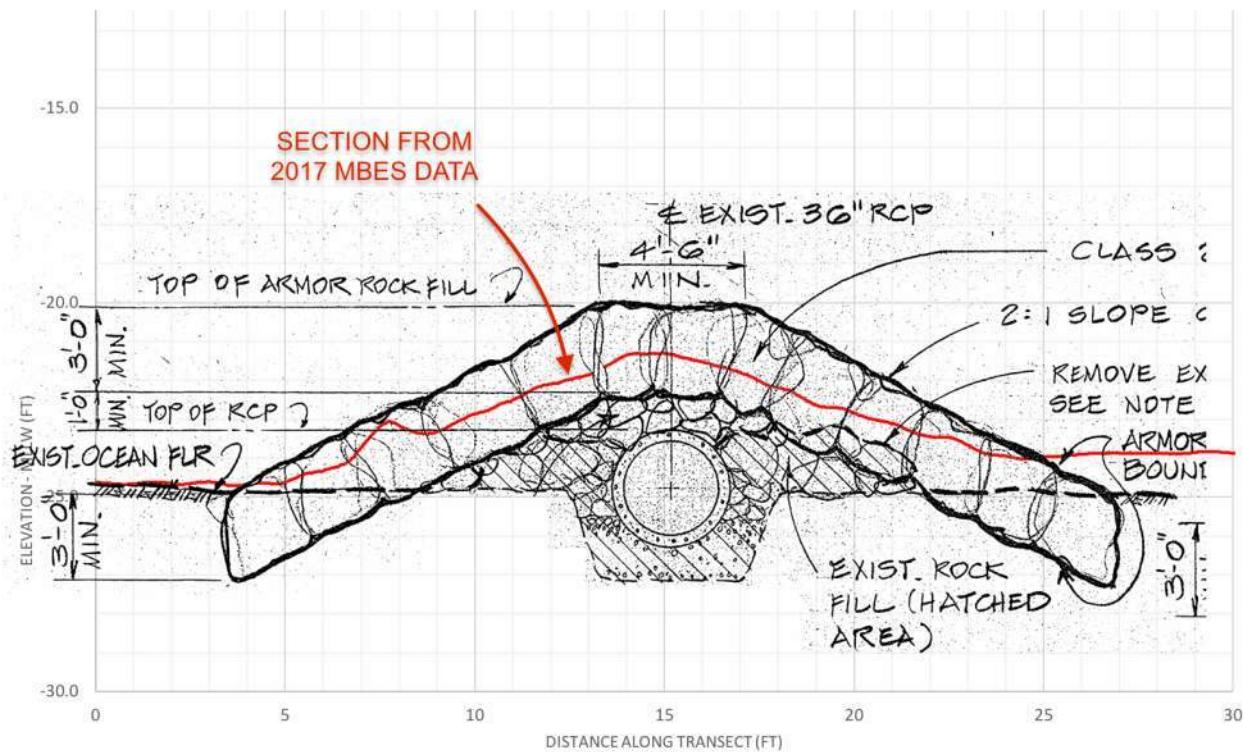
Figure 4-29. Cross section of MBES bathymetry (red) near station 10+00, overlaid with as-built profile

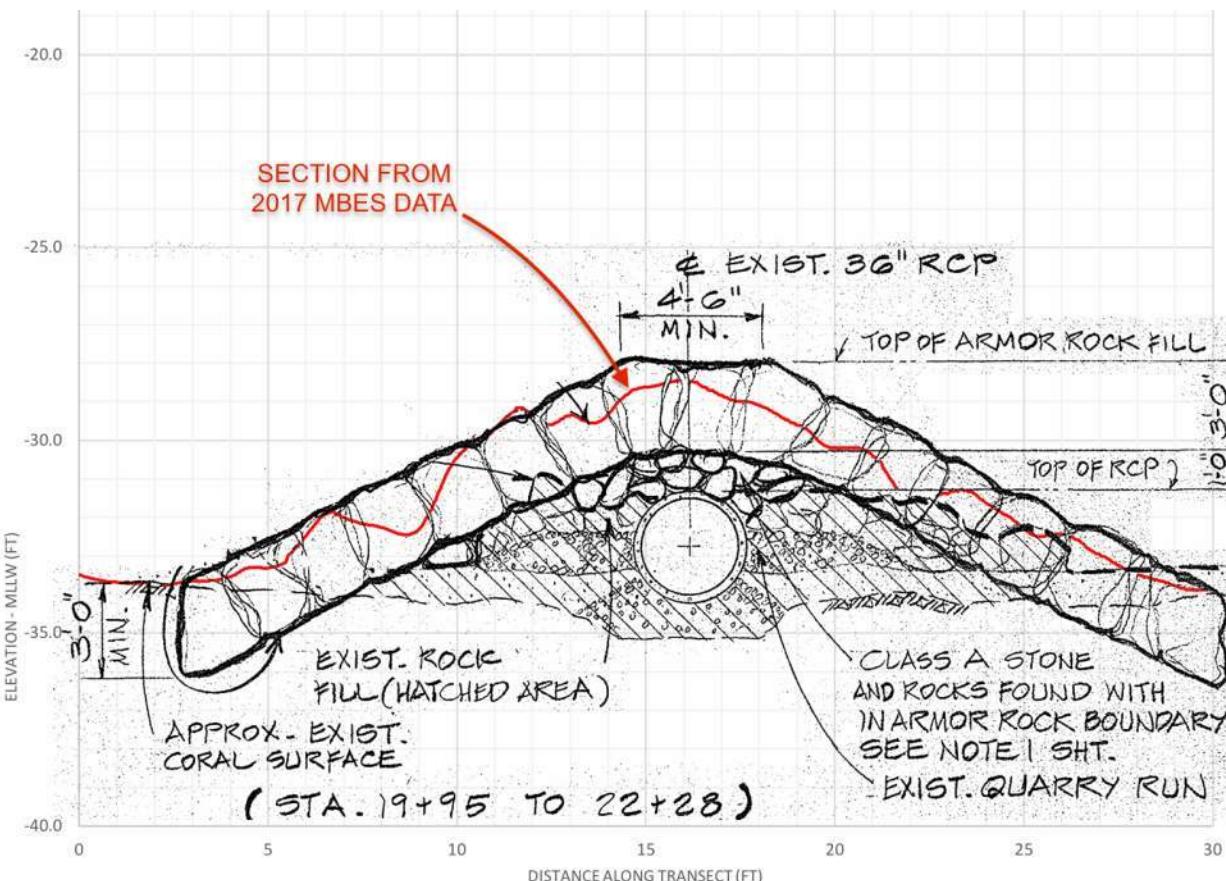
The ballast pile cross section at station 21+00, shown in Figure 4-31, follows the as-built typical section for this location generally well. Profile variations are seen where the multibeam has obtained depths in between individual large armor stones, resulting in a jagged curve in places. Those individual armor stones can be identified in the high resolution DTM shown in Figure 4-30. The outfall pipe appears to be well protected with ample reserves of ballast at this location, based on the comparison.

Figure 4-31. Cross section of MBES bathymetry (red) near station 21+00, overlaid with as-built profile

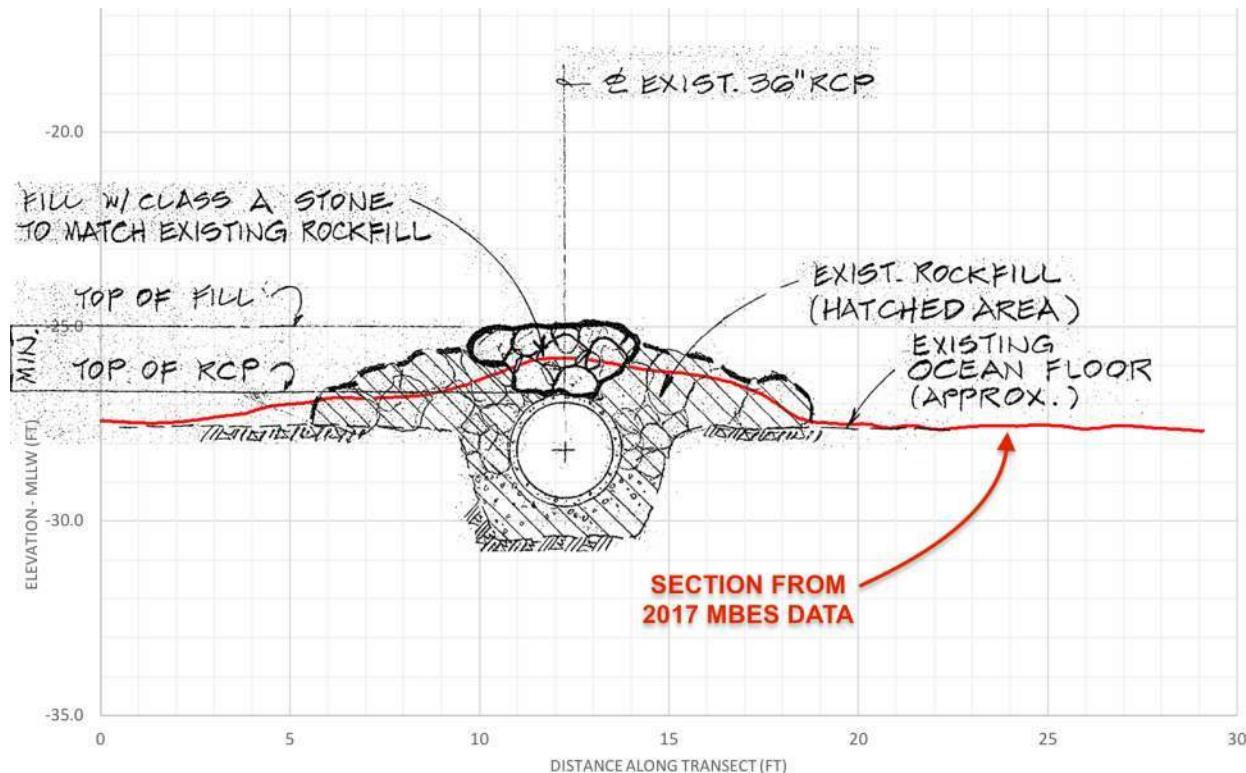
The 1986 modification plan to the ballast pile near station 23+50 was a limited area (10 ft x 4 ft) requiring additional stone for an area of previously exposed RCP (location shown in Figure 4-32). The section overlay comparison in Figure 4-33 suggests that the rock cover may be thinner than that called for by design, by approximately 1 ft. Again, the exact depth of the pipe under the pile at this location is unknown, and therefore the vertical alignment of the two sections may be offset. However, with the surrounding seafloor being hard substrate (not shifting sand), confidence with vertical alignment is slightly better than that for station 10+00. Inspectors were unable to see RCP joints between the individual stones at this location, and thus the repair is thought to be adequate. Future monitoring is recommended, however.

Figure 4-33. Cross section of MBES bathymetry (red) near station 23+50, overlaid with as-built profile

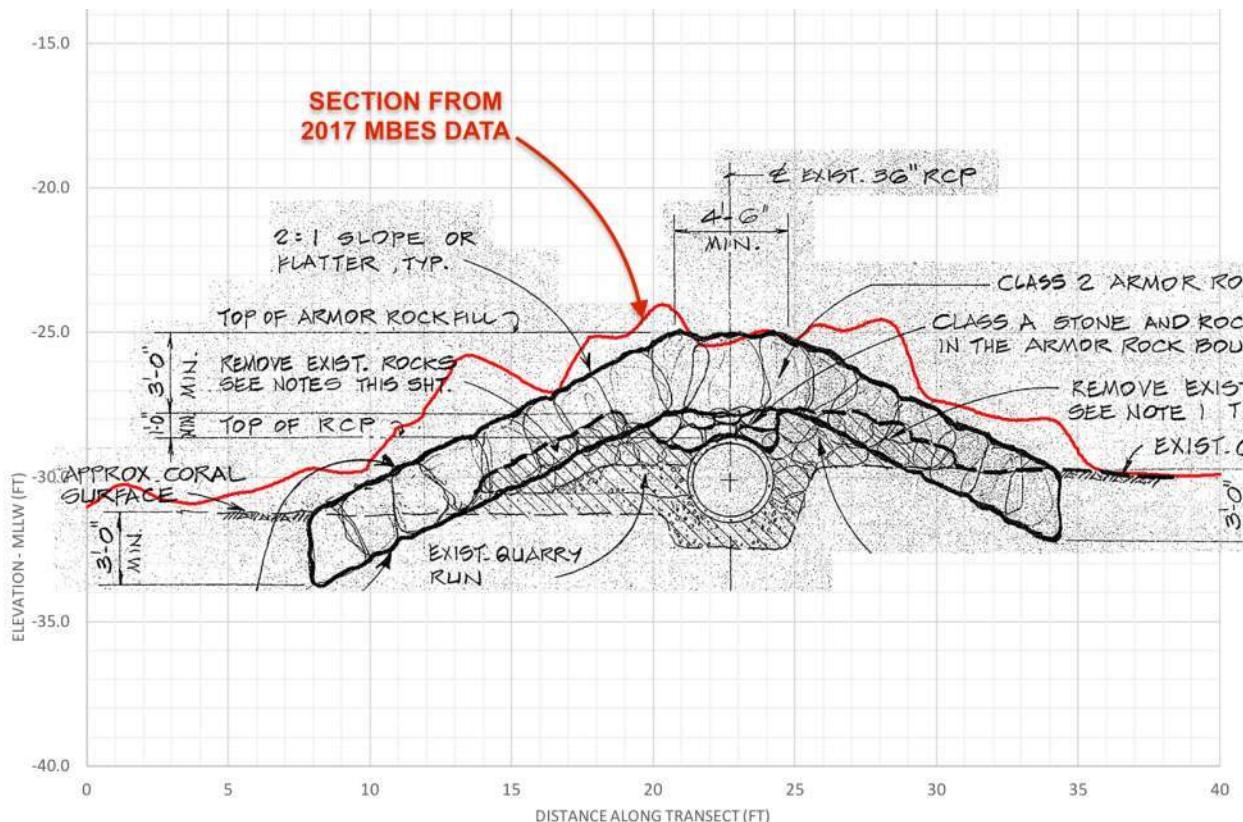
The section of ballasted outfall in the vicinity of Manhole 4, shown in plan view in Figure 4-34, is represented by the typical cross section illustrated in Figure 4-35. The as-built cross section and existing section profile (red) generally agree quite well at this location as shown, and suggest that the outfall pipe is well protected with ample reserves of ballast, based on the comparison.

Figure 4-35. Cross section of MBES bathymetry (red) near station 26+00, overlaid with as-built profile

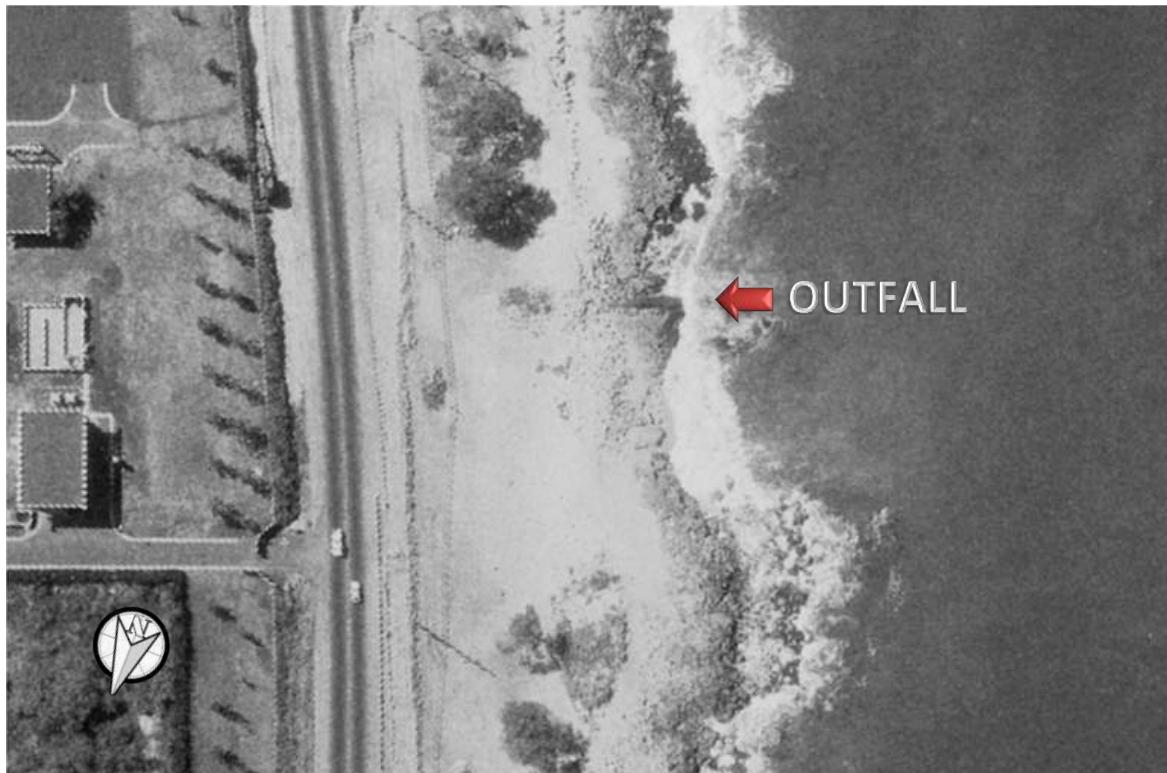
The historic shoreline as it existed in 1975, ten years after construction of the original outfall, is shown in Figure 5-5 below. It indicates that the outfall trench was aligned to enter the water at the apex of one of the smaller ‘teeth’ of the sawtooth shoreline noted above. The image also shows that the outfall largely appears to have supportive rock on both sides of the pipe as it enters the water. When the as-built plan is overlain on the 1975 image, as shown in Figure 5-6, it is estimated that the shoreline south of the pipe (*image top*) is approximately 75 feet from Pressure Manhole 1 (MH 1), and the shoreline to the north of the pipe (*image bottom*) is approximately 100 feet from MH 1. Thirty-two years later in 2007, the image in Figure 5-7 was taken, which indicates that some erosion of the southern flank of the trench has apparently occurred. Once more, it is useful to overlay the as-built plan as shown in Figure 5-8, where it is estimated that 25 – 30 feet of shoreline retreat has taken place along the south side of the pipe. In general, compared to the 1975 imagery in Figure 5-5, it appears that the entire mass of rock adjacent to the waterline along the southern flank has been fractured, broken up, and eroded away from the pipe.

Figure 5-5. Outfall landing shoreline condition, 1975 (source: UH Coastal Geology Group, 2019)

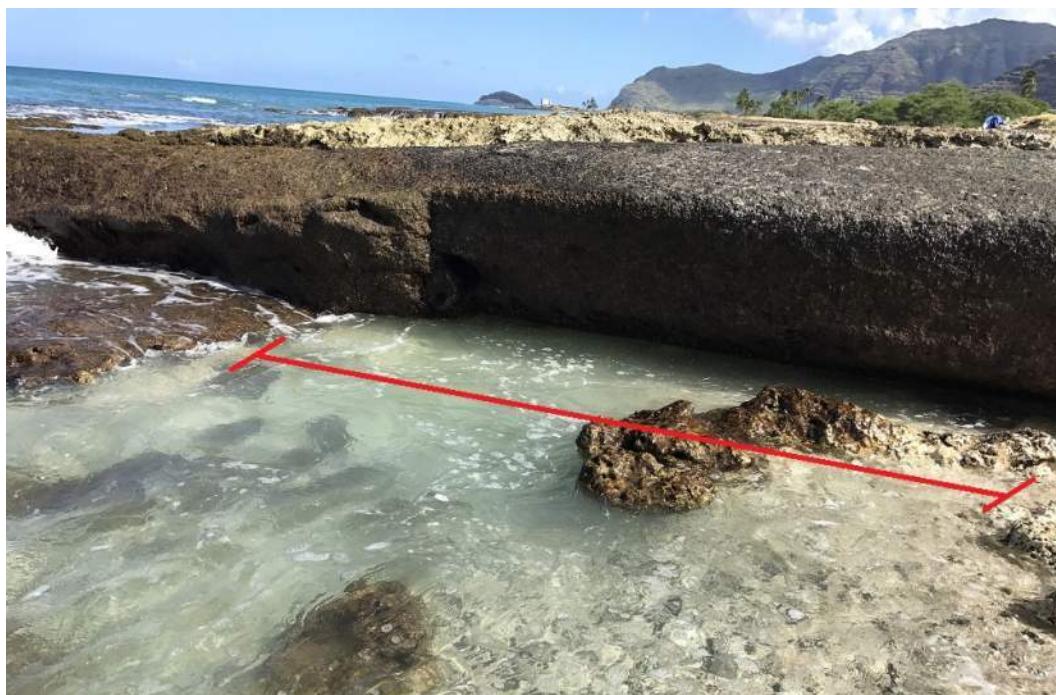
Observations from the site revealed an approximate 20-foot length of the 36-inch main barrel to be unsupported, with a gap of up to 1 foot as measured from the bottom of the pipe to the under laying natural substrate. The spanning section of unsupported pipe is located in the same general vicinity as the area of rock failure and erosion previously identified at the end of Section 5.2.1 above, and is illustrated by the image in Figure 5-9, where the red line indicates the approximate length of unsupported pipe.

Figure 5-9. Section of unsupported pipe on southern flank of outfall, near the waterline

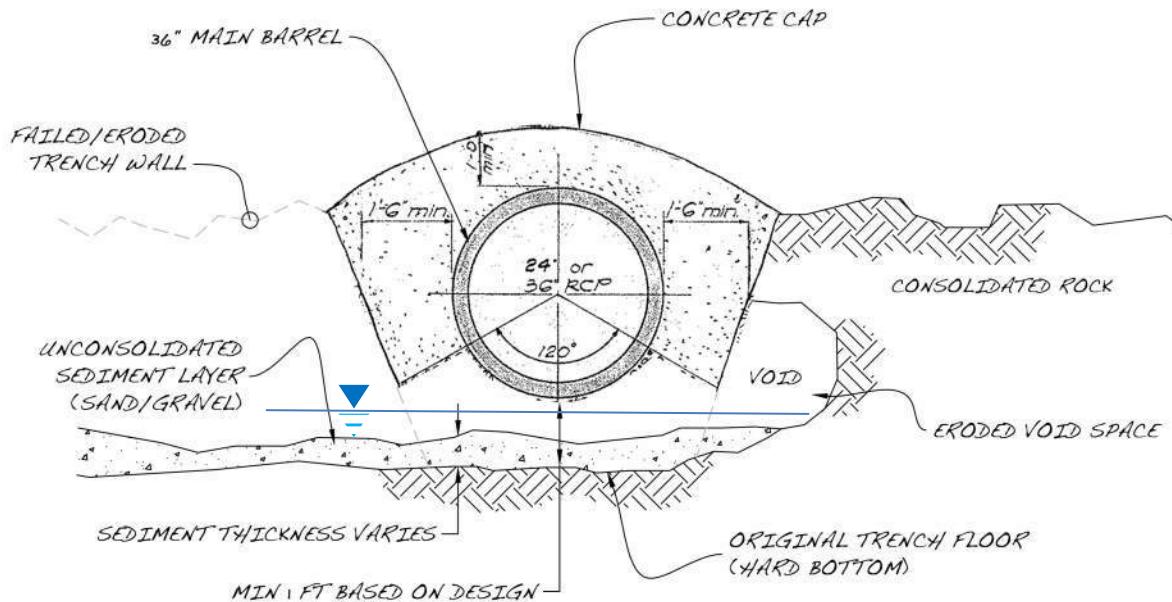
In this same region but approximately 20 to 30 feet landward of the spanned section, on the north flank of the pipeline, a gap or void space between the existing trench wall and grout jacket was observed. The gap is discontinuous, limited in length, and does not extend to the trench floor, as shown by the photograph in Figure 5-11. Further seaward on the north flank, in the region of the spanned section, several small holes (approximately 1 - 2 inches) were observed with bubbling water and air during wave action, indicating void spaces underneath, as illustrated by Figure 5-10.

Figure 5-10. Typical section of unsupported span of 36-inch main barrel, looking offshore near waterline

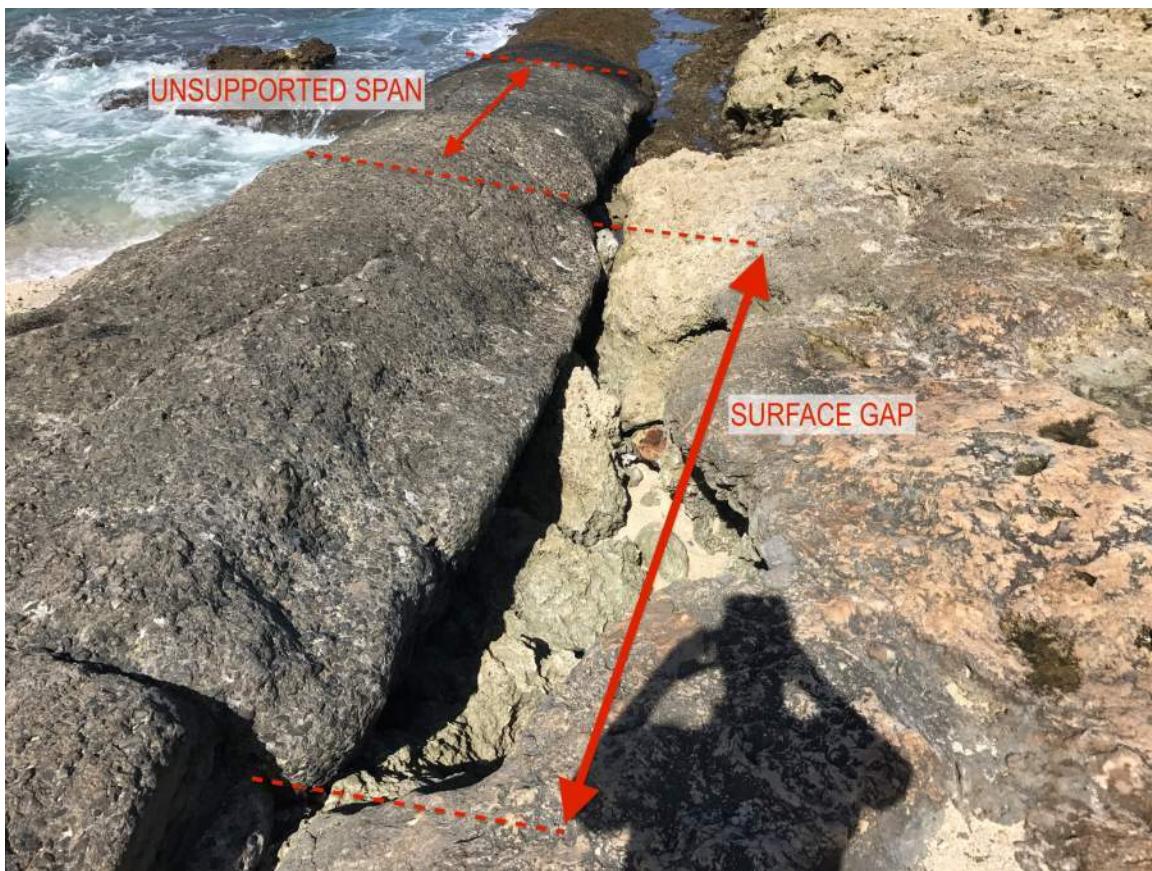
Figure 5-11. Surface gap and voids along north flank of pipeline near waterline/shoreline

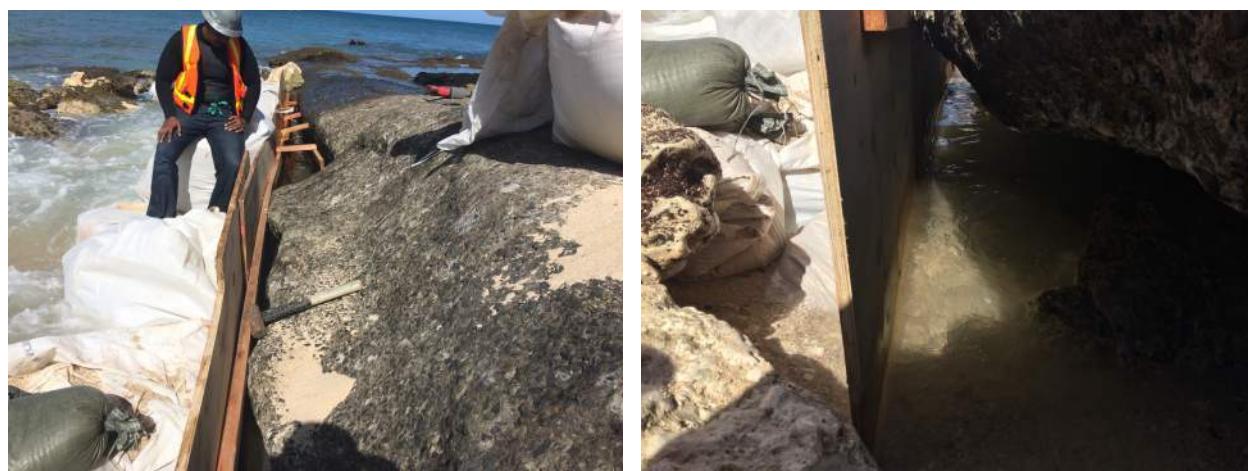
Figure 5-14. Sandbag caisson with plywood forms installation (left); close-up of void area within forms (right)

In order to mitigate the immediate hazard of potential failure of the pipeline at the unsupported span, an emergency repair was quickly designed and implemented until a permanent repair is possible. The conceptual cross section in Figure 5-12 illustrates the repair strategy, which basically involves removal of all loose beach material under the span, creation of a small cofferdam around the repair area using sandbags, installation of wooden forms, placement of strengthening rebar beneath the pipe, and finally pouring of marine concrete into the void space as shown. A conceptual plan view illustrating the horizontal extents of the repair is provided in Figure 5-13. The emergency repairs were implemented in June and July of 2018. Photographs of the construction process and final repaired condition are provided in Figure 5-14 through Figure 5-16. Note the difference in sand levels between Figure 5-9 and Figure 5-16.

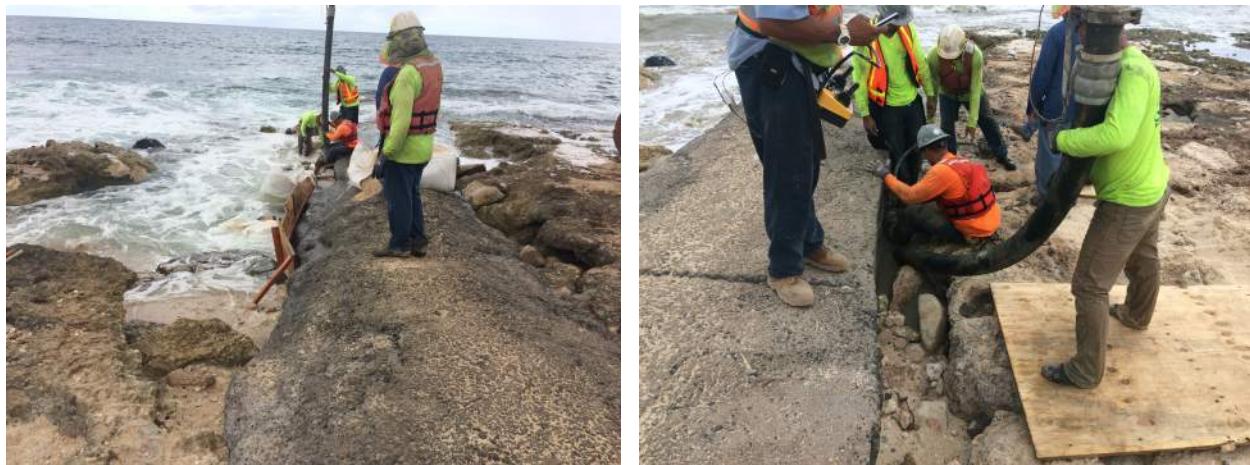
Figure 5-15. Concrete placement within formworks via boom truck (*left*); concrete pumped into gap (*right*)

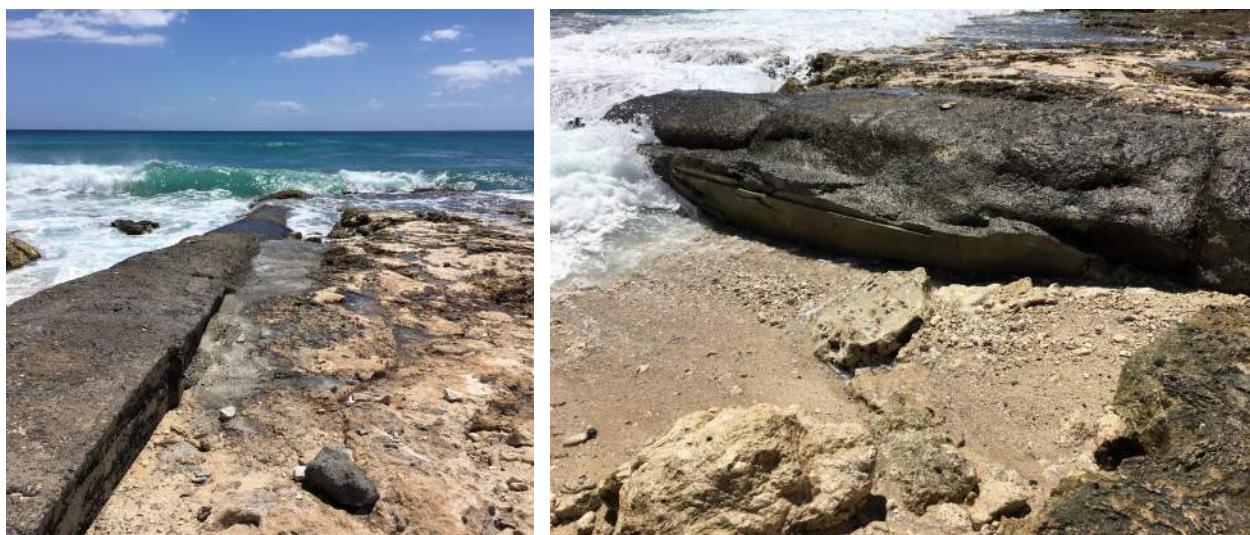
Figure 5-16. Finished repair, north side gap (*left*) and unsupported span (*right*)
