BOILER TUBE FAILURE REPORT (C-2 FORM)												
C2 FORM NO 1000000015 (C-2 FORM SHOULD BE SEND WITHIN 12HOURS OF SYNCHRONISATION)												
1)	STATION:	T007		2) UNIT	NO.	J02		3)	LAST UNIT OUT	AGE 14-12-2023	3

16) 1ST PASS RHS WATERWALL TUBE NO.85 FROM FRONT												
	EQUIPMEN	EQUIPMENT NUMBER T007U02BLR00324 EQUIPMENT DESCRIPTION 1ST PASS RHS WATERWALL										
	LOCATION	LOCATION DETAILS			SWS-BCS	LOCATIC			N DESCRIPTION NTPL UNIT-2 BOILER CIRCULATION SY			
	MATERIAL		s	A210 GR C		TUBE NUM			BER 0085 EQUIPMENT HEIGHT (MTS) 014			
	DESCRIPTION OF BOILER FAILED TUBE (CLEARLY IDENTIFYING TUBE NO, COIL NO, TUBE DIMENSION, TUBE MATERIAL AND X, Y, Z COORDINATES)

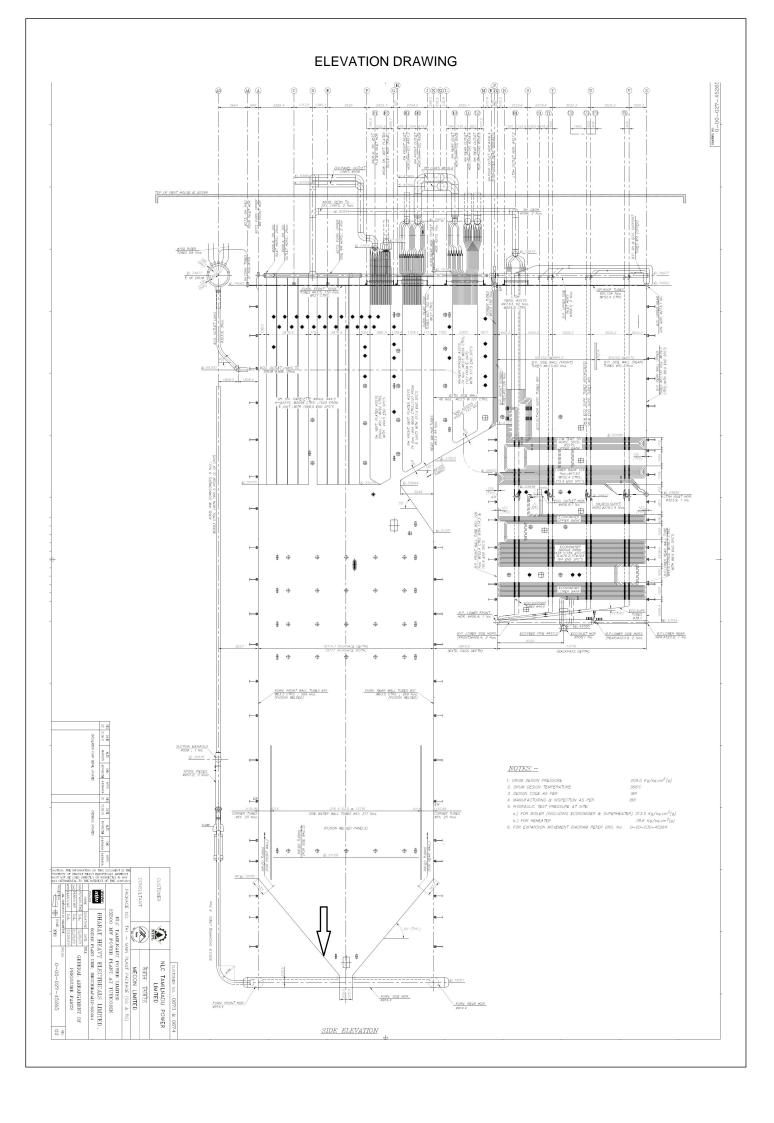
17)	1											
	Tube No. 85 1st pass RHS Waterwall 14 ML, SA210 Gr.C, D51x6mm smooth tube											
PHOTOGRAPHS												
18)	8) FAILURE BEFORE START OF REPAIRED LOCATION AFTER PRIMARY FAILED TUBE REPAIR WORK RESTORATION PRIMARY FAILED TUBE											
	DETAILS OF REPAIR WORK (SPECIFY JOINT DETAILS, COIL NO/ TUBE NO AND RESTORATION WORK)

19)	Damages to both the tubes were pinholes. Thus, the damage was ground to the root level and metallised. 2 Pin hole joints											
DE	DETAILS OF INSPECTION OF ADJACENT AND IDENTICAL LOCATIONS

20)	No observable defects in DPT											
STATION OBSERVATION W.R.T CAUSE OF TUBE FAILURE:												
21) Replacement of the tube during overhaul												
HISTORY OF WORK IN FAILED TUBE/COIL/LOCATION IN PAST FIVE YEARS												
	Date		m Numbe						Cause			
08	3-02-2024	1000	00000015 0085 014		014	SA210 GR C						
Sul	Submited by PRADEEP SRIKANTH A Submited on 08-02-2024 Designation DEPUTY CHIEF ENGINEER
