## **BOILER TUBE FAILURE REPORT (C-2 FORM)**

1) STATION:	NTPL	2) UNIT No.		II	3) LAST UNIT OUTAGE		: [	Jan-23 4) LAST UNIT		ГО/Н	Nov-21	
5) UNIT SHUTDOWN FROM		22	01	23		08	22	9	) OUTAGE HOURS	[		
6) WATER FILLING CLEARANCE		23	01	23		11	50		(ONLY DUE TO BTI	r)	hh	mm
7) CLEARANCE FOR LIGHTUP								1	O) GENERATION LO	ss [		
(AFTER REPAIR OF BTF)		dd	mm	уу		hh	mm		(ONLY DUE TO BTF)		MUS	
B) UNIT SYNCHRONISED AT												
11) BTF INSPEC	TED BY	dd	mm	уу		hh	mm					
BTF COMMITTEE HEAD					MTP					FQA		
CHEMISTRY						OPERATION					O&C

Tube Dimension D63.5x6.3mm; SA210 Gr.C, LHS Steam Cooled Wall @ 64 ML - Tube No. 1

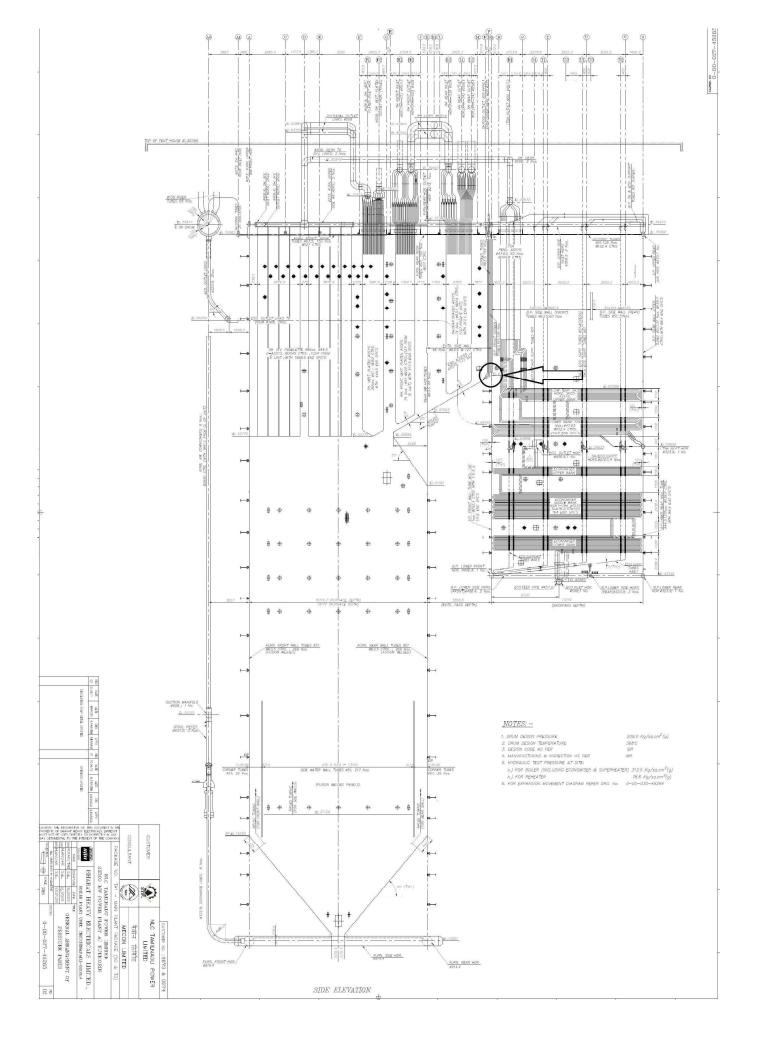
Attachment weld pinhole of LHS Steam Cooled Wall Tube No. 1 (Front to Rear). Secondary damage in Rear Screen Waterwall Tube 1 (LHS to RHS).

Replacement of Spool Pieces and attending to the Pinholes No of Spools Replaced - 1 at 64 ML; No. of pinholes attended - 1 at 64 ML
