BOILER TUBE FAILURE REPORT (C-2 FORM)											
C2 FORM NO (C-2 FORM SHOULD BE SEND WITHIN 12HOURS OF SYNCHRONISATION)											
1)	STATION:	T007		2) UNIT I	10. U	01	3)	LAST UNIT OUTAGE	10-06-2023

16)	16) REHEATER FRONT COIL 71 CIRCUIT 14										
	EQUIPME	EQUIPMENT NUMBER T007U01BLR05099 EQUIPMENT DESCRIPTION REHEATER FRONT COIL 71									
	LOCATION DETAILS			007-U01-BLR-S	WS-RHS	LOCATION DESCRIPTION 000					
	MATERIAL	=	S	A213T22		TUBE N	NUMBER 0014 EQUIPMENT HEIGHT (MTS) 060				
DESCRIPTION OF BOILER FAILED TUBE (CLEARLY IDENTIFYING TUBE NO, COIL NO, TUBE DIMENSION, TUBE MATERIAL AND X,Y,Z COORDINATES)

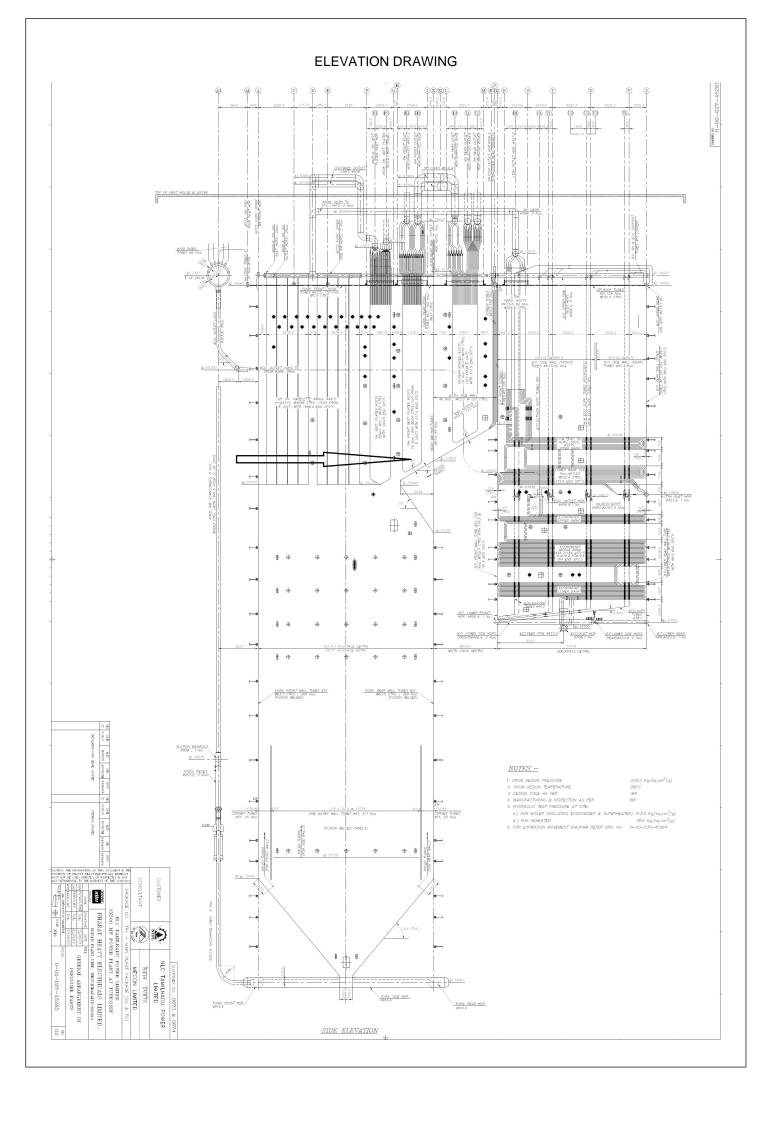
19)	Replacement of Bend of Circuit 14 of Reheater Front Coil 71										
DETAILS OF INSPECTION OF ADJACENT AND IDENTICAL LOCATIONS											
20)	Dye Penetrant test of adjacent bends undertaken. No observable defects										
STATION OBSERVATION W.R.T CAUSE OF TUBE FAILURE:											
Bend stress observed. Sending of damaged coil to CPRI for analysis is being undertaken											
HISTORY OF WORK IN FAILED TUBE/COIL/LOCATION IN PAST FIVE YEARS											
	Date	C2 Form Numb			Height	Material		Cau	use		
				0014	060	SA213T22					
Sub	Submited by PRADEEP SRIKANTH A Submited on 28-11-2023 Designation
