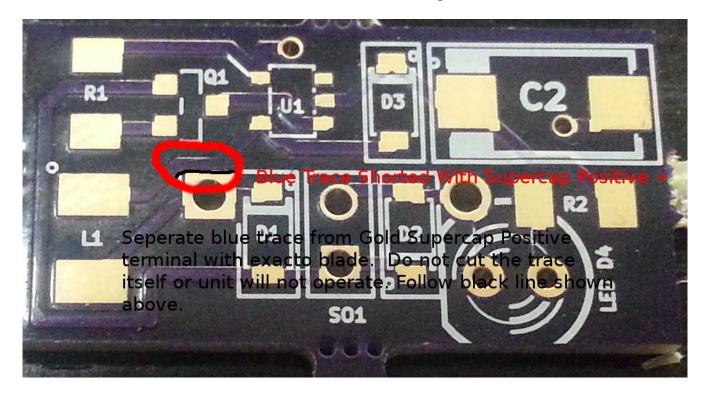
This is the bare board. I didn't even see the short. Look below again:

As you can see the trace coming from the top of L1 snakes around the positive terminal of the supercap and connects to the lower left corner of U1. What happened in this version of the circuit board is I enlarged the holes for the supercap but forgot to move the trace out of the way. The trace is actually touching the positive terminal of the supercap under the purple soldermask. This is causing most of the

power created my L1 to be wasted and not being sent up to U1. Use an exacto knife to seperate the trace from the positive terminal (see black line in last picture). This will remove the short circuit. DO NOT CUT THE TRACE WIDTHWISE or you will disconnect the top of L1 from U1 and then the unit will not work at all. This is 0.5oz copper you have to cut through so it is pretty thick. Take your time so you don't accidentally cut through the trace or worse slip and cut yourself in the process.

Once you have the trace cut put the unit in the sun for 8+ hours and it should perform significantly better.
