Middlesex County Shoreline Situation Report

Special Report in Applied Marine Science and Ocean Engineering SRAMSOE No. 368

December, 2000

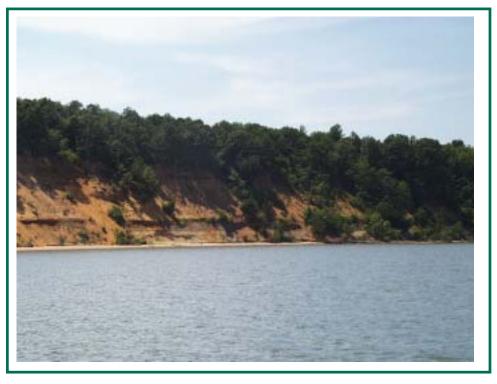
Eroding bluff along McKans Bay on the Rappahannock River...

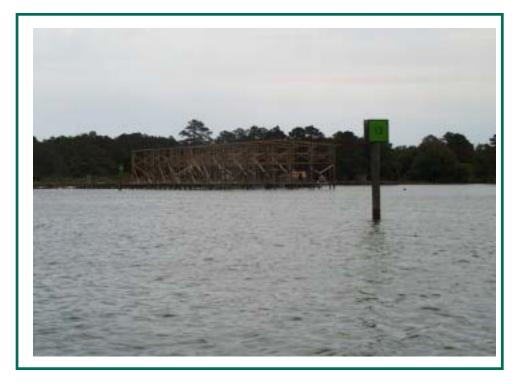
Middlesex shoreline construction.

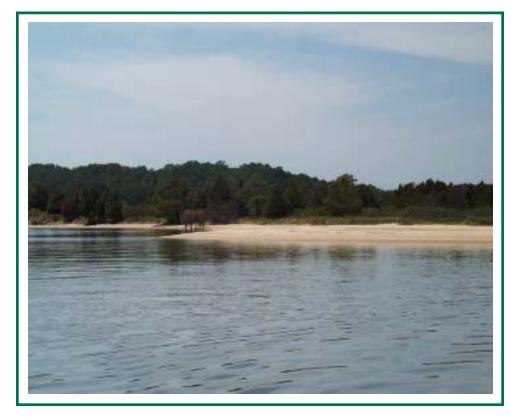
Sandy shore along Punchbowl Point on the Rappahannock River.

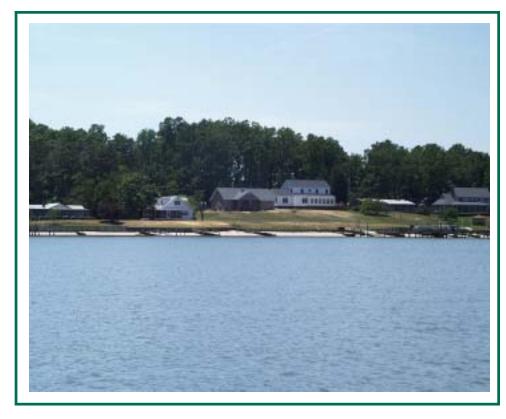
Groinfields and bulkheads along the sandy residential shore of McKans Bay.

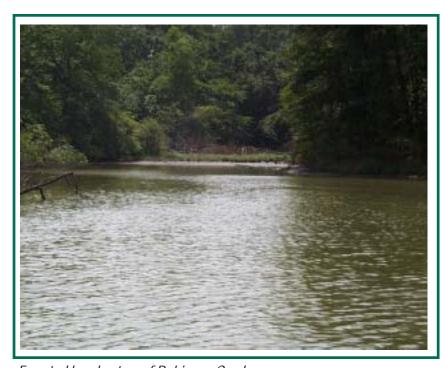
Forested headwaters of Robinson Creek.

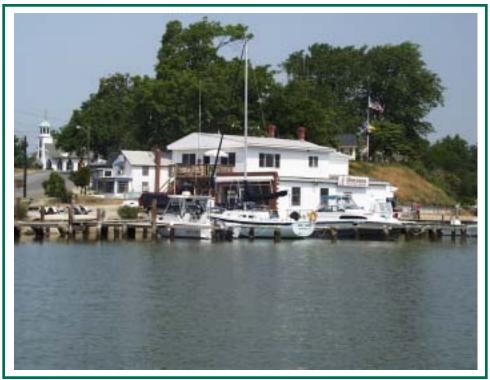
Urbanna Yachting Center on Urbanna Creek.

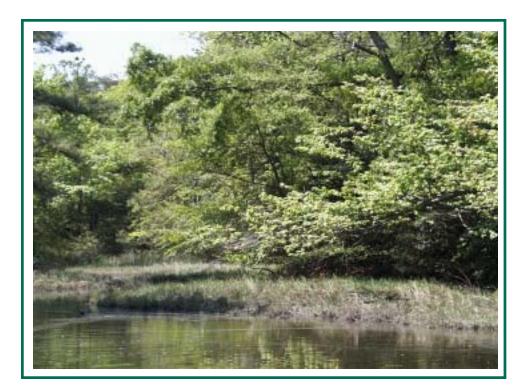
Fringe marsh along the upper reaches of Jackson Creek.

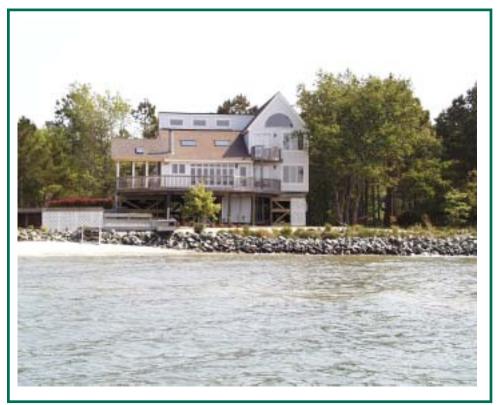
Residential shoreline protection at the entrance to Jackson Creek.

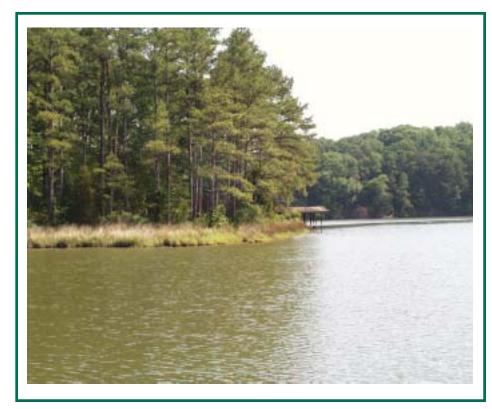
Pristine stretch of Urbanna Creek.

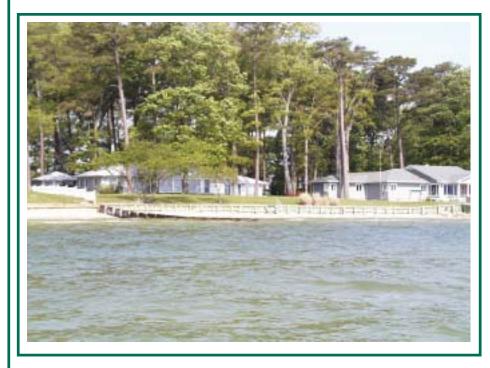
Shoreline Protection at Stove Point.

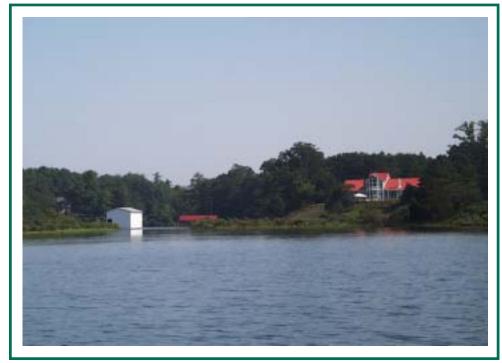
Inlet at Cores Creek.

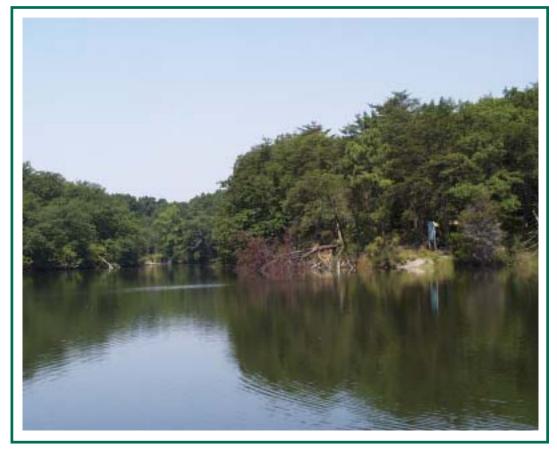
Upper reaches of Wilton Creek.

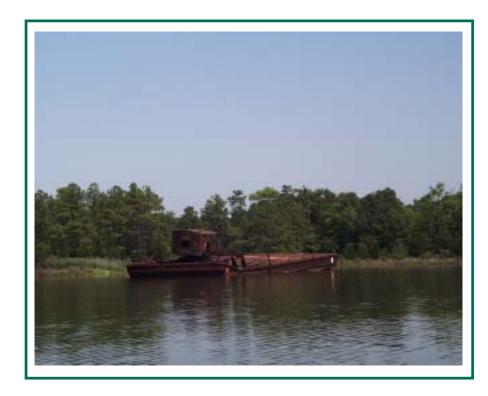
Abandoned vessel along the Piankatank River.

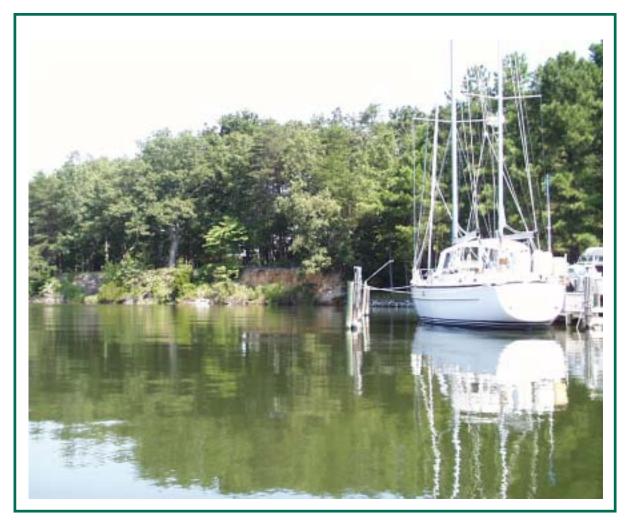
Upper reaches of Wilton Creek.
