Shock and Thermal Cycling Synergism Effects on Reliability of CBGA Assemblies

Reza Ghaffarian, Ph.D.
Jet Propulsion Laboratory
California Institute of Technology
Pasadena, California
818-354-2059
Reza. Ghaffarian@JPL.NASA.Gov

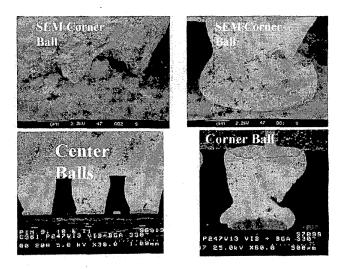
Damage induced by vibration was different in some cases as shown in Figures 3-4. Appearance of tensile deformation from the center of high balls as shown, was significantly different from those observed for thermal cycling condition. Similar to thermal cycle condition, damage was more dominant for the balls with higher distance to neutral point (DNP), especially for the corner balls. However, additional microcracks in eutectic solder joints, different from the norm for thermal cycling, were induced by tensile and shear load during random vibration.

$Figure \ 3 \ Thermally \ cycled \ samples \ after \ vibration. \ Note \ tensile \ failure \ for \ the \ corner \ ball \ and \ minimum \ damage \ for \ the \ center \ balls$

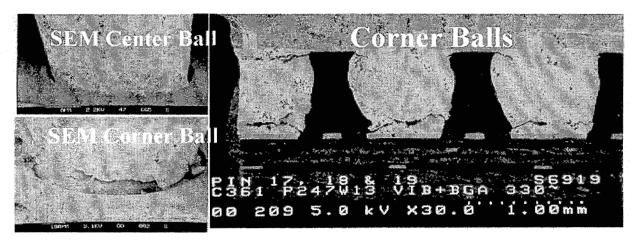
Figure 4 Thermal cycled samples after vibration. Note mechanical crack propagation at two locations and minimum damage at a center ball.

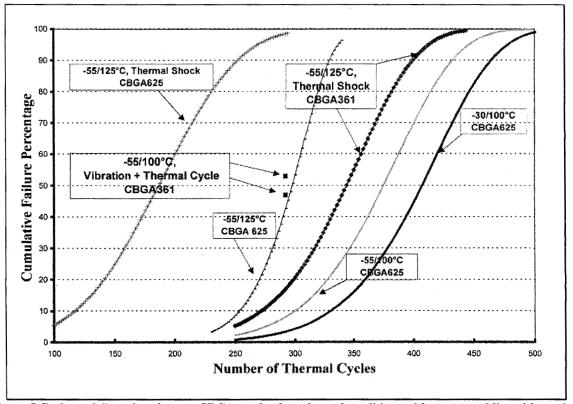
Figure 5 shows Weibull plots of cycles to first failures for CBGA 625 and CBGA 361 under four different thermal cycle conditions. To generate plots, cycles-to-failures for a population were ranked from low to high and failure distribution percentiles were approximated using median plotting position, $F_i = (i-0.3)/(n+0.4)$ (e.g., see Kapur,1977). Then, two-parameter Weibull distribution was used to characterize failure distribution. The Weibull cumulative failure distribution was used to fit cycles to failure data. The equation is

Cycles-to-failures for three assemblies with levels of rigidity and a priori vibration condition are shown in Table 3. Two test data for cycles-to-failure after vibration for the most sever condition, i.e. the test vehicles with no rigidity enhancement, were marked in Figure 5 for comparison only. It is difficult to draw a statistically meaningful conclusion because of insufficient sample size.

Figure 5 Cycles to failure data for two CBGAs under four thermal conditions with two assemblies with a priori vibration condition
