Martlet II Avionics Postmortem

Adam Greig, CU Spaceflight

October 2015

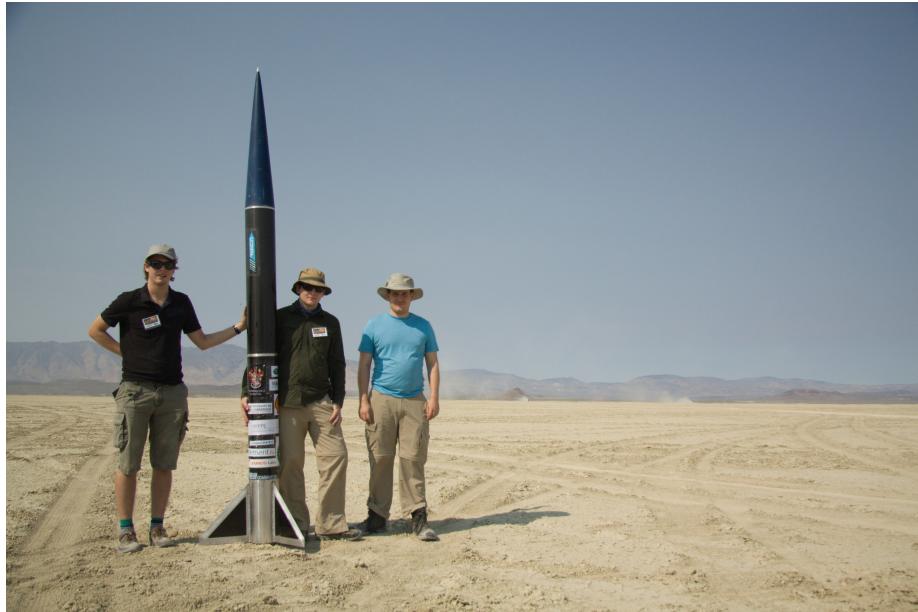
Figure 1: Martlet 2 in Black Rock Desert, Nevada, in October 2014

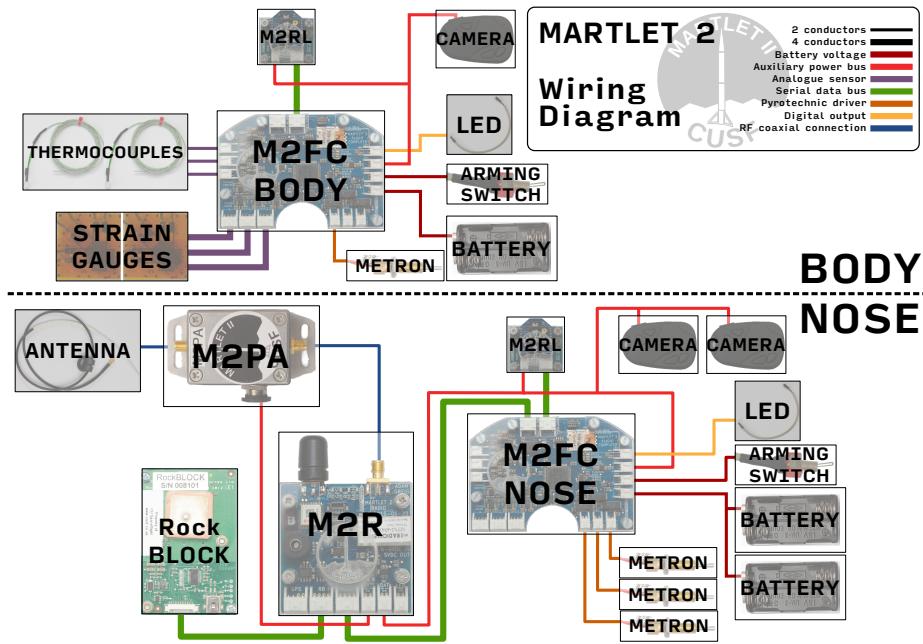
Figure 2: System Overview
