# Property and Timber Pest Report

Inspection Date: 23 Apr 2025

Property Address: 32 Richardson Street Chelmer 4068

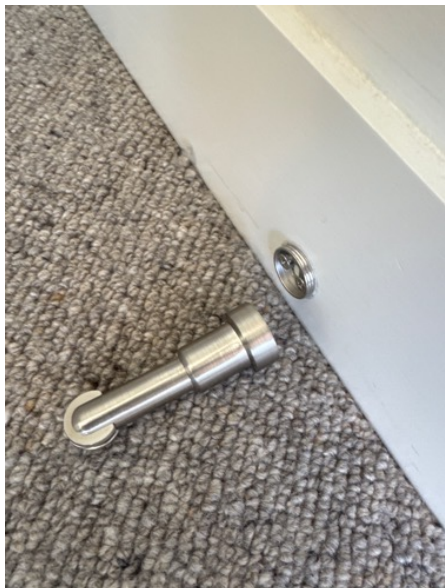
**Finding:** Door stop is detached from wall bracket.

Thread is damaged and will not screw on- replacement required.

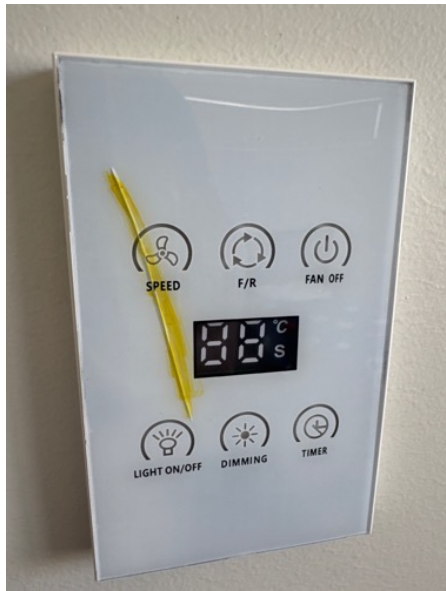
### Minor Defect 1.02

**Finding:** Fan control cover plates are cracked.

These cover plates are an acrylic material- replacement cover plates may be available.

Controls are functional.

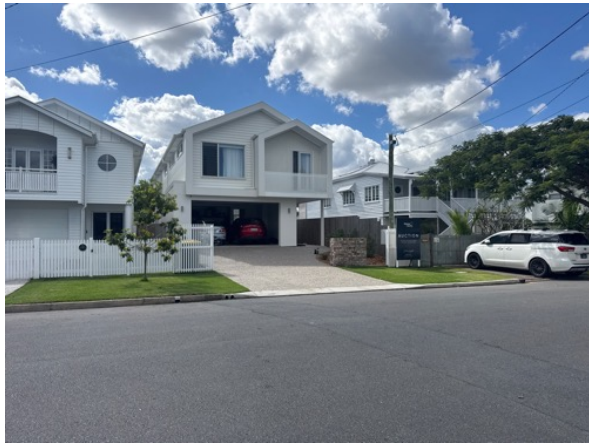
## For your information 2.02

**Location:** Driveway

**Finding:** Concrete driveway is in good condition.

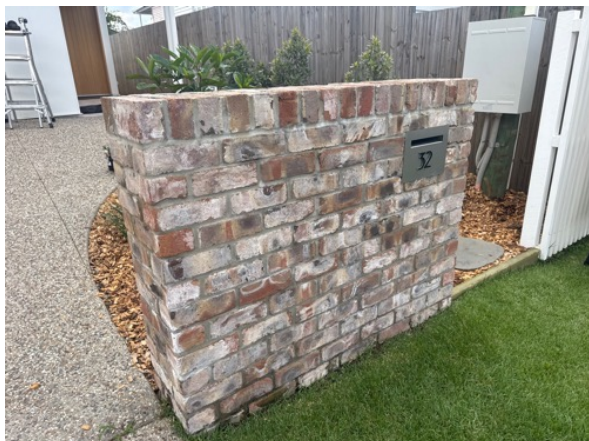
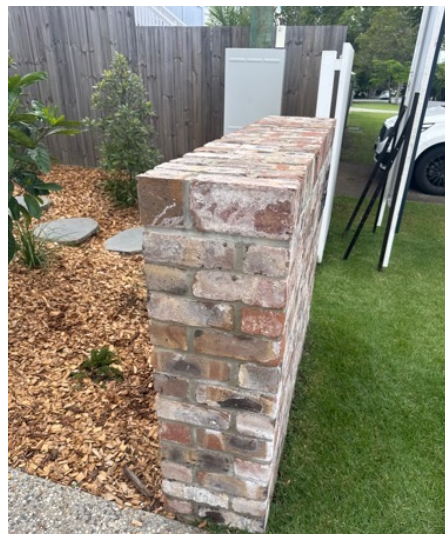
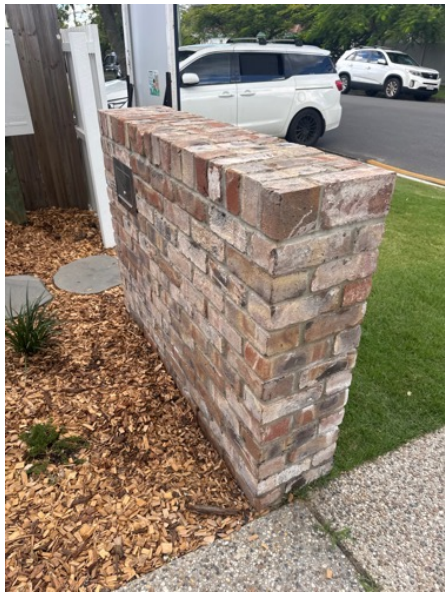
## For your information 2.03

**Location:** Fences

**Finding:** Brick letterbox is in good condition.

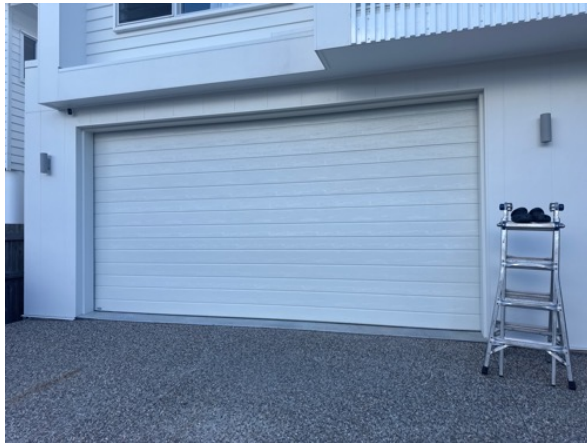
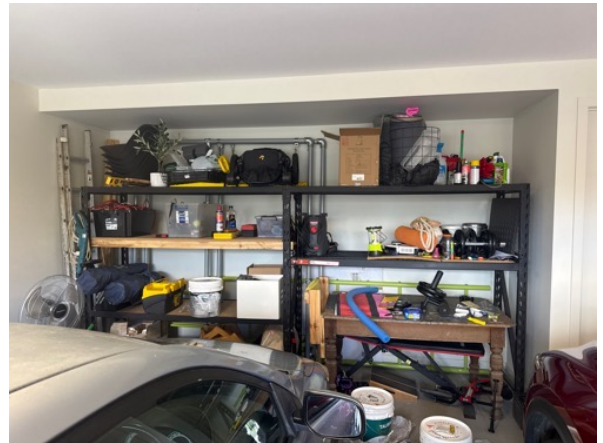
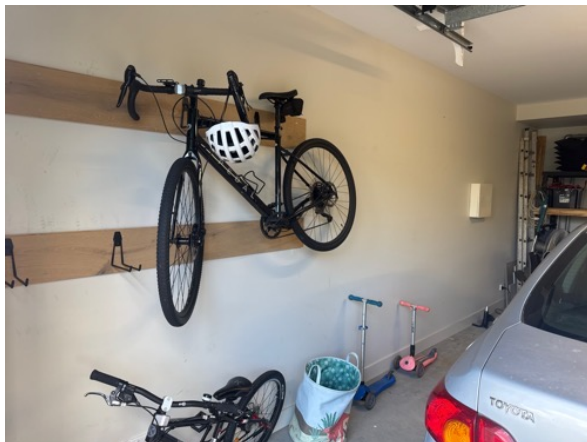
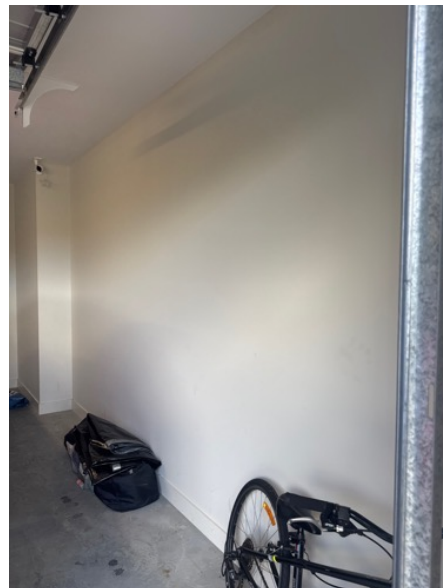
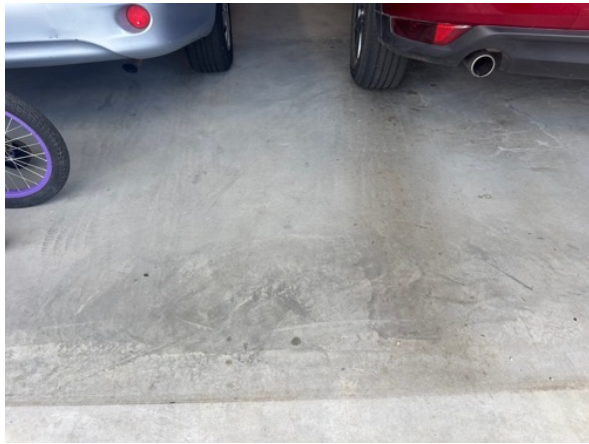
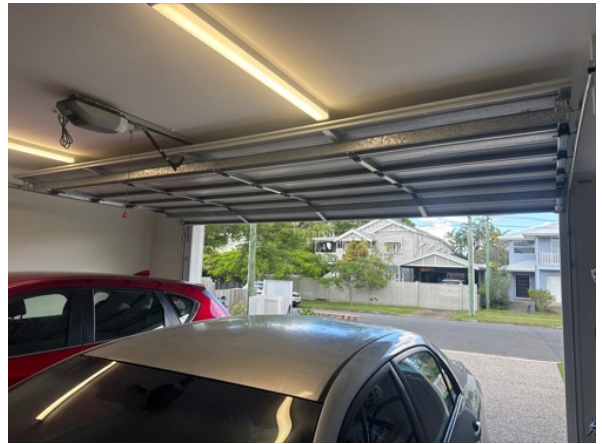
## For your information 2.04

**Location:** Garage

**Finding:** Garage appears in good condition with functional remote door.

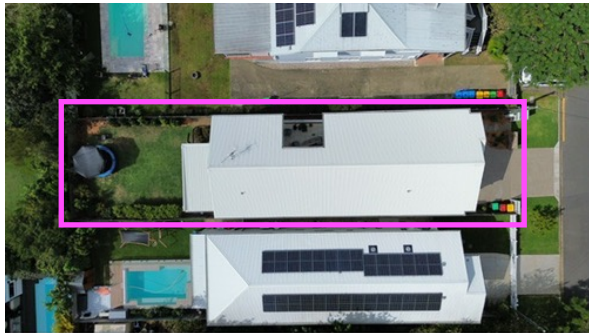
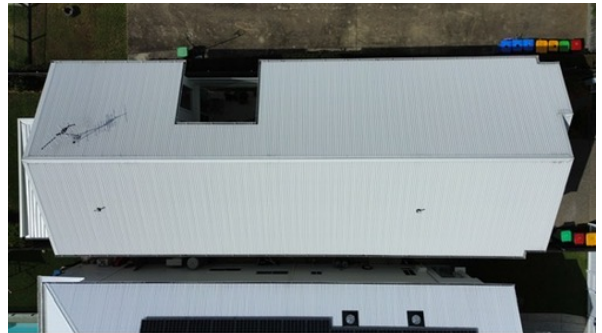
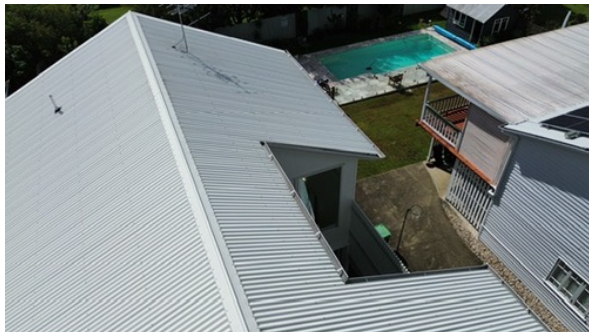
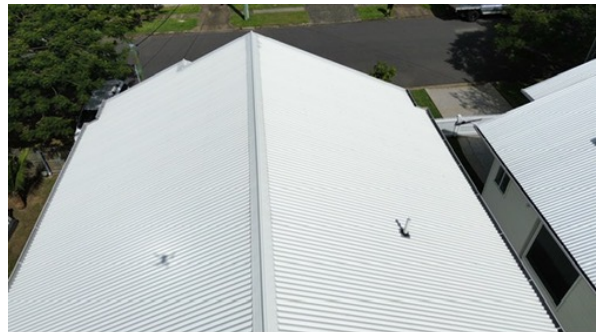
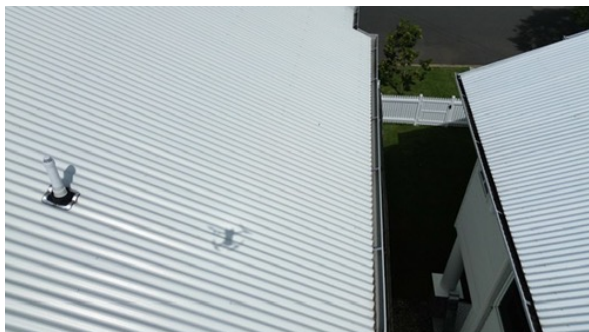
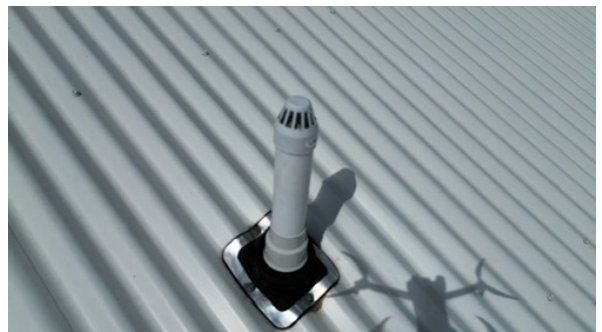
## For your information 2.05

**Location:** Roof exterior

**Finding:** Roof exterior (sheet metal) appears in good condition.  
Corrugated profile.

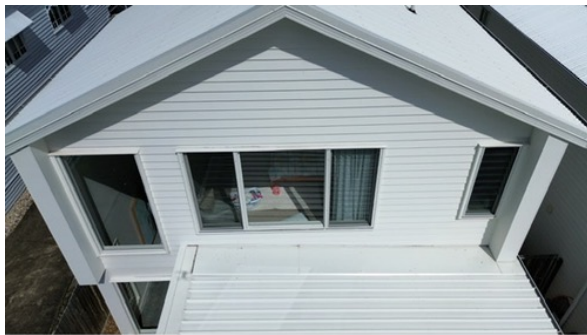
**Location:** External Walls

**Finding:** Linear fibre cement cladding appears in good condition and well sealed with paint.

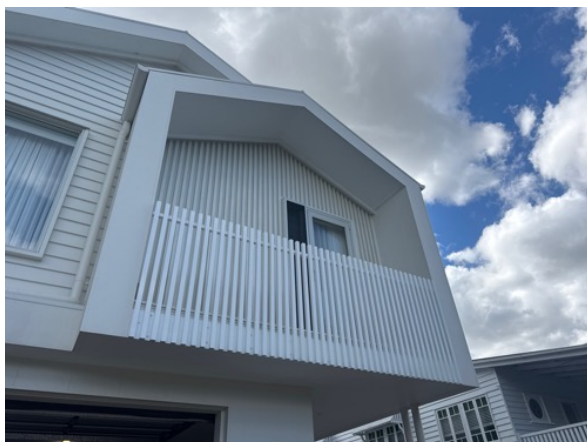
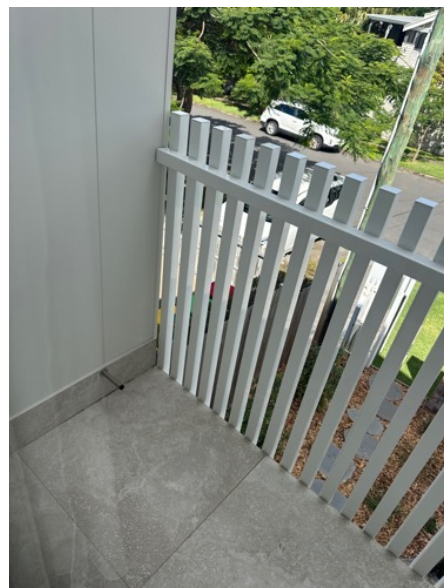
**Location:** Balcony

**Finding:** Balcony appears in good condition with tile finish and aluminium handrail.  
Handrail is compliant with minimum height of 1.0m and gaps less than 125mm.

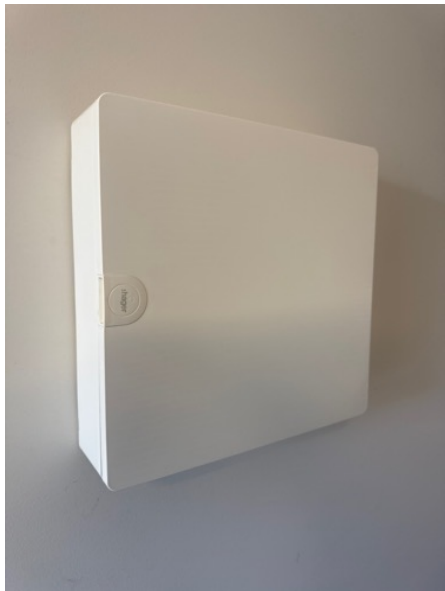
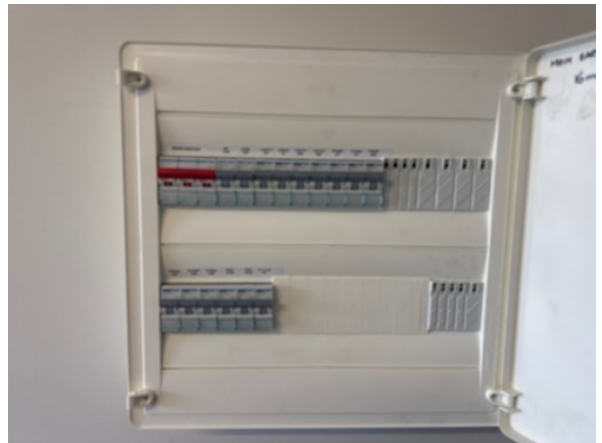
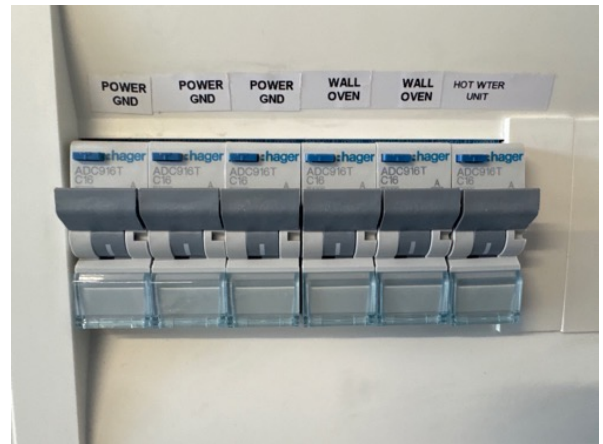
## For your information 2.08

**Location:** Electrical Sub-Board (circuits)

**Finding:** RCD (Electrical safety switches) installed to light and power circuits.

A Licenced Electrician is recommended to test all circuits to confirm compliance and safety as outside scope of Building Inspector.

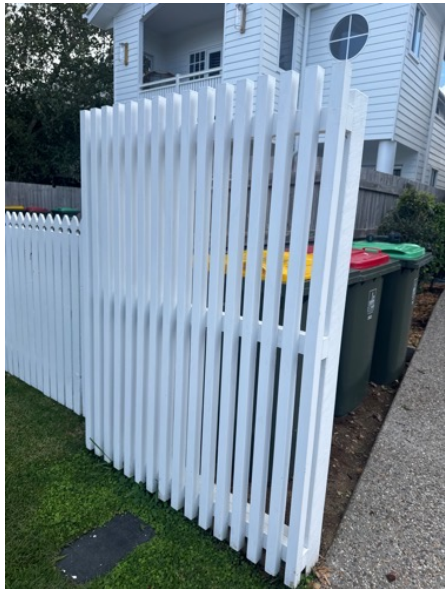
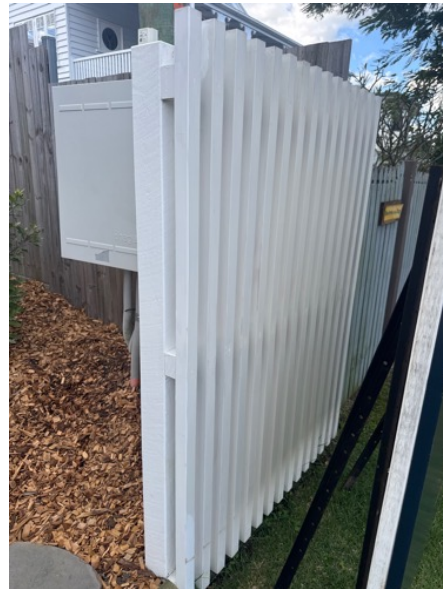
## For your information 2.09

**Location:** Fences

**Finding:** Timber feature fences are in good condition.

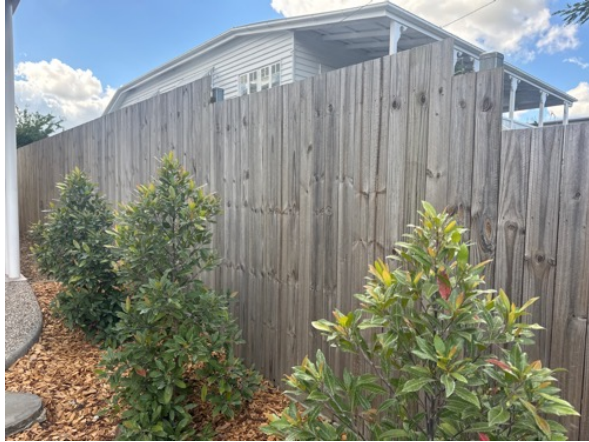
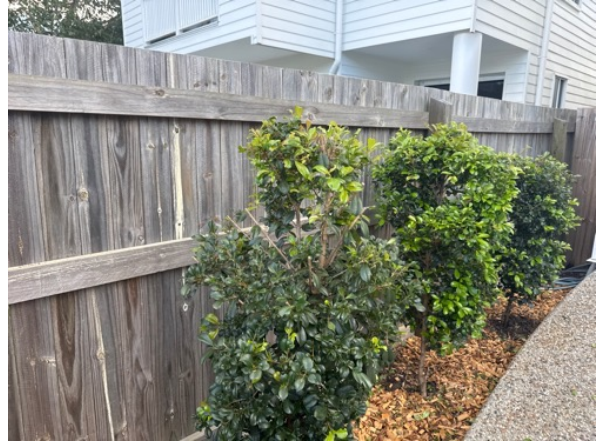
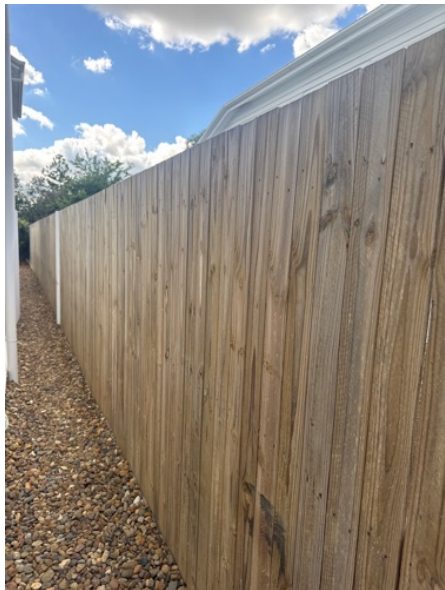
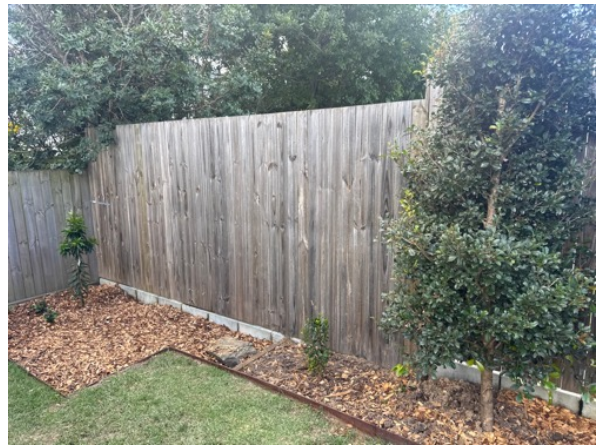
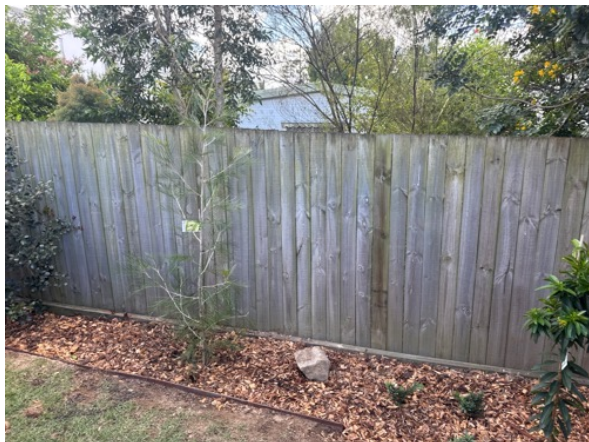
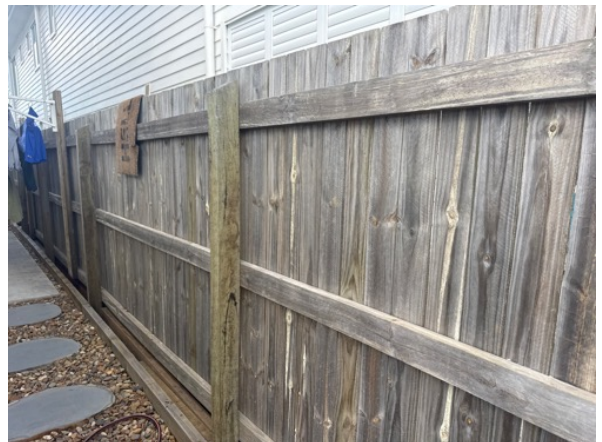
**Location:** Fences

**Finding:** Timber fences are in good condition.

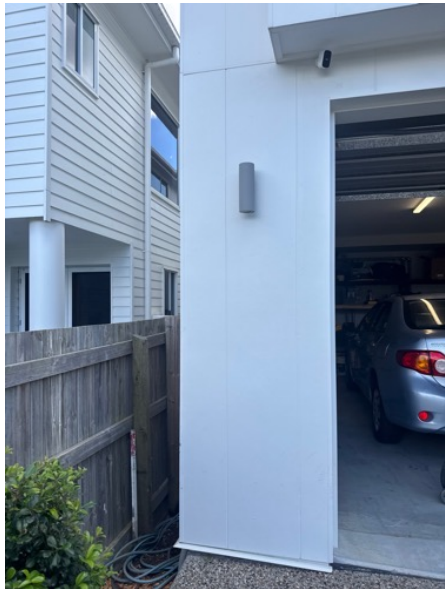
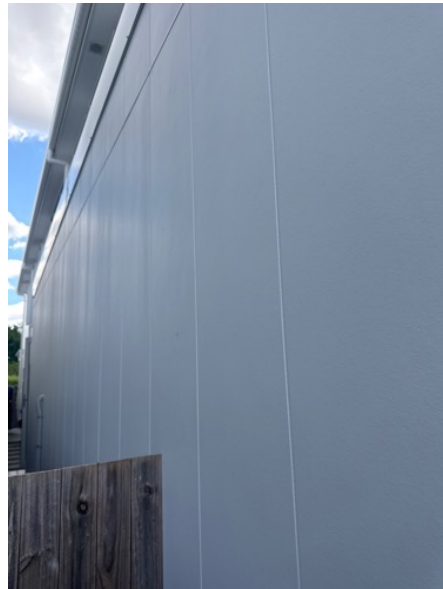
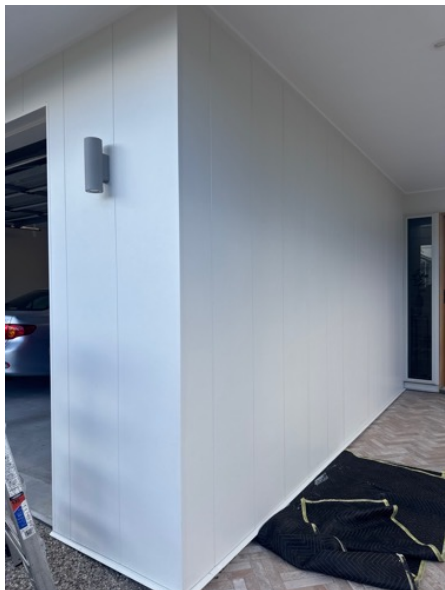
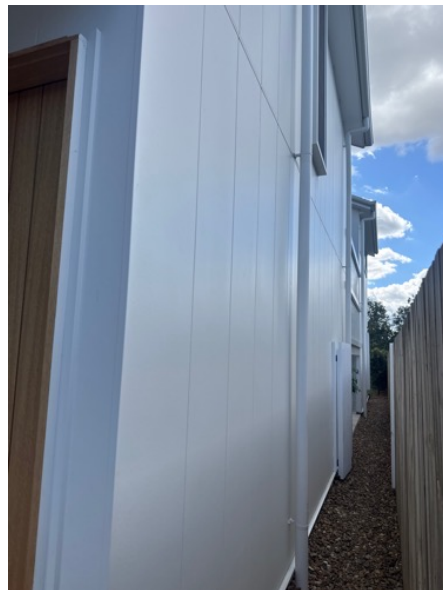
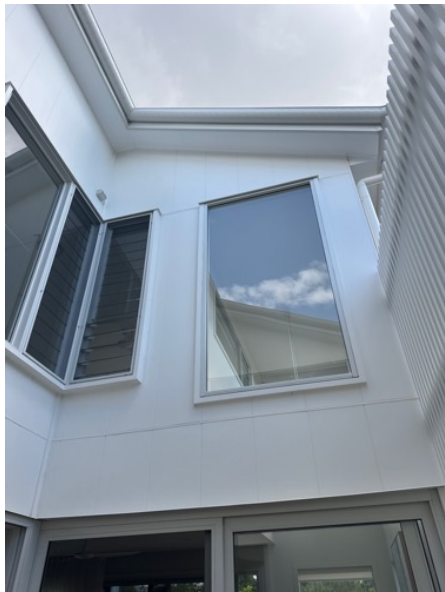
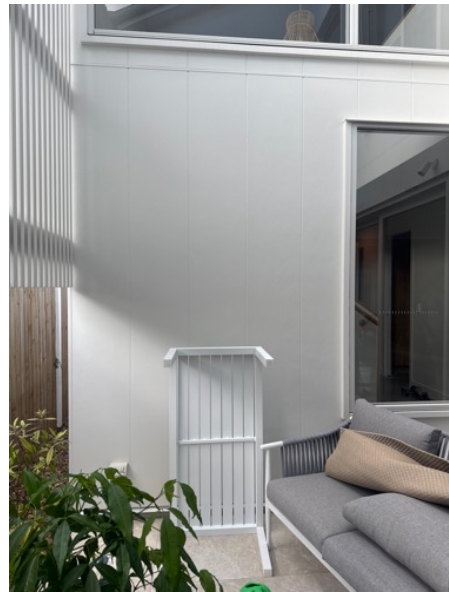
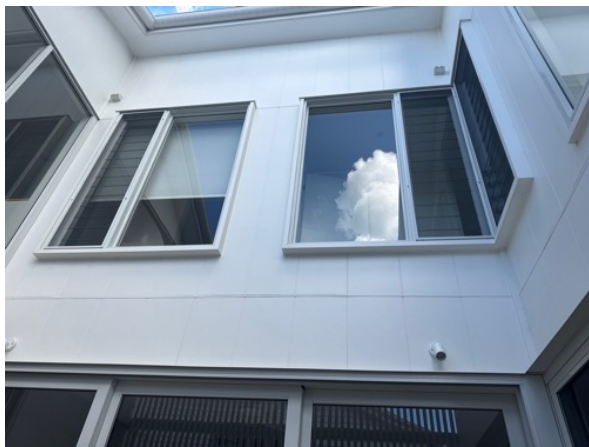
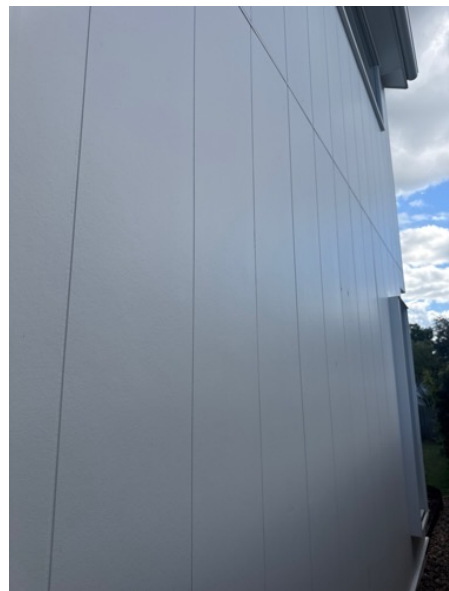
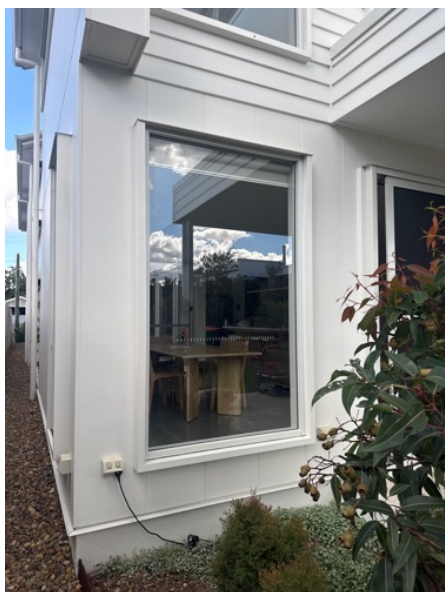
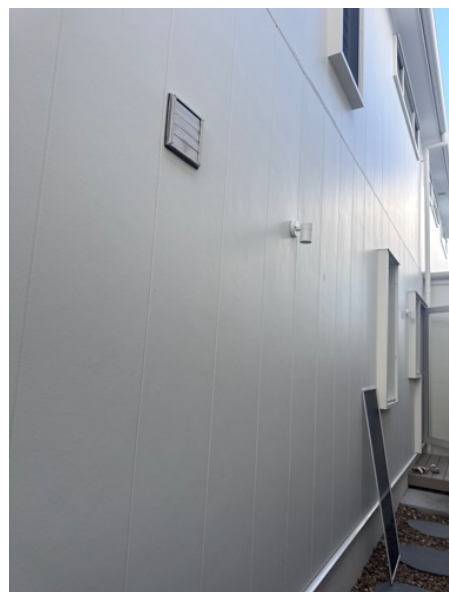
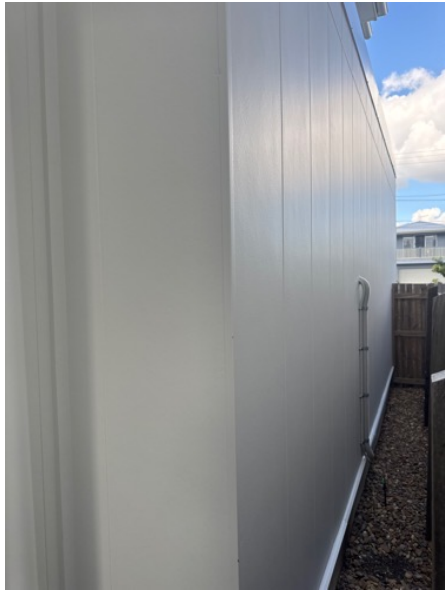
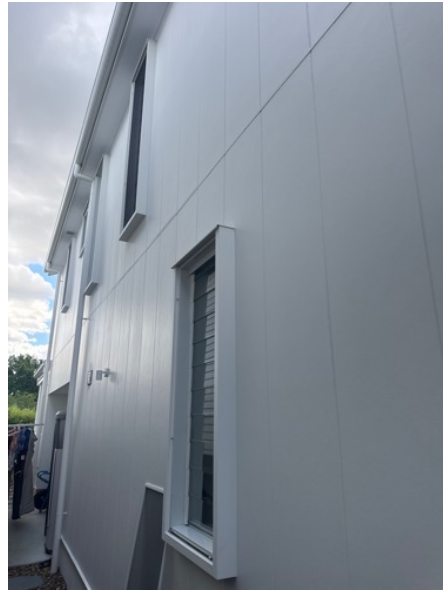
**Location:** External Walls

**Finding:** Fibre cement sheet panel cladding appears in good condition and well sealed with paint.

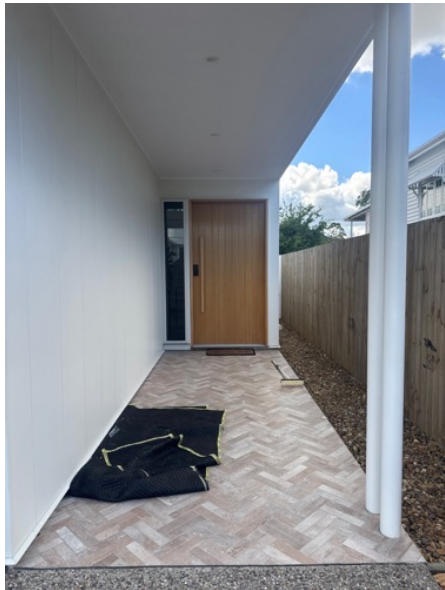
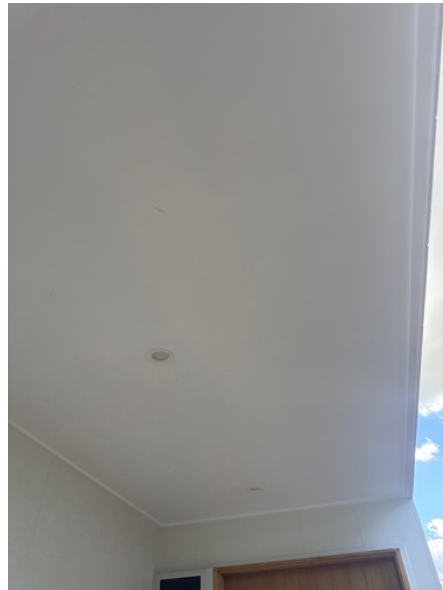
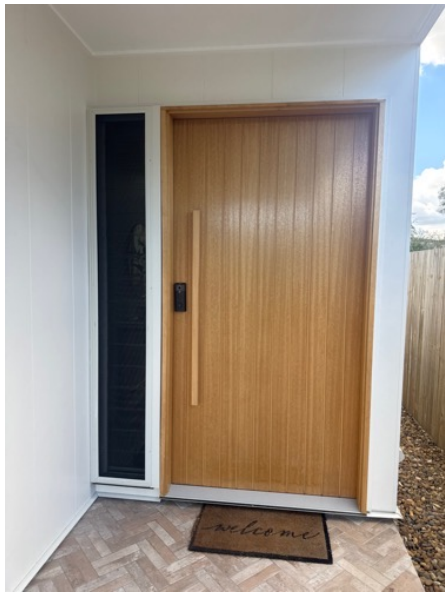
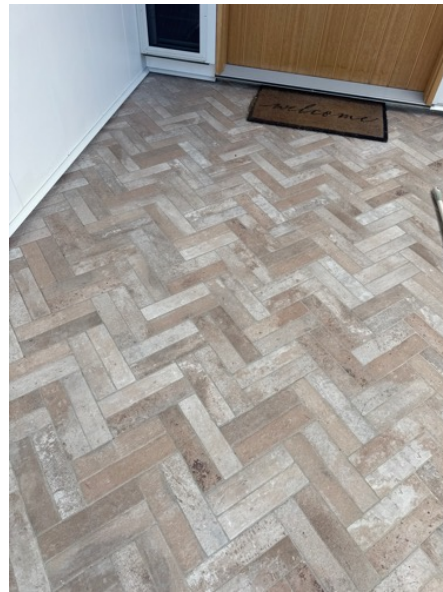
**Location:** Entry

**Finding:** Entry presents in good condition with upper floor extending over.

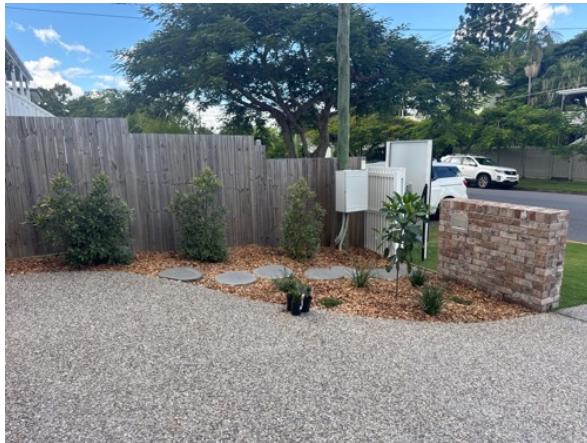
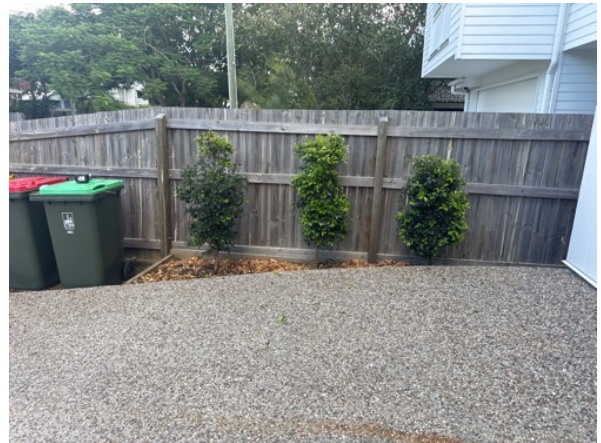
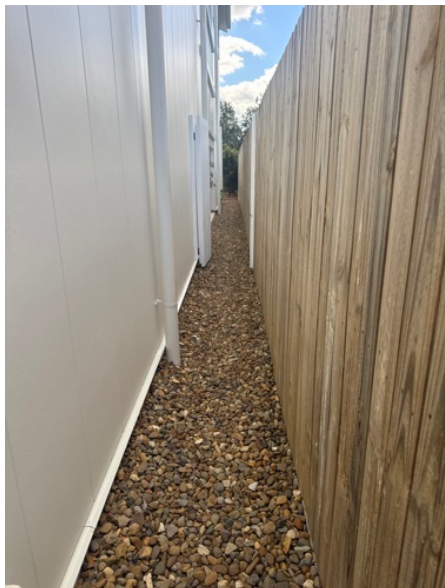
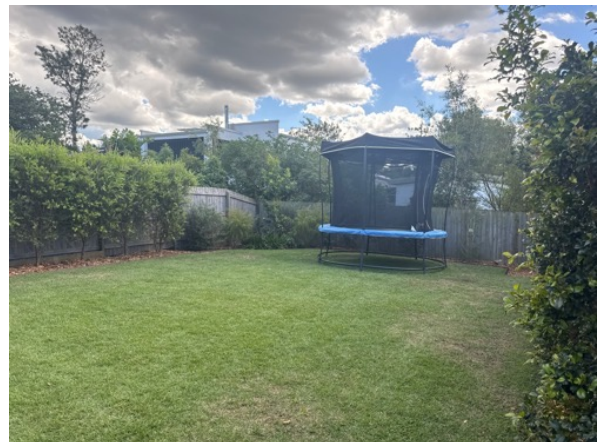
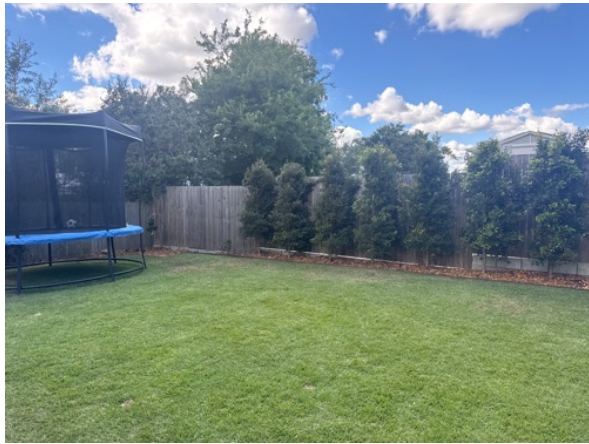
**Location:** The site

**Finding:** Grounds are landscaped with established gardens in good tidy condition.  
Lawn and gardens are maintained.

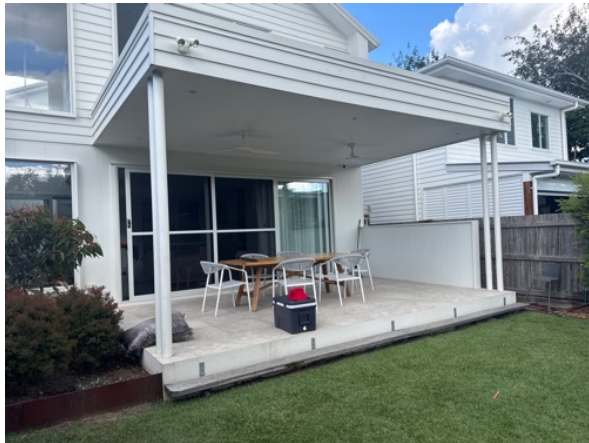
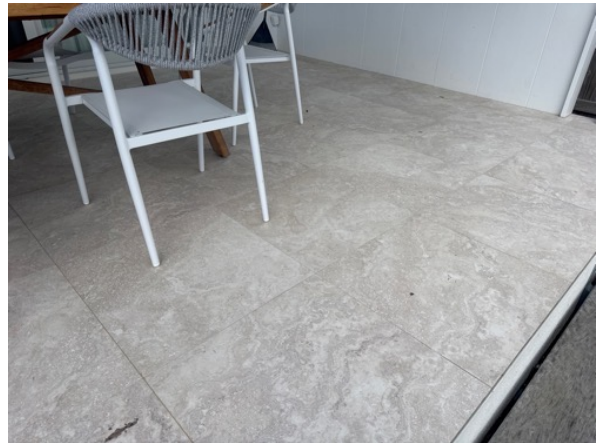
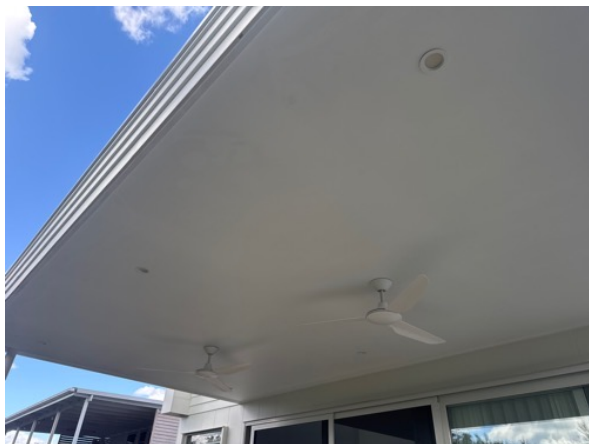
**Location:** Alfresco Area

**Finding:** Alfresco area is under roof with tiled floor finish.  
Good condition.

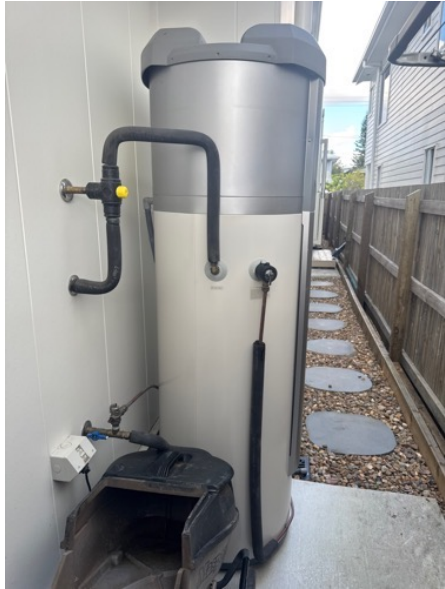
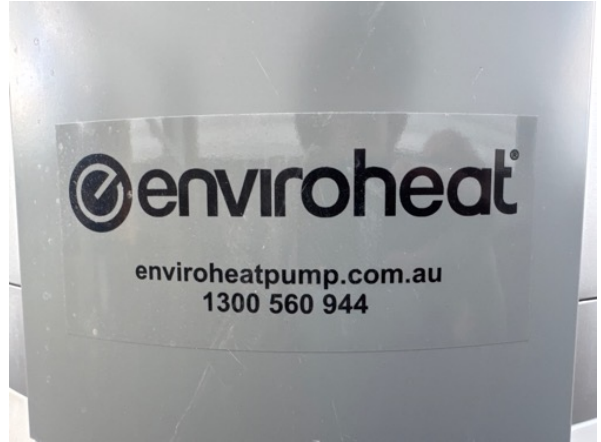
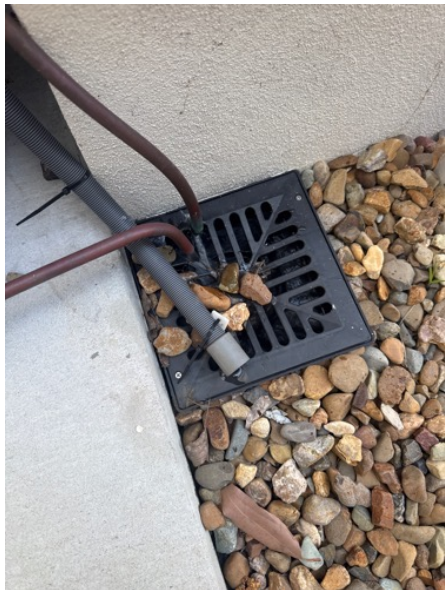
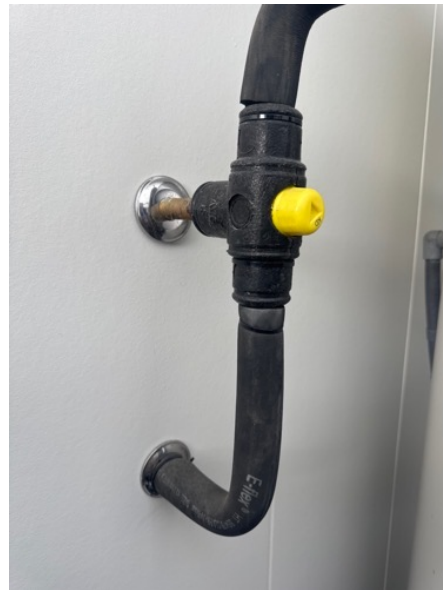
**Location:** Hot Water Unit

**Finding:** Electric hot water unit is functional 246 litre heat pump unit manufactured in unconfirmed year.  
Pressure Relief Valve should be operated regularly (3 monthly) to activate valve and flush drain-  
this will optimise operation and keep moving parts operational.

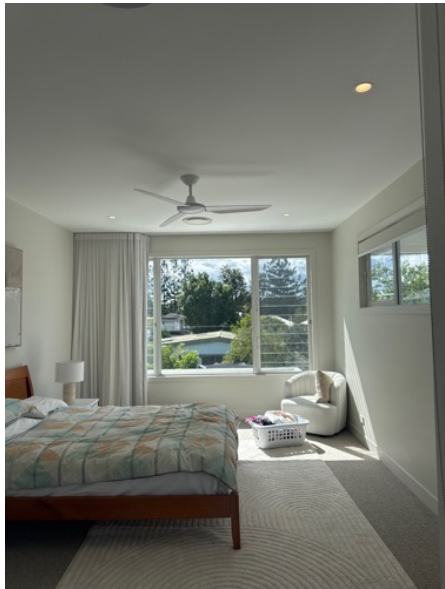
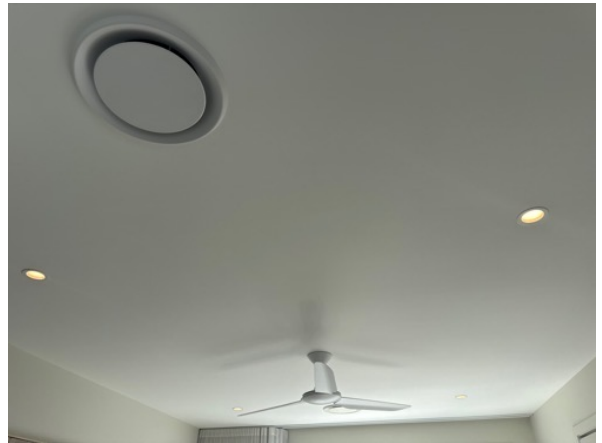
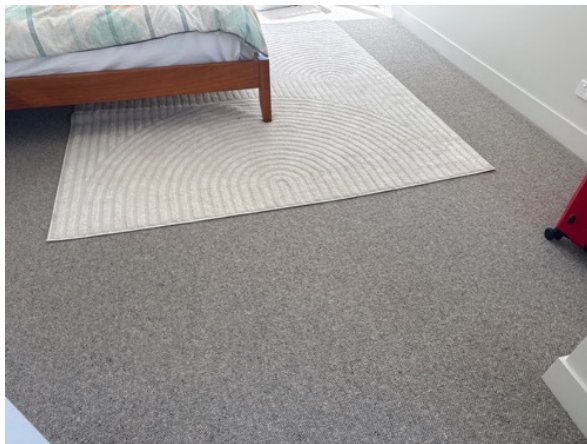
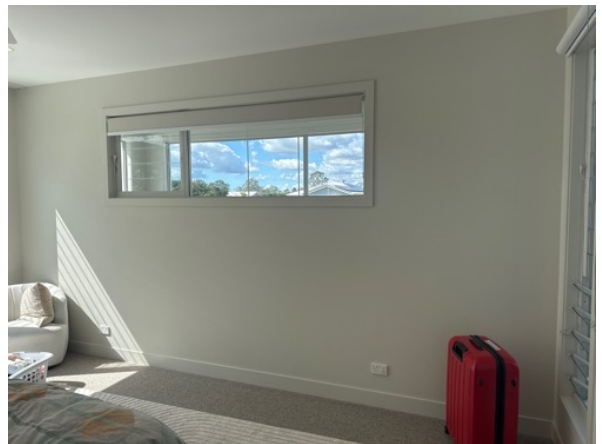
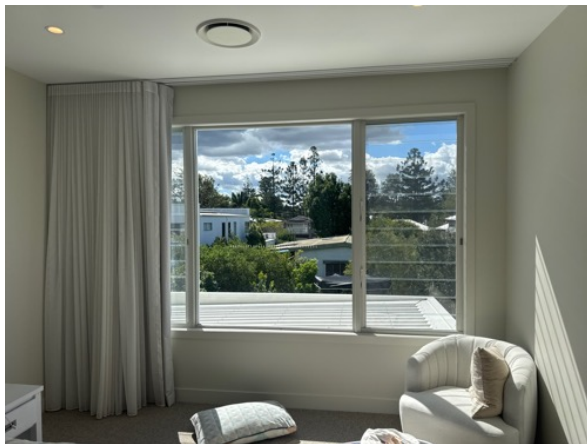
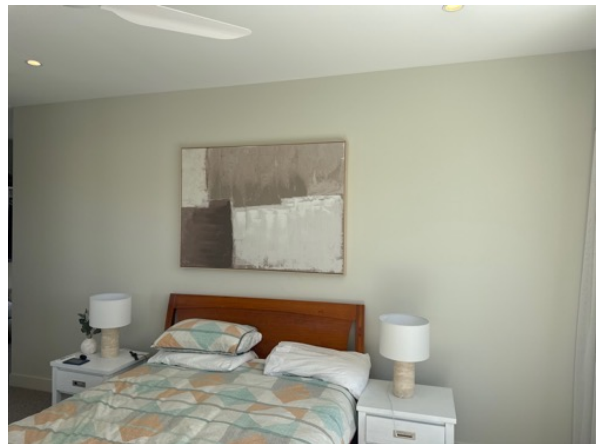
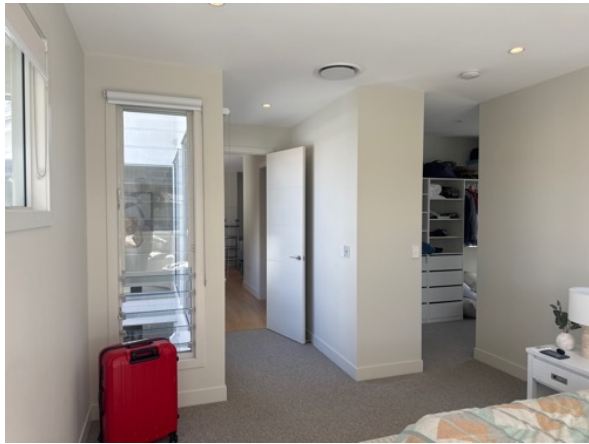
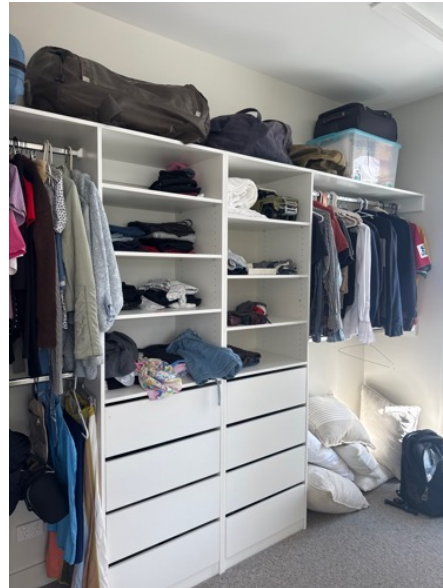
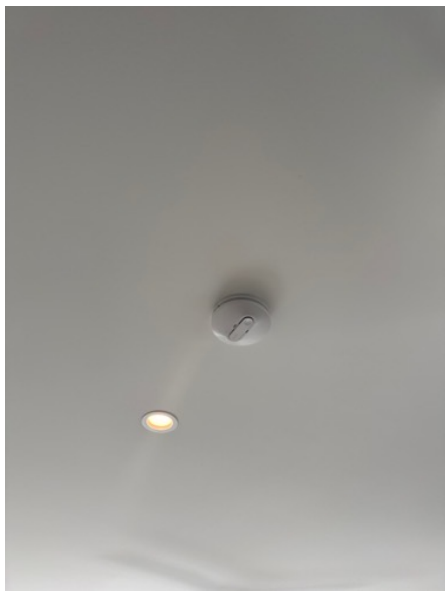
**Location:** Bedroom 1

**Finding:** Bedroom- presents in good condition and has been well maintained.  
Smoke detector installed- Vendor to provide smoke detector compliance certification.

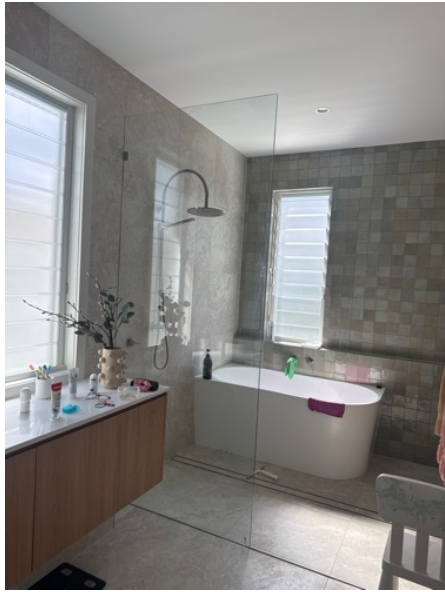
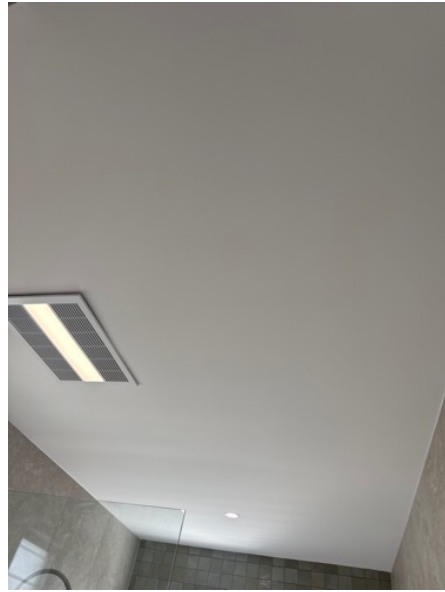
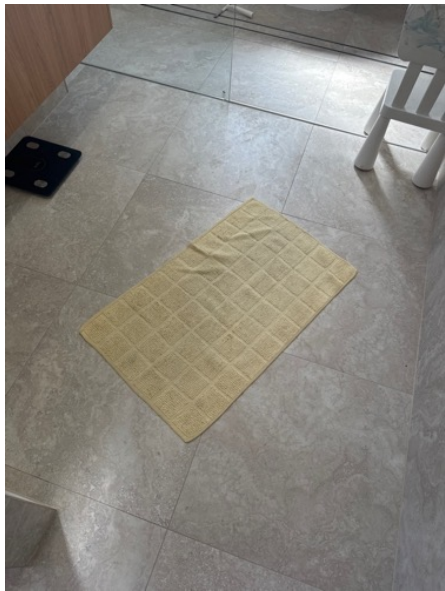
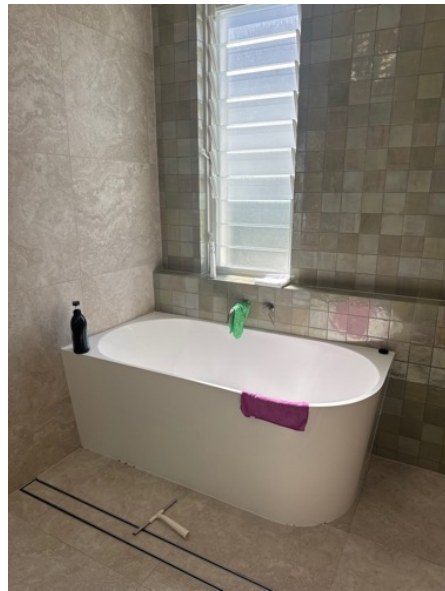
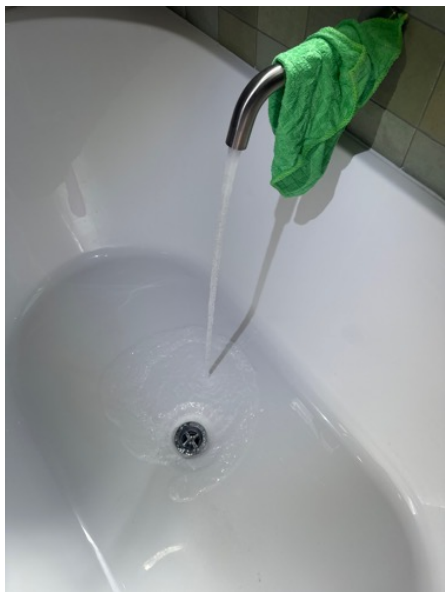
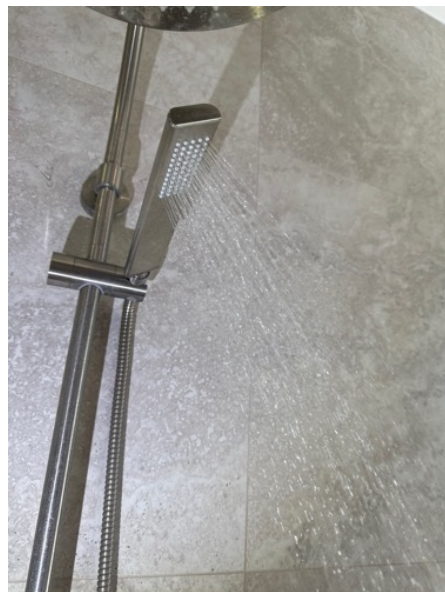
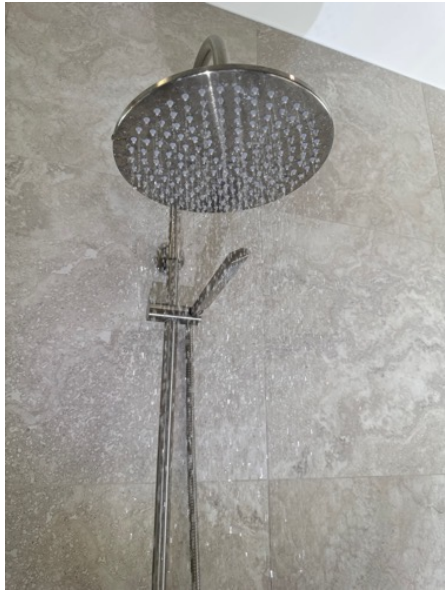
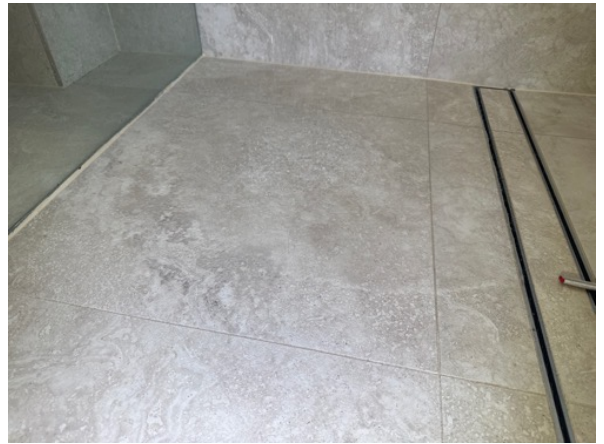
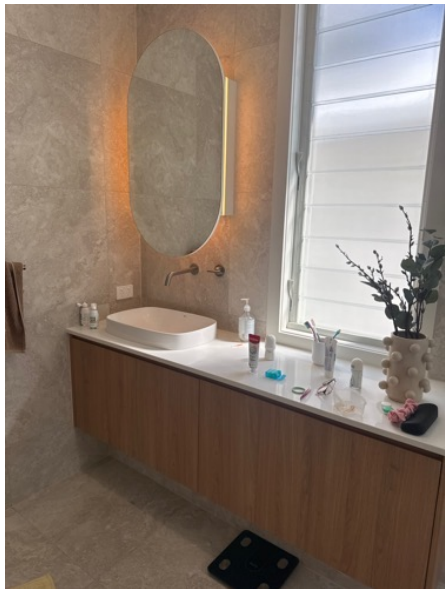
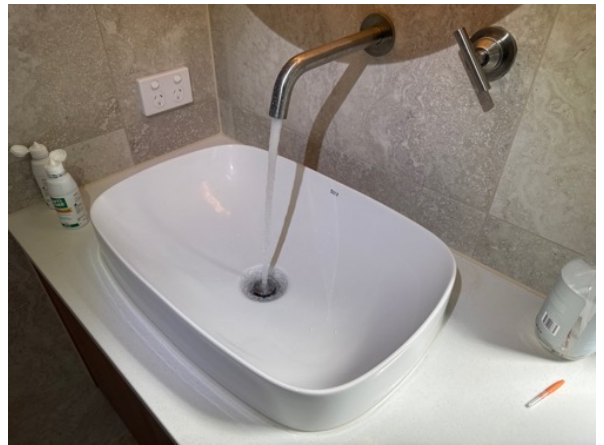
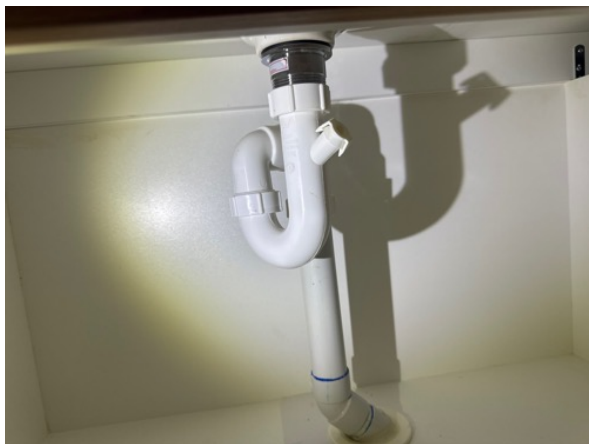
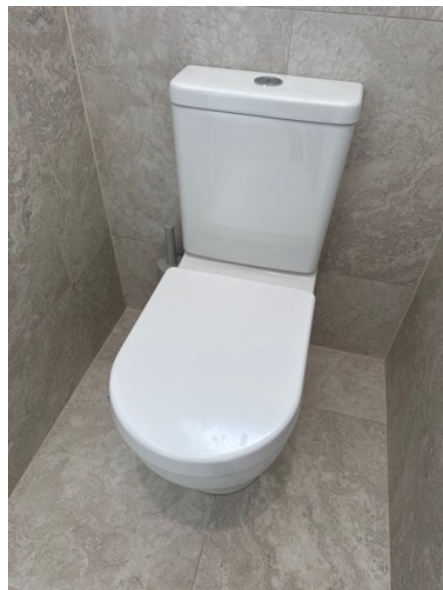
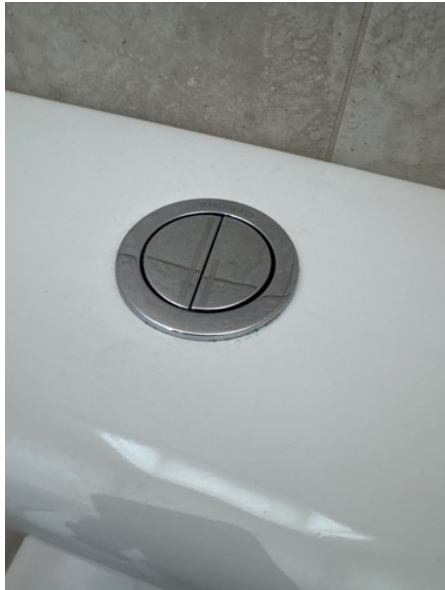
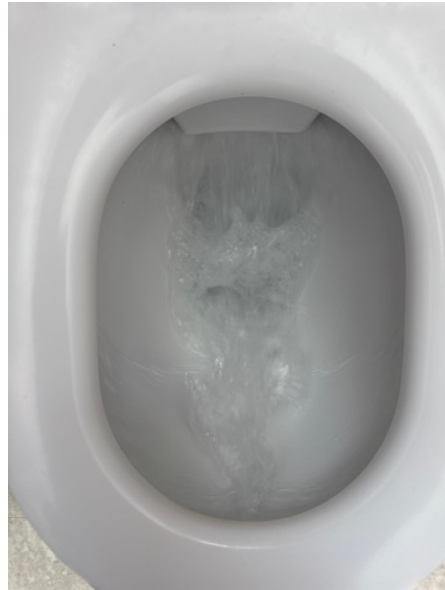
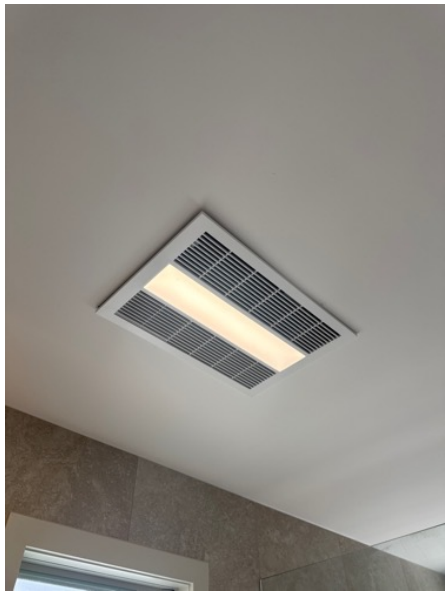
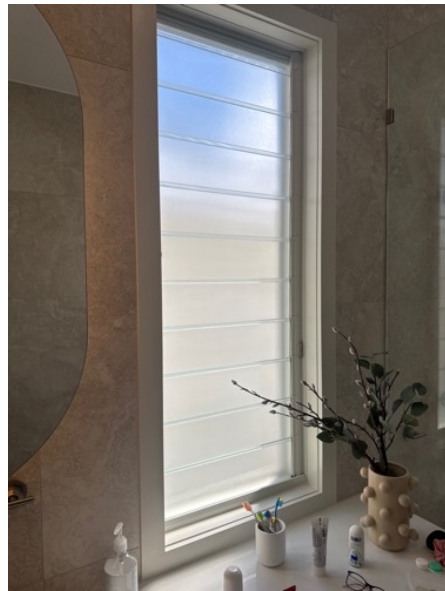
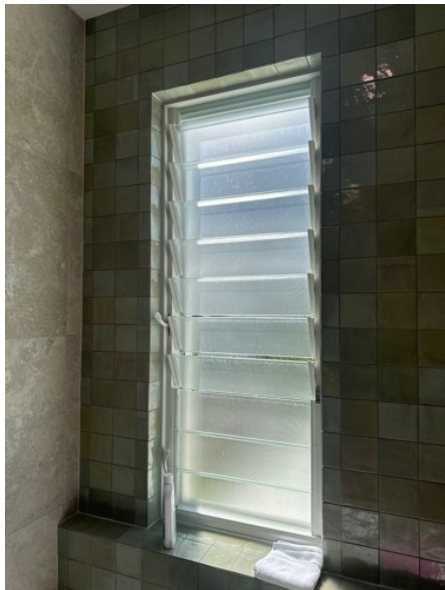
**Location:** Ensuite

**Finding:** Ensuite presents in good functional condition and has been well maintained.

Ventilation: Natural (window) and mechanical exhaust.

Water pressure is satisfactory with water draining away.
