# Property and Timber Pest Report

Inspection Date: 23 Apr 2025

Property Address: 32 Richardson Street Chelmer 4068

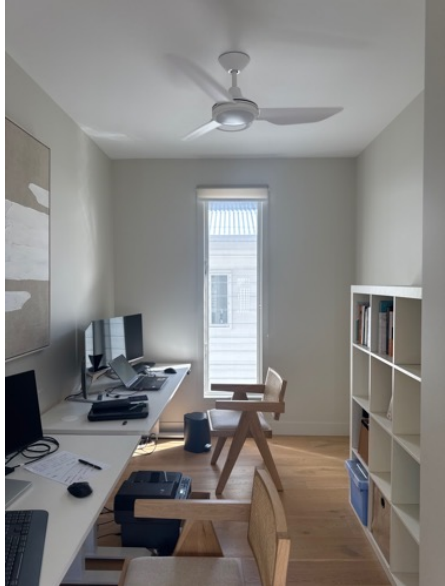
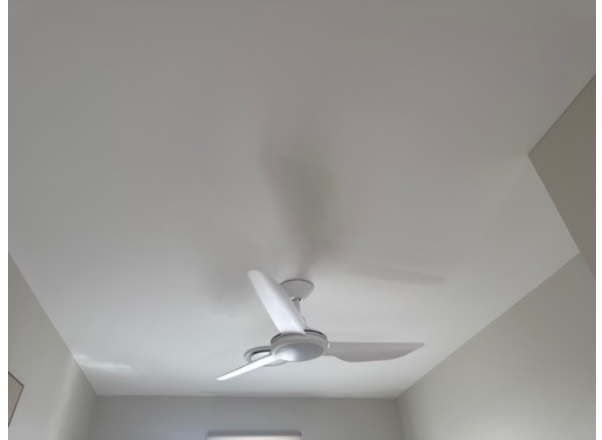
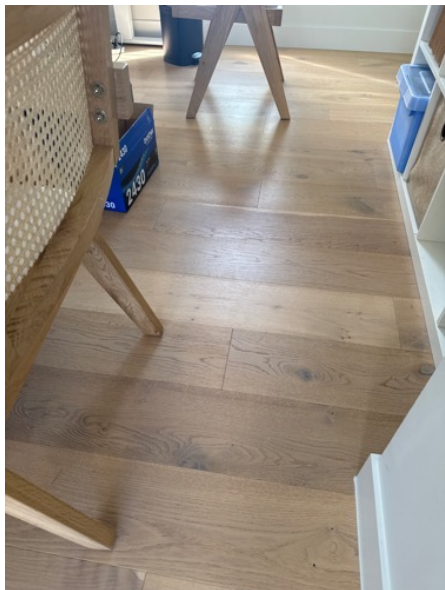
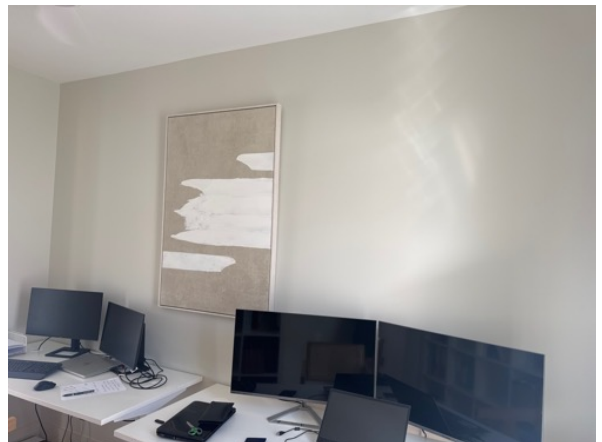
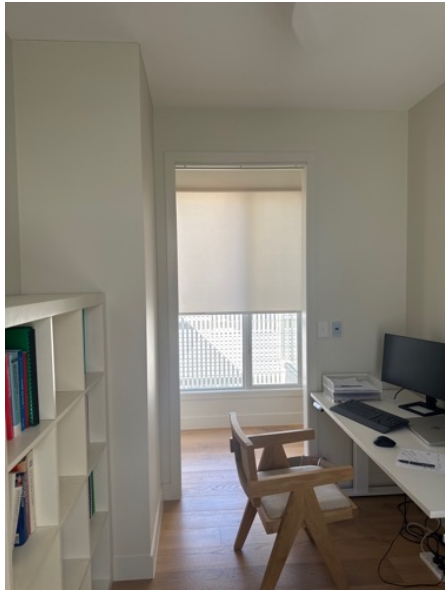
**Location:** Study

**Finding:** Study appears in good condition.

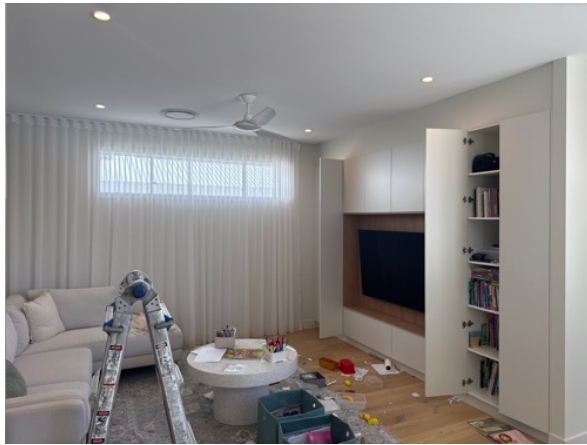
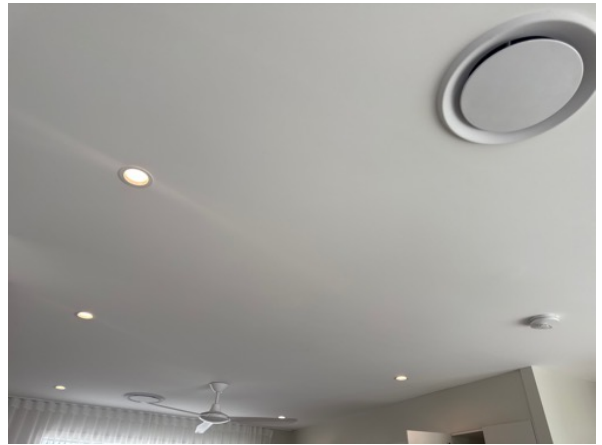
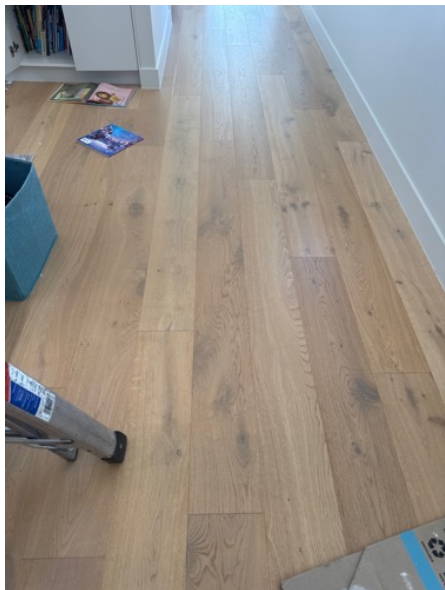
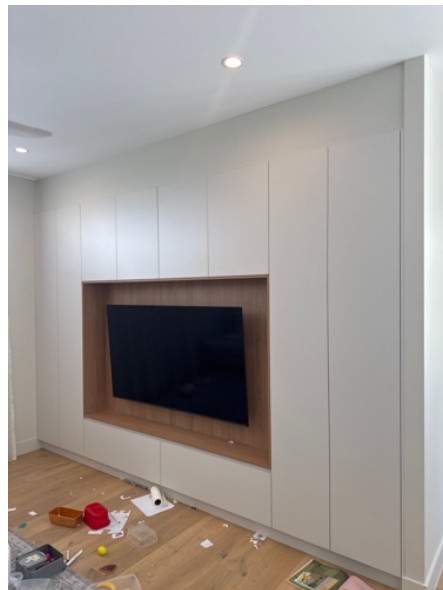
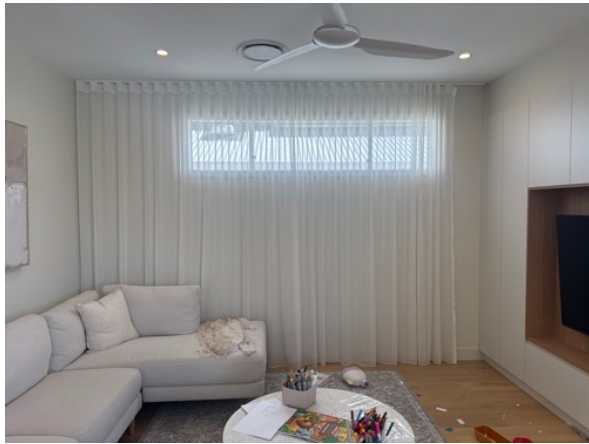
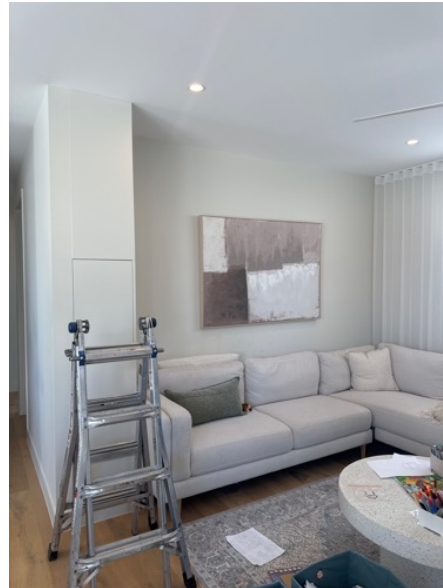
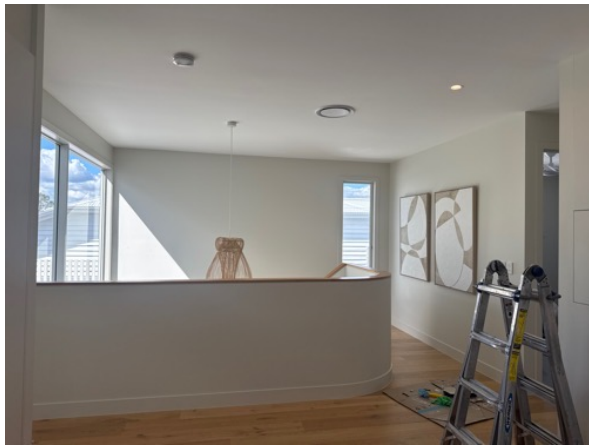
**Location:** Living area

**Finding:** Living area presents in good condition and has been well maintained.  
Good condition.

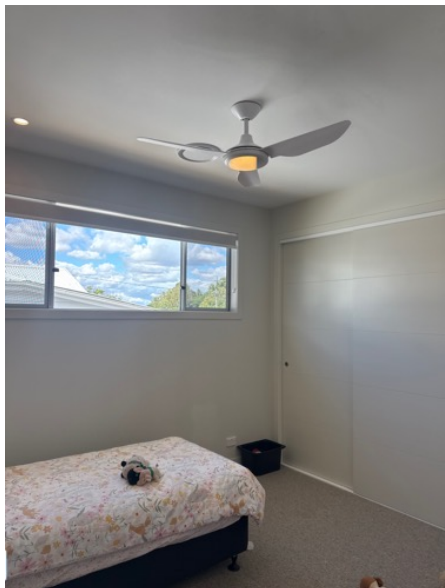
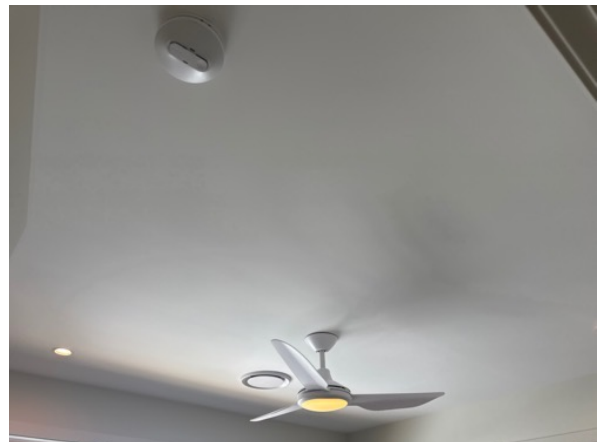
**Location:** Bedroom 2

**Finding:** Bedroom- presents in good condition and has been well maintained.  
Smoke detector installed- Vendor to provide smoke detector compliance certification.

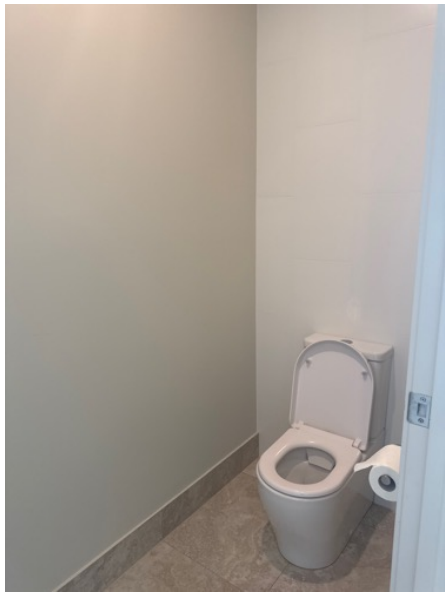
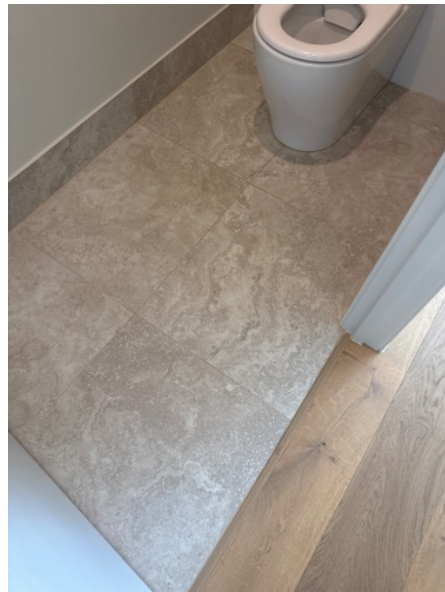
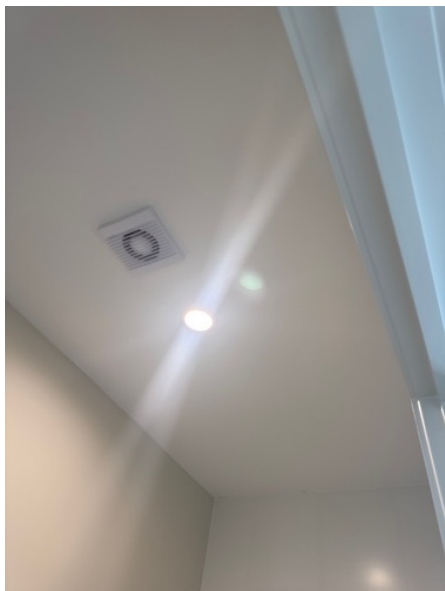
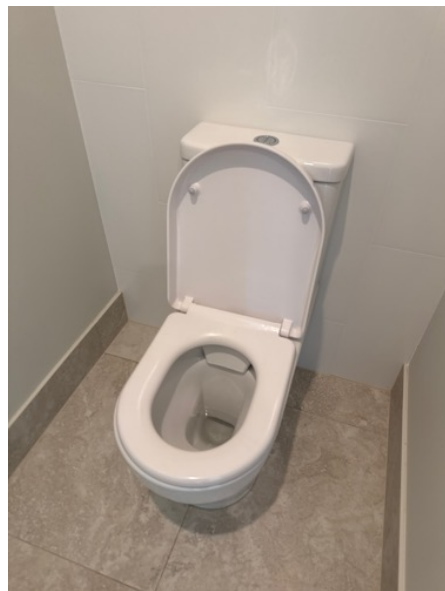
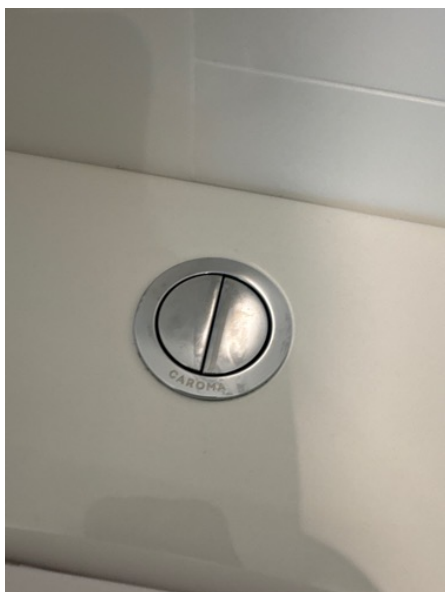
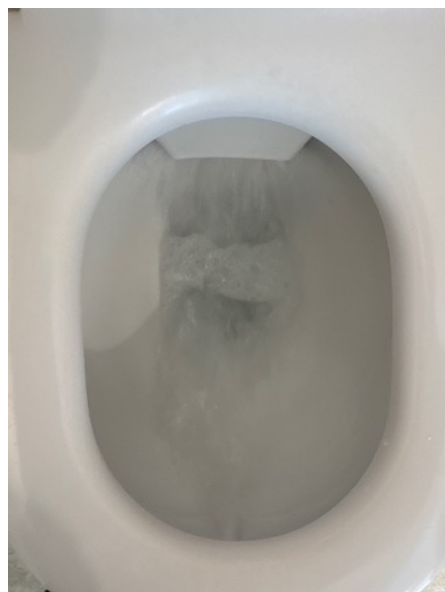
## For your information 2.22

**Finding:** Dual flush toilet is in good functional condition.  
Half and full flush functional.

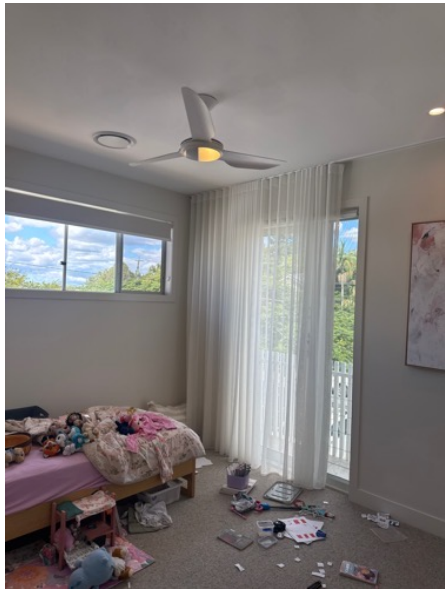
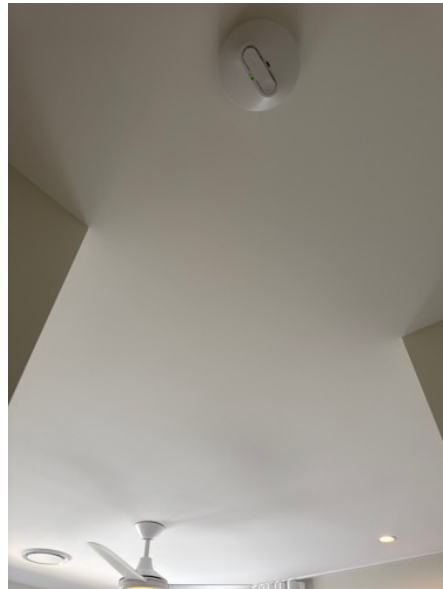
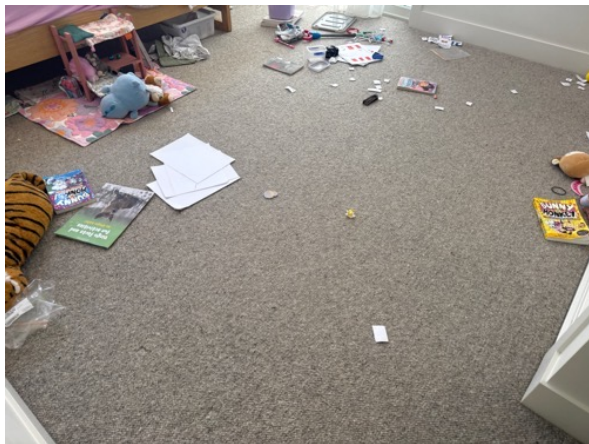
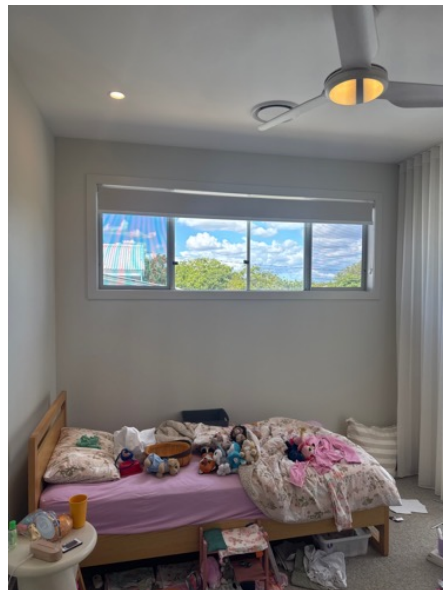
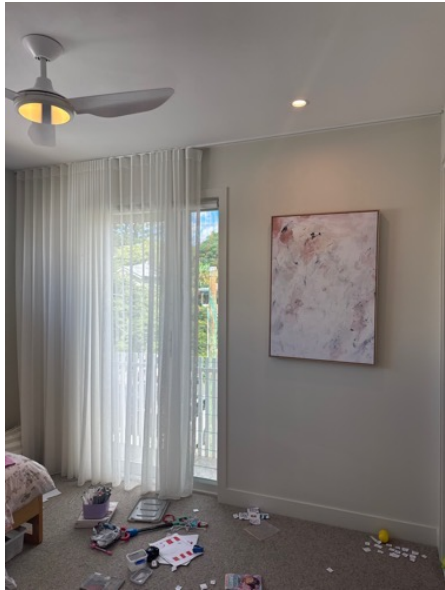
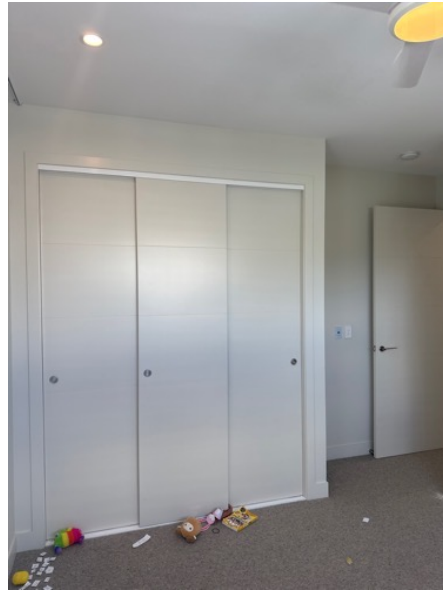
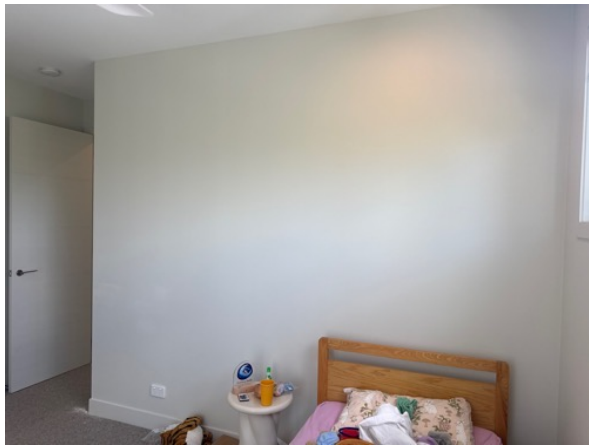
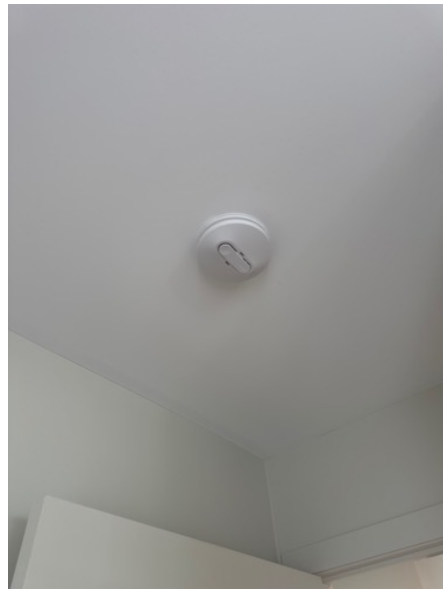
## For your information 2.23

**Finding:** Bedroom- presents in good condition and has been well maintained.  
Smoke detector installed- Vendor to provide smoke detector compliance certification.

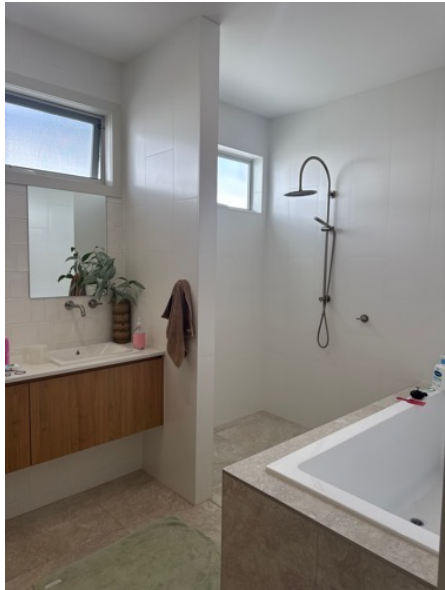
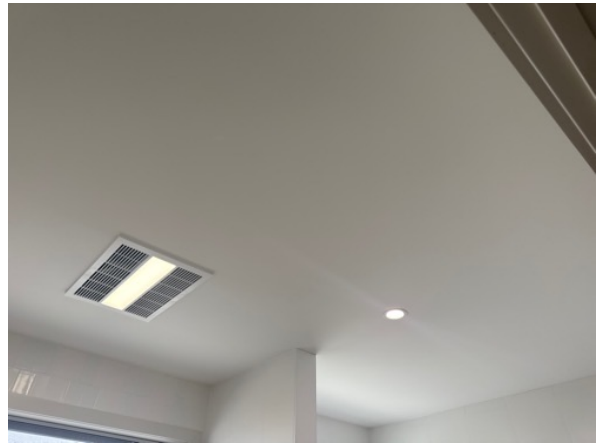
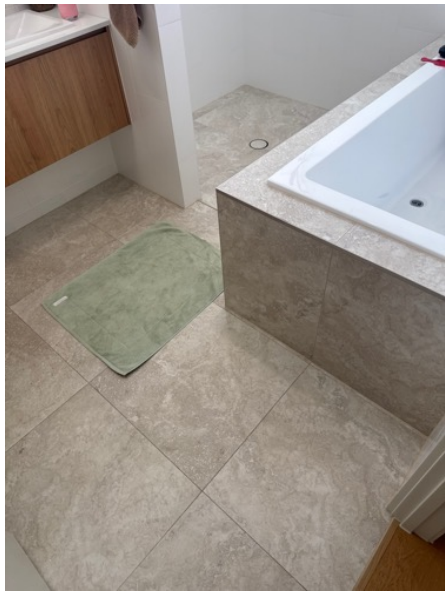
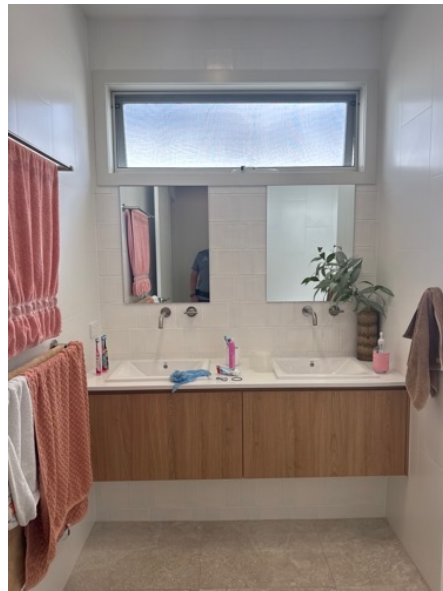
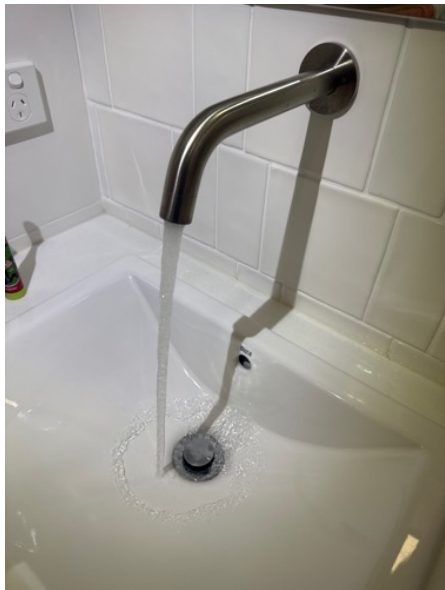
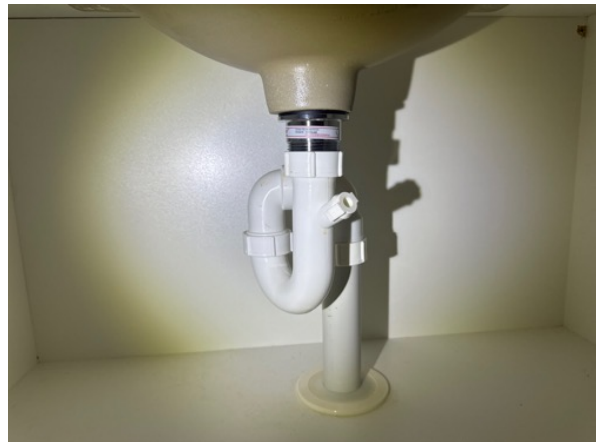
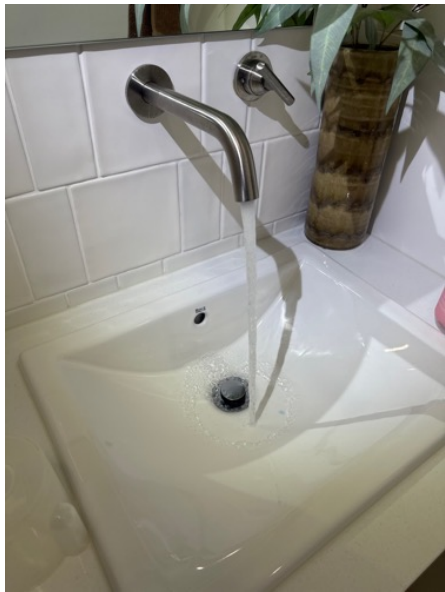
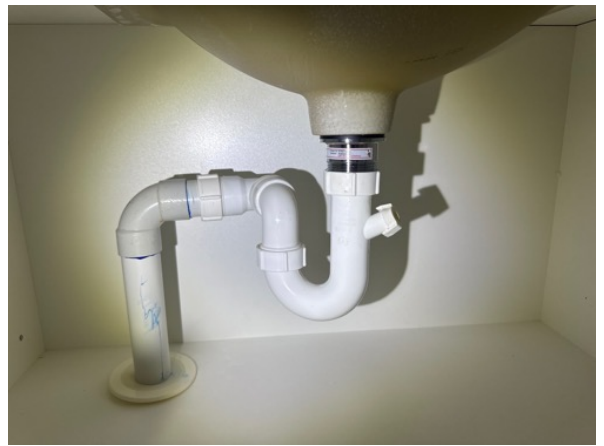
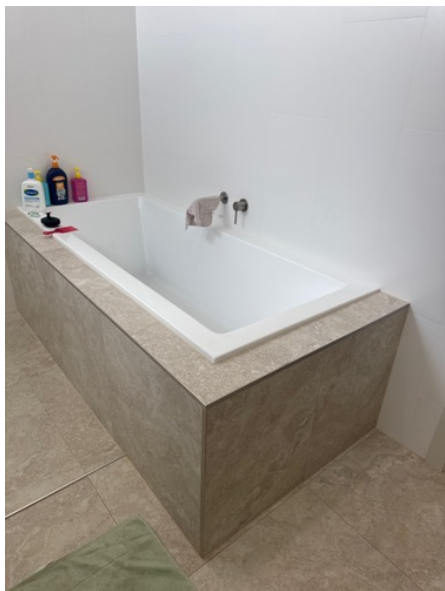
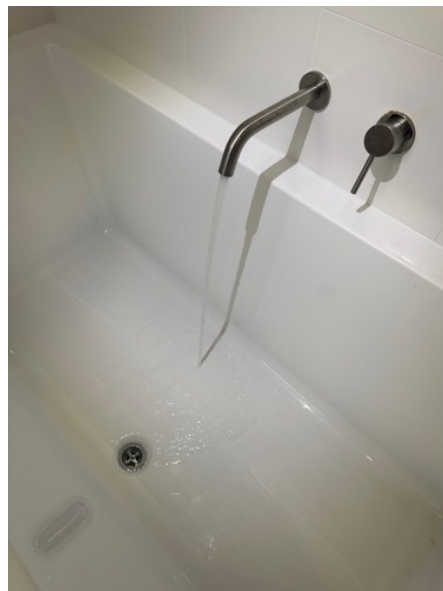
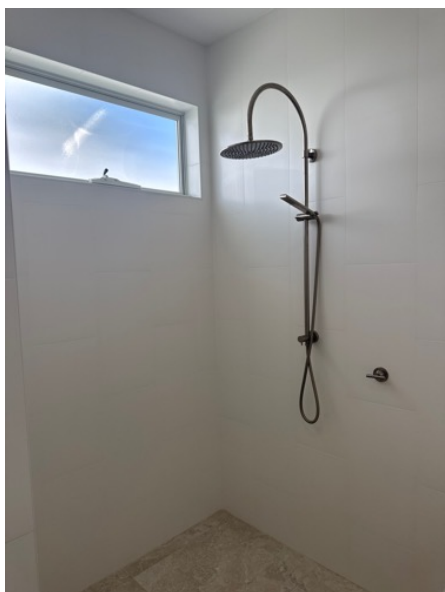
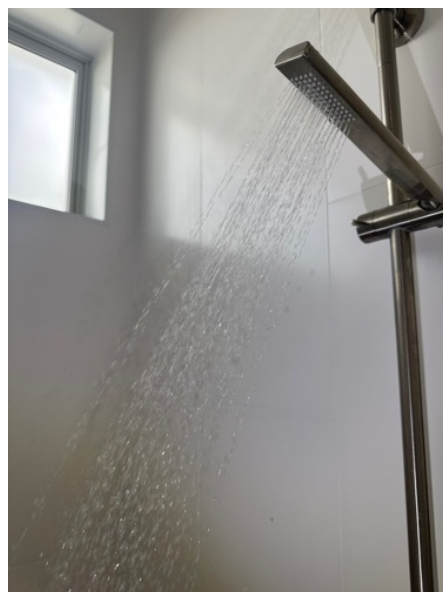
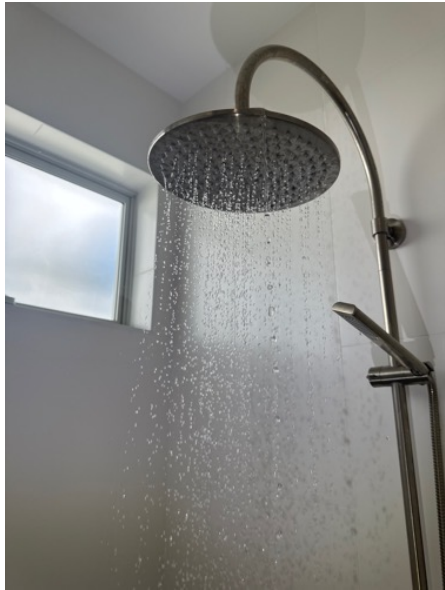
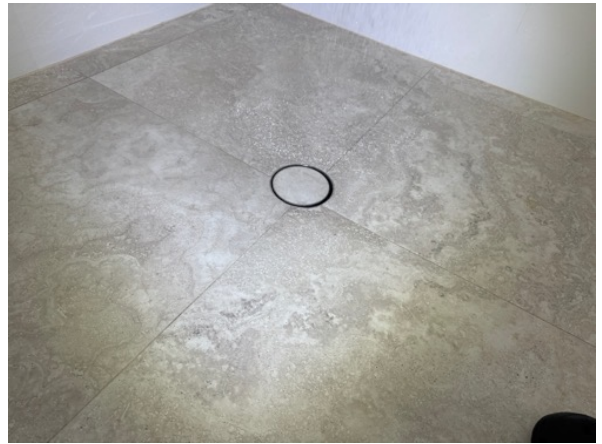
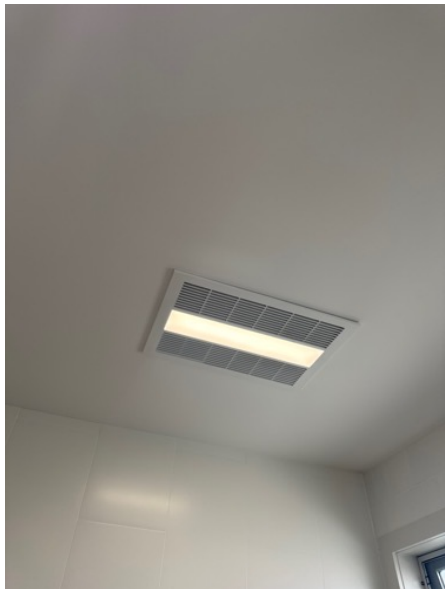
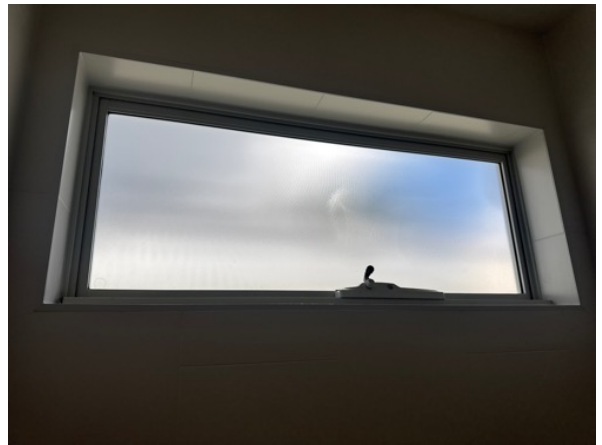
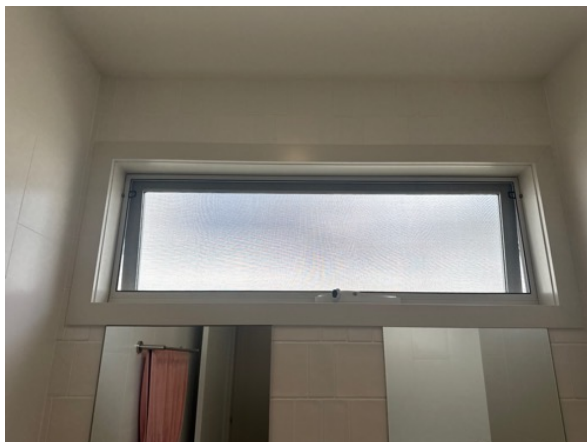
## For your information 2.24

**Finding:** Bathroom- good functional condition and has been well maintained.

Ventilation: Natural (window) and mechanical exhaust.

Water pressure is satisfactory with water draining away.

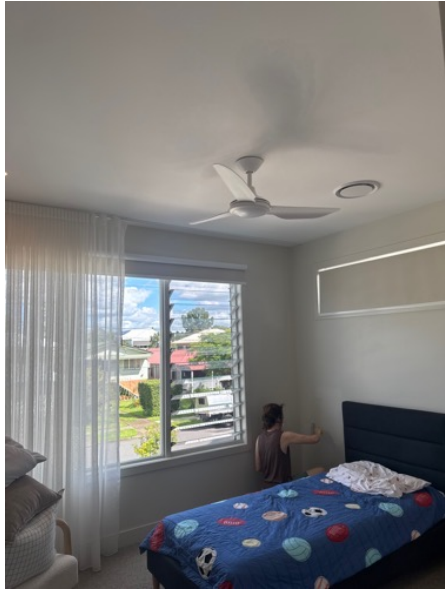
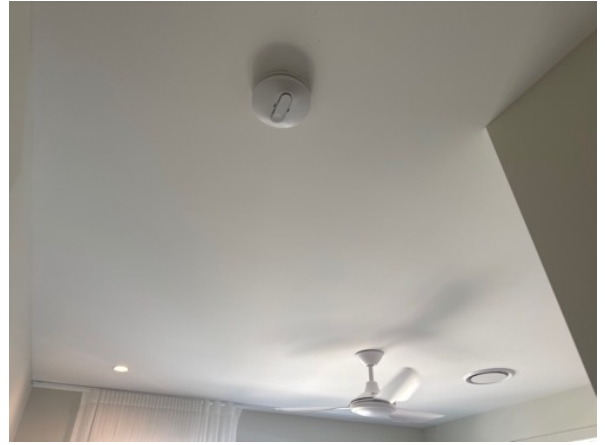
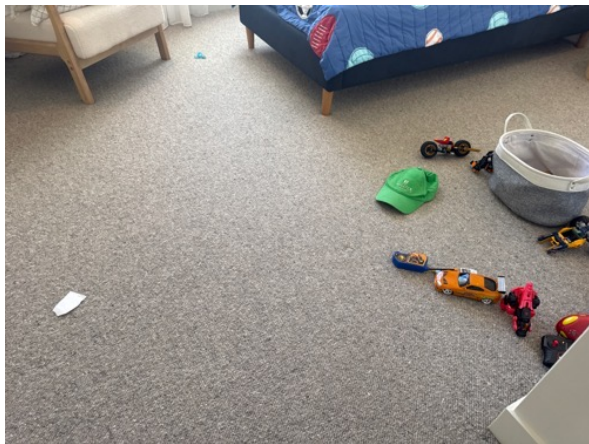
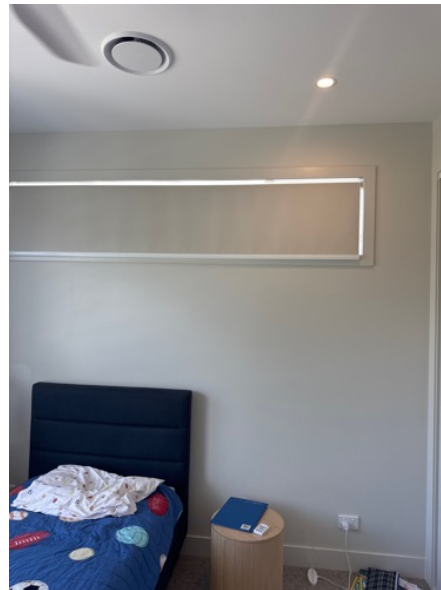
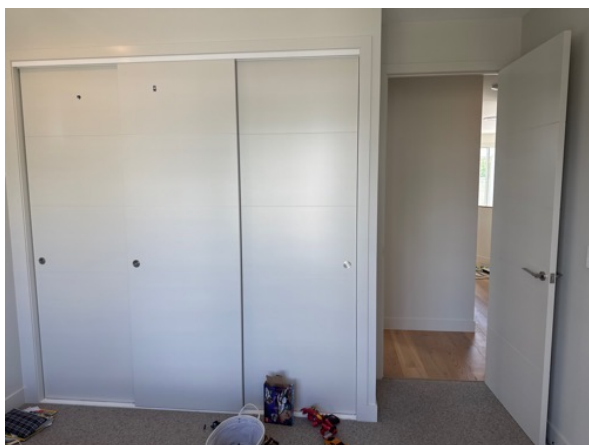
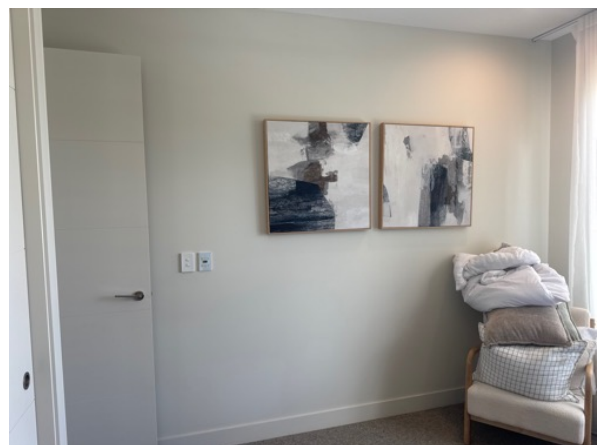
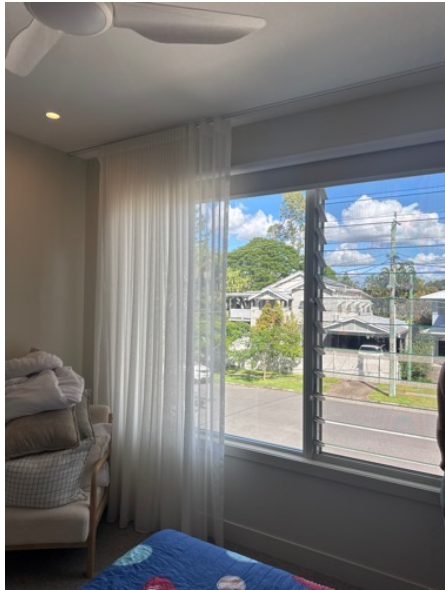
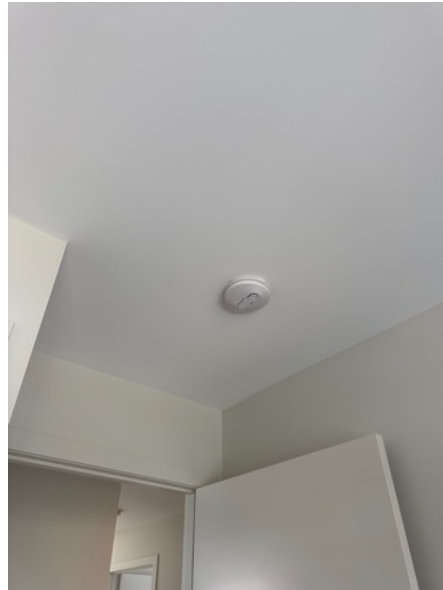
**Location:** Bedroom 4

**Finding:** Bedroom- presents in good condition and has been well maintained.  
Smoke detector installed- Vendor to provide smoke detector compliance certification.

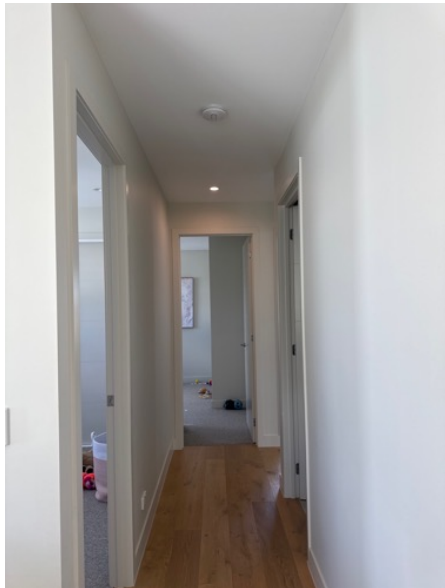
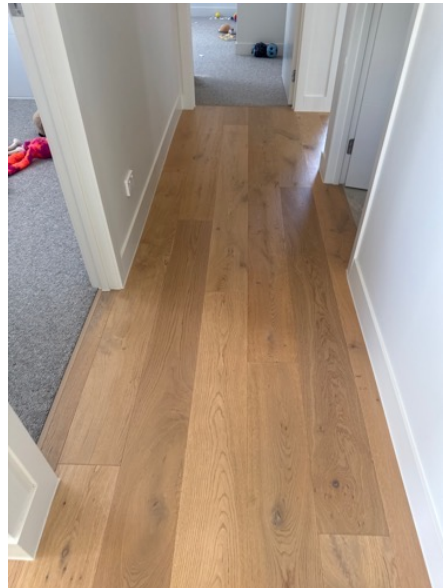
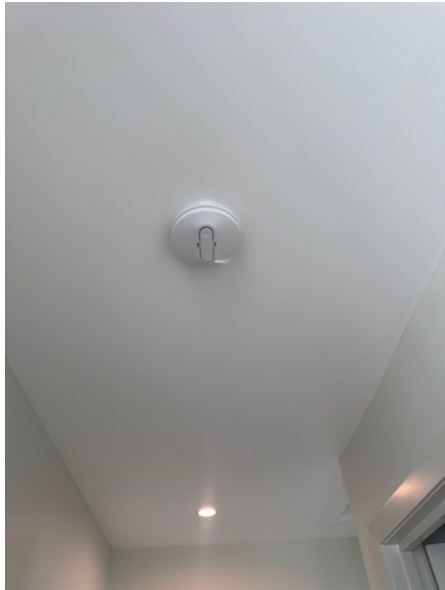
**Location:** Hallway

**Finding:** Hallway presents in good condition.

Smoke detector installed- Vendor to provide smoke detector compliance certification.

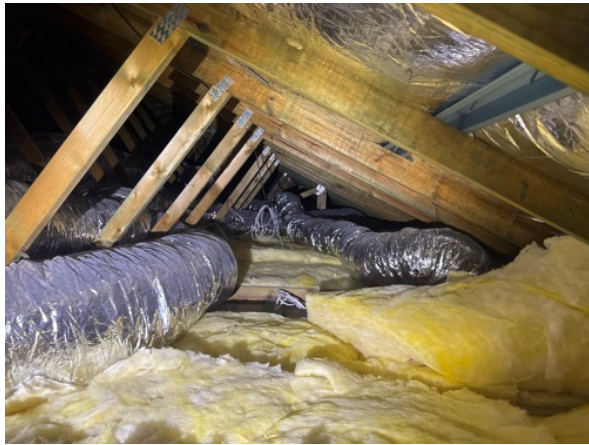
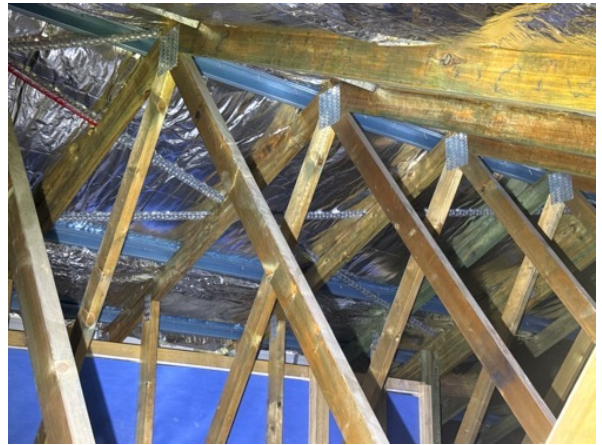
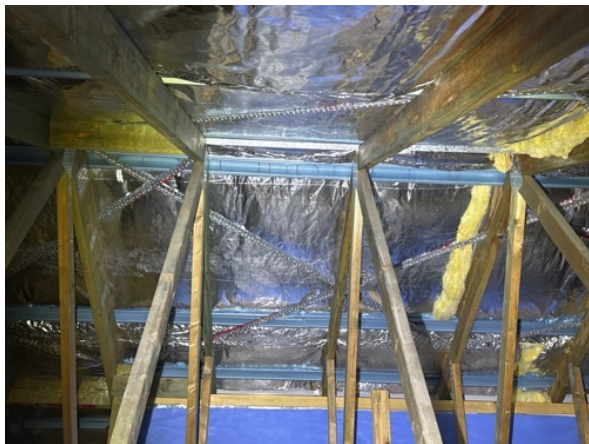
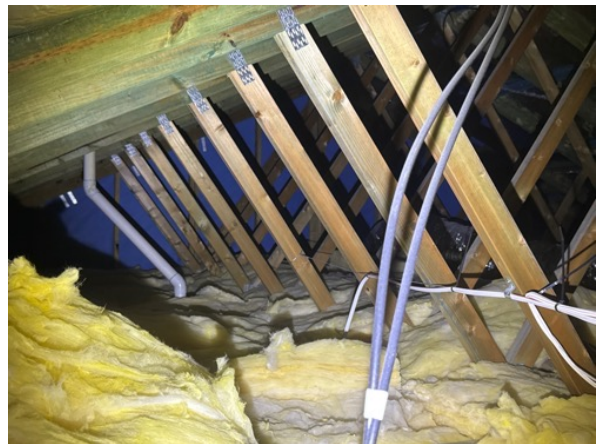
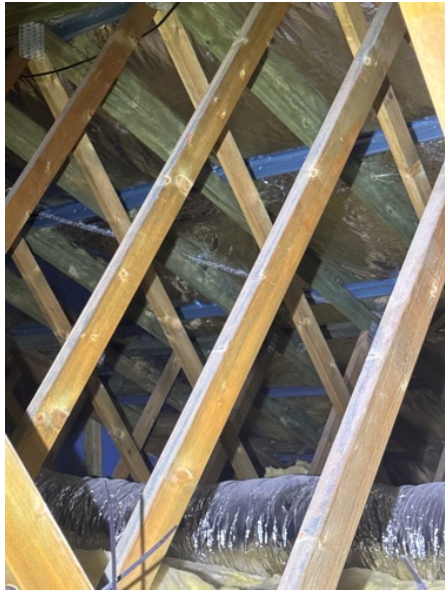
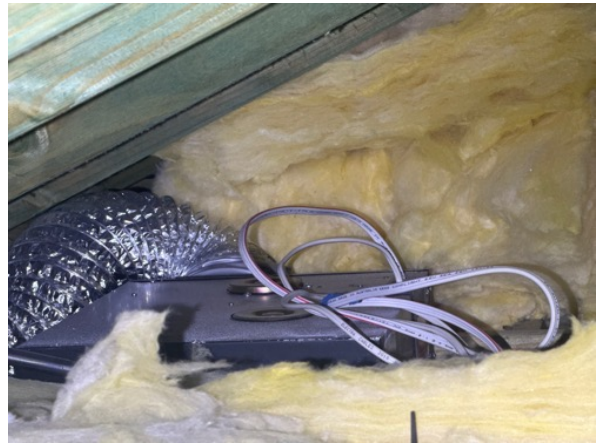
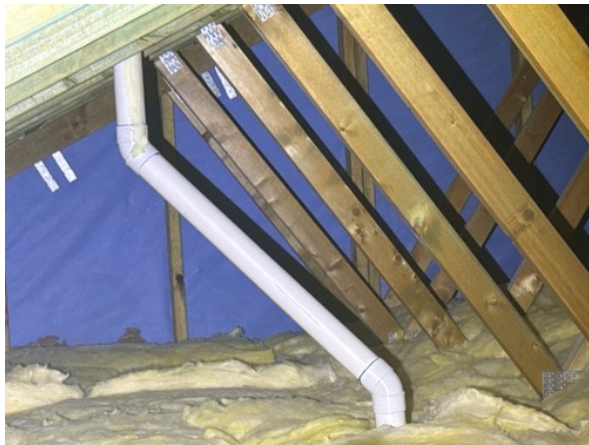
**Location:** Roofspace

**Finding:** Pine truss roof frame supports metal roofing system.  
Appears in good condition with fibreglass thermal insulation installed.

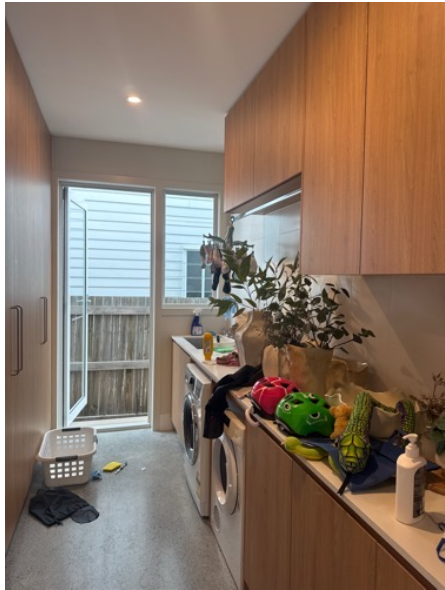
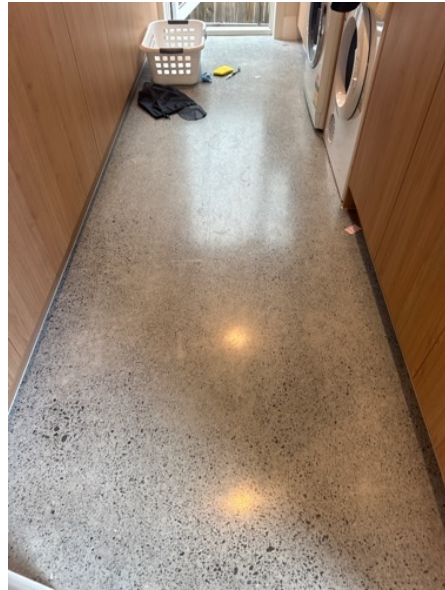
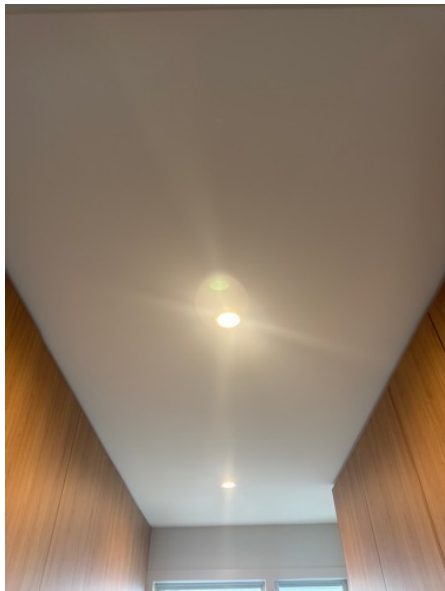
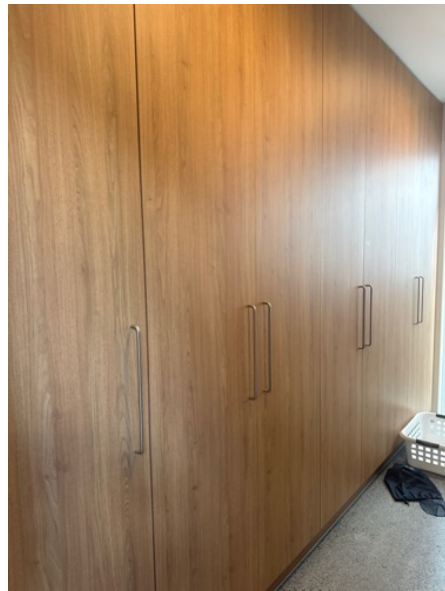
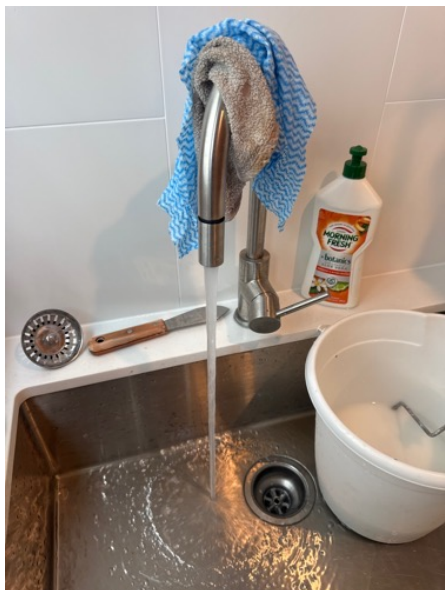
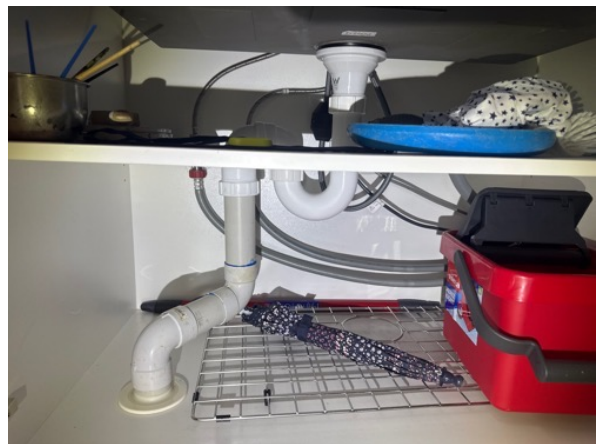
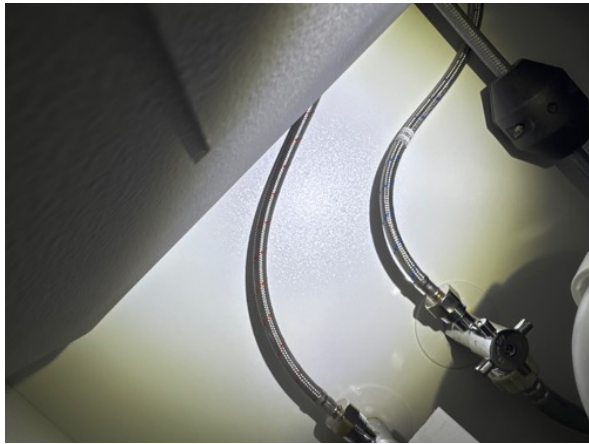
**Location:** Laundry

**Finding:** Laundry and facilities appear in good functional condition.  
Water pressure is satisfactory with water draining away.

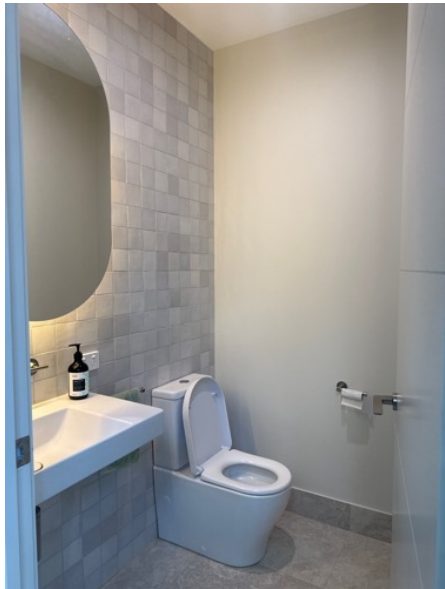
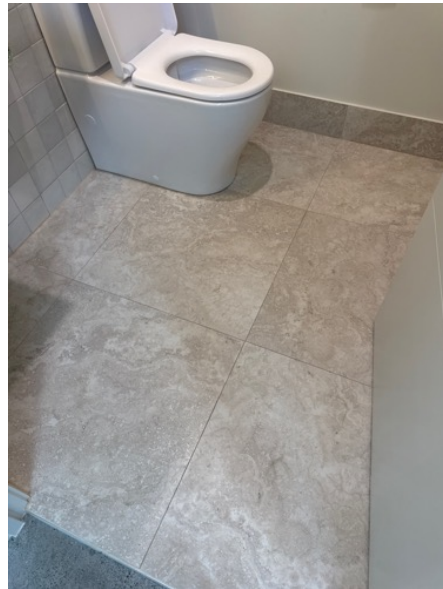
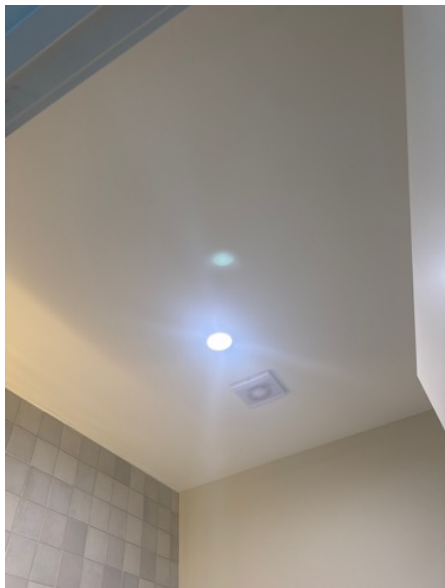
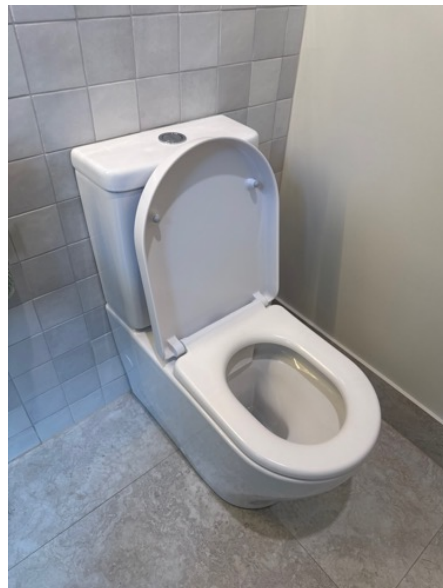
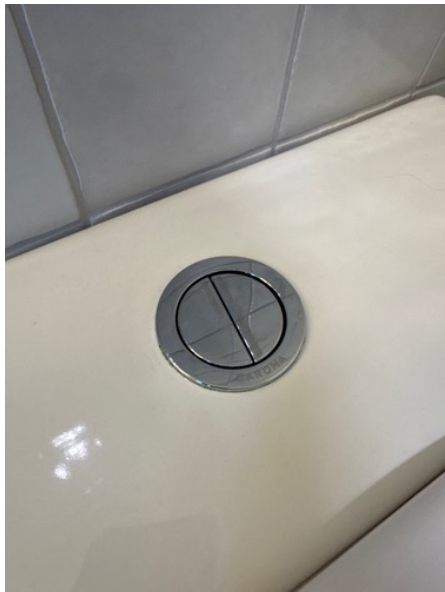
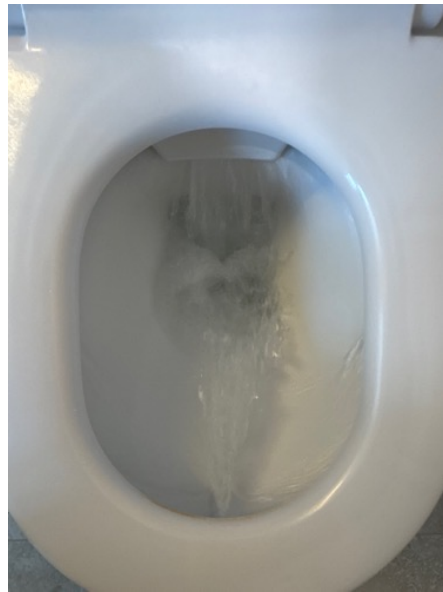
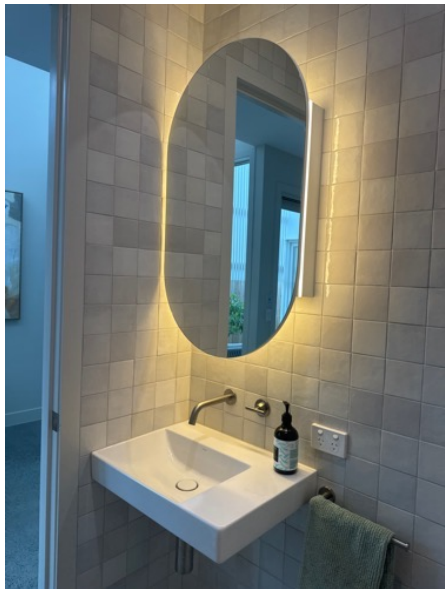
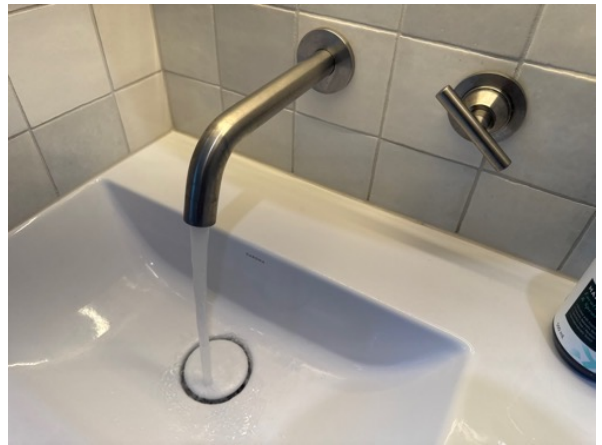
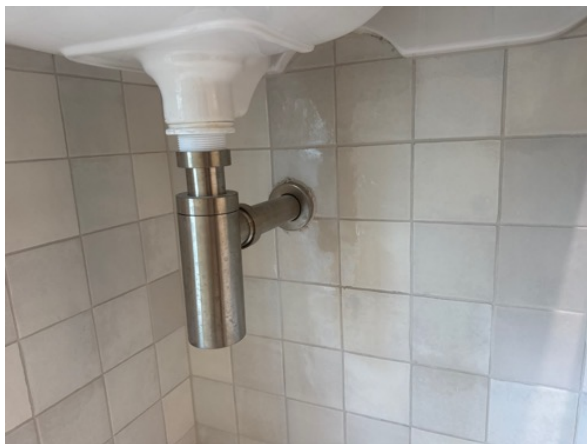
**Location:** Toilet- Ground Level

**Finding:** Dual flush toilet is in good functional condition.  
Half and full flush functional.

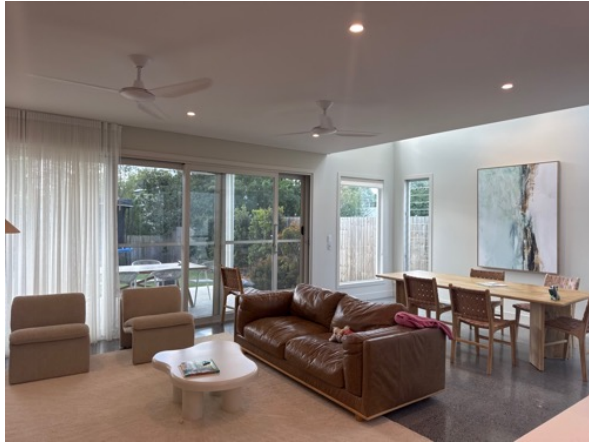
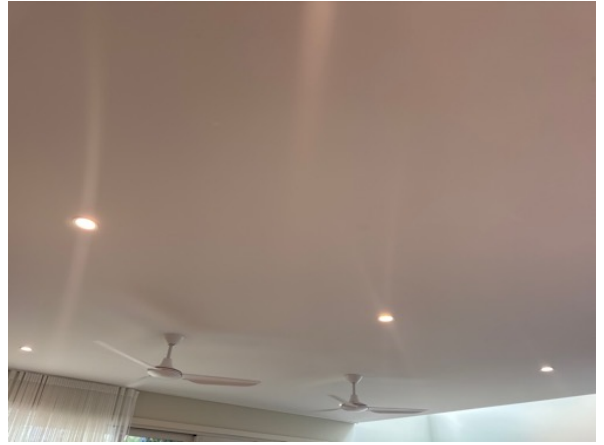
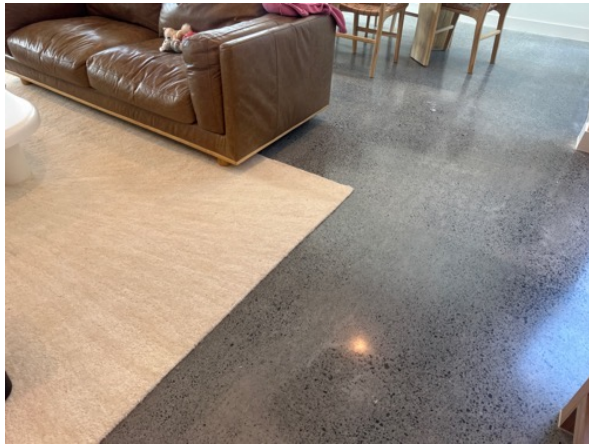
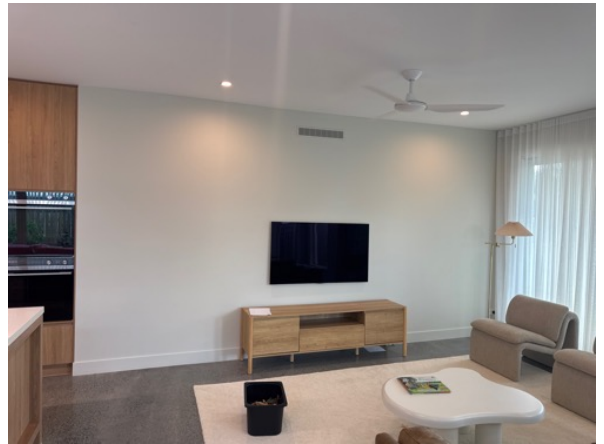
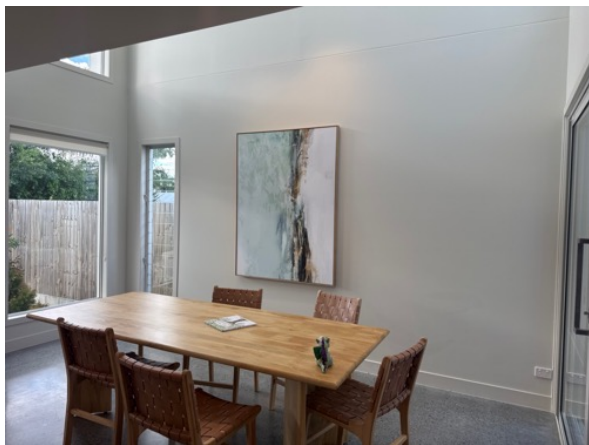
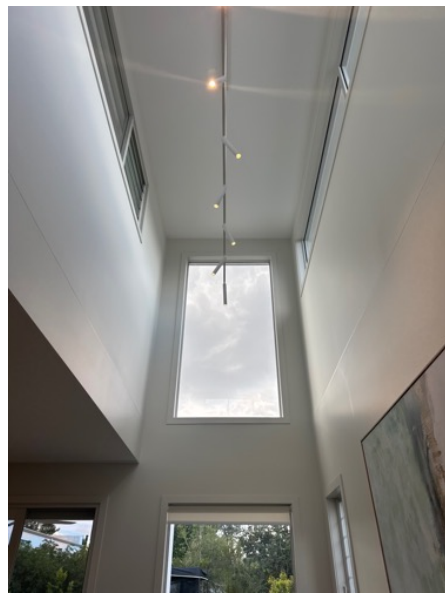
**Location:** Living area

**Finding:** Living area presents in good condition and has been well maintained.  
Good condition.
