# Property and Timber Pest Report

Inspection Date: 23 Apr 2025

Property Address: 32 Richardson Street Chelmer 4068

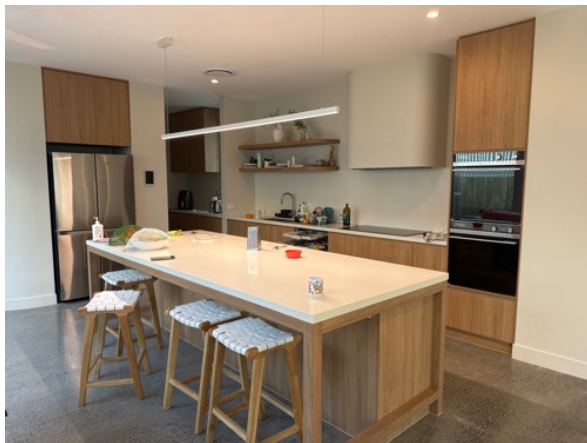
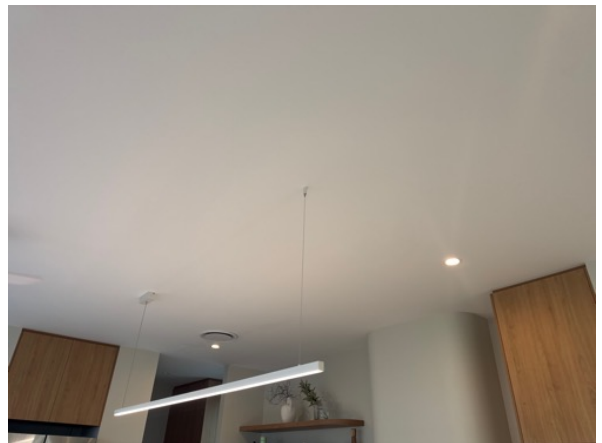
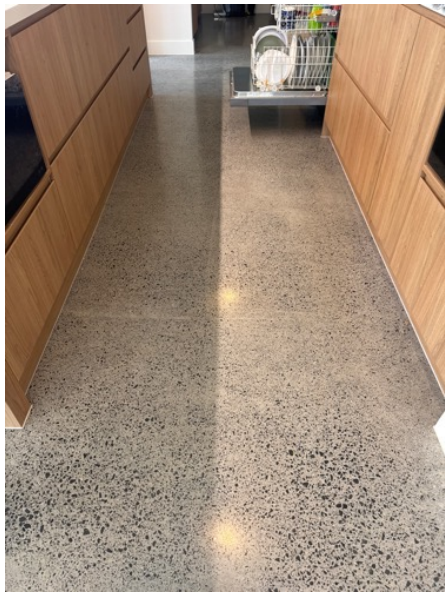
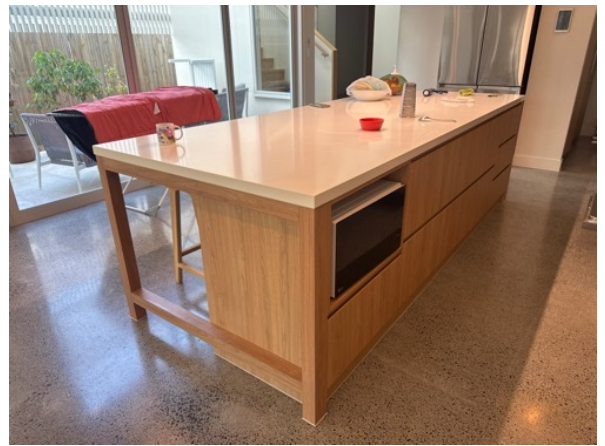
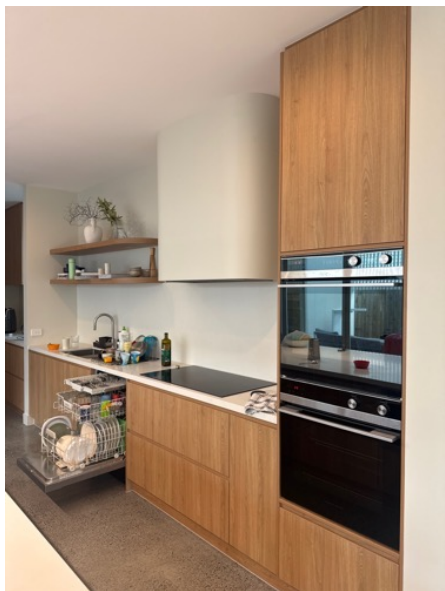
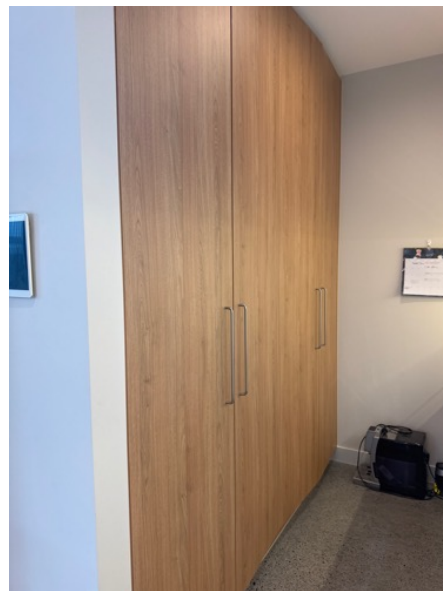
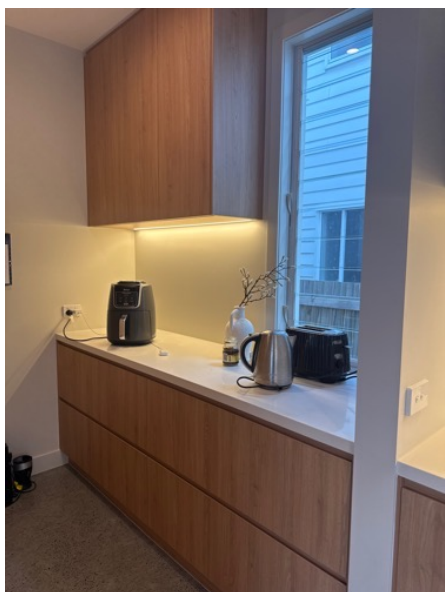
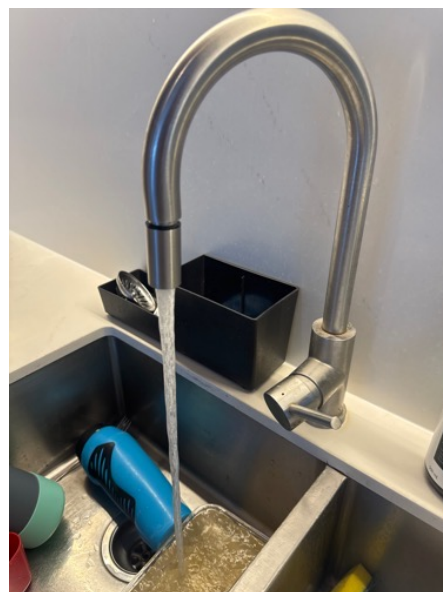
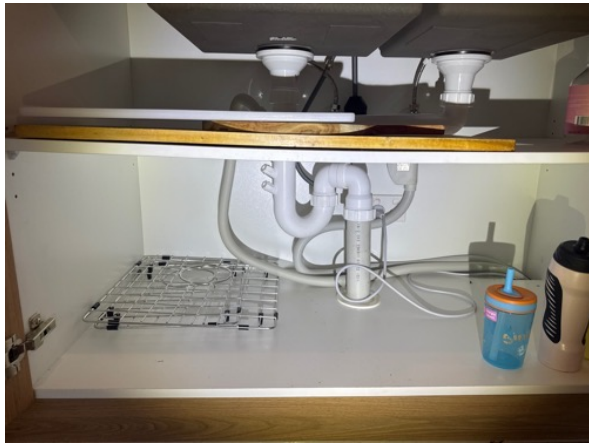
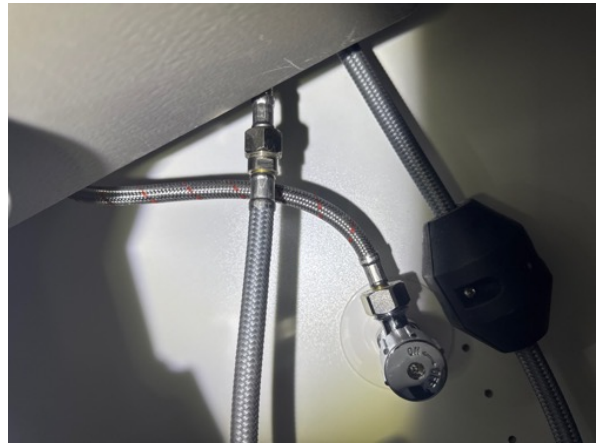
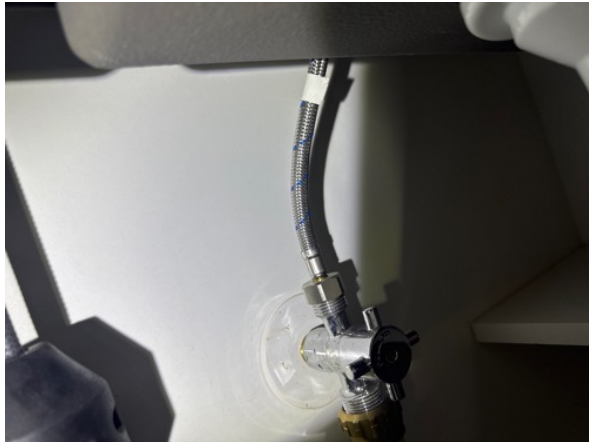
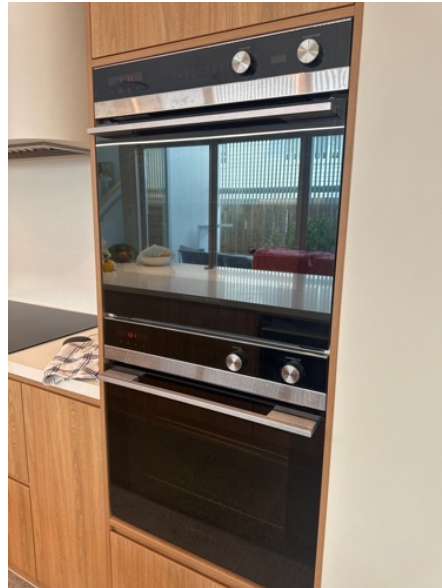
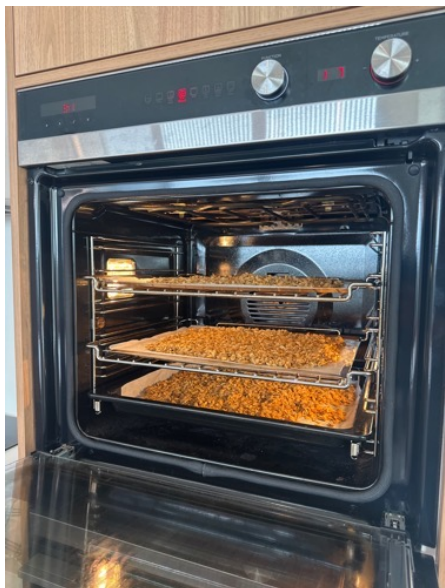
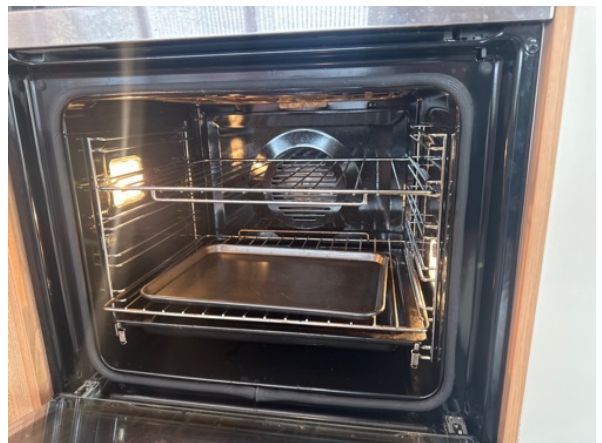
## For your information 2.31

Kitchen- good functional condition and has been well maintained.

Dishwasher: not tested for function- display panel was functional when turned on.

Water pressure is satisfactory with water draining away.

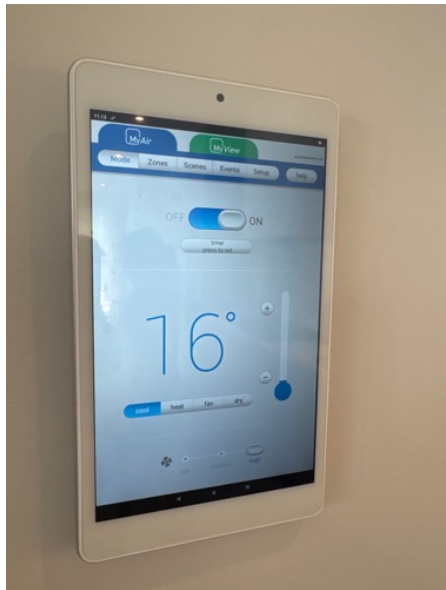
## For your information 2.32

**Location:** Air Conditioning Services

**Finding:** Ducted air conditioning unit is functional.

Units should be serviced and cleaned regularly to ensure optimal operation and hygiene.

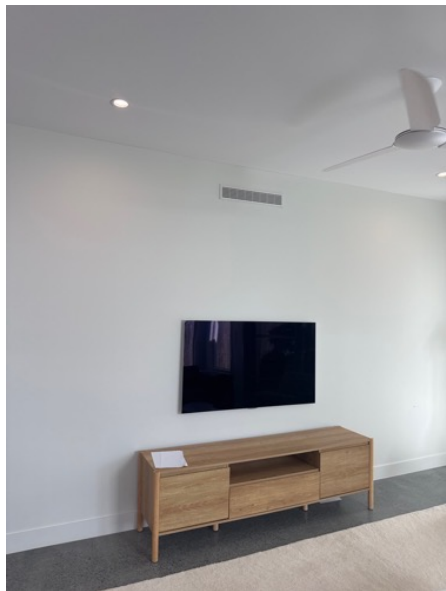
## For your information 2.33

**Location:** Living area

**Finding:** Ducted air conditioning outlet has confirmed cool air flowing.  
Blue colouring of thermal image confirms cool air flow.

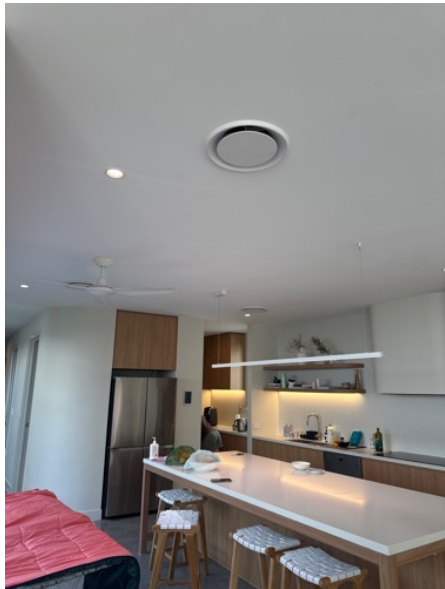
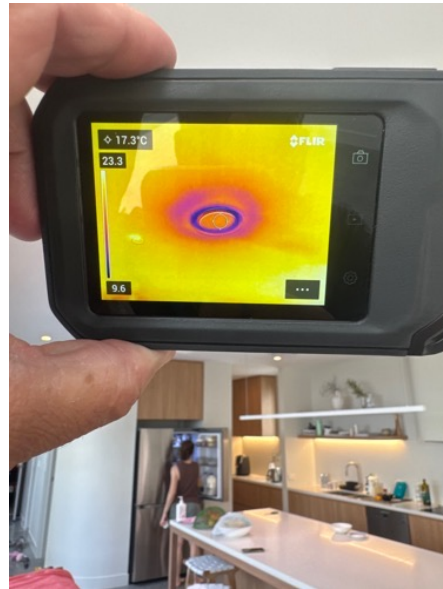
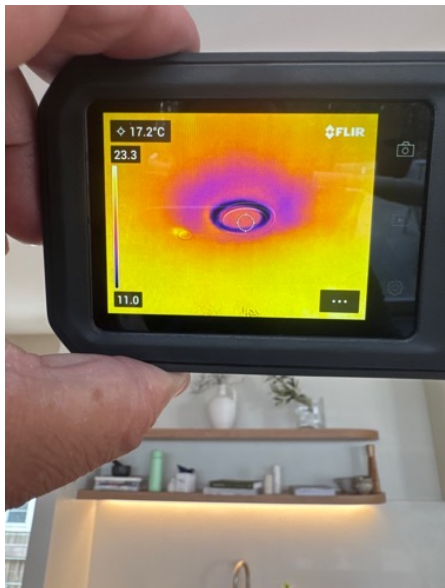
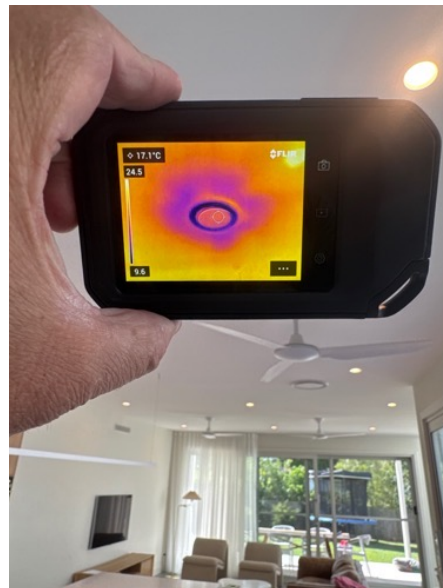
## For your information 2.34

**Finding:** Ducted air conditioning outlet has confirmed cool air flowing.  
Blue colouring of thermal image confirms cool air flow.

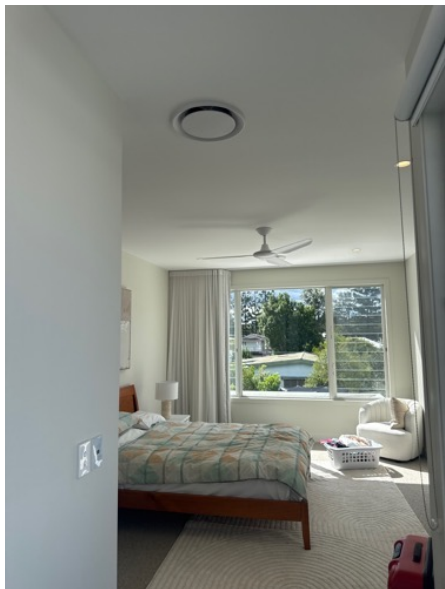
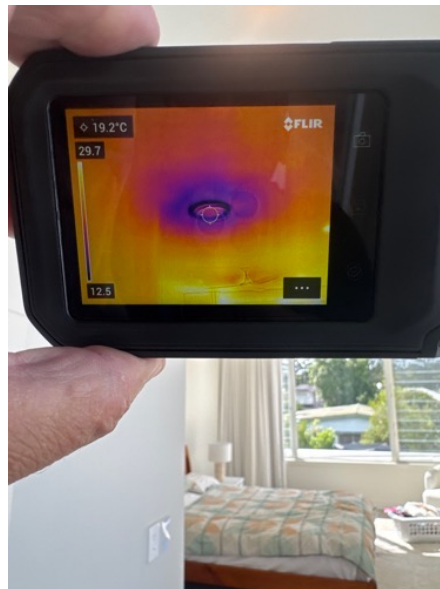
## For your information 2.35

**Finding:** Ducted air conditioning outlet has confirmed cool air flowing.  
Blue colouring of thermal image confirms cool air flow.

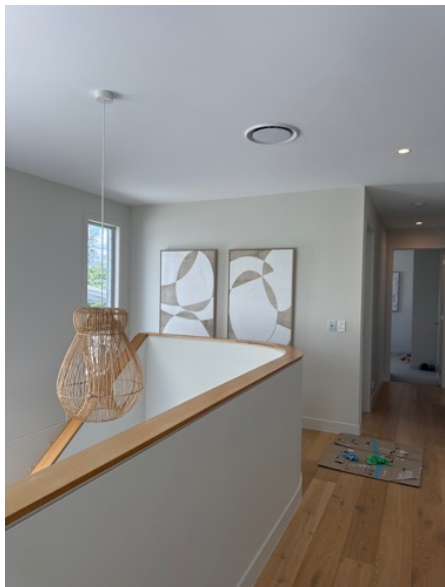
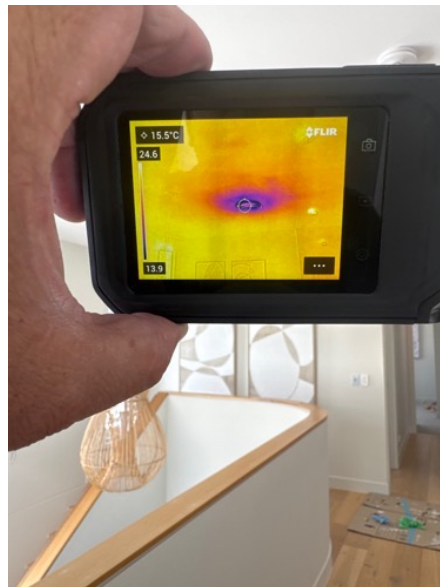
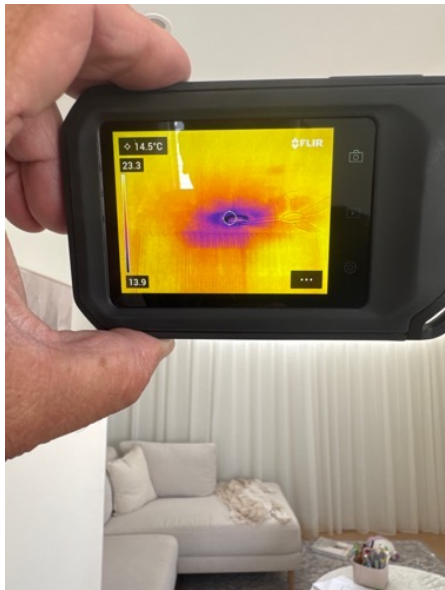
## For your information 2.36

**Finding:** Ducted air conditioning outlet has confirmed cool air flowing.  
Blue colouring of thermal image confirms cool air flow.

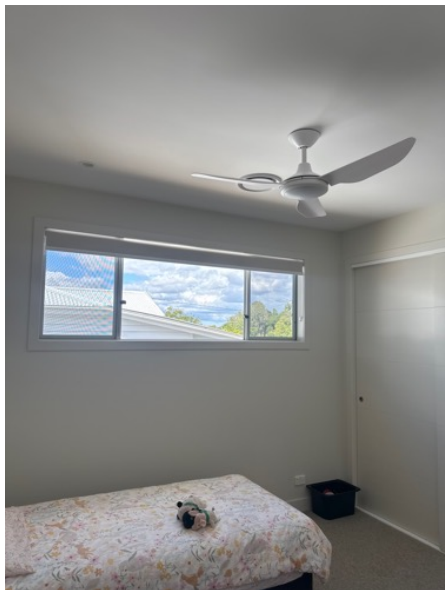
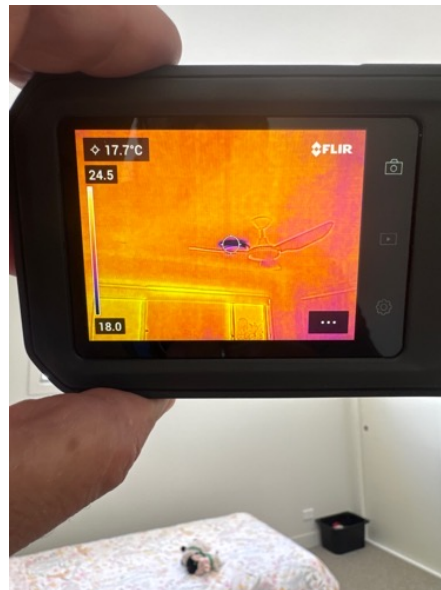
### For your information 2.37

**Finding:** Ducted air conditioning outlet has confirmed cool air flowing.  
Blue colouring of thermal image confirms cool air flow.

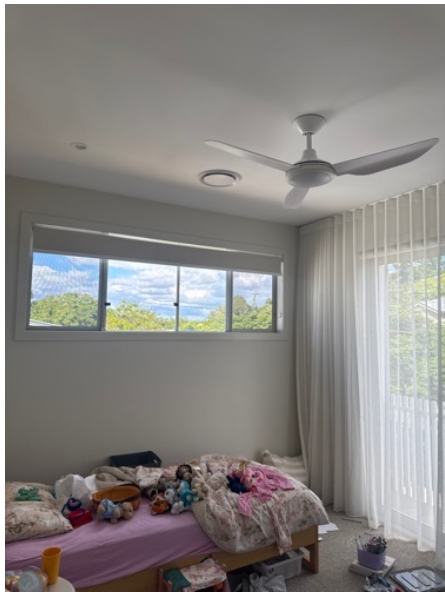
**Location:** Bedroom 3

**Finding:** Ducted air conditioning outlet has confirmed cool air flowing.  
Blue colouring of thermal image confirms cool air flow.

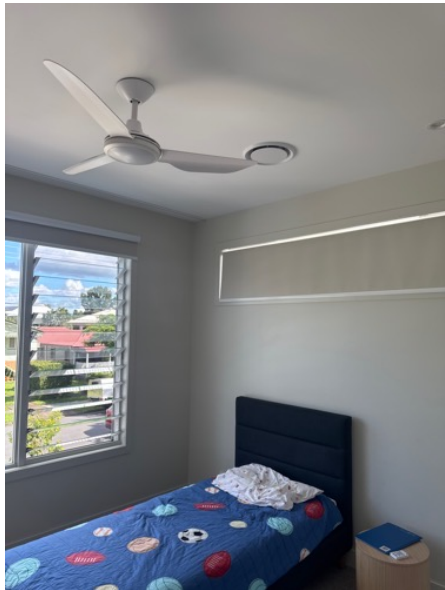
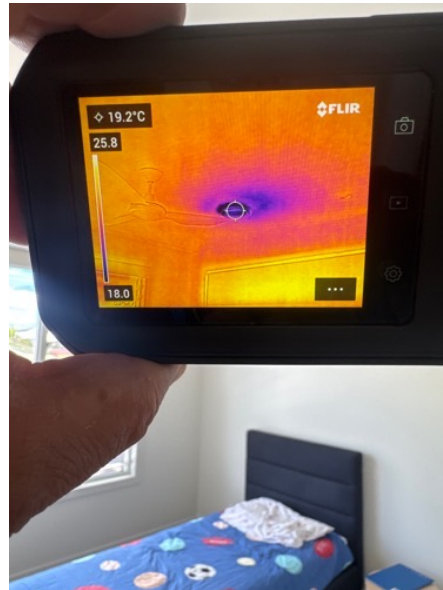
## For your information 2.39

**Finding:** Ducted air conditioning outlet has confirmed cool air flowing.  
Blue colouring of thermal image confirms cool air flow.

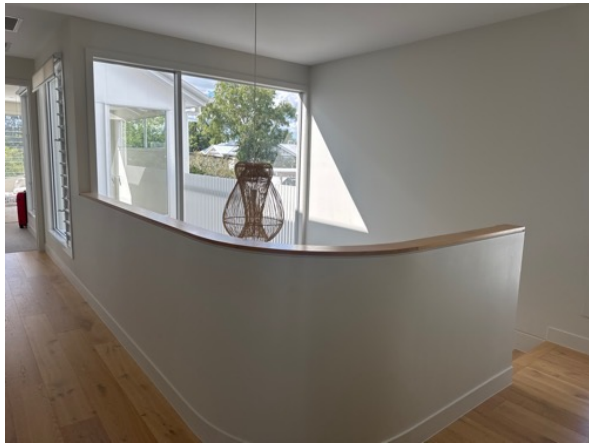
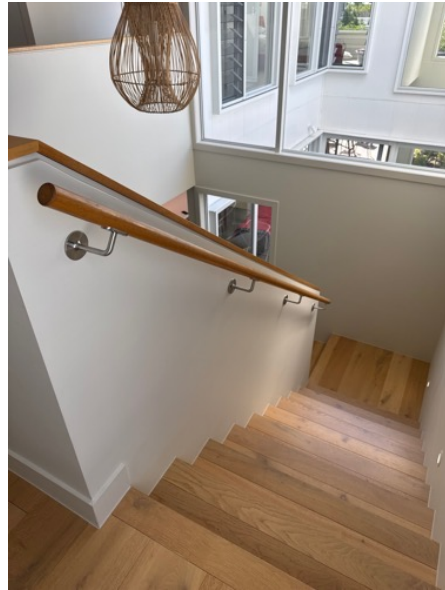
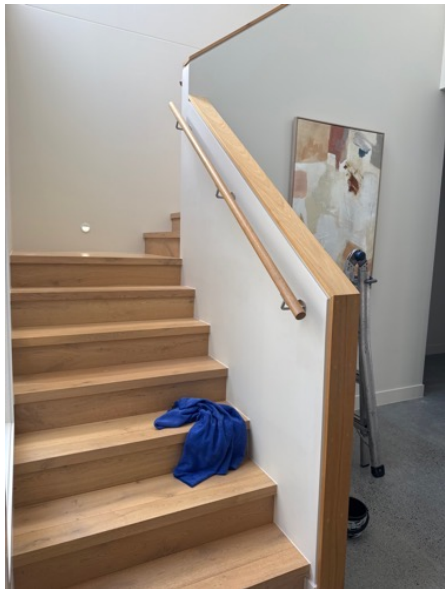
## For your information 2.40

**Finding:** Internal stairs and handrail appear in good condition.  
Handrail is rigid.
