Failure Analysis of a 1/4" Ball Valve

Ghulam Haider, Daniel Moses

March 13, 2018

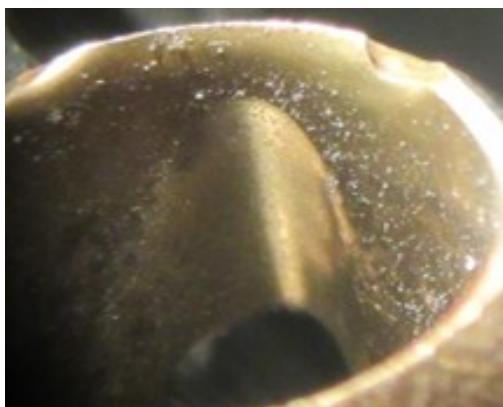
The valve ball is a brass alloy 60-40 percent copper-zinc, respectively. The ball is externally coated with a thin nickel plating. Examination of the ball revealed several distinct erosion and corrosion patterns. Internal erosion was dominated by a single channel as shown in Figure 3. This channel was smooth and shiny in appearance.

Figure 3: Internal Ball Erosion
