**AARTI STEEL INTERNATIONAL LIMITED**  
**Ludhiana, Punjab**

**INDUSTRIAL INTERNSHIP REPORT**

**Analysis of Macrostructural Defects in Rolled Steel Products**

*with Detailed Metallurgical Investigation of Vanadium Micro-alloyed Steel (Heat No. 1907)*

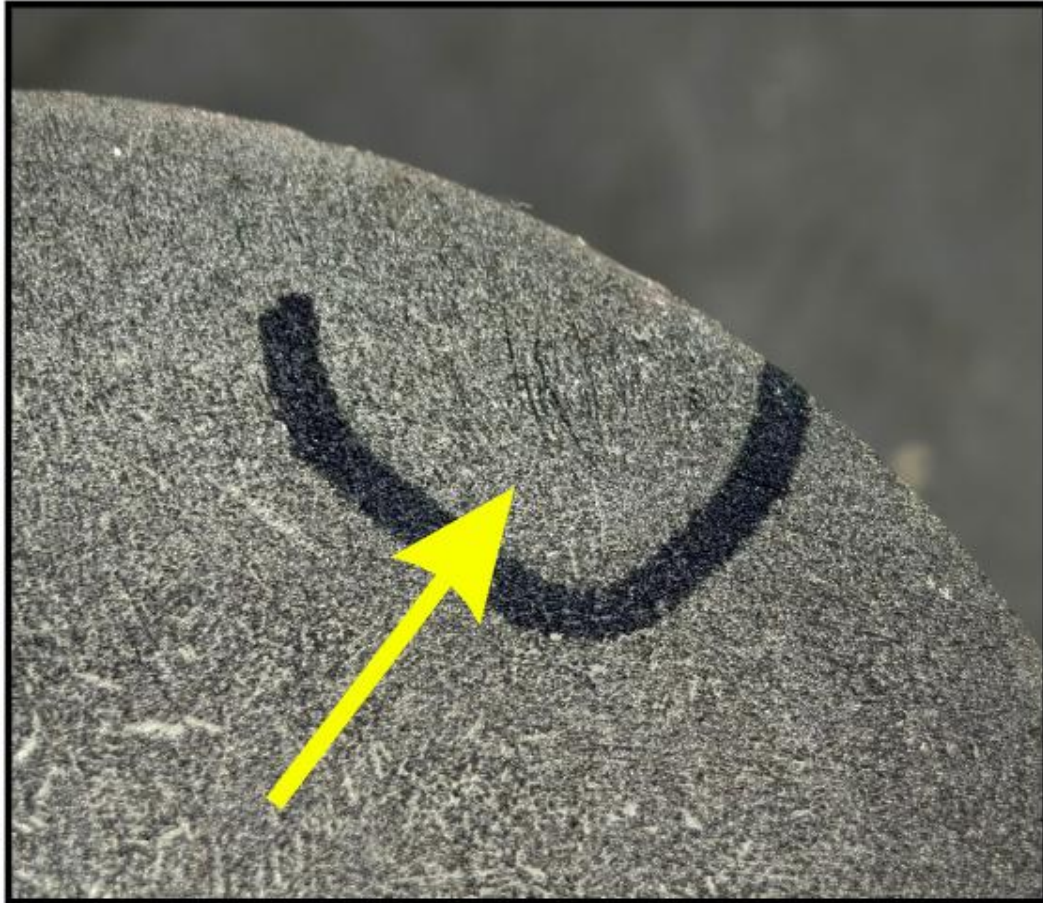
*Figure 2.4: Macro-etched samples showing Subsurface Crack.*

A subsurface crack is an internal crack located just below the billet surface, forming as a result of localized stress concentration. Such stress concentrations are commonly induced by chemical segregation, the presence of non-metallic inclusions, or thermal stresses generated during casting, all of which create a locally weakened region that is prone to cracking either during the casting process itself or in subsequent rolling operations.
