8 SIDDALINGA TEMPLE Place - Managundi

District: Dharwad
Taluk: Dharwad
Locality: Managundi

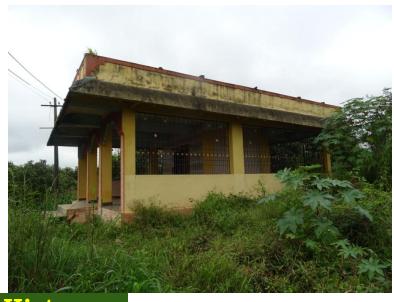
This east facing small temple has a garbhagraha only and in ruins. The antarala and sabhamandapa are completely fallen. In the garbhagrah is a sivalinga. The garbhagraha has two doorframes on east and west. The garbhagraha has simpler tri-shakha doorframe. The garbhagraha has Ratna Shakha type of Jalavatayanas, the left one is damaged. The ceiling of the garbhagraha has Padma. In fornt of the garbha graha is a seated Nandi (damaged). On the either side of the garbhagraha doorframe are sculptures of Ganesha and surya are damaged. On the stylistic ground the temple may belongs to 11th and 12th century A. D.
