DAILY REPORT / DR-2026-07-12 / V1

# Daily field report - electrical rough-in

Cooper Residence Renovation / CR-2026-017 / Cooper Residence / Ground floor

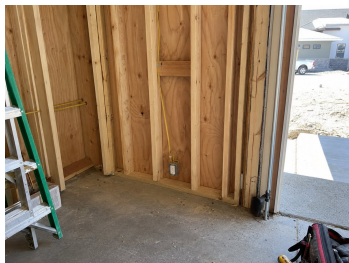
| TYPE | EVIDENCE | LOCATION / CAPTURE |
|---|---|---|
| PHOTO | <b>Garage east wall context</b><br>Open stud wall near the garage entry door; GFCI rough-in visible. | Residence / Garage / East wall /<br>Entry door<br>2026-07-12T10:18:00-07:00 |

Garage east wall context

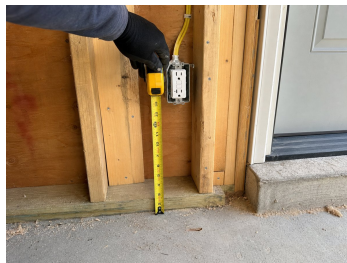
Garage GFCI elevation was documented and routed to punch before wall close-in.

| TYPE | EVIDENCE | LOCATION / CAPTURE |
|---|---|---|
| MEASUREMENT | <b>GFCI centerline tape measurement</b><br>Tape shows receptacle centerline at approximately 12 inches AFF. | Residence / Garage / East wall /<br>Entry door<br>2026-07-12T10:18:20-07:00 |

GFCI centerline tape measurement

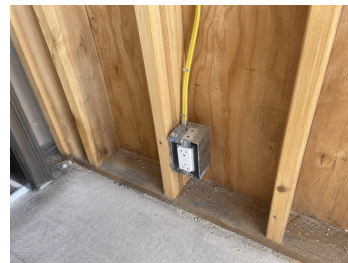
| TYPE | EVIDENCE | LOCATION / CAPTURE |
|---|---|---|
| PHOTO | <b>Receptacle rough-in detail</b><br>Close view of the installed box before wall close-in. | Residence / Garage / East wall /<br>Entry door<br>2026-07-12T10:18:38-07:00 |

Receptacle rough-in detail
