| D593227 performed by: Eduardo Pivaral | | Type: Frequent | Date: Apr 13, 2026 |
| Structure: Monorail | | Description: (Perris.CA)APPL. 600 | Customer: Wabash |
| Hoist 1: Konecranes | Hoist 1: 10000791468 | Hoist 1: 5 Ton | Hoist 1: CLX250425005 |

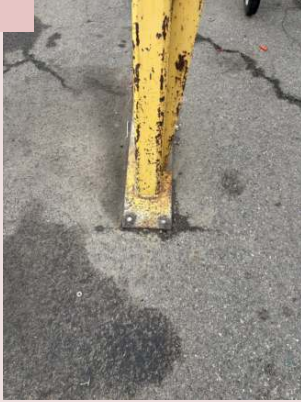
#### Beam Bracing

**Note:** Monorail legs are not secured properly.

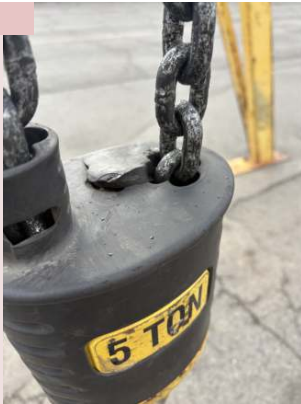
#### Lower Block

**Note:** Lower block rubber cover is damaged.

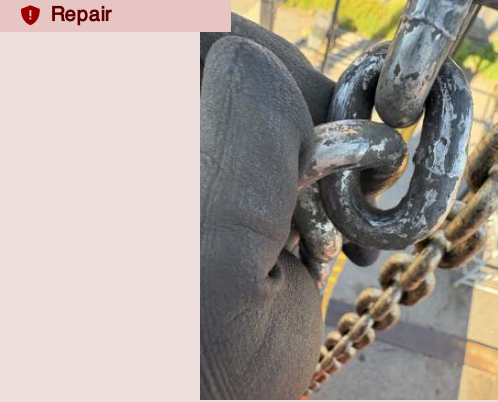
Rope/Chain

**Note:** Load chain is worn.
