| 🔧 D400049 performed by: Calvin Waller | | Type: Frequent | Date: Mar 24, 2026 |
| Structure: Under Running Bridge - Single Girder | | Description: Tx Hoist 49 3H South Cran | Customer: Wabash |

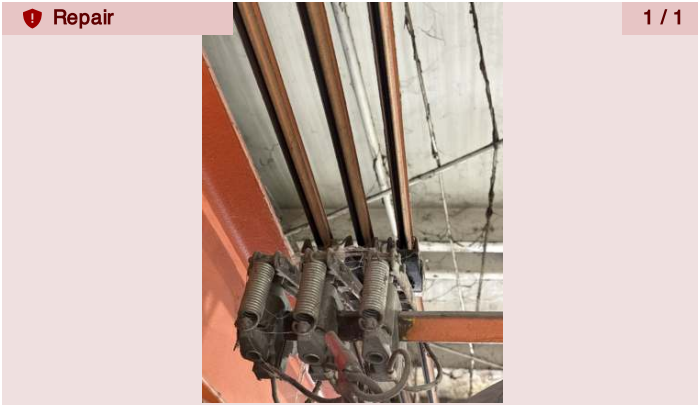
1 / 1

#### Conductors/Festoon System

🚩 Repair

**Note:** Does not have a ground rail

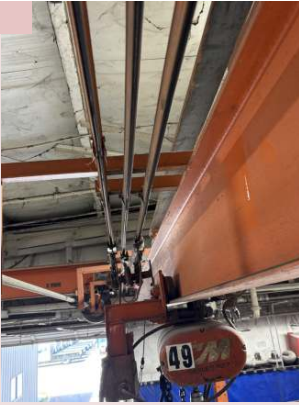
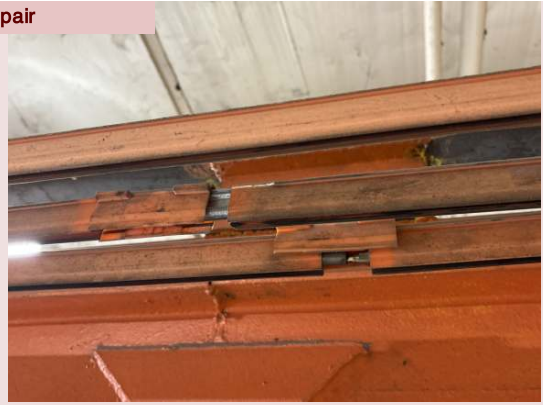
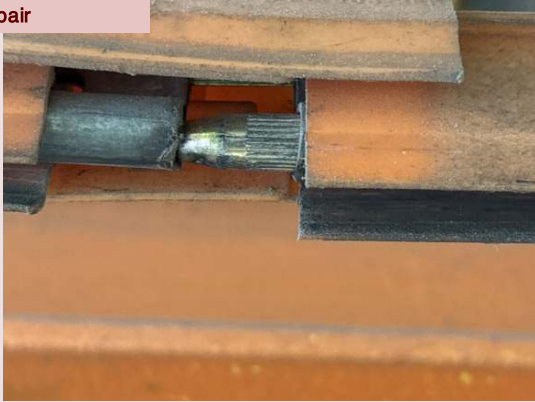
**Festoons**

Repair

**Note:** Power rail, does not have a ground rail, insulation on power bars are sliding, power bars are seperating
