### SERVICE INFORMATION

Customer: Wabash @ Wabash Cadiz KY

Job #: 0267286

D532229-Bay# 6 Middle R&M Hoist Serial# HHW11917 Replace Wire Rope Assembly D532230- Bay# 6 Middle R&M Hoist Serial# HGW07090 Replace Wire Rope Assembly

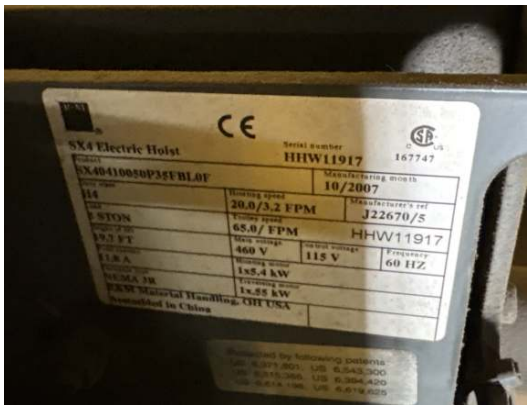
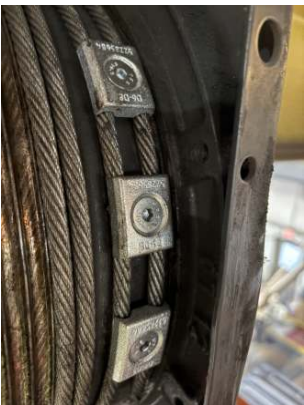
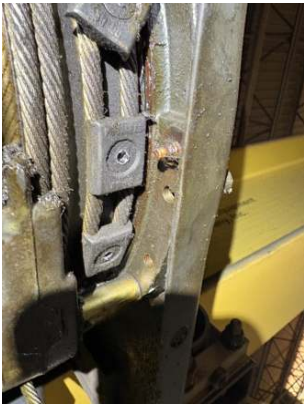
**D532229**

Rope clip Allen heads are stripped. Moore will have to be ordered prior to being able to change rope. The existing ones will need to be extracted.

Cut old rope clips out and removed Allen bolts. Completed rope change and installed new rope clips and bolts
