# Through-Wall Leak Repair of a 12" Cooling-Water Welding-Neck Flange

Engineering Case Study — Mechanical Piping Design & Analysis

| Project Classification Code | MC-REP-U46-CWS-032 — Line 12"-CWS-46-032-B1, Unit U46 |

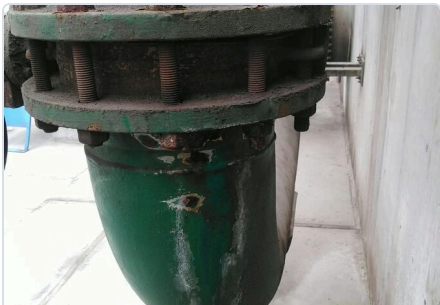
**FIG 1 As-found condition.** 12" WN flange assembly on the cooling-water riser, Unit U46.

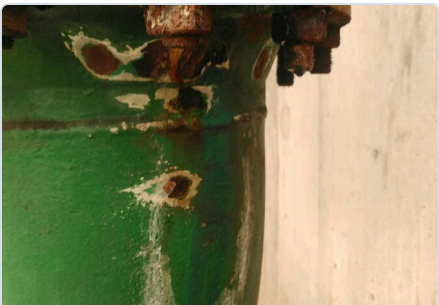
**FIG 2 Defect.** Localized wall loss and ≈3 mm through-wall perforation at the flange neck.

A pressurized through-wall leak developed at the neck of a 12" welding-neck flange on cooling-water line 12"-CWS-46-032-B1 (Unit U46). Localized external corrosion had thinned the neck to perforation (≈3 mm defect), breaching the pressure boundary. The constraint set was demanding: the circuit had to **remain in service**, the geometry — a flange-to-elbow transition — ruled out a simple sleeve, and any repair had to be defensible by calculation against the code and the client's own engineering specifications before a welder ever struck an arc.

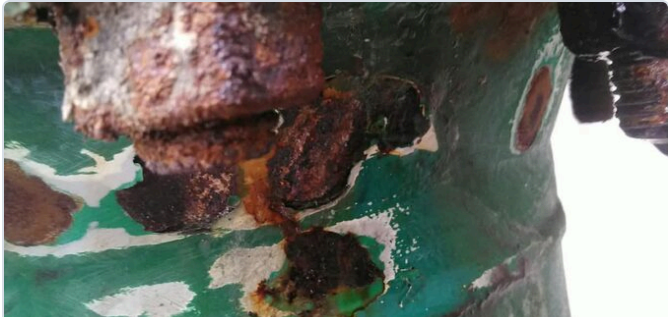
**FIG 4** Corrosion morphology. External metal loss concentrated at the neck-to-flange fillet — the perforation origin.
