Optimizing Design Is Hard Enough—What Can You Do About Cosmetics Issues

Jorge Santos

Mold Flow Analyst
Advance Engineering, Research & Innovation

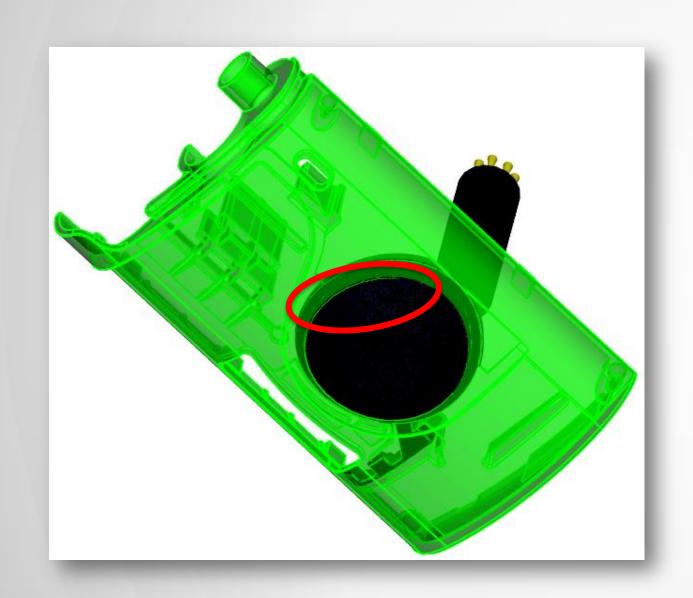
Surface Defect

Case Study Secondary Issue Material Change
