## LA GALA CONSTRUCTION

## STRUCTURAL EXHIBIT

**PROJECT:** New Garage Addition to Existing Structure

**DRAWING TITLE:** CMU Wall — Crack at New Garage / Existing Tie-In (Plan)

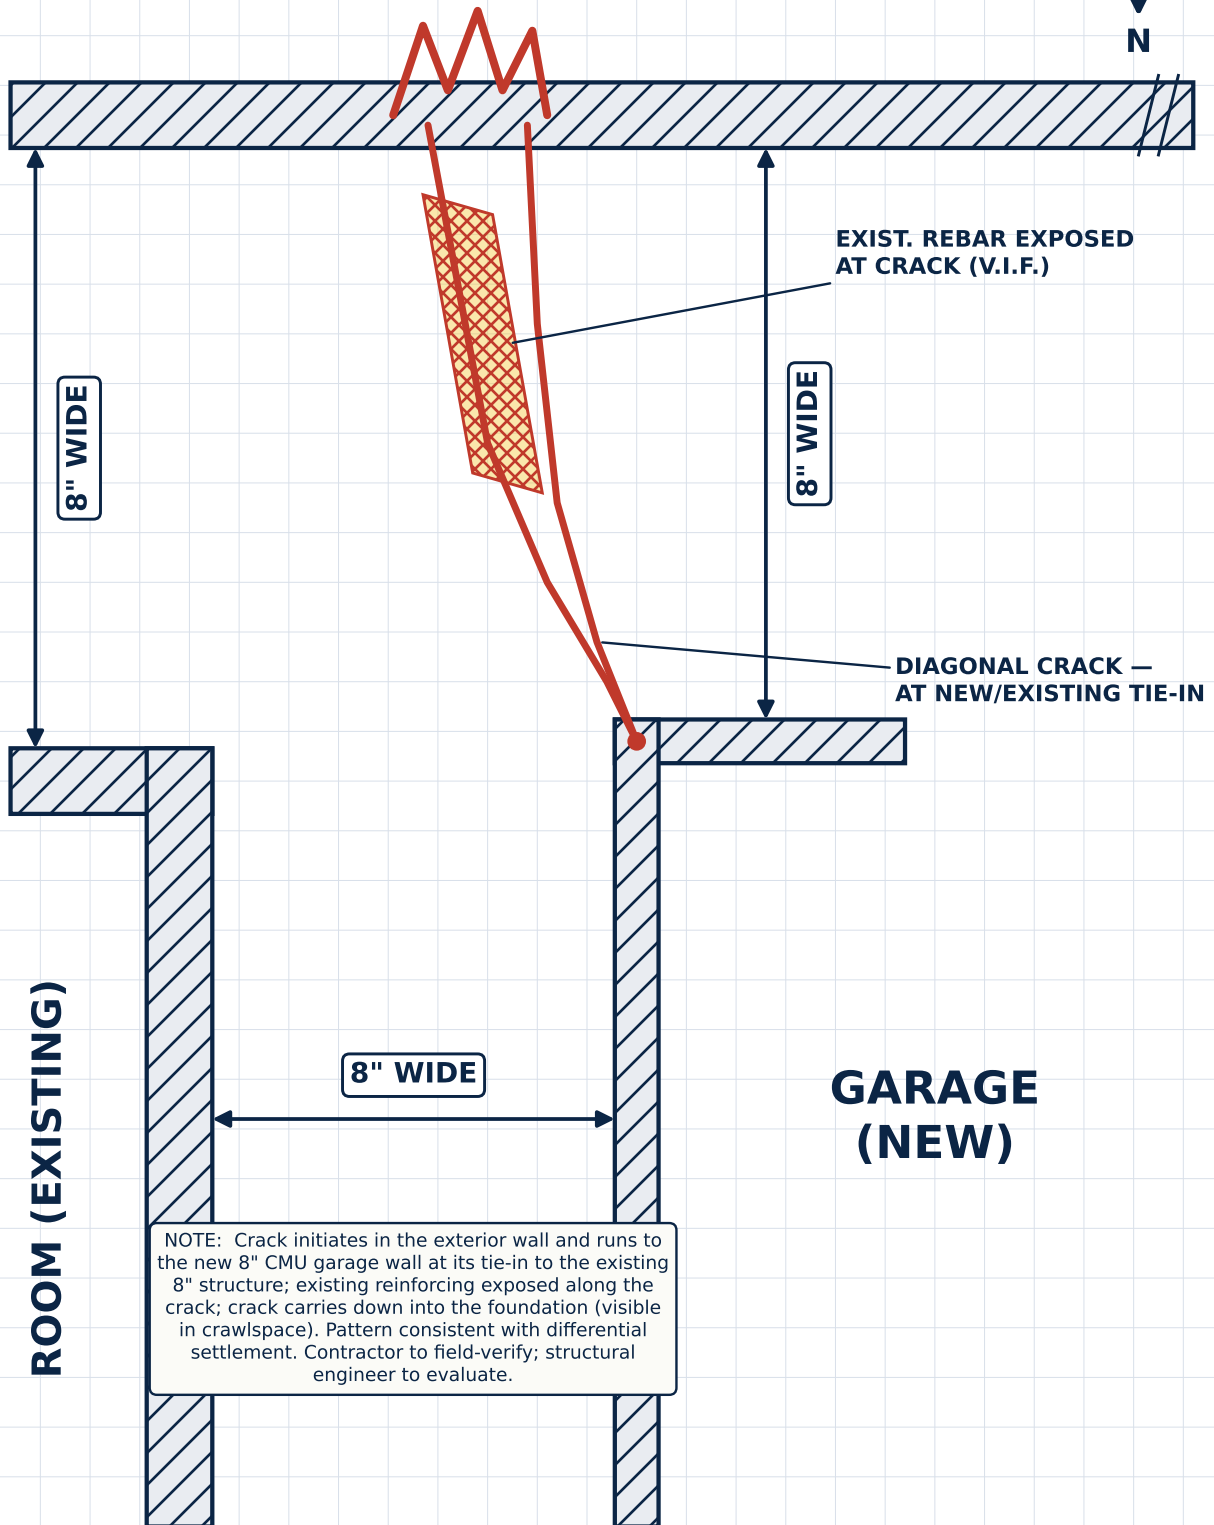
**SHEET:** SK-1

NOTE: Crack initiates in the exterior wall and runs to the new 8" CMU garage wall at its tie-in to the existing 8" structure; existing reinforcing exposed along the crack; crack carries down into the foundation (visible in crawlspace). Pattern consistent with differential settlement. Contractor to field-verify; structural engineer to evaluate.
