## STRUCTURAL EXHIBIT

**PROJECT:** New Garage Addition to Existing Structure

**DRAWING TITLE:** CMU Wall — Crack at New Garage / Existing Tie-In (Plan)

**SHEET:** SK-1

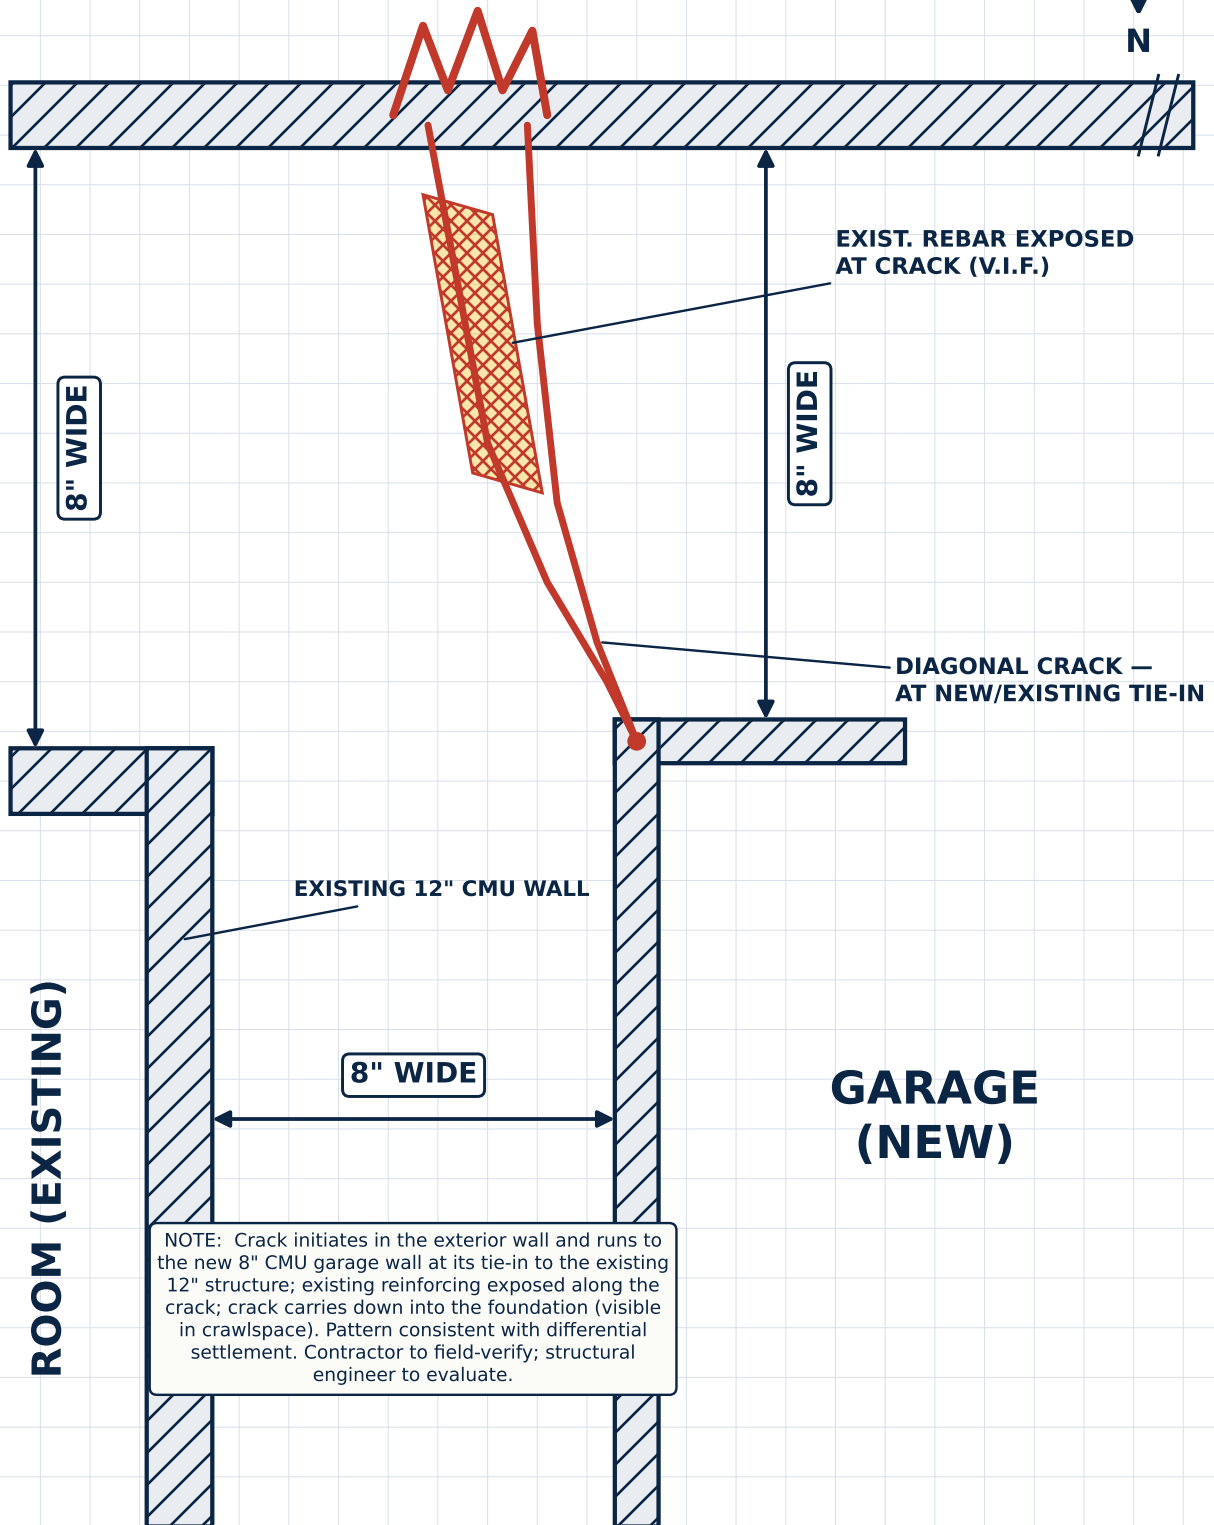
NOTE: Crack initiates in the exterior wall and runs to the new 8" CMU garage wall at its tie-in to the existing 12" structure; existing reinforcing exposed along the crack; crack carries down into the foundation (visible in crawlspace). Pattern consistent with differential settlement. Contractor to field-verify; structural engineer to evaluate.
