ES_LPC435x/3x/2x/1x Flash Errata sheet LPC435x/3x/2x/1x flash-based devices

Rev. 6.6 — 20 April 2016

Errata sheet

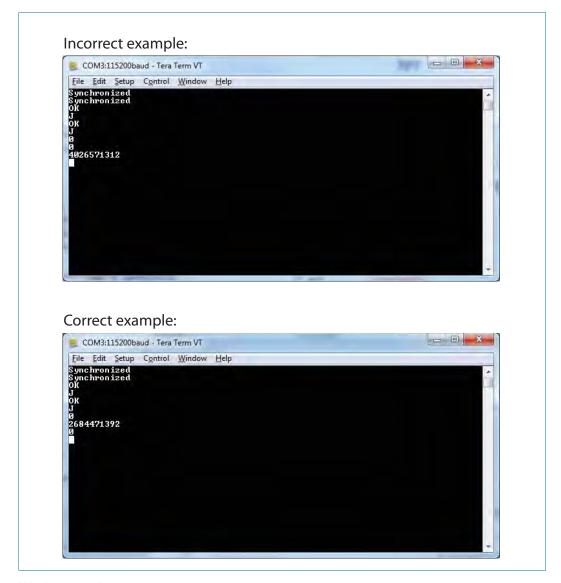
3.6 ISP.1

The 'J' command in ISP mode should return an error code, followed by an ASCII string representation of the part ID, followed by a 0. However what is actually returned is the error code, followed by a 0, followed by an ASCII string representation of the part ID. The problem is the last two items returned are swapped.

There is no work-around for this problem.

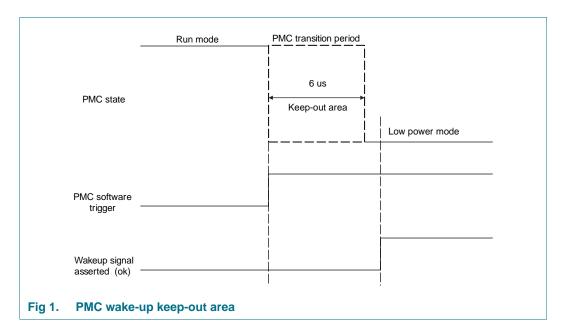
3.8 PMC.1

When the chip is in a transition from active to Deep Sleep, Power Down, or Deep Power Down, wake-up events are not captured and they will block further wake-up events from propagating. The time window for this transition is 6 uS and is not affected by the chip clock speed. After a wake-up event is received during the PMC transition, the chip can only recover by using an external hardware reset or by cycling power.

Make sure that a wake-up signal is not received during the Deep Sleep, Power Down, or Deep Power Down transition period. An example circuit to work around this could include an external 6 uS one shot which could be triggered via software using a GPIO line when entering Deep Sleep, Power Down, or Deep Power Down mode. The one-shot's output could be used to gate the wake-up signal(s) to prevent receiving a wake-up signal during the PMC transition period. Depending on the system design, it may also be needed to latch the wake-up signal(s) so that they will still be present after the one-shot's 6 uS time-out.

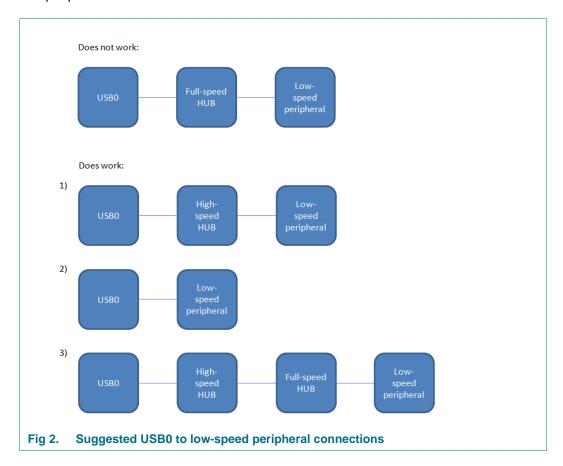
3.11 USB.1

The USB controller called USB0 is unable to communicate with a low-speed USB peripheral in host mode when there is a full-speed hub directly connected to the USB0 port and a low-speed peripheral is connected in the tree somewhere below this full-speed hub. Only USB0 has this problem; the other USB controller, USB1 does not.

There is no work-around for this problem. It is suggested that the low-speed USB peripheral is either connected directly to USB0 or a high-speed hub is placed between that peripheral and USB0.

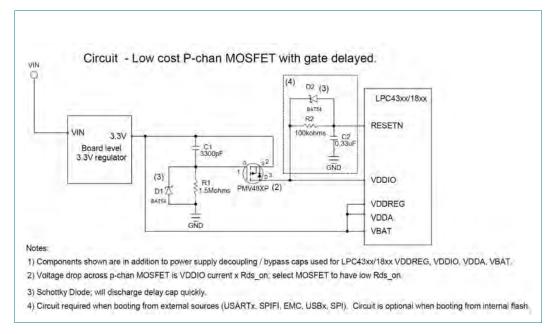
3.19 OTP.1

On all packages, repeated power cycling of the device may cause erroneous programming of the OTP banks. During ramp-up, the VDDREG supply voltage does not have enough time to settle and initialize the OTP controller before valid programming voltage is reached on the VPP pin. This may cause accidental programming of the OTP banks. Accidental programming of the OTP banks does not occur during power-down of the supply voltage.

- Boot from internal memory:
 - When VDDREG, VDDIO, and VDDA pins are tied together, the supply voltage must have a linear ramp-up time of at least 2 ms.
 - When VDDREG, VDDIO, and VDDA pins are not tied together, the power supplied to the VDDIO pin should be delayed by 2 ms after the power supply on the VDDREG and VDDA pins stabilizes at the operating voltage level.
- Boot from external sources (USARTx, SPIFI, EMC, USBx, SPI):
 - Do not tie VDDIO to VDDREG and VDDA pins. The power supplied to the VDDIO pin should be delayed by 2 ms after the power supply on the VDDREG and VDDA pins stabilizes at the operating voltage level. The signal to the RESETN pin must also be delayed by 2 ms after the power supply on the VDDIO pin stabilizes at the operating voltage level.

The following circuit diagram is an example that shows the P-channel MOSFET with the gate delayed and the R-C delay circuit connected to the RESETN pin.
