# Electrical installation condition - 8 October 2026

| Project | Riverside Court - Cat B Fit-Out, Phase 2 |
| Reference | EIC-2026-10-001 |

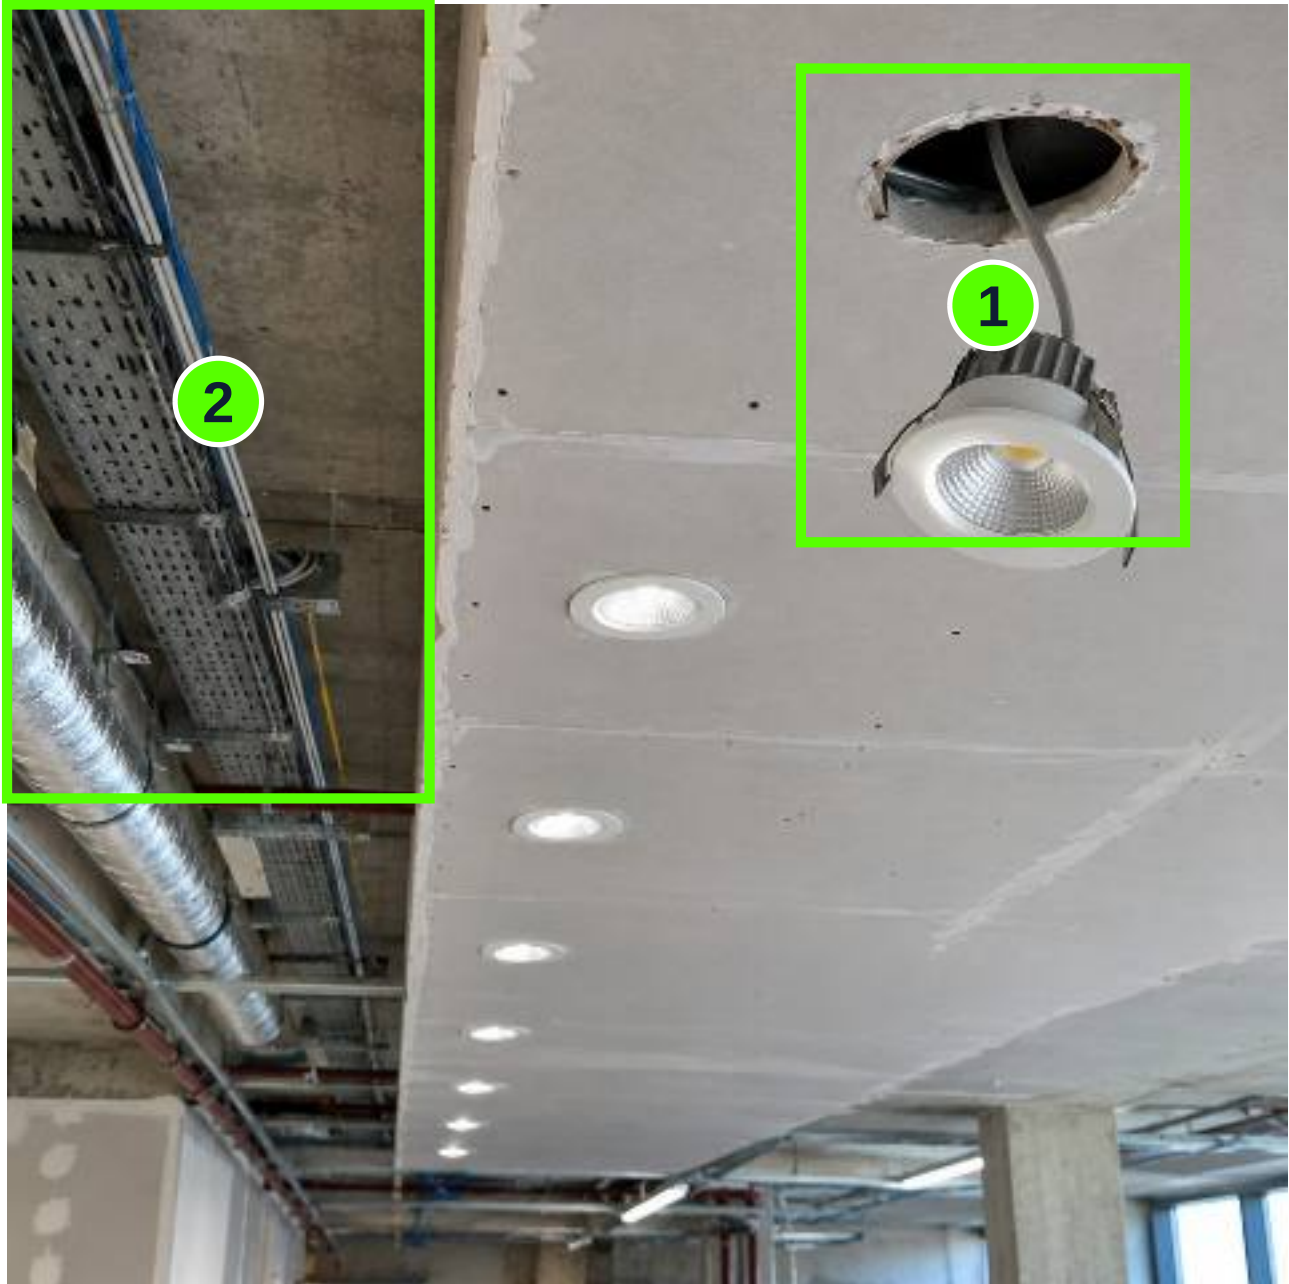
Photograph 2 - 2 items on this photograph, 2 pins on this photograph

Pin 1 - Item 10 - A recessed luminaire in the plasterboard ceiling at the upper right of the image is hanging from its aperture on a fl...

Pin 2 - Item 12 - To the left of the image, cable tray and basket containment are installed at high level above the ceiling line, carry...

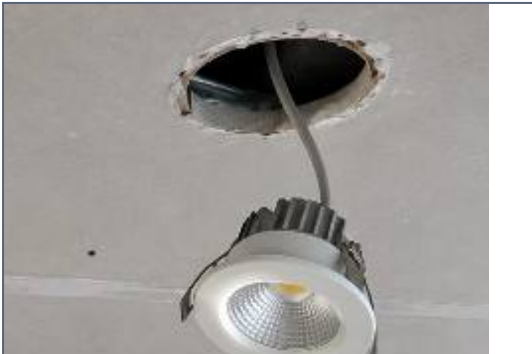
### Pin 1 of 2 - photograph 2

A recessed luminaire in the plasterboard ceiling at the upper right of the image is hanging from its aperture on a flexible cord, fully out of the ceiling void. The luminaire body carries an exposed metallic heat sink and the cord is unsupported over its free length. The unit is not secured to the ceiling, is not connected to any support or fixing, and the aperture is left open and unsealed. In this condition the luminaire is a suspended object above the working area.

Isolate the lighting circuit and prove dead before any work on the unit. Re-seat the luminaire in its aperture with the correct retaining clips, restore the cord and any terminations, then reinstate and reseal the aperture. Verify secure fixing and correct termination by test before re-energising.

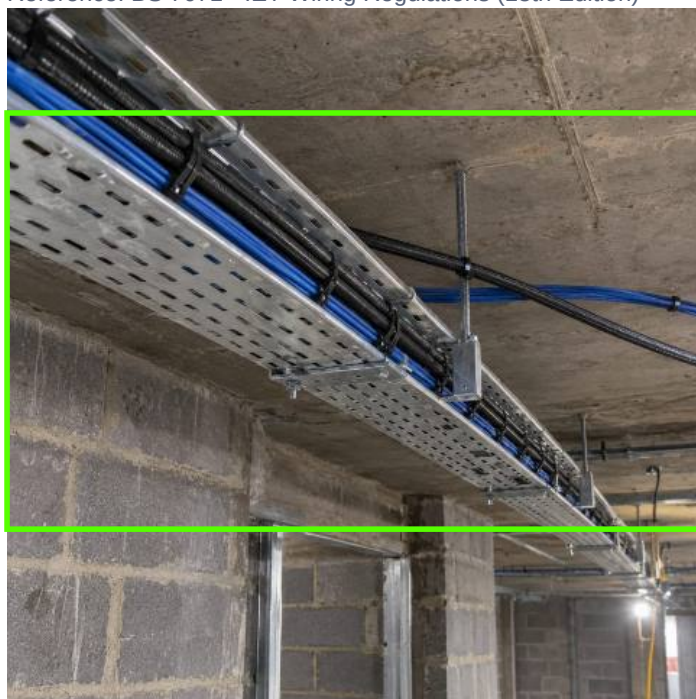
The perforated steel cable tray is suspended from the soffit on threaded rod hangers with pressed bracket fixings. At the far end of the visible run, cables cross onto the tray with no visible tray edge protection or drop-out restraint, and the tray appears to terminate without a stop end. The visible condition of the tray itself is sound and the cables are dressed neatly within it.

Isolate and prove dead before working on the containment. Fit an end stop or drop-out plate to the tray termination and provide edge protection or a suitable protective device where cables enter and leave the tray, so that the cable sheath cannot chafe on the perforated edge. Confirm the finished arrangement against BS 7671:2018+A4:2026, with the specific regulation number to be confirmed.

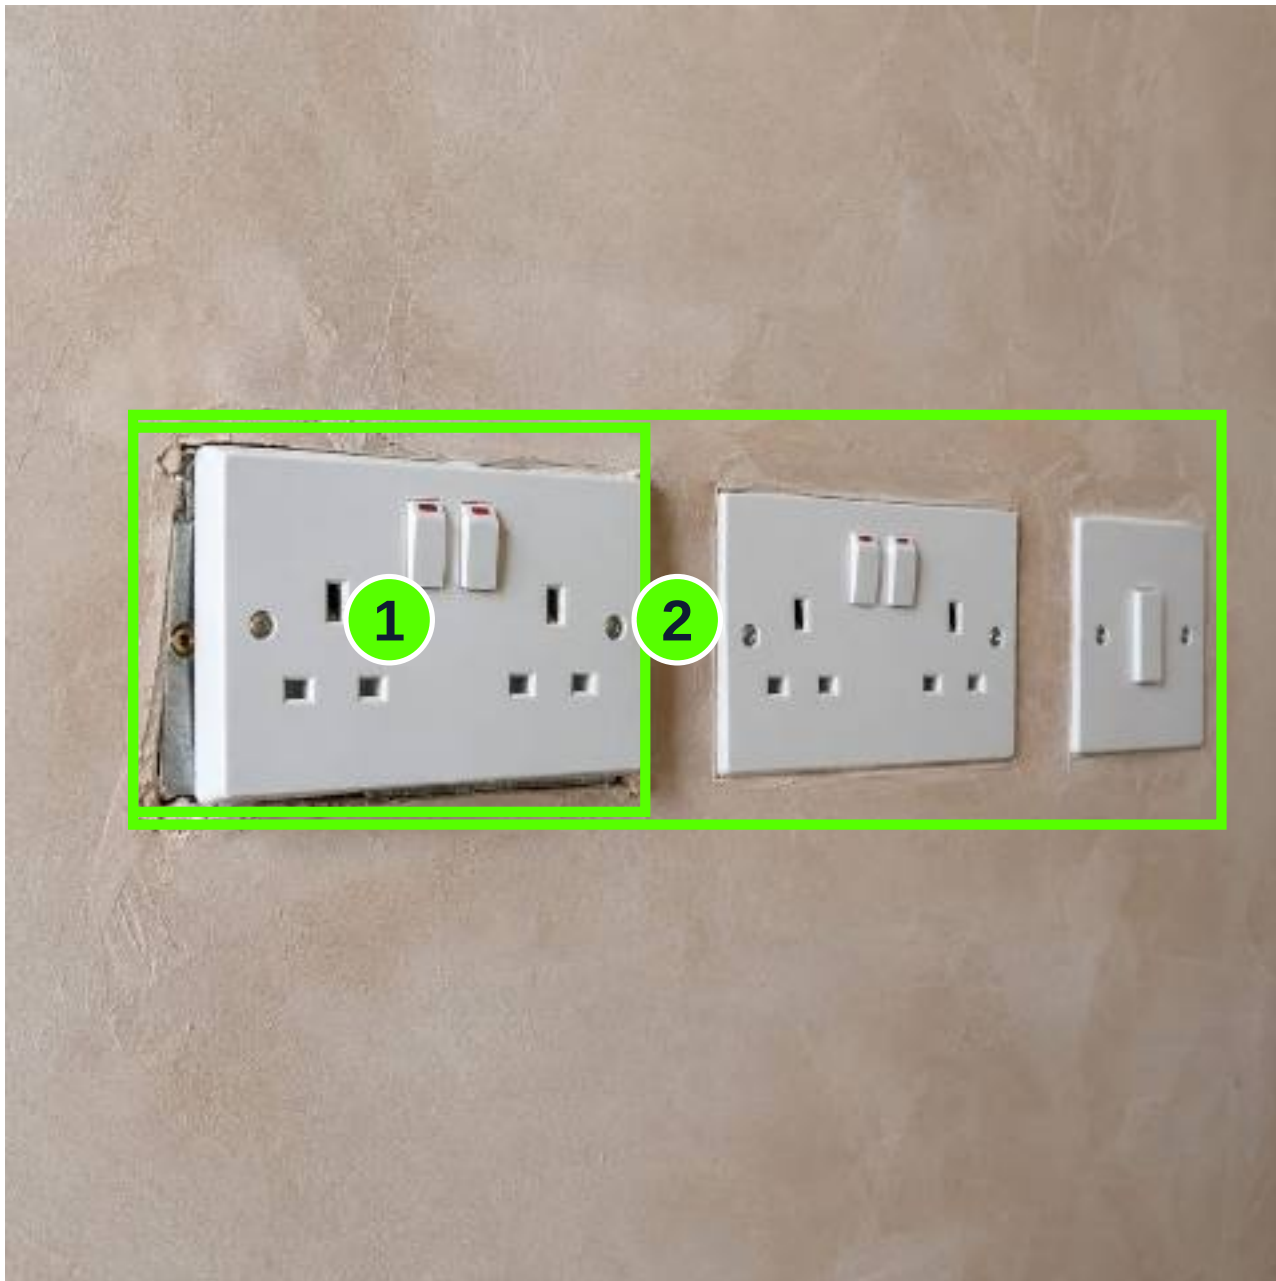
Photograph 5 - 2 items on this photograph, 2 pins on this photograph

Pin 1 - Item 8 - The metal back box of the left-hand twin socket outlet protrudes proud of the plaster finish and the surrounding plas...

Pin 2 - Item 9 - Both twin socket outlets and the associated switch plate are installed at differing heights and the spacing between t...

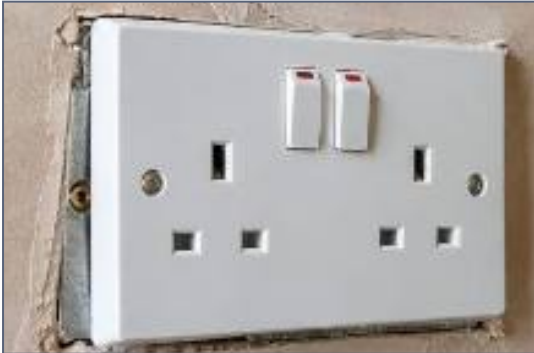
### Pin 1 of 2 - photograph 5

The metal back box of the left-hand twin socket outlet protrudes proud of the plaster finish and the surrounding plaster has been broken away, leaving a gap between the box and the wall face. The box and its fixing lug are exposed, and the accessory plate does not sit flush against the finished wall. The level of enclosure integrity expected around an accessory at a finished wall is therefore not achieved at this position.

Isolate the circuit and prove dead before any work at the accessory. Make good the plaster reveal around the back box so that the box sits within the finished wall face, then refit the accessory plate square and flush, ensuring the plate makes effective contact with the wall and that no gap remains around its perimeter. Where the box cannot be brought back, engage a competent person to reset it. Energise only after the accessory has been refitted and the circuit verified.

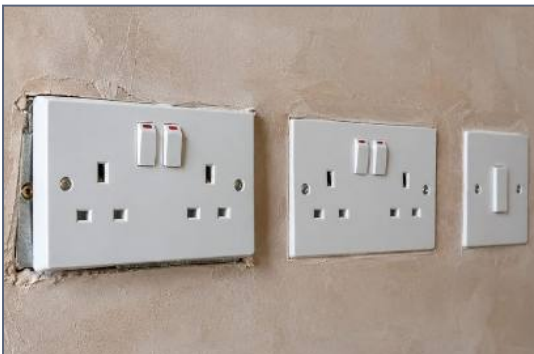
### Pin 2 of 2 - photograph 5

Both twin socket outlets and the associated switch plate are installed at differing heights and the spacing between the plates is irregular, with the left-hand outlet set lower than the outlet to its right. The mounting heights have not been set consistently along the wall run.

Where the wall finish is to be reworked in any event, reset the boxes to a common height datum, taken from the finished floor level, and confirm the heights against the project specification before closing up. The circuit must be isolated and proved dead before any box is repositioned, and the accessories re-verified on completion.

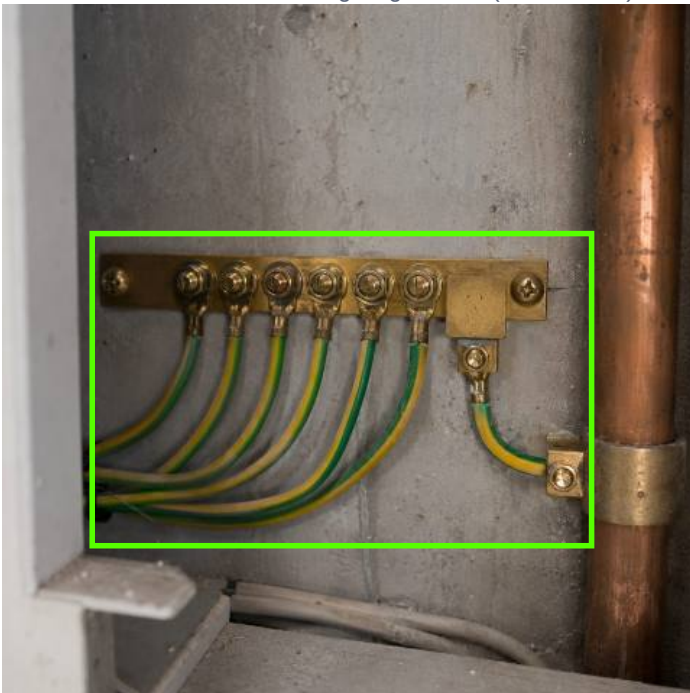
A brass main earthing bar is mounted on a bare concrete wall within an enclosure position. Six green/yellow circuit protective conductors are terminated to the bar by individual crimped lugs under set screws. A further connection is taken from a small square brass block fitted to the bar by a single bolt, and a green/yellow conductor of smaller cross-sectional area runs from that block to a brass earthing clamp on the adjacent copper pipe. The lug terminations on the bar are made at a consistent pitch and the conductors are dressed in a bundle to the lower left. The bar is fixed directly to the concrete wall face without an insulating stand-off, and the incoming conductors are not enclosed in conduit or trunking at the point where they leave the bar, so the protective conductors remain exposed and unsupported over the bundle to the left of the bar. The conductors are not individually identified by circuit.

Isolate and prove dead before any work to the bar. Re-form the conductor bundle into a defined route and secure it at regular centres to the wall or into a length of trunking or conduit, so that no protective conductor is left free-dressed. Fit individual circuit identification to each protective conductor by durable numbering or ferruling, and record the conductor sizes and the earth fault loop impedance readings in the schedule of test results. Confirm the continuity of every protective conductor and the main protective bonding connection by test, issued by a competent person on a certificate.

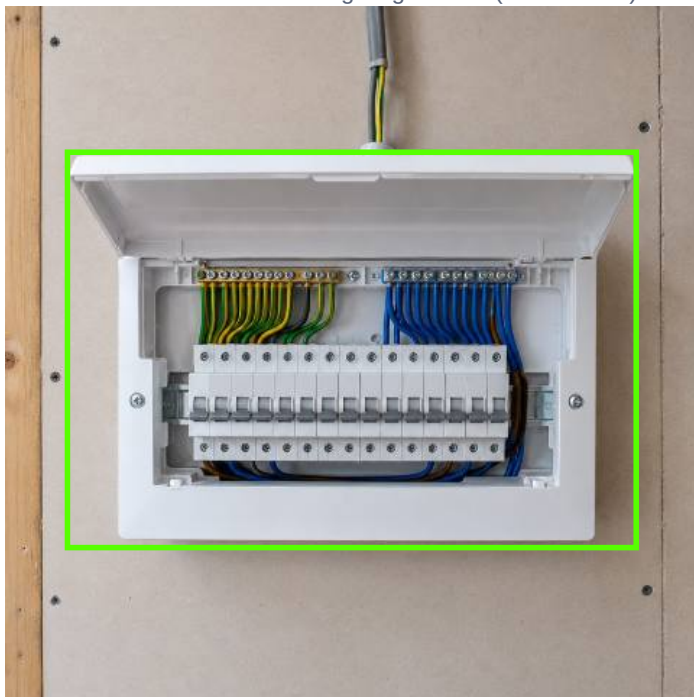
A consumer unit is mounted on a plasterboard wall with the front cover removed, exposing the busbar, neutral bar, earth bar and the incoming meter tails above the enclosure. The internal connections are visible but the cover is not fitted and the installation cannot be judged complete from this view.

Do not energise or leave energised with the cover removed. Confirm isolation and lock-off, then have a competent person refit the front cover and verify the enclosure is complete and secure before the installation is put back into service.
