# Finding identification & remedial schedule - 8 October 2026

| Project | Riverside Court - Cat B Fit-Out, Phase 2 |
| Reference | SNG-2026-10-006 |

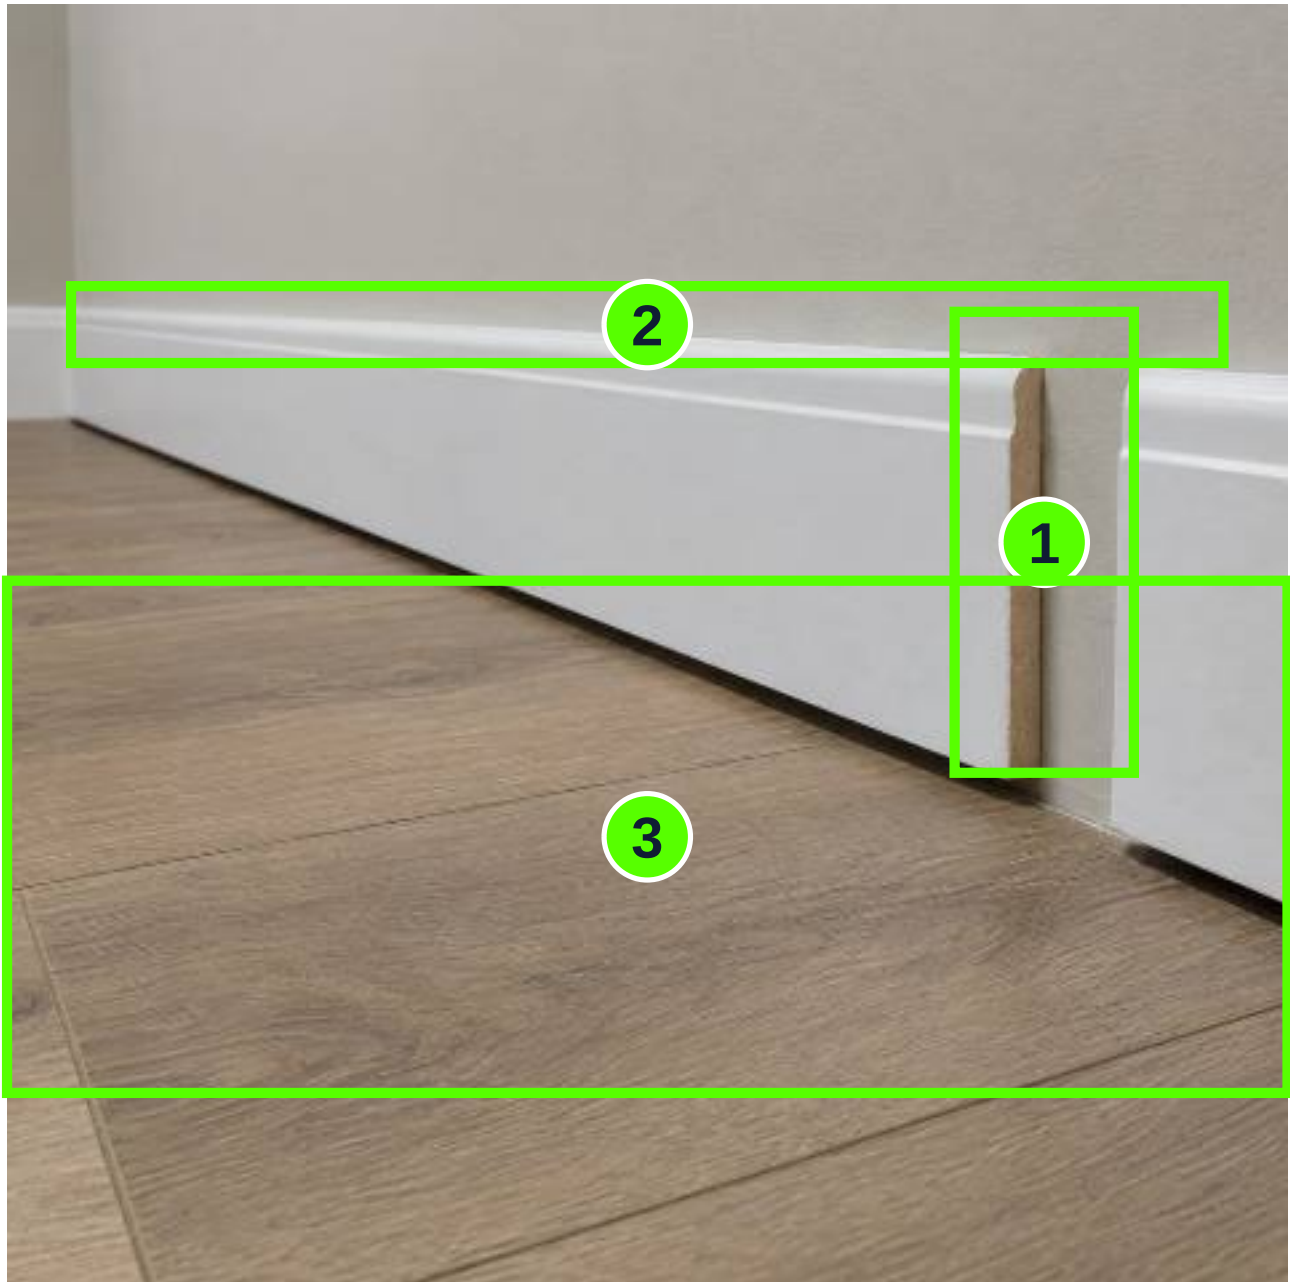
Photograph 1 - 3 items on this photograph, 3 pins on this photograph

- Pin 1 - Item 16 - A length of primed skirting board has been fitted short against an adjoining return, leaving an open butt joint of ap...
- Pin 2 - Item 17 - The skirting boards appear to be fitted direct to the wall face with no visible caulk or sealant line to the top edge...
- Pin 3 - Item 18 - The junction between the floor covering and the base of the skirting is tight and appears to be covered by the skirt.

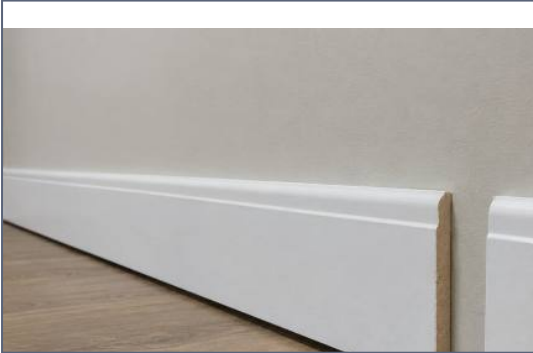
### Pin 2 of 3 - photograph 1

The skirting boards appear to be fitted direct to the wall face with no visible caulk or sealant line to the top edge where the skirting meets the plaster. The junction reads as a hard painted edge rather than a sealed joint. The painted finish to the boards is otherwise sound and the face is free of runs or blistering.

Likely cause: The most likely cause is that decoration has been carried out without the sealing of the skirting junction, or that the sealant has yet to be applied. A photograph cannot confirm which, and the item may simply be work in progress.

Confirm on site whether a caulk line was specified to the top edge. Where it was, rake out and apply a paintable acrylic caulk to the junction, tool it off, allow to cure and decorate. Where no caulk was specified, confirm the specified finish before adding one, as some specifications deliberately call for a dry shadow gap.

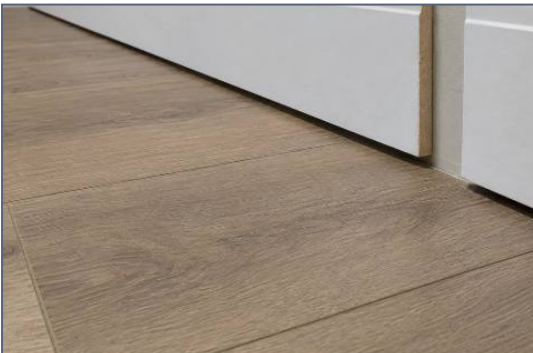
### Pin 3 of 3 - photograph 1

The junction between the floor covering and the base of the skirting is tight and appears to be covered by the skirt. The flooring is laid with the boards running parallel to the wall and the joints are close. No scuffing, lifting or moisture staining to the floor covering is visible in the area shown.

Review the junction at handover once the skirting joint has been rectified, confirming the floor covering is not trapped or damaged by the skirting and that any specified expansion allowance at the perimeter is present. No action is required if the junction remains sound.

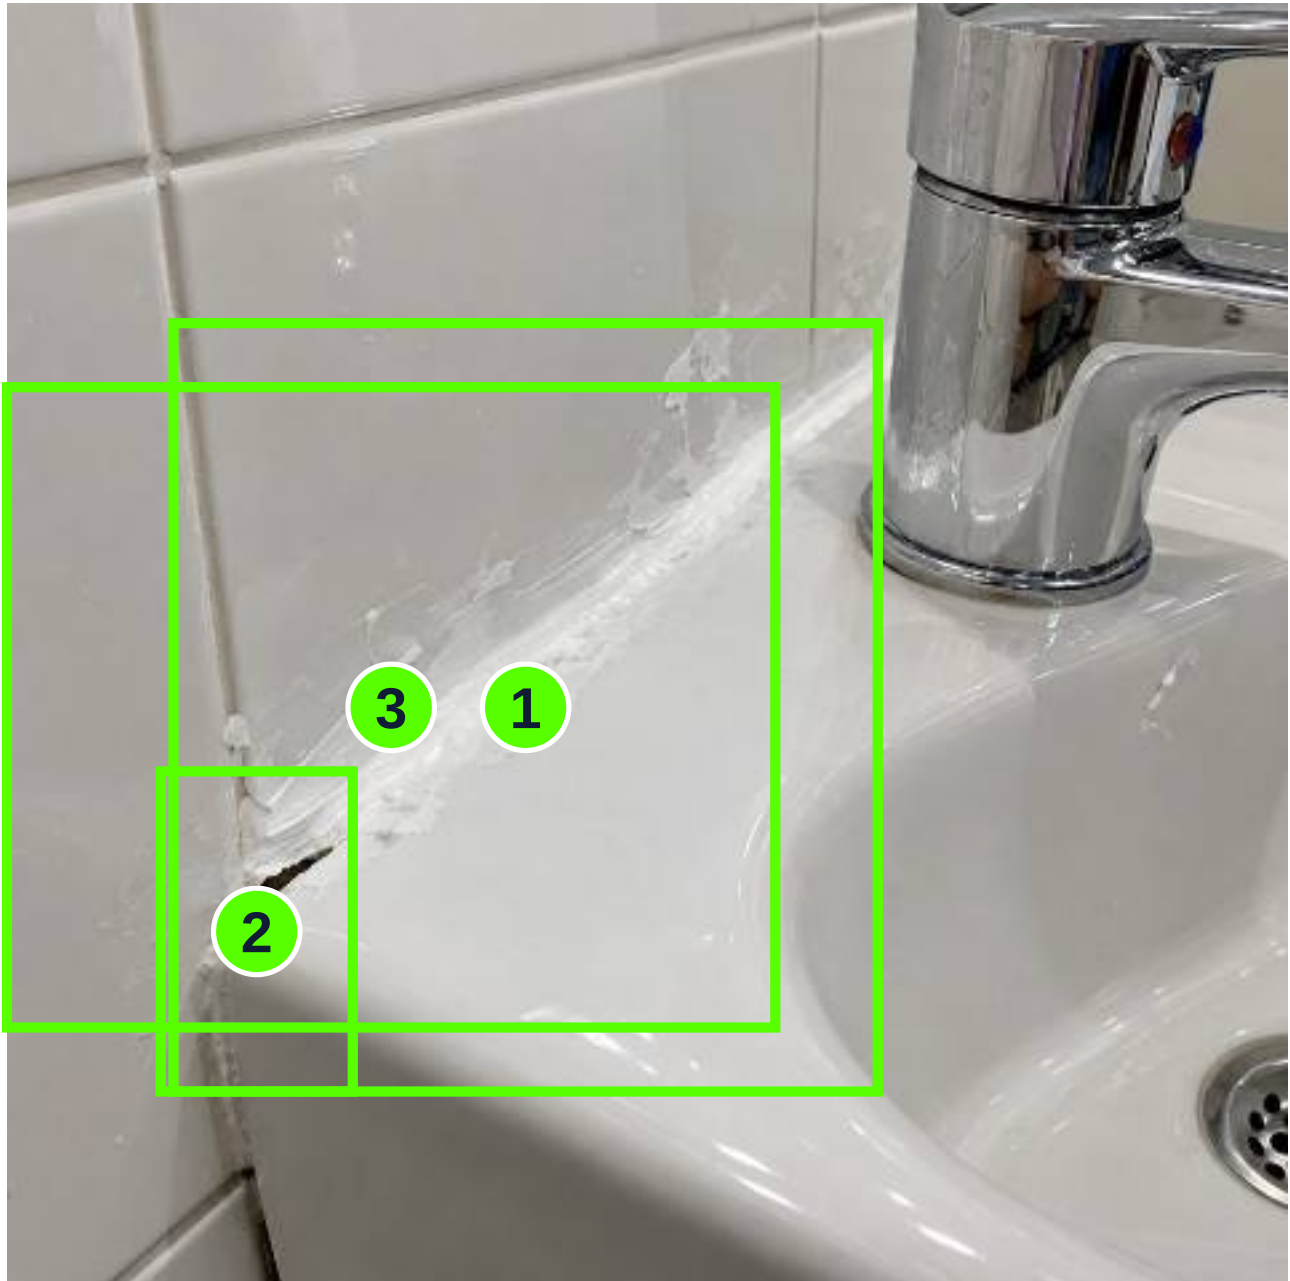
Photograph 2 - 3 items on this photograph, 3 pins on this photograph

- Pin 1 - Item 13 - The silicone sealant at the junction between the rear upstand of the white ceramic basin and the tiled wall has been ...
- Pin 2 - Item 14 - A dark void is visible at the base of the sealant run where it meets the rear left corner of the basin upstand, appro...
- Pin 3 - Item 15 - Sealant residues are present on the glazed face of the basin adjacent to the tap and on the tile faces to the left of...

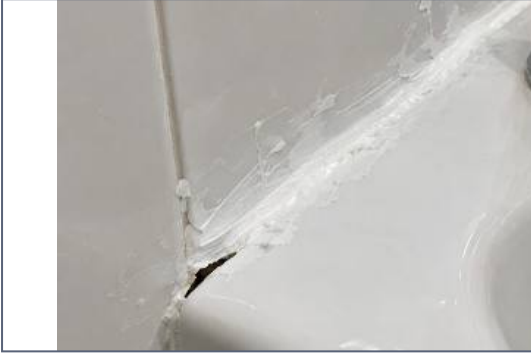
### Pin 3 of 3 - photograph 2

Sealant residues are present on the glazed face of the basin adjacent to the tap and on the tile faces to the left of the joint. These appear to be surplus material from the sealing works rather than damage to the glaze.

Likely cause: Surplus sealant left on adjacent surfaces during application, without a final clean-up pass.

Remove the residues with a plastic scraper and a suitable solvent or sealant remover, taking care not to abrade the glaze or the tile face, once the joint itself has been rectified.

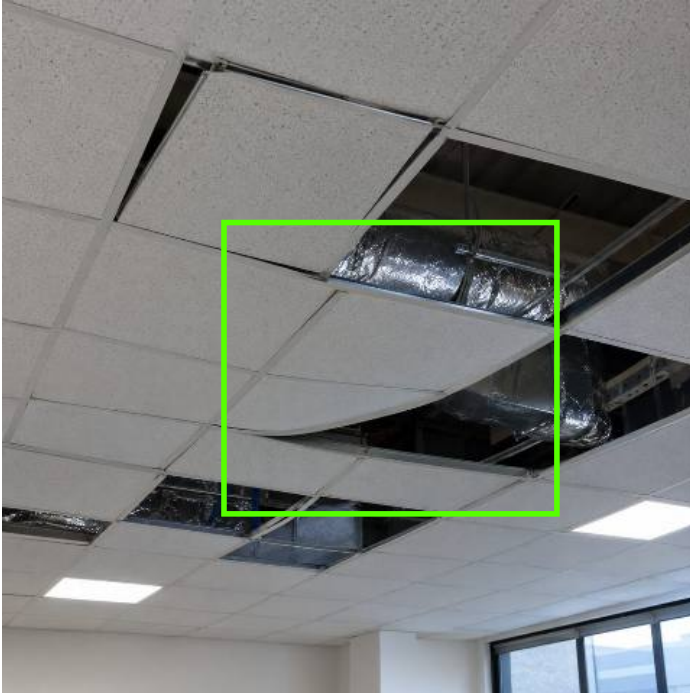
Pieces of ceiling tile are sagging below the underside of the grid, one adjacent to the open void at the centre of the image and a further two in the lower left of the frame. The tiles have lost flatness and are sitting proud of the grid line. No staining or water marking is evident on the affected tiles from this view.

Likely cause: Moisture uptake, overloading or physical distortion during handling and installation are all plausible. A single photograph does not allow the cause to be established.

Lift and reseal the affected tiles onto the grid flanges. If the sagging recurs or the tiles will not sit flat, remove one tile and inspect the void for moisture, damaged grid sections or overloading. Replace any tile that remains deformed.

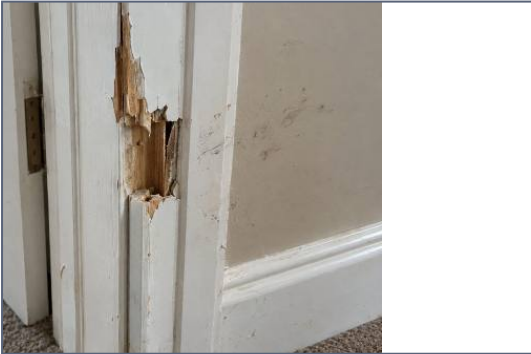
### Pin 2 of 2 - photograph 10

The timber face of the casing to the right of the damaged area, and the adjacent section to the left, carry multiple fine scratches, scuffs and filled marks in the painted finish, spread across an area of approximately 300 mm in height. The paint film is intact but the surface is inconsistent and shows evidence of previous local filling that has not been fully levelled.

Likely cause: The scuffing and uneven filling are most likely the result of handling and minor site damage, with subsequent local repair and filling carried out without full preparation of the surrounding finish.

Abrade the affected areas to a sound edge, spot prime any exposed substrate, fill and level the existing depressions, and apply a full preparatory coat and two finish coats to the casing to achieve a uniform finish.

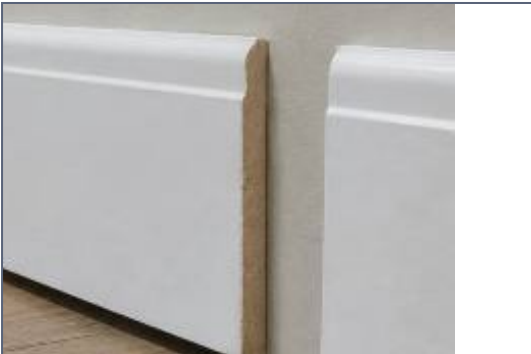
### Pin 1 of 3 - photograph 1

A length of primed skirting board has been fitted short against an adjoining return, leaving an open butt joint of approximately 8 to 10 mm between the two sections. The cut end of the board is exposed and unfinished, showing the bare MDF core with no primer, sealant or paint to the end grain. The gap is open along the full height of the skirting and is not filled.

Likely cause: The most likely cause is that the board was cut short during installation, either through inaccurate setting out or because the run was worked to a closing dimension and the last length was not measured back to the return. A secondary plausible cause is movement of the board after fixing, where insufficient or incorrectly spaced fixings have allowed the joint to open. It is not possible to determine from the photograph which of these applies.

Cut a short infill section of matching skirting to close the gap, or refit the board to a tight butt against the return. Prime all cut ends before fitting, fix to the wall with the specified adhesive and mechanical fixings, fill the joint, then caulk and decorate. Confirm on site who owns the joint between the skirting run and the adjoining return before making good.

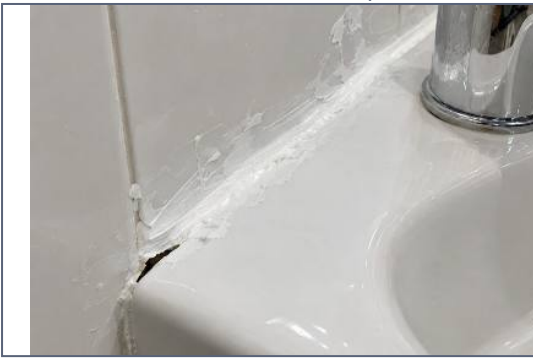
#### Pin 1 of 3 - photograph 2

The silicone sealant at the junction between the rear upstand of the white ceramic basin and the tiled wall has been applied poorly and smeared across the tile face and the basin surfaces. The sealant line is irregular in width, feathered against the glaze, and spread in patches over an area roughly 250 mm wide and 120 mm high around the tap. Tooling is absent: the bead is left as a series of smears rather than a continuous fillet.

Likely cause: The most likely cause is application of the sealant without tooling or masking, applied by an operative not experienced in sanitaryware sealing. An alternative or contributory cause is a re-seal carried out over an inadequately cleaned and prepared joint.

Cut out and remove the existing silicone mechanically with a sealant remover or sharp blade, clean both faces with a suitable solvent to remove all residue and grease, allow to dry, then apply a single continuous bead of sanitary-grade silicone and tool it immediately to a consistent fillet. The tiler or sanitaryware installer owns this junction.

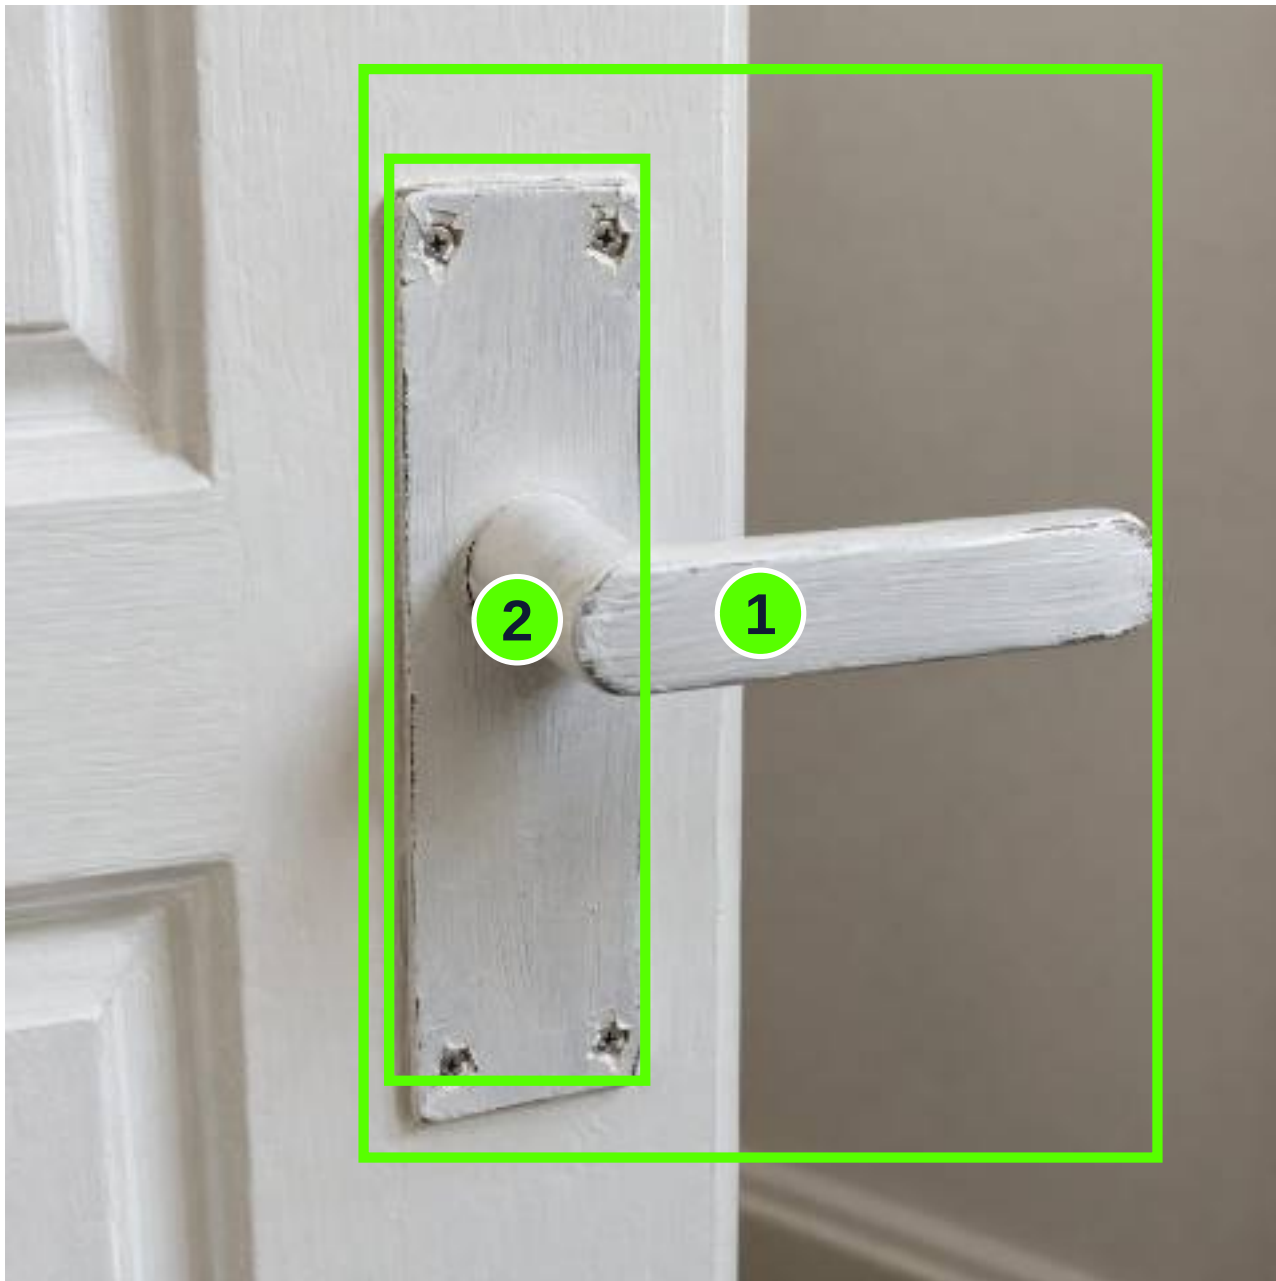
Photograph 3 - 2 items on this photograph, 2 pins on this photograph

Pin 1 - Item 3 - The door lever handle has been painted over, with the coating bridging the lever, the rose and the backplate as a sin...

Pin 2 - Item 4 - The four backplate screws have been painted over and the coating has filled the screw slots.

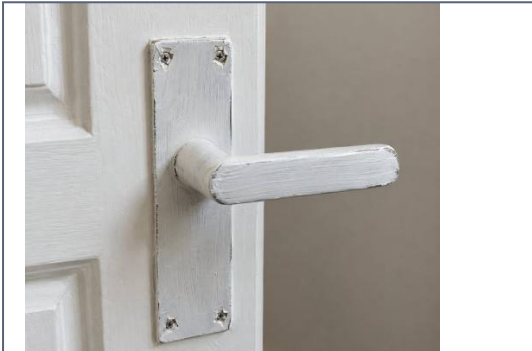
#### Pin 1 of 2 - photograph 3

The door lever handle has been painted over, with the coating bridging the lever, the rose and the backplate as a single continuous film of paint. The lever-to-rose junction is sealed by paint, and the brush marks run across the handle where the hand grips. The coating is heavy along the top edge of the lever, where it is most likely to chip away in use.

Likely cause: The handle was left in place when the door was decorated, so the coating was applied across the lever, rose and backplate. Loss of the screw heads is a consequence of the same work rather than a separate cause.

Strip the paint from the lever, rose and backplate, remove the handle from the door, clean the paint out of the screw slots and the lever pivot, and refit. Make good and redecorate the handle and backplate separately from the door leaf so that the lever is free to operate and is not bridged by paint.

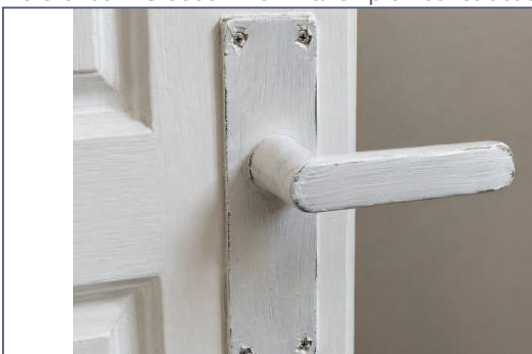
#### Pin 2 of 2 - photograph 3

The four backplate screws have been painted over and the coating has filled the screw slots. The screw heads are buried in the coating and cannot be driven with a screwdriver without first cutting the paint out of each slot.

Likely cause: The screws were not removed or masked before the door was painted, so the coating was applied directly over the fixing heads.

Cut the paint out of each screw slot, remove the backplate screws, clean the threads and slots, and refit the handle. Redecorate with the ironmongery removed, or mask the screw heads individually if the handle must remain in place.

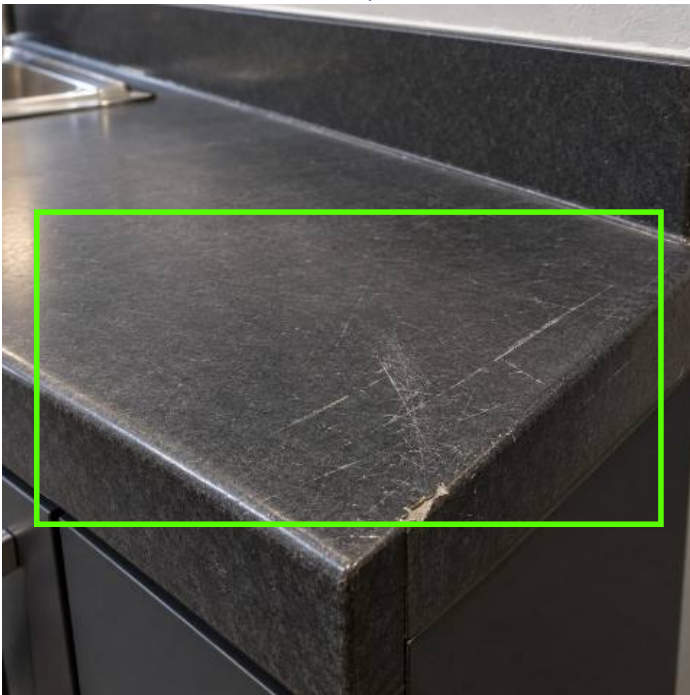
The dark grey worktop surface carries a widespread pattern of fine surface scratching, with a denser concentration extending across approximately the front half of the visible counter and a further cluster of linear scratches running diagonally towards the front corner. The scratches are shallow and appear to be confined to the polished surface layer. The density of the marking indicates mechanical abrasion across a substantial part of the visible area rather than a single localised scuff.

Likely cause: Mechanical abrasion during handling, storage, installation or the protection regime. Protection left in place too long, or grit trapped beneath protective covering, is a common contributor. The photograph does not permit the cause to be established with certainty.

Confirm the worktop material and its specified finishing regime before any action is taken. Establish whether the abrasion is confined to the surface layer or has penetrated the decorative finish; where it is superficial, a specialist stone or solid-surface restorer should undertake a controlled abrasive polish of the affected area and re-establish the specified sheen. Where the marking extends below the surface layer, the affected section will require replacement and re-jointing to the upstand and sink cut-out. Photographic records of the affected area should be taken before works commence, as further scratching is likely during any remaining site activity.

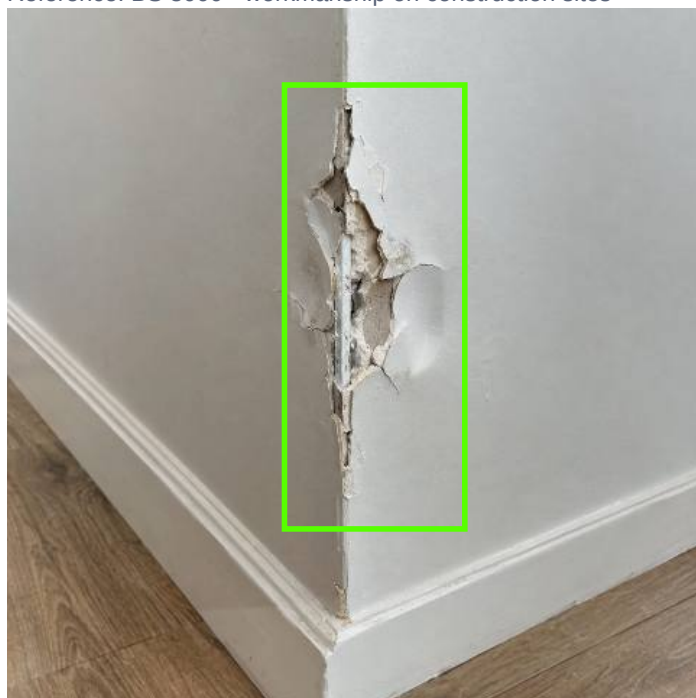
The external corner between the two plastered wall faces is damaged over a vertical run of approximately 200mm. A metal angle bead is exposed along the corner and the plaster skim has broken away from it in irregular flakes, leaving the grey backing coat and the bright metal bead visible. The damage is widest at the upper third of the exposed section, roughly 60mm across on the face to the right, and tapers to a crack below. The remaining plaster edges are proud and feather-edged, and the painted finish is fractured back from the break line.

Likely cause: Most likely impact damage to the corner arris after plastering, either from a trolley, board or other site movement, which has broken the skim away from the bead. A secondary possibility is that the bead was not adequately bedded or fixed, so the plaster never bonded to it and failed under minor contact. The photograph alone does not establish which, and both should be checked on site before the repair is specified.

Cut back the paint and loose plaster to sound, well-bonded material around the full extent of the damage. Check the angle bead is correctly fixed and does not move under finger pressure; refix or replace if it is loose, and confirm it is set plumb and true before making good. Pre-wet the edges, fill flush over the bead with a suitable patching plaster in two coats, allow to dry, then fill and sand the corner to a true arris. Spot prime and repaint the full corner to a natural break in the wall finish so the patch does not read. Carry out after the room is otherwise finished to avoid repeat damage.

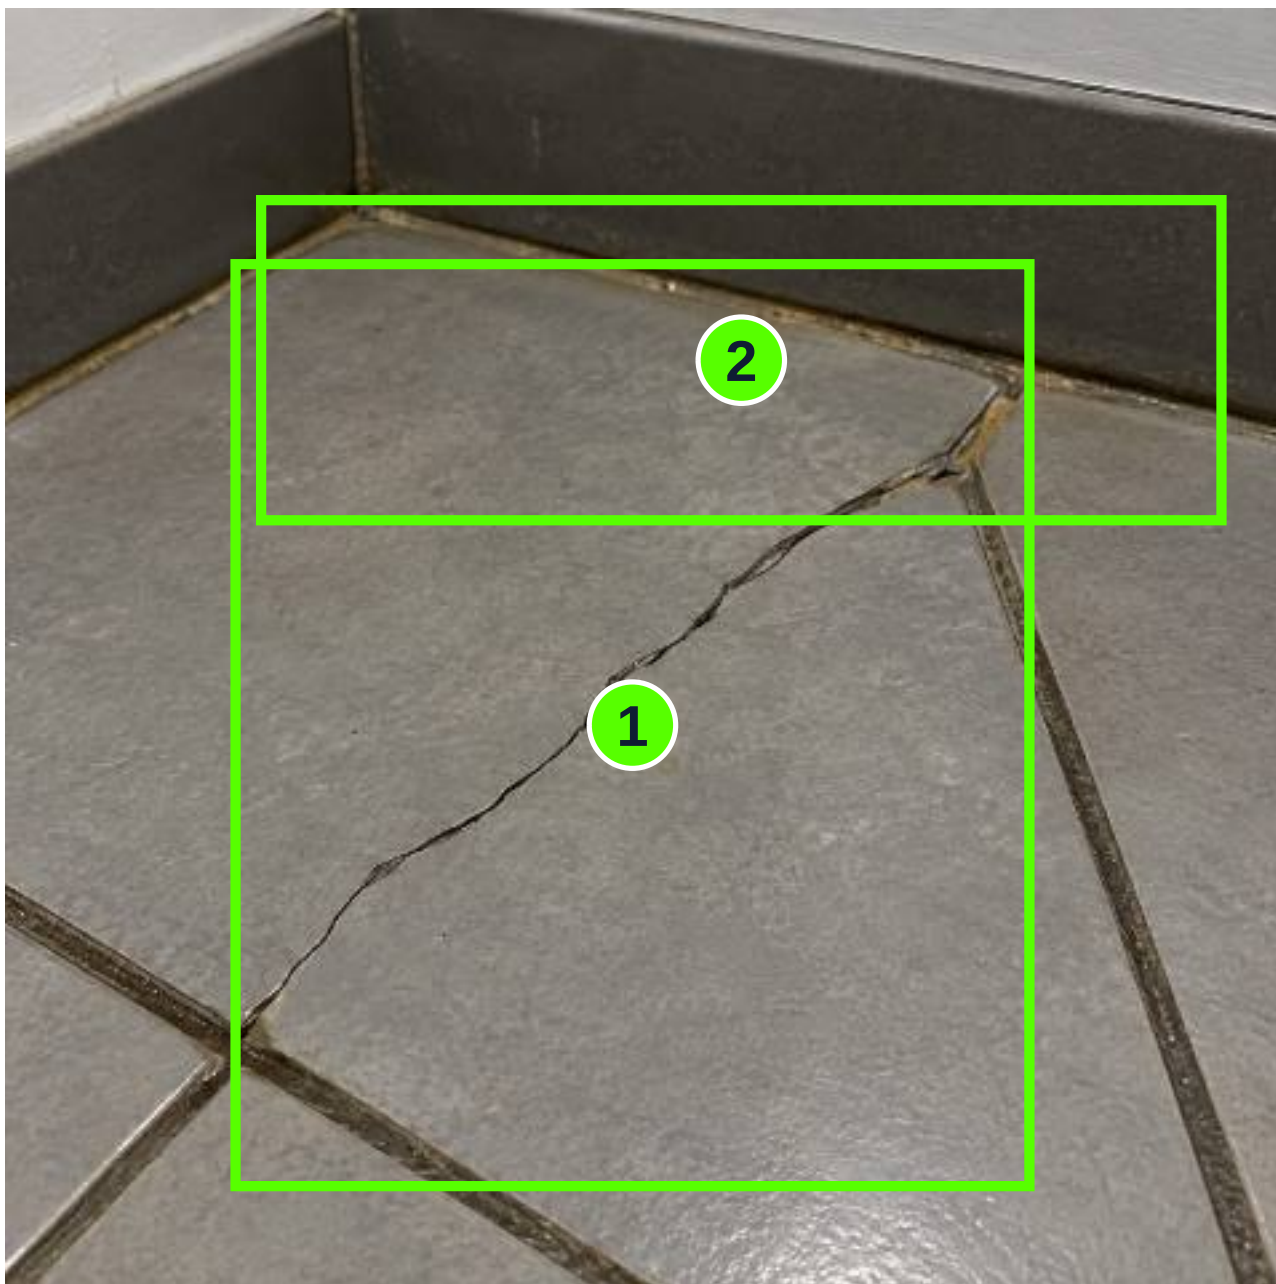
Photograph 6 - 2 items on this photograph, 2 pins on this photograph

Pin 1 - Item 11 - A single diagonal crack runs across one floor tile for approximately 400 mm, passing through the tile body from the j...

Pin 2 - Item 12 - The expansion or movement gap between the perimeter of the tile field and the base of the skirting is filled with gro...

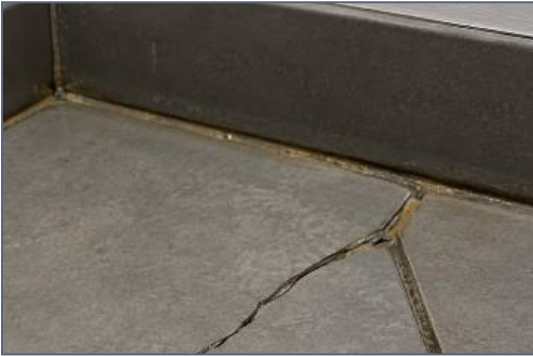
### Pin 2 of 2 - photograph 6

The expansion or movement gap between the perimeter of the tile field and the base of the skirting is filled with grout rather than a compressible sealant. The junction is bridged hard over its visible length of approximately 1.5 m, and the grout line at this interface shows fine hairline separation in places.

Likely cause: The grout appears to have been carried into the perimeter joint in place of a compressible sealant, most likely because the movement joint detail was not identified or was overlooked at installation.

Rake out the grout at the perimeter junction back to a clean, dry, sound substrate and install a compressible backing rod with a flexible sealant compatible with the tile and skirting, leaving the joint free to move. Confirm the joint owner: the perimeter movement joint at a skirting interface is normally the tiling trade's responsibility, with the skirting itself the joiner's, and the interface must be agreed on site before work proceeds.

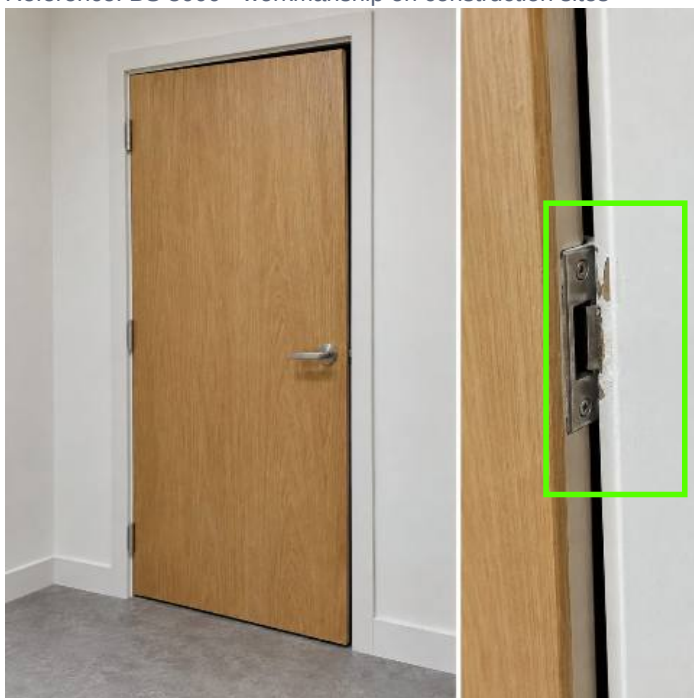
At the striker plate position on the closing jamb, the timber reveal behind the metal plate has broken away and the plate is bedded unevenly against the cut. The painted face of the lining adjacent to the plate is chipped and ragged over an area of approximately 40 mm by 60 mm, and the plate sits proud of the surrounding face. The strike is not rebated flush into sound timber.

Likely cause: Most probably the strike rebate was cut too deep or the fixing screws were over-tightened, causing the plate to pull and the surrounding timber to break out. It is also possible the lining is of a composite or hollow construction that does not accept a rebate well.

Remove the strike plate and ironmongery from the jamb. Cut out the damaged section of lining and let in a solid timber repair, or replace the affected length of lining. Re-form a clean rebate to the correct depth, refit the strike plate flush and true, and make good the paint finish. Confirm the door latch engages fully and the door closes without effort before decoration is signed off.

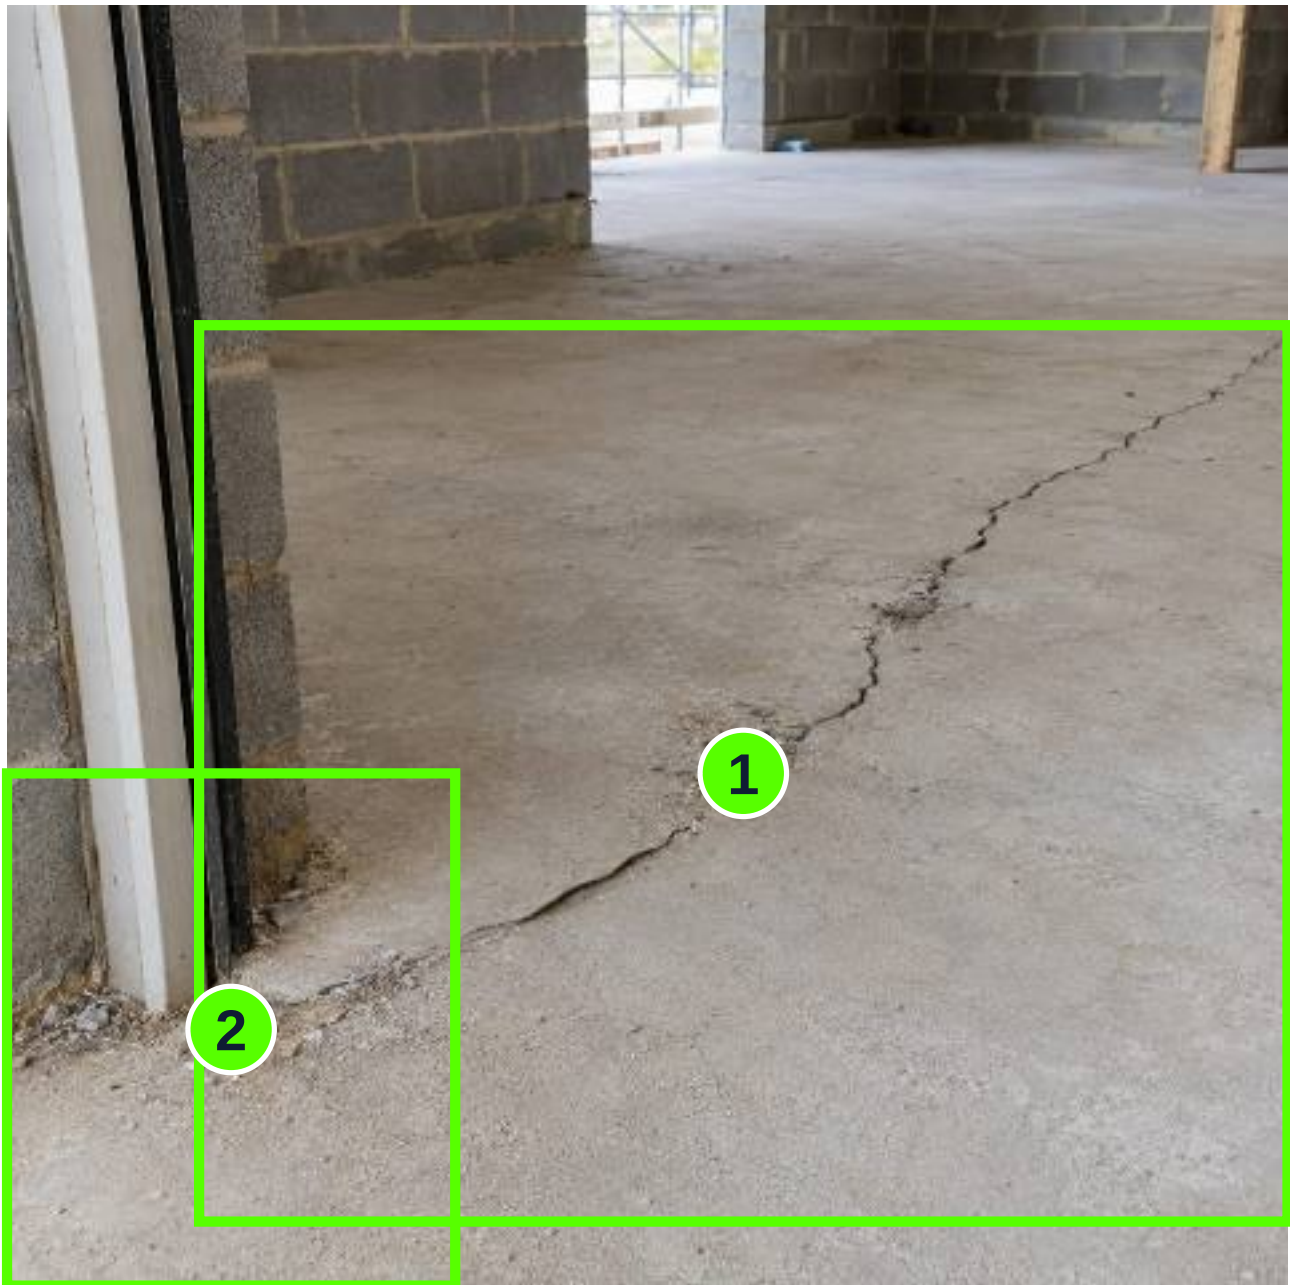
Photograph 9 - 2 items on this photograph, 2 pins on this photograph

Pin 1 - Item 19 - The concrete floor slab carries a continuous crack running diagonally across the visible floor area, from the thresho...

Pin 2 - Item 20 - At the threshold opening, the junction between the concrete floor slab and the base of the blockwork wall and the doo...

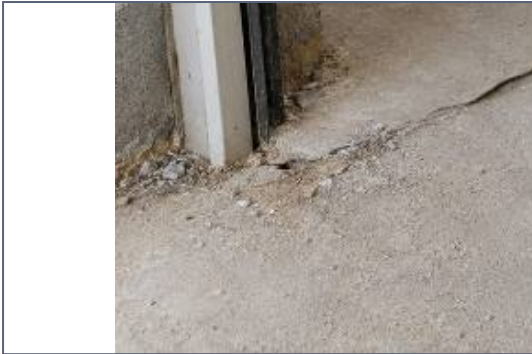
### Pin 2 of 2 - photograph 9

At the threshold opening, the junction between the concrete floor slab and the base of the blockwork wall and the door frame is broken down, with loose aggregate, mortar and debris present in the gap. The frame sits on a small mortar or screed bed which is crumbly and uneven, and there is a visible gap between the underside of the frame and the slab. The extent of the gap and whether a weather seal or damp-proof detail is present cannot be confirmed from this image.

Likely cause: Most likely the bedding or pointing at the threshold has broken down through impact from traffic or from the frame installation, or the base bed was laid on a dusty or unprepared slab and has debonded. It may also be that the junction has never been properly finished, and this is incomplete work still to be done.

Remove all loose mortar, aggregate and debris from the threshold junction and clean back to sound material. Confirm on site whether this is an external opening: if it is, the threshold must incorporate a continuous damp-proof course and a sealed weather detail in accordance with the manufacturer's instructions for the frame system. Re-point and make good the base bed to the frame, sealing the junction with a suitable external-grade sealant, and ensure the damp-proof course is lapped and continuous. Refer the detail to the principal contractor's design lead where the as-built junction does not match the specified detail.

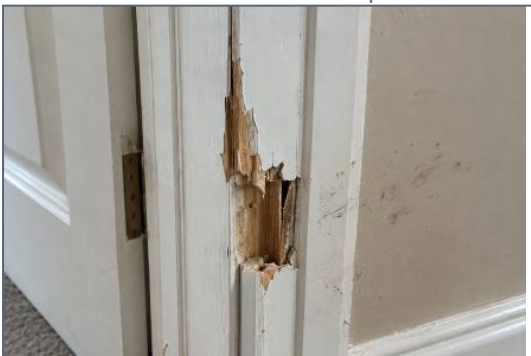
**Pin 1 of 2 - photograph 10**

The lower section of the door casing, at strike-plate height and immediately below it, has suffered significant loss of timber. A ragged area of paint and substrate, approximately 120 mm in height and 40 mm in width, has been broken away to reveal exposed softwood grain and splintered fibre. The damage penetrates below the paint film into the body of the architrave or liner, and the painted edge returns are cracked and lifting around the perimeter of the loss.

Likely cause: The damage is most likely the result of impact from a door-mounted item, a skip or trolley, or the door being forced against the strike plate. It may also be the consequence of the strike plate having been set proud and binding, causing the timber to break away under repeated use. The photograph does not permit the cause to be determined with certainty.

Rake out all loose and friable material from the damaged area and cut back to sound timber. Fill the void in layers using a two-part repair filler or a timber dutchman securely fixed and glued, then sand flush with the surrounding face. Prime the bare timber, carry out local filling of the surrounding paint cracks, and apply two coats of finish to match the existing door casing.

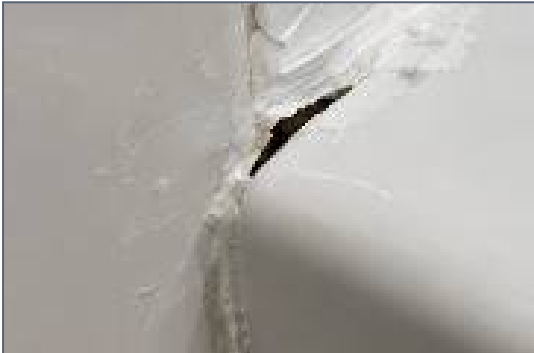
### Pin 2 of 3 - photograph 2

A dark void is visible at the base of the sealant run where it meets the rear left corner of the basin upstand, approximately 40 mm long. The sealant bridges across the gap rather than filling the junction, so an open edge remains at the tile-to-basin interface.

Likely cause: The most likely cause is sealant applied over an unprepared or damp joint, preventing adhesion across the full depth of the gap. A second possibility is insufficient sealant applied to a joint wider than the practical limit for a single bead.

Remove the bridging sealant, clean out and dry the joint, then fully pack and seal the junction with sanitary-grade silicone carried in a continuous bead into the corner. Where the gap exceeds the sealant's movement capability, insert a closed-cell backing rod first. Further opening up may be required if water has already tracked behind the tiling.

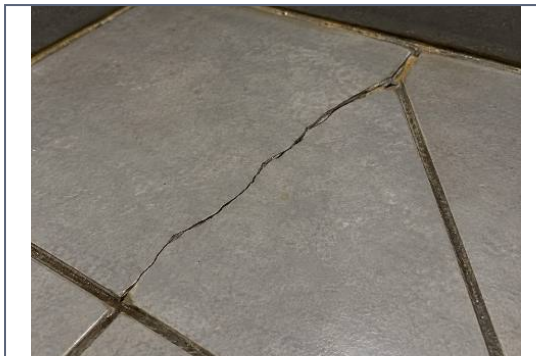
**Pin 1 of 2 - photograph 6**

A single diagonal crack runs across one floor tile for approximately 400 mm, passing through the tile body from the joint at the lower left corner up to the joint at the upper right, where it terminates at the wall skirting. The crack is open and continuous over its full length, with slight lippage visible at the fracture line. The tile remains in place but is fractured through its thickness.

Likely cause: Most likely impact damage from a dropped object or point load during construction traffic, or thermal or moisture movement where no movement joint has been provided. A defect in the screed or bedding beneath the tile is also plausible and cannot be excluded from the photograph.

Cut out and replace the affected tile. Rake back the bedding and adhesive to sound material, check the screed beneath for cracking or debonding, and re-lay on a full bed of flexible adhesive to the manufacturer's instructions, leaving the correct perimeter and movement joints. Do not fill or grout over the crack. Confirm whether the crack propagates into adjacent tiles or the screed before replacement is specified, as a wider substrate defect would change the repair.

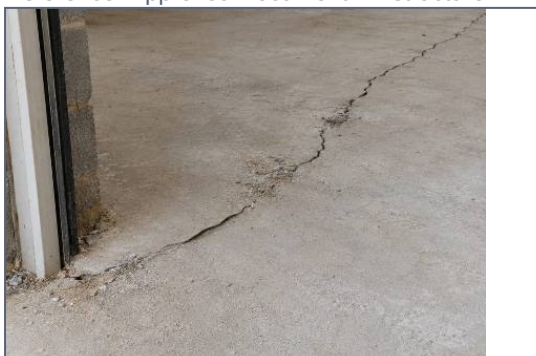
**Pin 1 of 2 - photograph 9**

The concrete floor slab carries a continuous crack running diagonally across the visible floor area, from the threshold of the opening in the lower left towards the right edge. The crack is irregular and meandering, with a width generally in the order of 2 to 4 mm, opening slightly wider at the junction with the wall and threshold, where the slab edge is visibly broken down and spalled. Localised loss of surface material and loose arisings are present alongside the crack over a length of approximately 0.5 m. The crack extends beyond the frame of the photograph, and its full length and termination cannot be established from this image.

Likely cause: The crack is most likely a shrinkage or early-age movement crack in the slab, or a settlement crack at the junction between the slab and the wall or threshold. It may also follow the line of a construction joint or the edge of a thinner section of slab. A single photograph cannot establish the cause with certainty, and the pattern and width need to be confirmed on site, with a structural assessment where the crack is wide or shows displacement.

Establish the full extent and depth of the crack by opening up with a proprietary crack-width gauge and, where depth is in doubt, a limited core or drilled investigation. Where the crack is confirmed to be a static shrinkage or settlement crack and is no longer moving, rake out the crack to a sound profile, remove loose material, and fill with a semi-rigid epoxy or cementitious repair mortar to the slab manufacturer's instructions. Where the crack is wider than 5 mm or shows vertical displacement between the faces, refer to the structural engineer before filling. Record the crack with a tell-tale or crack gauge for a monitoring period where movement is suspected. Make good the spalled arisings at the threshold before final floor finishes are laid.
