# Schedule of Condition - 8 October 2026

| Project | Riverside Court - Cat B Fit-Out, Phase 2 |
| Reference | SOC-2026-10-001 |

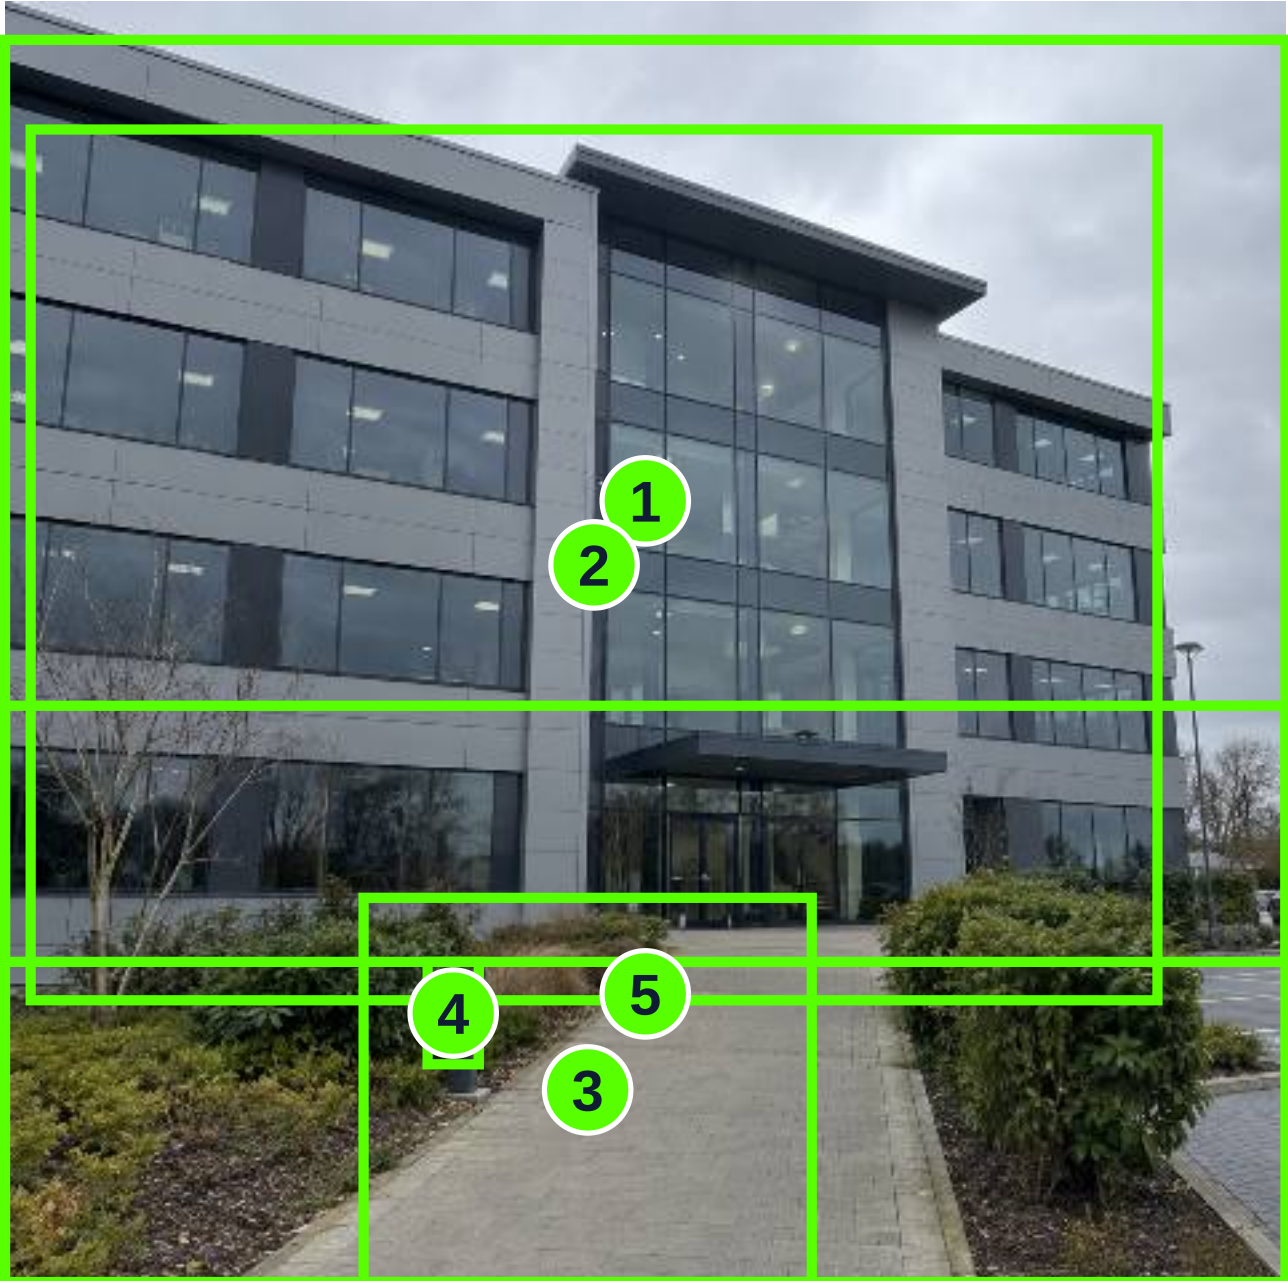
Photograph 1 - 5 items on this photograph, 5 pins on this photograph

Pin 1 - Item 21 - The grey rainscreen cladding panels to the principal elevation are visible across all four storeys.

Pin 2 - Item 22 - The curtain walling and window glazing to the elevation, including the full-height glazed entrance bay, are intact.

Pin 3 - Item 24 - The paved approach to the entrance is laid in modular block paving.

Pin 4 - Item 25 - A single column-form bollard luminaire is visible to the left of the paved approach.

Pin 5 - Item 27 - Ornamental shrub planting and deciduous trees in the beds adjoining the paved approach are visible.

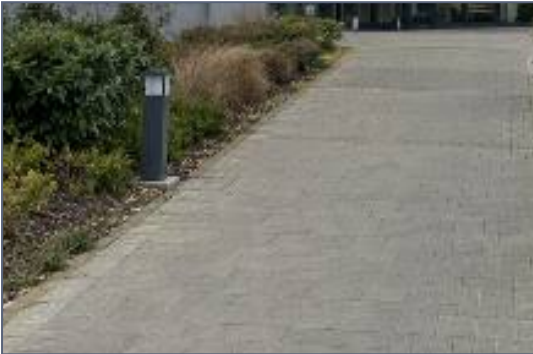
**Pin 3 of 5 - photograph 1**

The paved approach to the entrance is laid in modular block paving. The surface appears level and intact, with no visible cracking, rutting, ponding or missing units. Moss or algae growth is visible in the joints within the landscaped margins, which is typical of the season and the shaded position.

Routine maintenance. Vegetation should be kept clear of the paving edges to prevent joint opening.

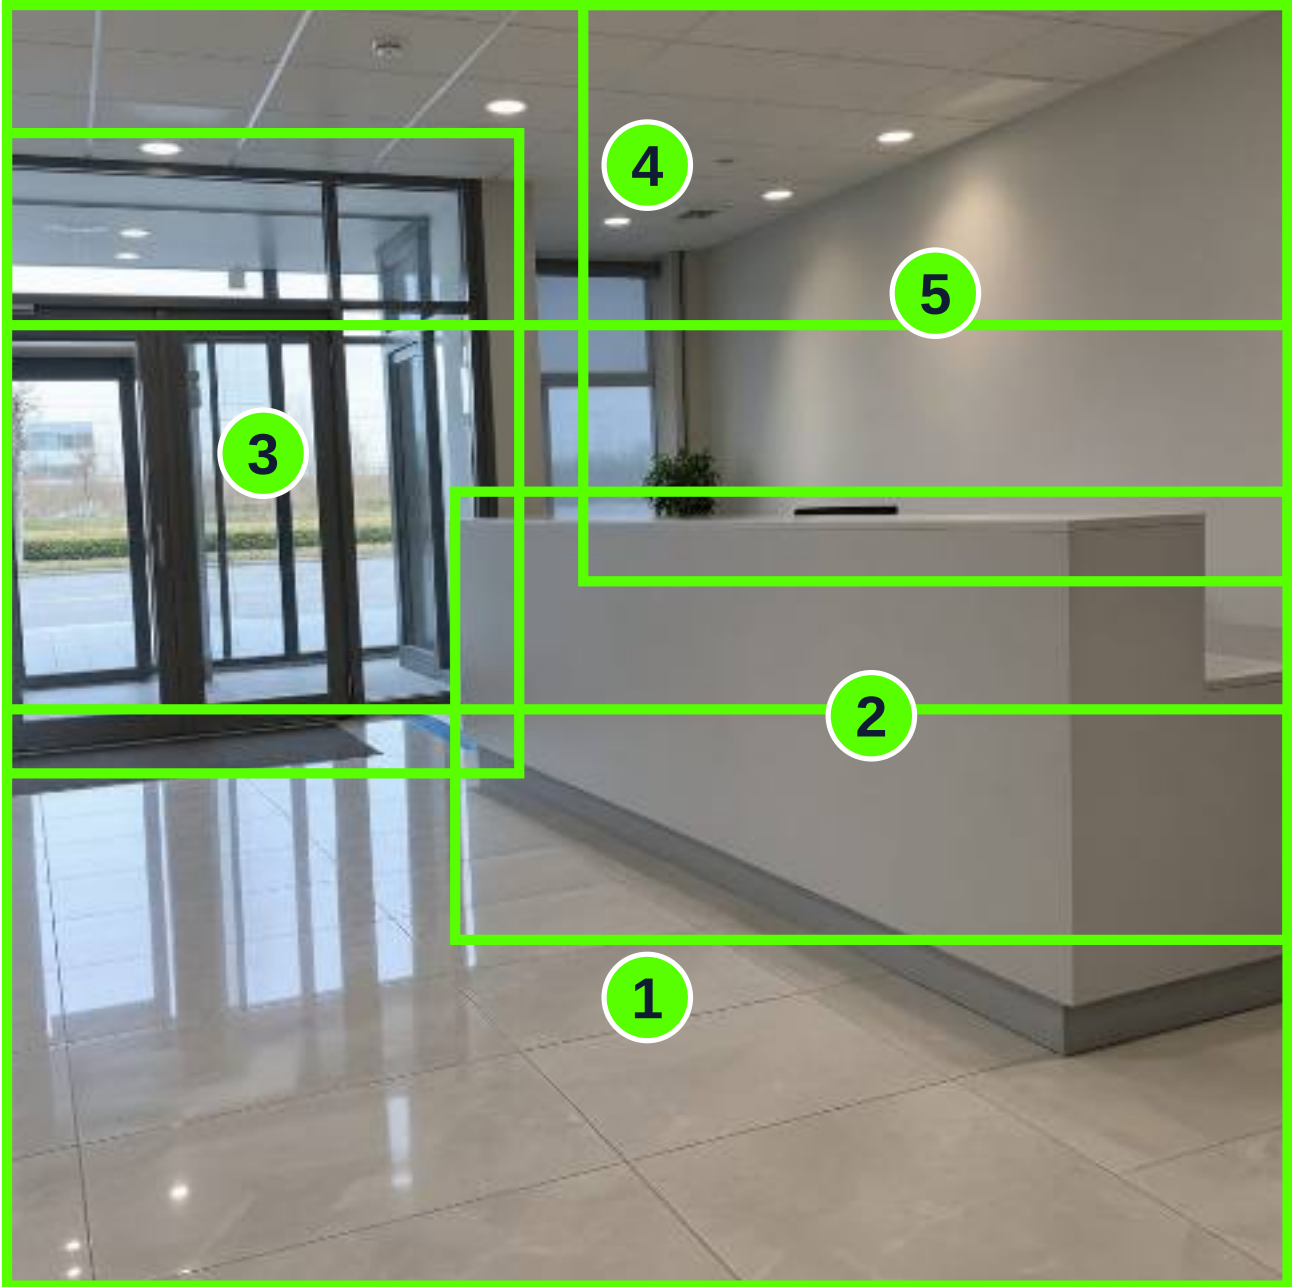
Photograph 2 - 5 items on this photograph, 5 pins on this photograph

- Pin 1 - Item 10 - Reception floor finished with large-format polished stone-effect tiles laid to a grid, with a reflective surface.
- Pin 2 - Item 11 - A white reception desk is present to the centre right of the frame, of solid panel construction with a plain front an...
- Pin 3 - Item 12 - A full-height glazed entrance screen with aluminium frames is present to the left of the frame, comprising double doo...
- Pin 4 - Item 13 - A suspended ceiling of square lay-in tiles is present across the upper portion of the frame, with recessed downlights...
- Pin 5 - Item 14 - The walls to the reception area, including the return wall behind the desk, are finished with a plain painted or appl...

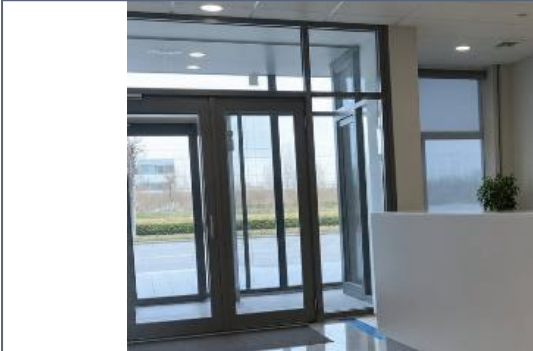
**Pin 3 of 5 - photograph 2**

A full-height glazed entrance screen with aluminium frames is present to the left of the frame, comprising double doors and fixed screens with a transom over. The glazing and frames are visible; the glass is clear, the frames appear straight and fully glazed, and no visible breakage, distortion or open joint is supported by the photograph. A mat is laid inside the threshold. The external paving and planting beyond the glazing are visible through the glass.

No action required to the glazing on the evidence of this photograph. Include the door closers, ironmongery and frame seals in the routine maintenance inspection.

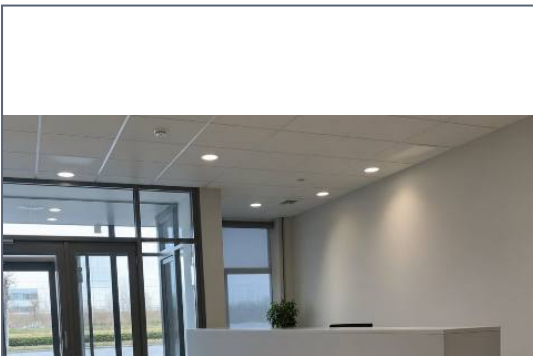
**Pin 4 of 5 - photograph 2**

A suspended ceiling of square lay-in tiles is present across the upper portion of the frame, with recessed downlights and a small ceiling-mounted detector. The tiles are visible and appear level and uniform, with no visible sagging, staining, damaged tile or displaced grid member supported by the photograph.

No action required. Continue routine inspection of the ceiling void and the lighting for the duration of the maintenance regime.

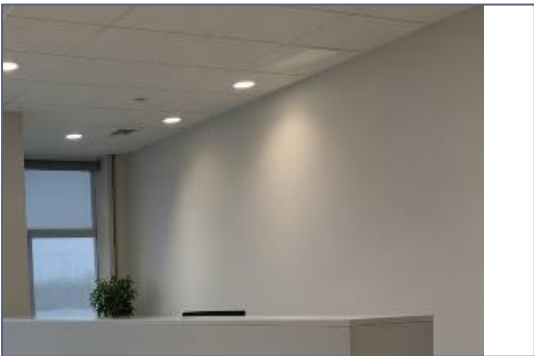
Pin 5 of 5 - photograph 2

The walls to the reception area, including the return wall behind the desk, are finished with a plain painted or applied lining in a light grey or white tone. The surfaces are visible and appear uniform, with no visible cracking, staining, blistering or impact damage supported by the photograph. Shadowing at the wall and ceiling junction is consistent with the lighting.

No action required. Maintain under the routine decorative cycle and inspect wall protection in circulation areas as part of planned maintenance.

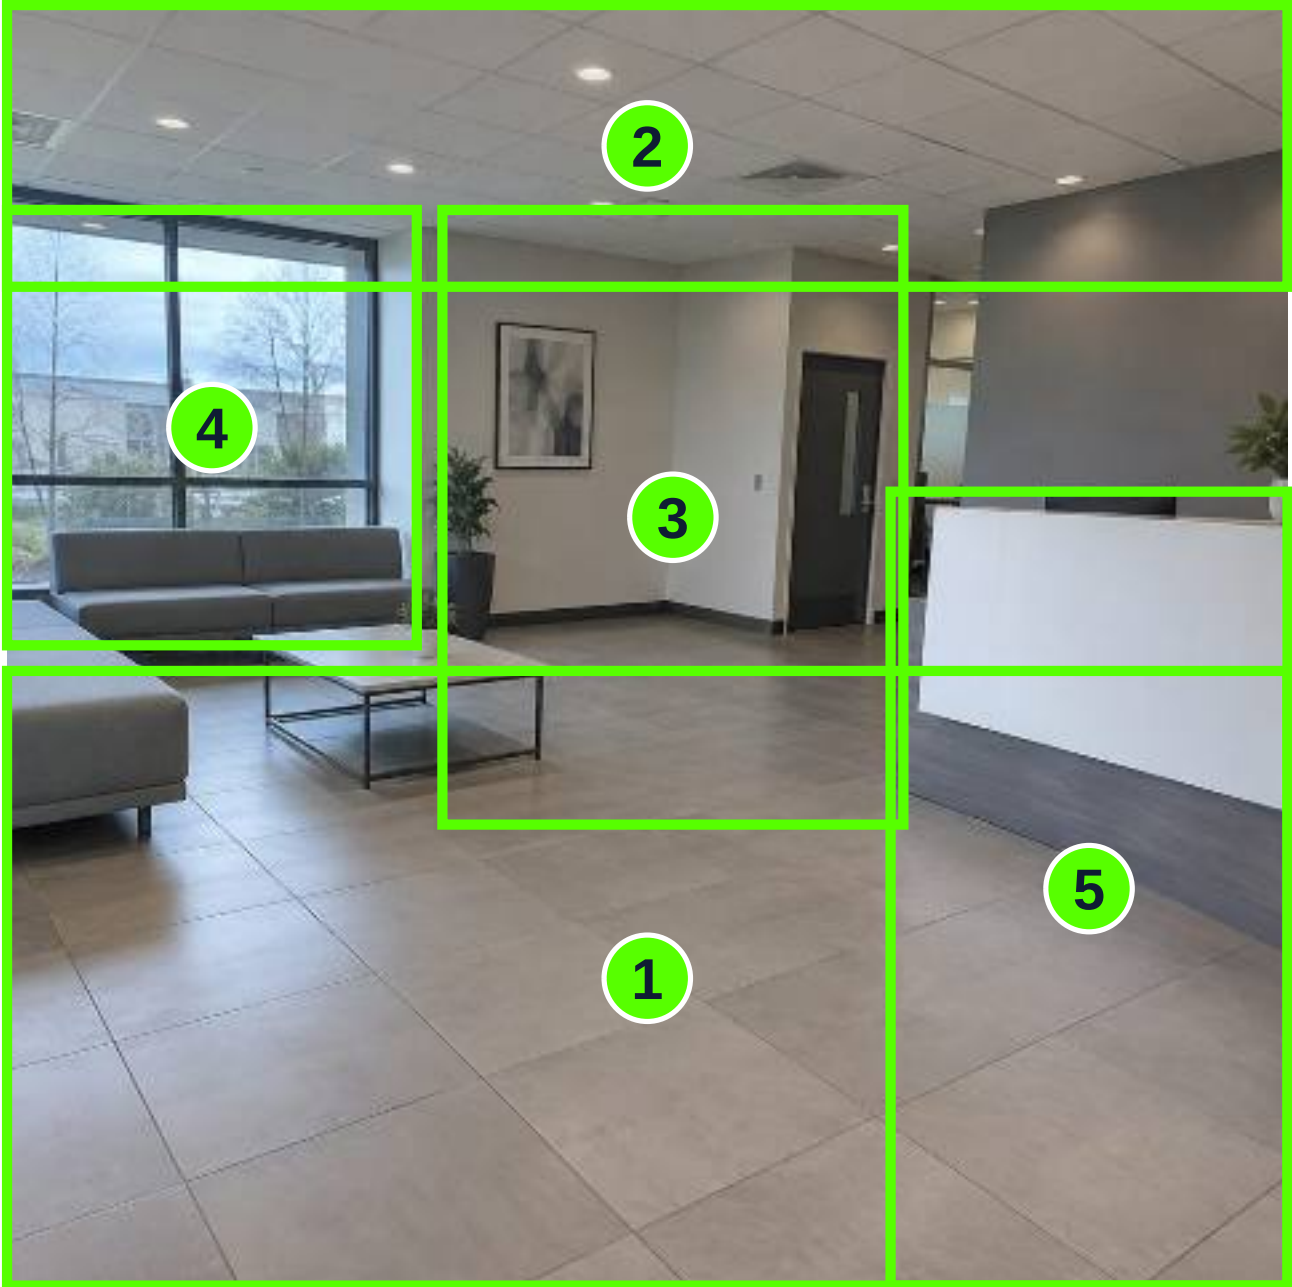
Photograph 3 - 5 items on this photograph, 5 pins on this photograph

Pin 1 - Item 15 - The reception floor is finished in large-format rectangular tiles laid to a regular grid with narrow joints.

Pin 2 - Item 16 - A suspended ceiling of square tiles in a concealed grid spans the reception area, incorporating recessed downlighters...

Pin 3 - Item 17 - Internal partitions are finished in a light neutral paint with a darker contrasting panel to the right-hand wall, and...

Pin 4 - Item 18 - A large fixed glazed screen with dark metal framing forms the left-hand elevation, with a horizontal transom dividing...

Pin 5 - Item 19 - A reception desk occupies the right-hand side of the space, formed of a light-coloured upper face panel over a darker...

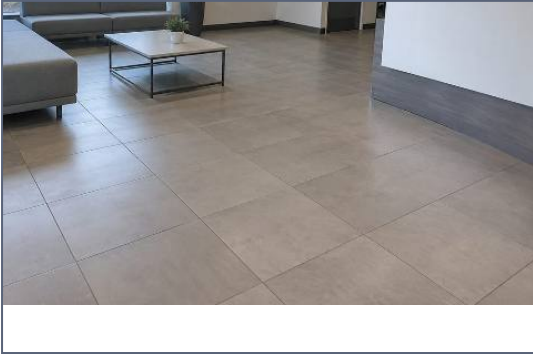
**Pin 1 of 5 - photograph 3**

The reception floor is finished in large-format rectangular tiles laid to a regular grid with narrow joints. Across the area visible in the photograph the tiling is intact and evenly laid, with no visible cracking, lipping, lifting or open joints. The surface is clean and carries a uniform sheen consistent with a recently cleaned floor. The photograph does not permit inspection of the joints at close range or of the floor beneath the furniture.

No action required. Continue routine cleaning and periodic inspection of joints at floor level.

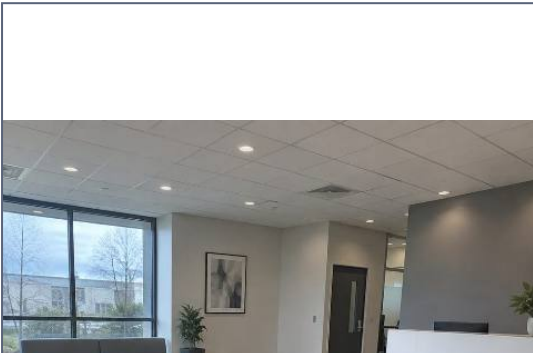
**Pin 2 of 5 - photograph 3**

A suspended ceiling of square tiles in a concealed grid spans the reception area, incorporating recessed downlighters and a square diffuser grille. The tiles visible are flat, closely fitted and free of staining, sagging or displacement. The grid lines run true and no tiles are missing within the field of view. The photograph does not permit assessment of the ceiling above the tiles or of the services within the void.

No action required. Retain routine inspection.

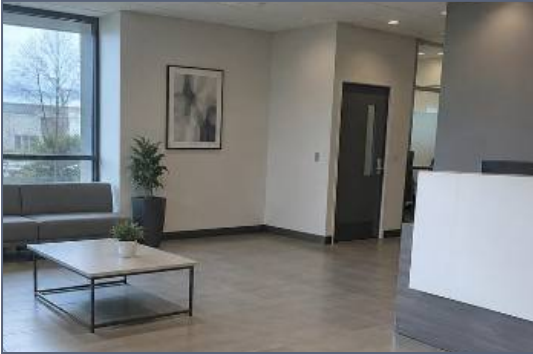
**Pin 3 of 5 - photograph 3**

Internal partitions are finished in a light neutral paint with a darker contrasting panel to the right-hand wall, and a dark skirting is fitted at the wall base. The painted surfaces visible appear even and intact, without blistering, cracking or visible marking. The skirting is present and continuous across the visible length. Lighting conditions create shadow variation across the wall plane which limits assessment of fine surface defects.

No action required. Retain routine decoration cycle.

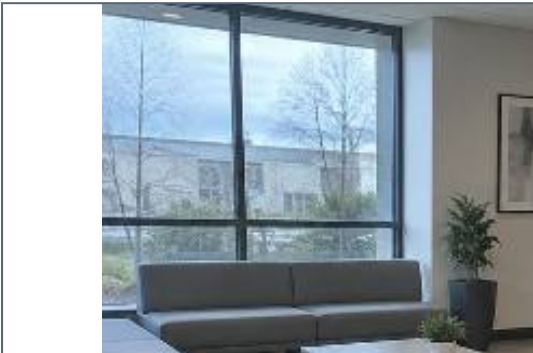
**Pin 4 of 5 - photograph 3**

A large fixed glazed screen with dark metal framing forms the left-hand elevation, with a horizontal transom dividing the units. The glass and framing appear intact from this distance, with no visible crack, seal failure or condensation between panes. The photograph is taken from within the space and does not permit close inspection of the frame, gaskets or perimeter seals, or of any opening light operation.

No action required. Retain periodic inspection of frame, gaskets and perimeter seals.

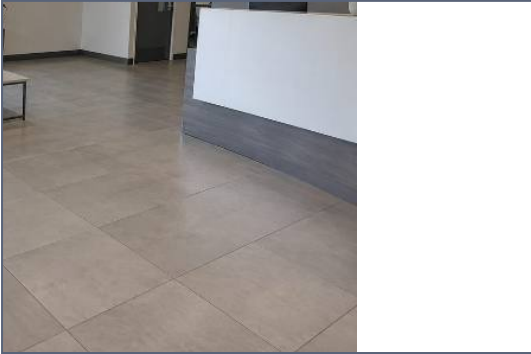
**Pin 5 of 5 - photograph 3**

A reception desk occupies the right-hand side of the space, formed of a light-coloured upper face panel over a darker plinth return. The visible faces are flush and undamaged with no impact damage, chips or lifting at the joins. Only two faces of the unit are visible in the photograph; the concealed elevations and any service access are not assessable.

No action required.

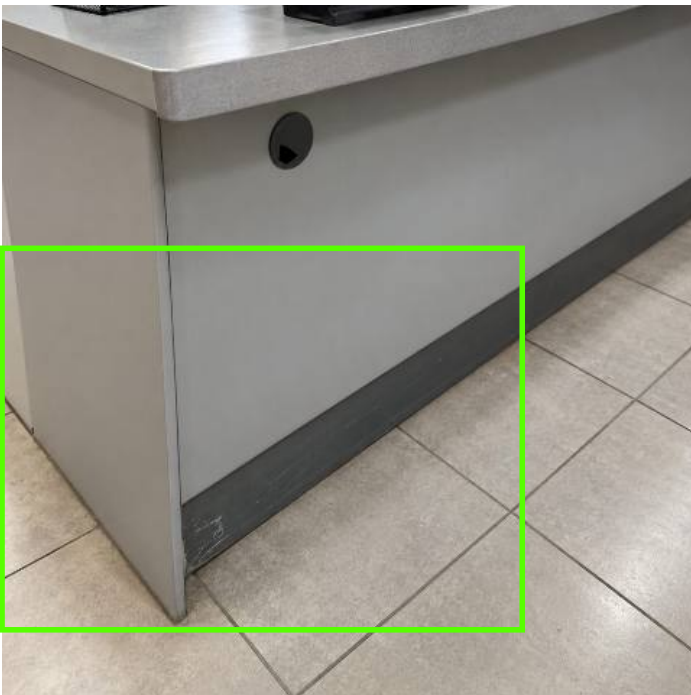
The light grey painted base panel of the counter unit is visible at the front face and the returned left end. The panel is in sound decorative order generally; a dark grey plinth or kick strip runs along the base of the unit and this strip is visibly scuffed and abraded, with the finish worn away in patches along the front elevation and more heavily at the external corner. The corner between the front plinth and the returned end is chipped and the substrate is exposed at the arris.

Planned repair: prepare and redecorate or replace the plinth/kick strip finish to the affected lengths, with the external corner made good. No action is required to the counter carcass.

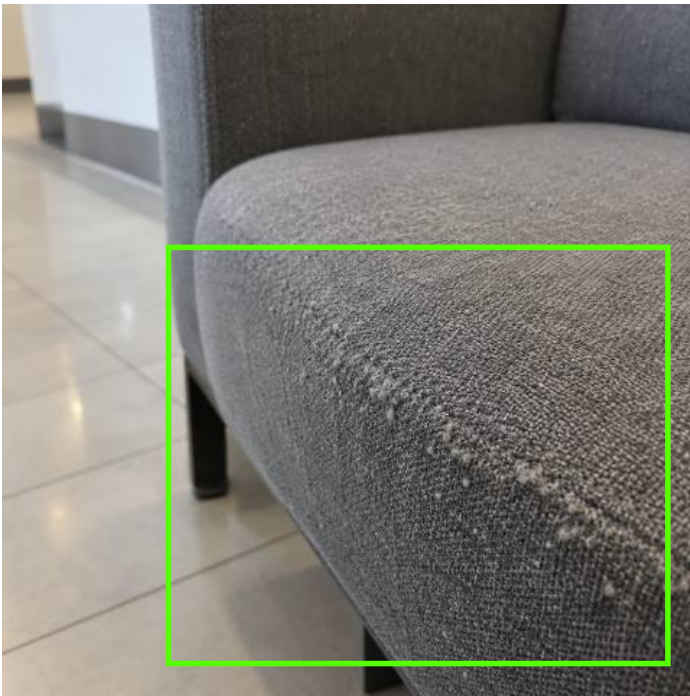
**Condition grade: C - Fair. Deteriorating, planned repair or replacement.**

The upholstered seat cushion at the front edge of the armchair is abraded along its leading arris. The woven fabric has worn through to reveal the backing yarns, producing a pale, frayed band approximately 200 mm in length across the front and upper corner of the cushion face. Surrounding fabric remains intact and taut over the foam, with no splitting of the seams and no visible staining, soiling or impact damage. A dark timber or composite leg is visible at the lower left. The floor finish, comprising large-format light tiles with a dark skirting line in the background, is visible beyond the chair and is not the subject of this observation.

Planned repair. The cushion cover requires replacement, or a matched panel insert to the worn arris, at the next available maintenance visit.

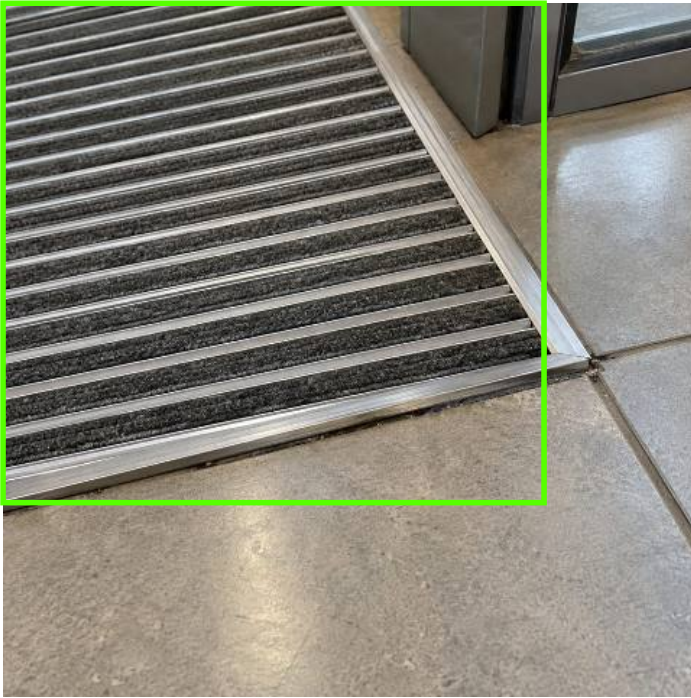
An entrance matting system of the aluminium rail and heel-resistant insert type is present, formed of parallel tread rails with profiled metal capping edges and mitred corner junctions. The insert material is visibly soiled and darkened across the width, indicating accumulated detritus. The aluminium rails present a bright, sound appearance with no visible distortion, displacement or missing sections within the photographed extent. The mitred junction at the left-hand edge is tight and the capping trim sits flat.

Routine maintenance is required. The matting inserts are to be cleaned in accordance with the manufacturer's guidance, and the rail fixings are to be checked and the well vacuumed at the next scheduled maintenance visit.

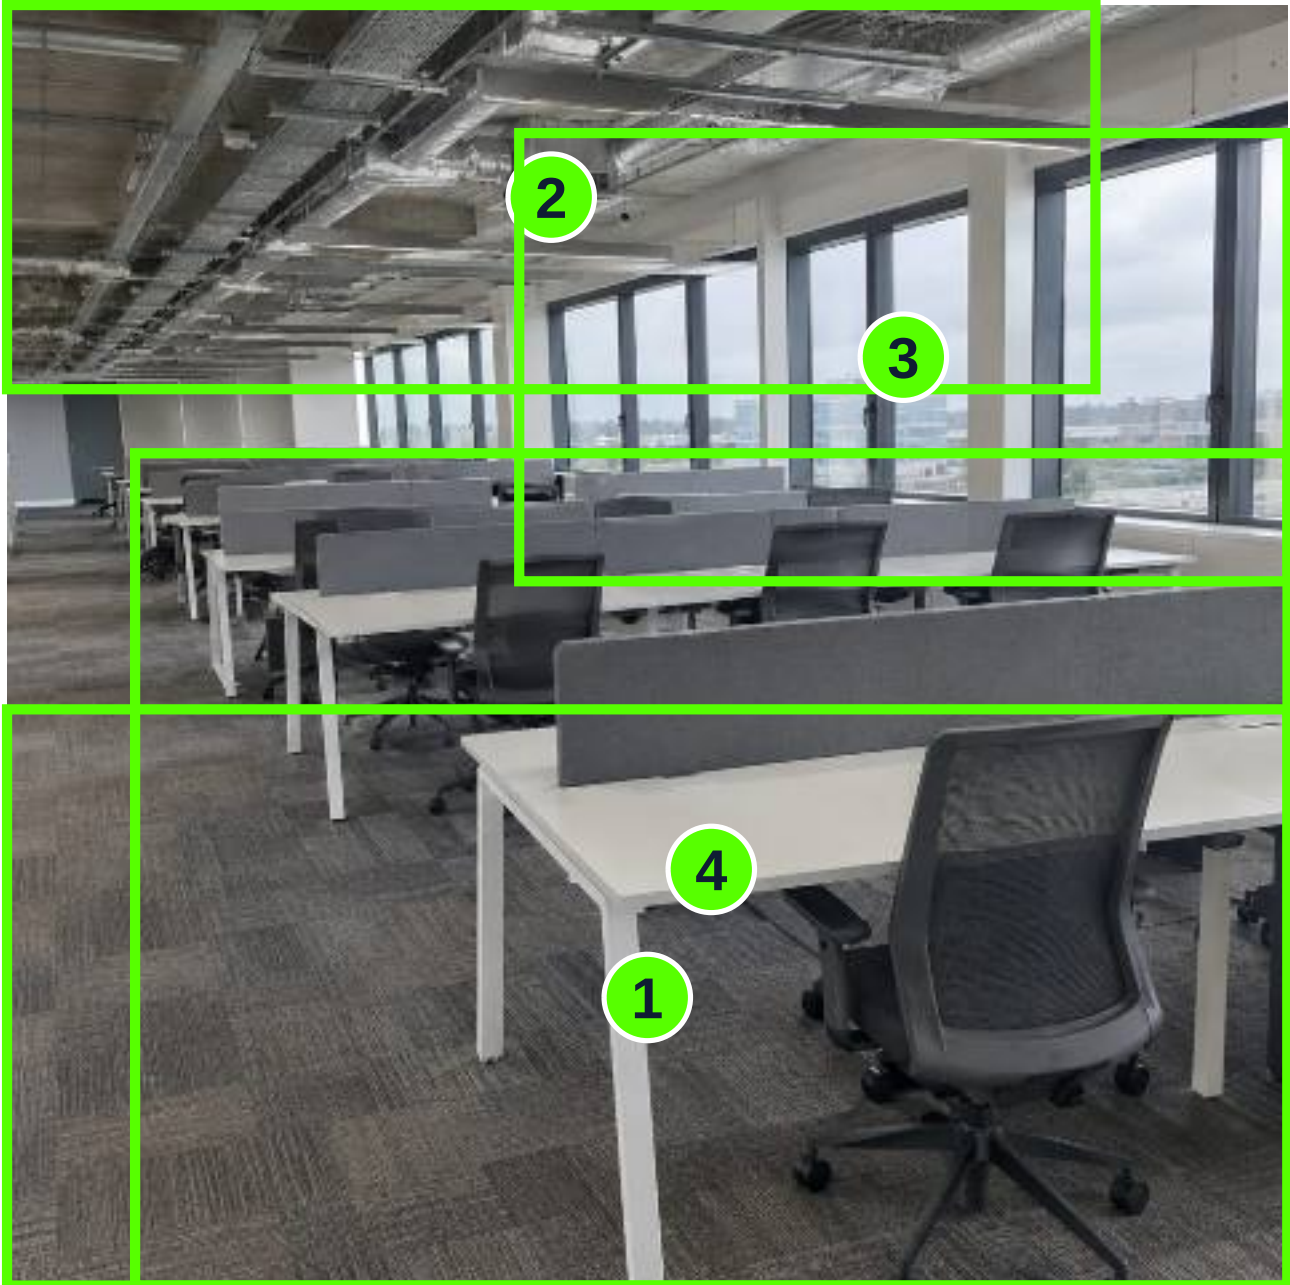
Photograph 7 - 4 items on this photograph, 4 pins on this photograph

Pin 1 - Item 6 - Open-plan office floor finish comprising grey loop-pile carpet tiles laid in a quarter-turn pattern.

Pin 2 - Item 7 - Exposed soffit above the office area with galvanised ductwork, cable tray, pipework and services suspended from hangers.

Pin 3 - Item 8 - Full-height glazed curtain walling to the external elevation, comprising dark-framed units with opening lights.

Pin 4 - Item 9 - Bench desking in white finish with grey fabric screen dividers and mesh-backed task chairs on castors.

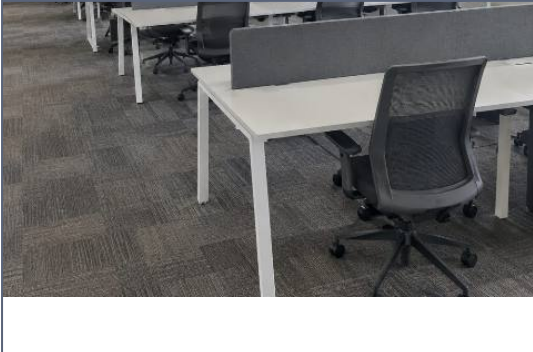
**Pin 1 of 4 - photograph 7**

Open-plan office floor finish comprising grey loop-pile carpet tiles laid in a quarter-turn pattern. The finish is continuous and appears recently laid, with no visible lifting, fraying, staining, delamination or joint separation within the extent of the view. Minor local soiling is evident in the circulation areas.

Routine maintenance. Clean in accordance with the manufacturer's maintenance regime and maintain a small stock of replacement tiles for future localised renewal.

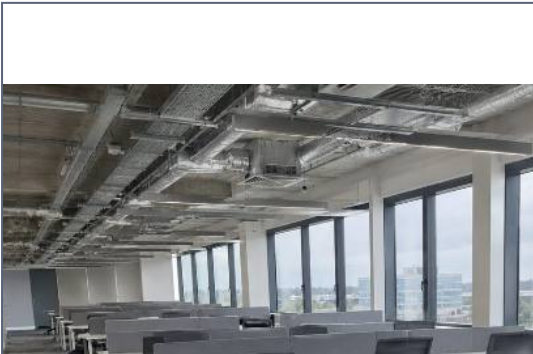
**Pin 2 of 4 - photograph 7**

Exposed soffit above the office area with galvanised ductwork, cable tray, pipework and services suspended from hangers. The services are installed in an orderly arrangement. A number of linear light fittings are suspended below the soffit. Damage in the form of dents, impact damage, displaced supports, water staining or corrosion is not evident in the areas visible.

No action on the visible condition. Confirm support spacings, fire stopping at penetrations and service labelling as part of the completion record before handover.

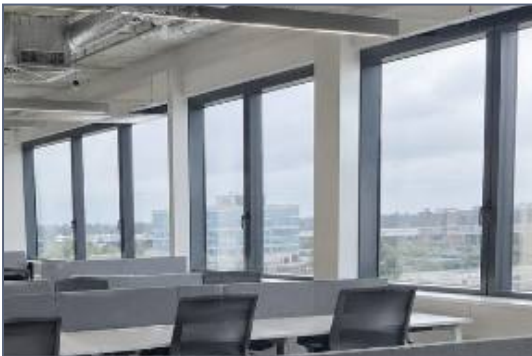
**Pin 3 of 4 - photograph 7**

Full-height glazed curtain walling to the external elevation, comprising dark-framed units with opening lights. The frames, gaskets and glazing visible in the elevation appear intact, with no visible cracking, sealant failure, water ingress staining or damaged ironmongery. Reflections in the glass limit the inspection of the lower frame junctions.

No action on the visible condition. Verify gasket compression, drainage path and perimeter sealant as part of the faade completion inspection.

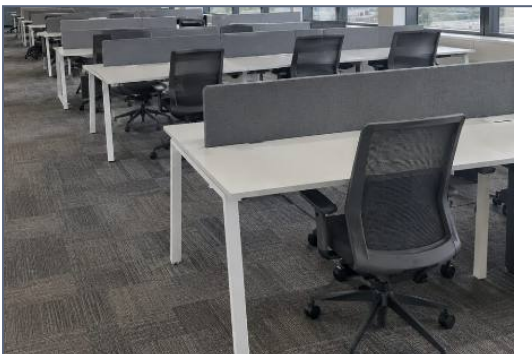
**Pin 4 of 4 - photograph 7**

Bench desking in white finish with grey fabric screen dividers and mesh-backed task chairs on castors. The desking appears recently installed and undamaged, with edge banding intact and leg frames undented. The furniture is in place and the installation reads as complete.

No action. Record the condition at handover for dilapidations purposes.

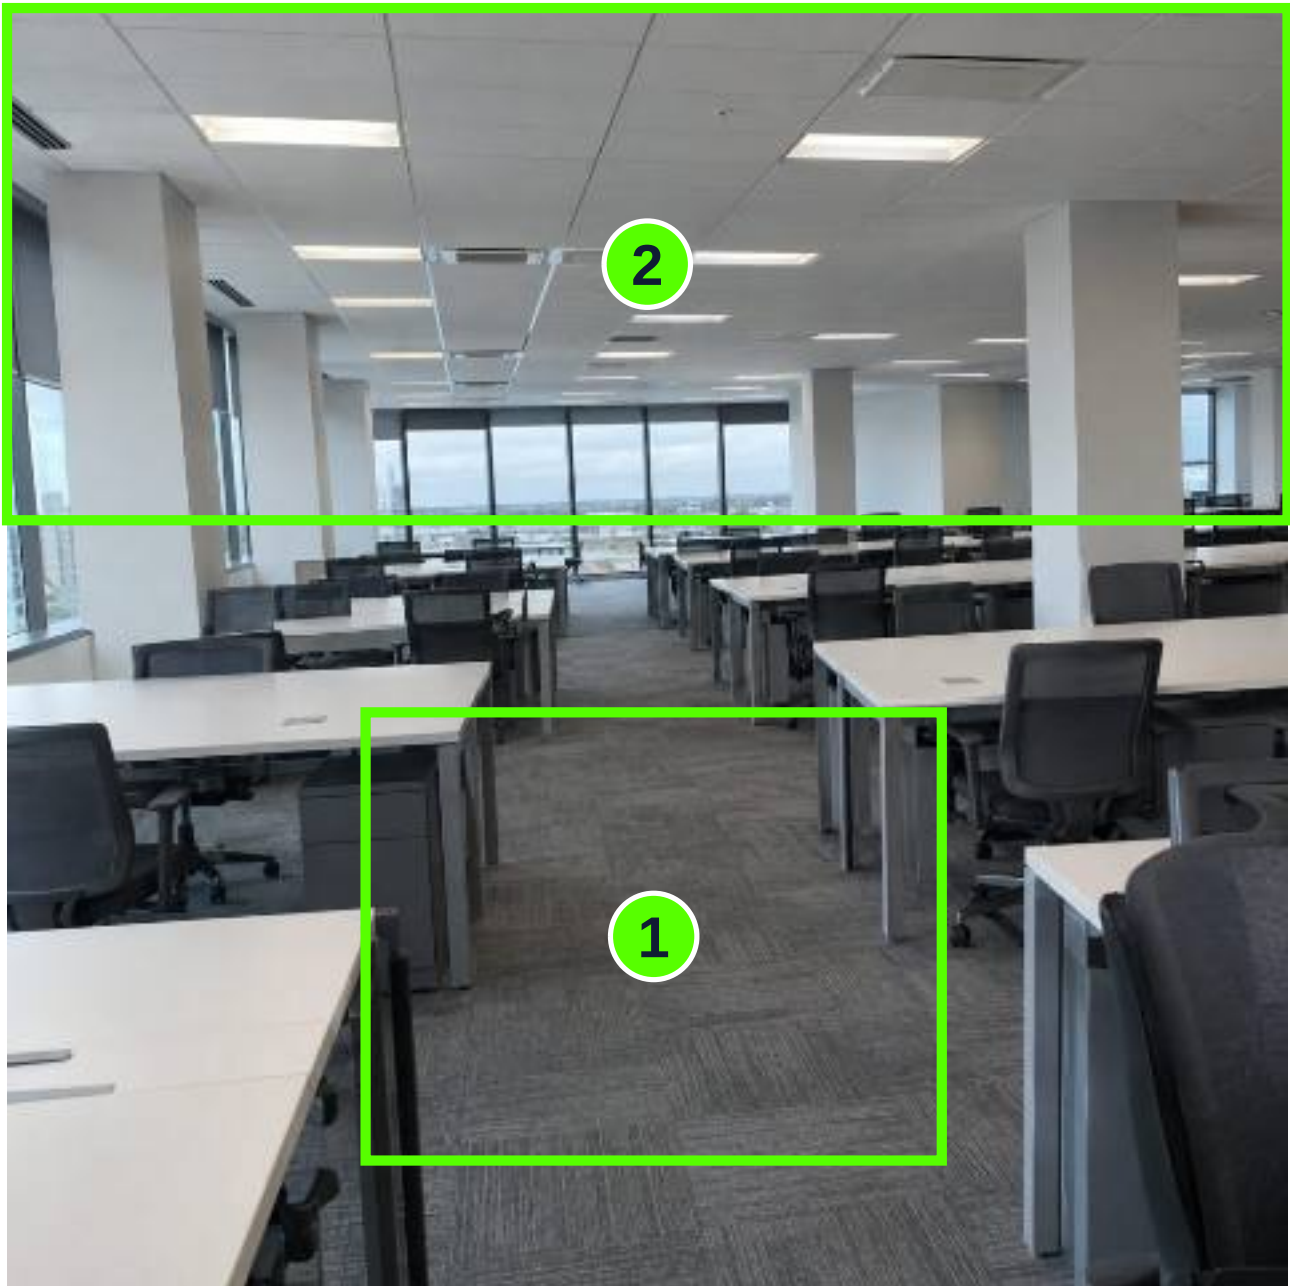
Photograph 8 - 2 items on this photograph, 2 pins on this photograph

Pin 1 - Item 3 - The carpet tiling to the open-plan floor area is visibly stained and discoloured in the central circulation zone, wit...

Pin 2 - Item 4 - The metal grid suspended ceiling is in place and the tiles are generally true and aligned, with recessed luminaires a...

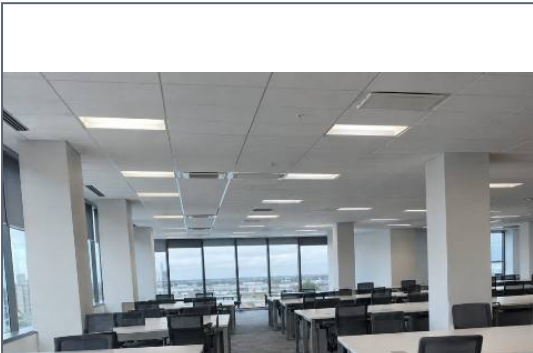
**Pin 2 of 2 - photograph 8**

The metal grid suspended ceiling is in place and the tiles are generally true and aligned, with recessed luminaires and diffusers set within the grid. Light fittings are illuminated and appear complete. The visible ceiling plane and grid lines are sound, with no sagging, displaced tiles or open grid apertures apparent in this view.

No action. Routine maintenance only.
