# Electrical installation condition - 8 October 2026

| Project | Riverside Court - Cat B Fit-Out, Phase 2 |
| Reference | EIC-2026-10-001 |

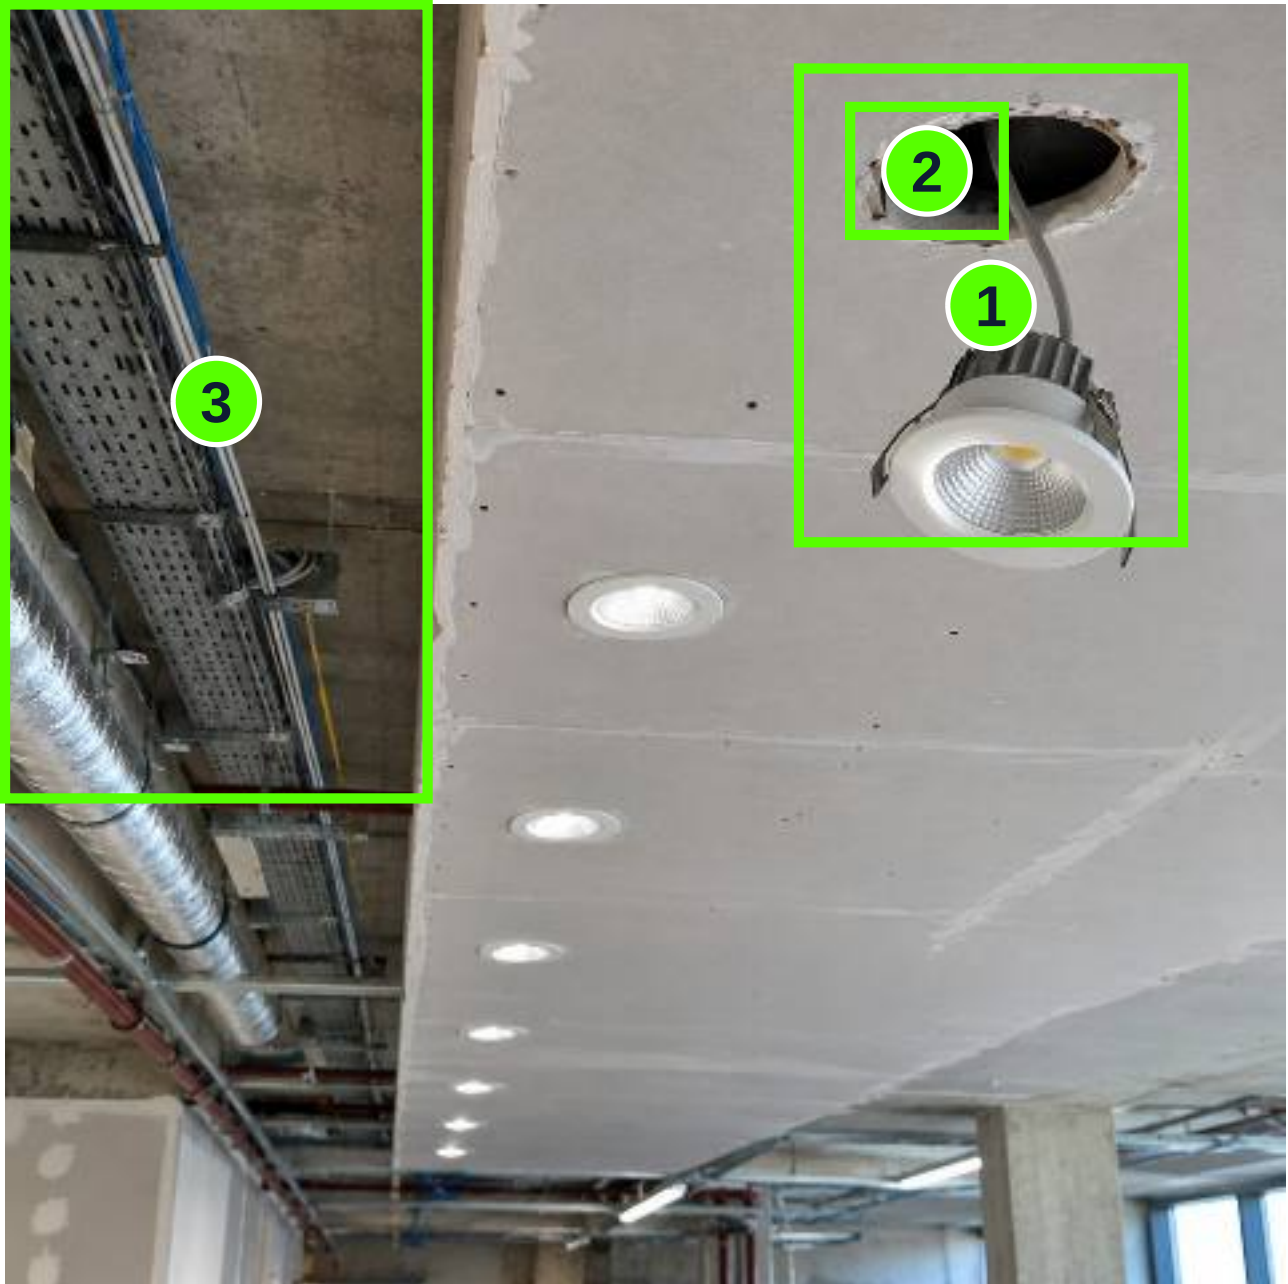
Photograph 2 - 3 items on this photograph, 3 pins on this photograph

- Pin 1 - Item 10 - A recessed luminaire in the plasterboard ceiling at the upper right of the image is hanging from its aperture on a fl...
- Pin 2 - Item 11 - The open ceiling aperture at the same location as the displaced luminaire shows a dark void in which cable or connect...
- Pin 3 - Item 12 - To the left of the image, cable tray and basket containment are installed at high level above the ceiling line, carry...

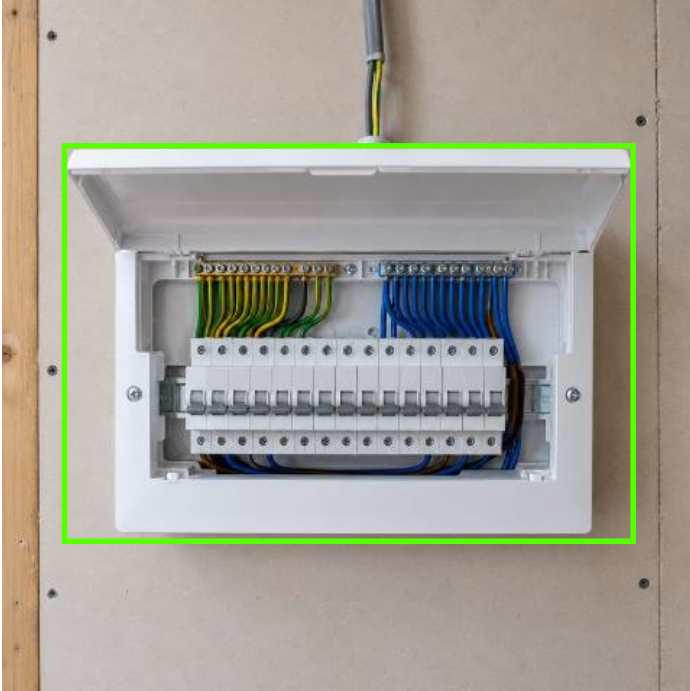
A consumer unit is mounted on a plasterboard wall with the front cover removed, exposing the busbar, neutral bar, earth bar and the incoming meter tails above the enclosure. The internal connections are visible but the cover is not fitted and the installation cannot be judged complete from this view.

Do not energise or leave energised with the cover removed. Confirm isolation and lock-off, then have a competent person refit the front cover and verify the enclosure is complete and secure before the installation is put back into service.

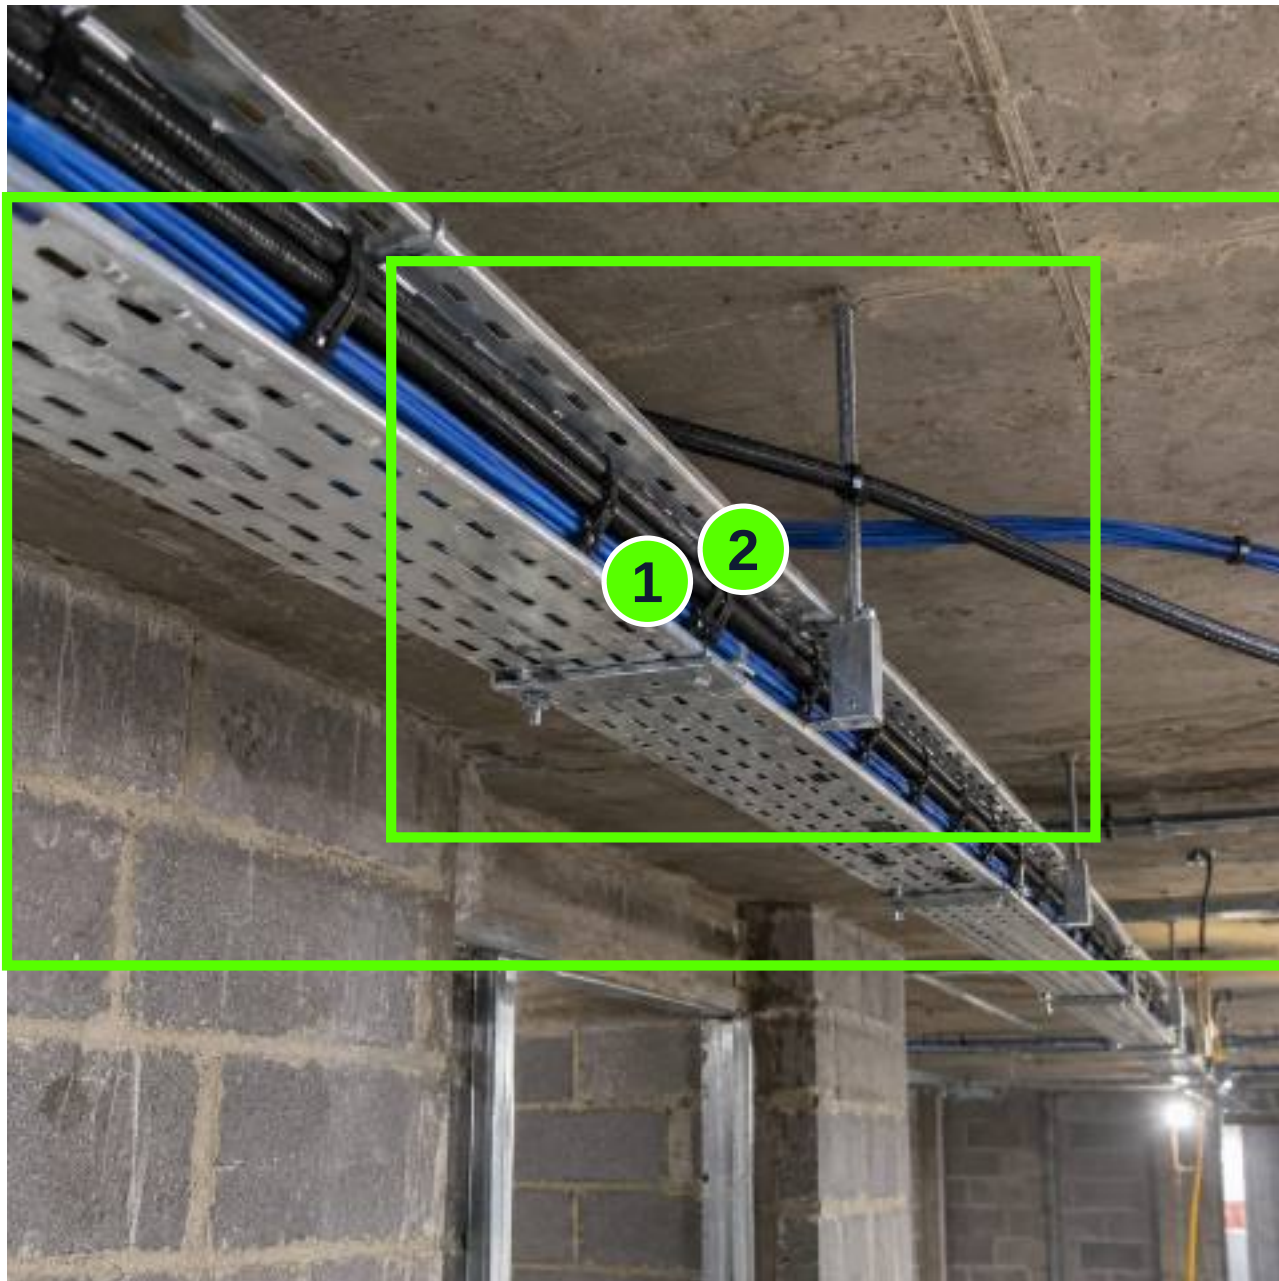
Photograph 4 - 2 items on this photograph, 2 pins on this photograph

Pin 1 - Item 3 - The perforated steel cable tray is suspended from the soffit on threaded rod hangers with pressed bracket fixings.

Pin 2 - Item 4 - The cable tray hanger arrangement is visible only in part.

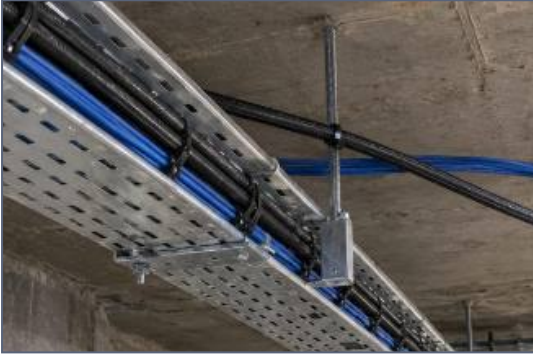
**Pin 2 of 2 - photograph 4**

The cable tray hanger arrangement is visible only in part. The spacing of the threaded rod supports along the run cannot be measured from the photograph, and the load carried by each fixing cannot be judged. The adequacy of the support spacing requires confirmation on site by a person.

Measure the actual hanger centres against the manufacturer's published support spacing for the tray type and the installed load. Confirm the soffit fixings are correct for the substrate. Record the result on the inspection schedule.

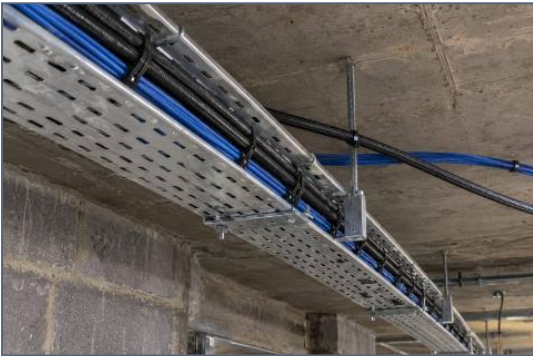
**Pin 1 of 2 - photograph 4**

The perforated steel cable tray is suspended from the soffit on threaded rod hangers with pressed bracket fixings. At the far end of the visible run, cables cross onto the tray with no visible tray edge protection or drop-out restraint, and the tray appears to terminate without a stop end. The visible condition of the tray itself is sound and the cables are dressed neatly within it.

Isolate and prove dead before working on the containment. Fit an end stop or drop-out plate to the tray termination and provide edge protection or a suitable protective device where cables enter and leave the tray, so that the cable sheath cannot chafe on the perforated edge. Confirm the finished arrangement against BS 7671:2018+A4:2026, with the specific regulation number to be confirmed.

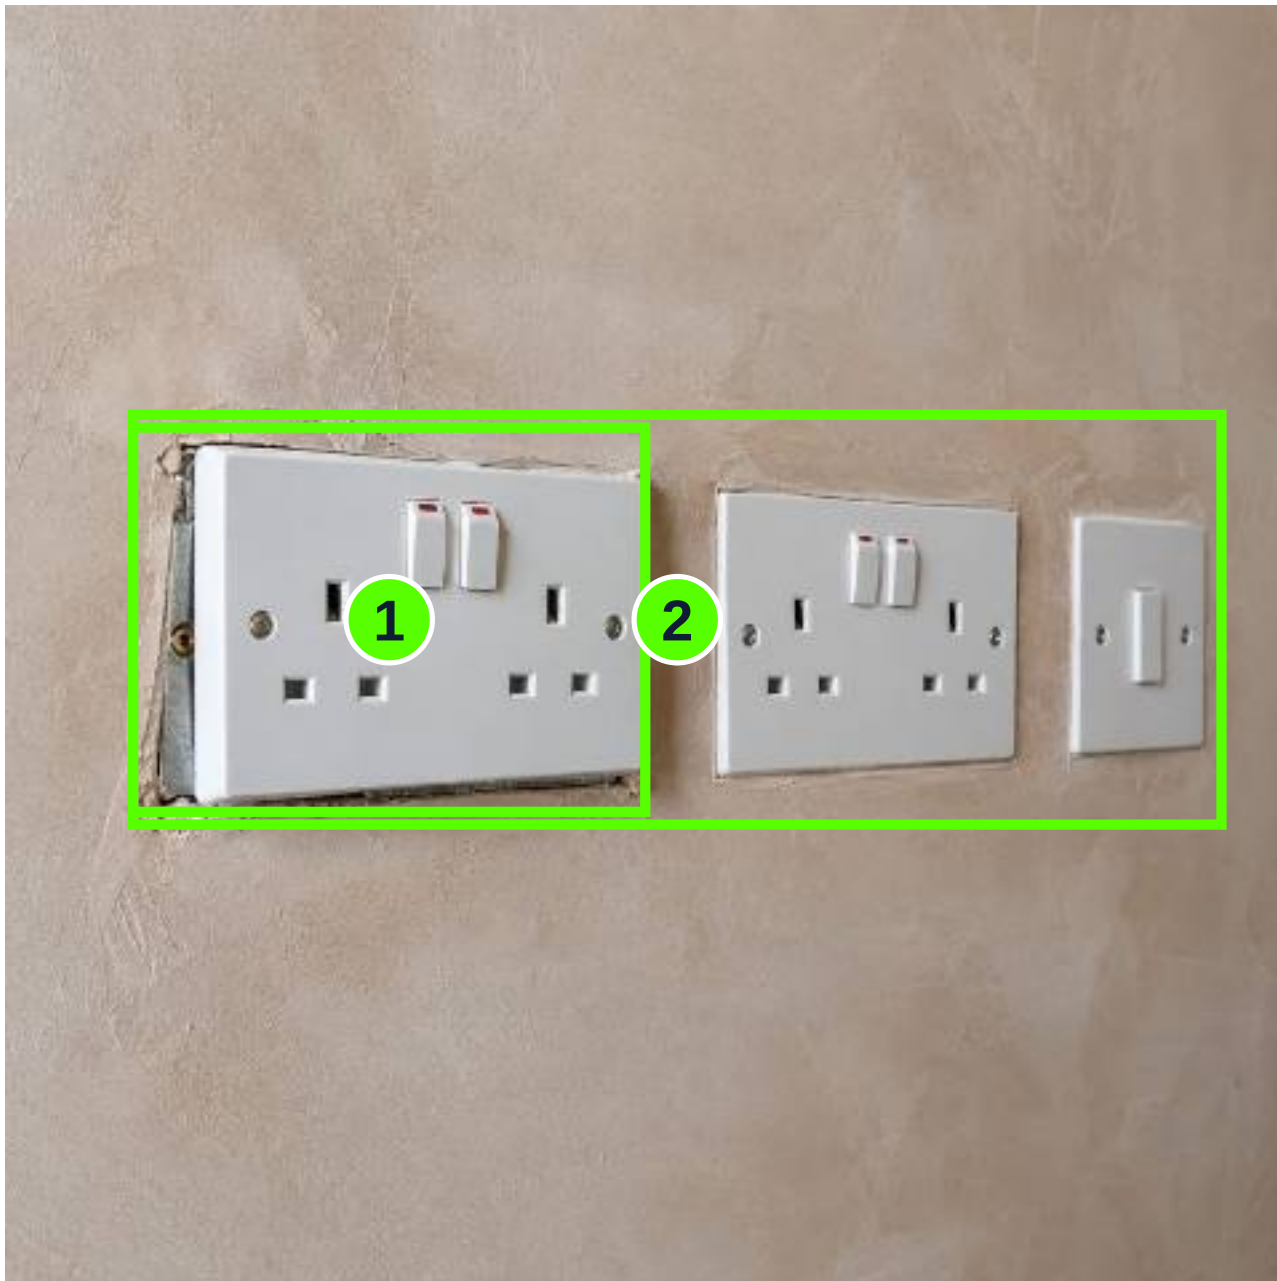
Photograph 5 - 2 items on this photograph, 2 pins on this photograph

Pin 1 - Item 8 - The metal back box of the left-hand twin socket outlet protrudes proud of the plaster finish and the surrounding plas...

Pin 2 - Item 9 - Both twin socket outlets and the associated switch plate are installed at differing heights and the spacing between t...

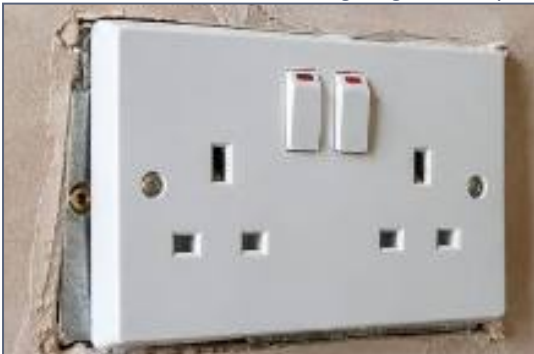
**Pin 1 of 2 - photograph 5**

The metal back box of the left-hand twin socket outlet protrudes proud of the plaster finish and the surrounding plaster has been broken away, leaving a gap between the box and the wall face. The box and its fixing lug are exposed, and the accessory plate does not sit flush against the finished wall. The level of enclosure integrity expected around an accessory at a finished wall is therefore not achieved at this position.

Isolate the circuit and prove dead before any work at the accessory. Make good the plaster reveal around the back box so that the box sits within the finished wall face, then refit the accessory plate square and flush, ensuring the plate makes effective contact with the wall and that no gap remains around its perimeter. Where the box cannot be brought back, engage a competent person to reset it. Energise only after the accessory has been refitted and the circuit verified.

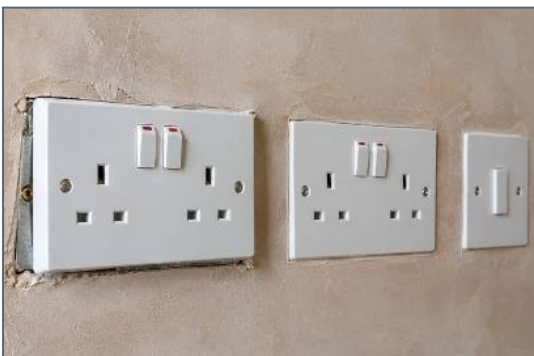
**Pin 2 of 2 - photograph 5**

Both twin socket outlets and the associated switch plate are installed at differing heights and the spacing between the plates is irregular, with the left-hand outlet set lower than the outlet to its right. The mounting heights have not been set consistently along the wall run.

Where the wall finish is to be reworked in any event, reset the boxes to a common height datum, taken from the finished floor level, and confirm the heights against the project specification before closing up. The circuit must be isolated and proved dead before any box is repositioned, and the accessories re-verified on completion.

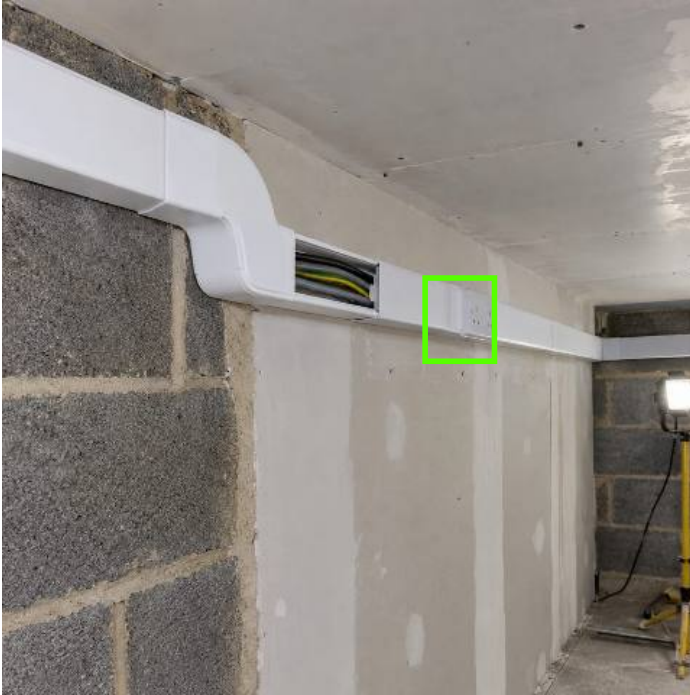
A flat accessory box is mounted within the trunking run and is secured by only two screws, set diagonally. The remaining fixing positions are unfilled, and the box does not present as a fully fixed, closed enclosure consistent with good installation practice.

Isolate the circuit and prove dead, then secure the accessory at all its fixing positions using the appropriate screws and close the enclosure fully. Confirm the terminations within the box and test the circuit before re-energising.

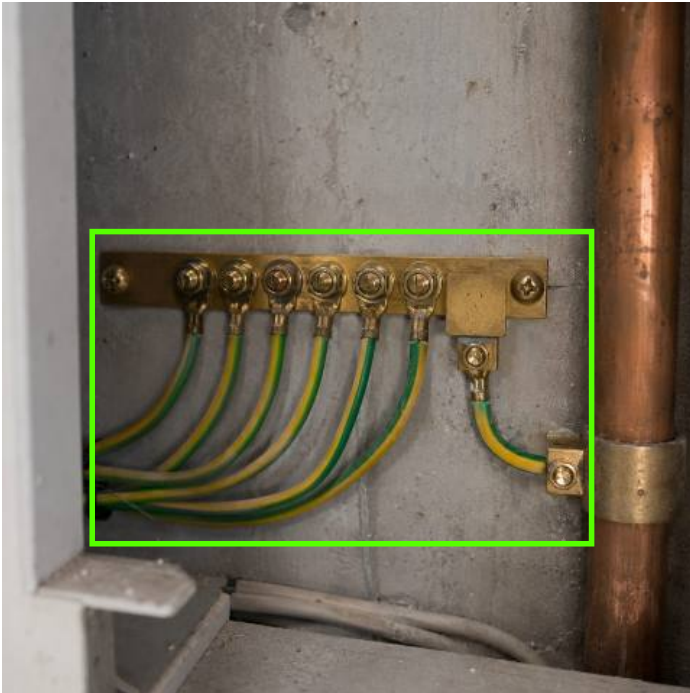
A brass main earthing bar is mounted on a bare concrete wall within an enclosure position. Six green/yellow circuit protective conductors are terminated to the bar by individual crimped lugs under set screws. A further connection is taken from a small square brass block fitted to the bar by a single bolt, and a green/yellow conductor of smaller cross-sectional area runs from that block to a brass earthing clamp on the adjacent copper pipe. The lug terminations on the bar are made at a consistent pitch and the conductors are dressed in a bundle to the lower left. The bar is fixed directly to the concrete wall face without an insulating stand-off, and the incoming conductors are not enclosed in conduit or trunking at the point where they leave the bar, so the protective conductors remain exposed and unsupported over the bundle to the left of the bar. The conductors are not individually identified by circuit.

Isolate and prove dead before any work to the bar. Re-form the conductor bundle into a defined route and secure it at regular centres to the wall or into a length of trunking or conduit, so that no protective conductor is left free-dressed. Fit individual circuit identification to each protective conductor by durable numbering or ferruling, and record the conductor sizes and the earth fault loop impedance readings in the schedule of test results. Confirm the continuity of every protective conductor and the main protective bonding connection by test, issued by a competent person on a certificate.

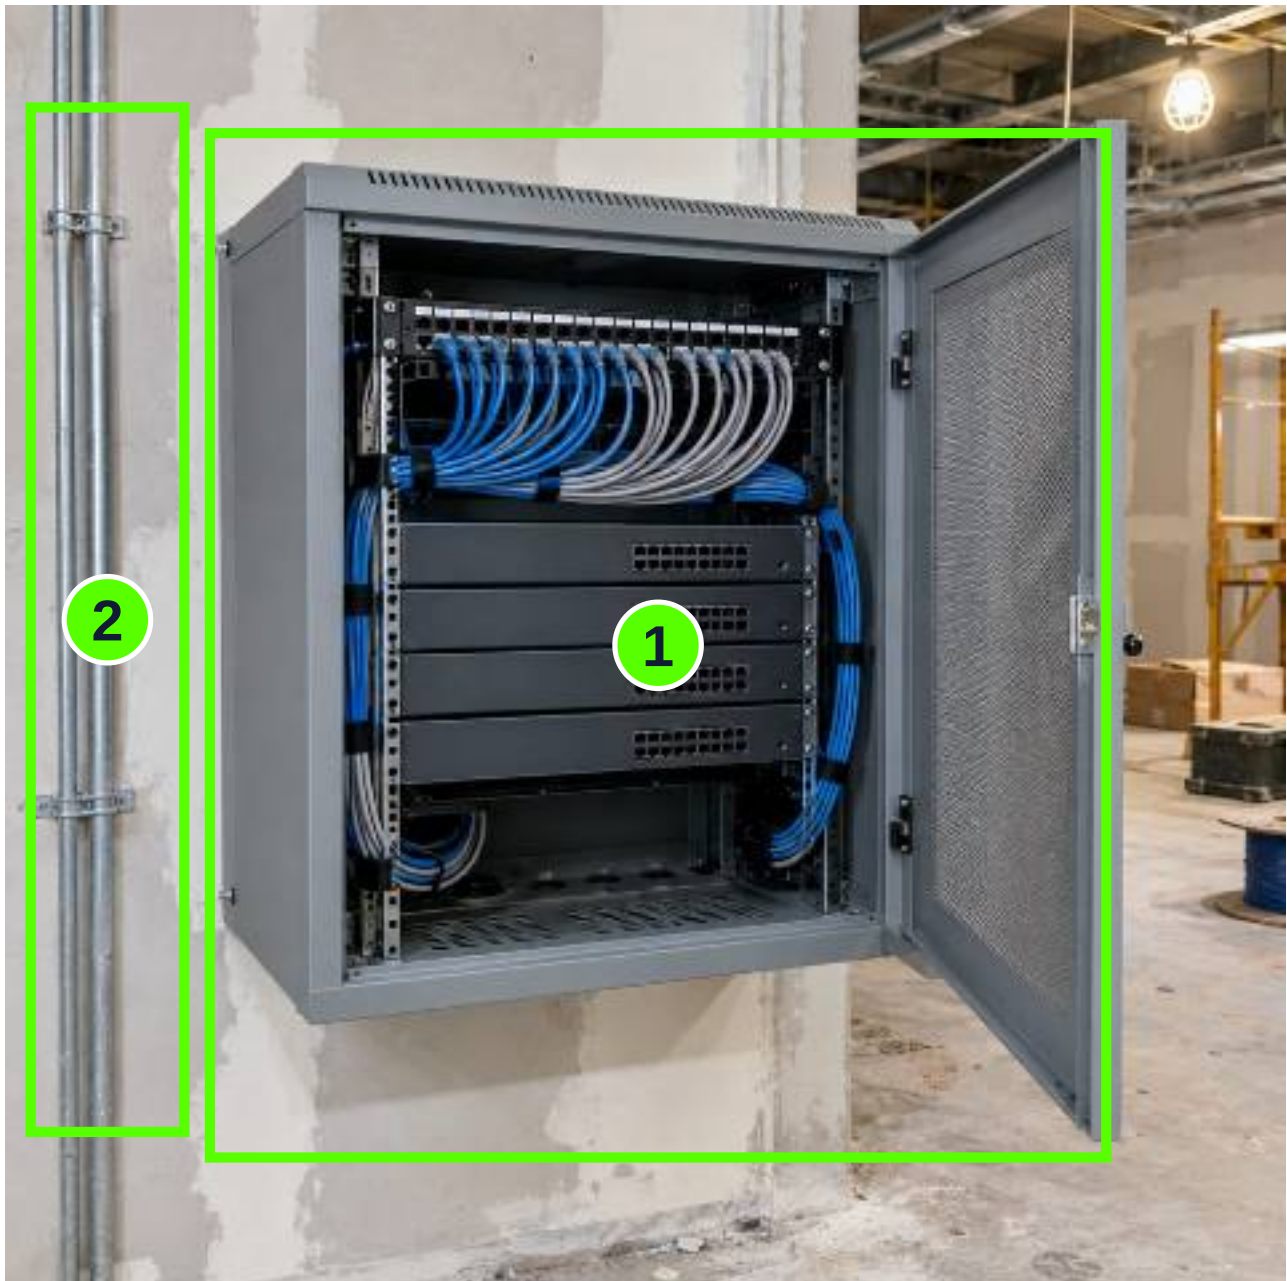
Photograph 7 - 2 items on this photograph, 2 pins on this photograph

Pin 1 - Item 5 - A wall-mounted steel communications cabinet is secured to a plastered wall with its mesh door open and undamaged.

Pin 2 - Item 6 - A galvanised steel conduit drop is fixed to the plastered wall to the left of the cabinet with two metal saddles, sec...

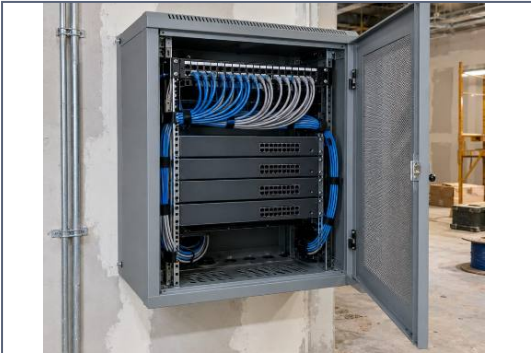
### Pin 1 of 2 - photograph 7

A wall-mounted steel communications cabinet is secured to a plastered wall with its mesh door open and undamaged. Data cabling within the cabinet is dressed with hook-and-loop ties and formed into a service loop. The cable management is neat, terminated and complete, and no exposed live conductive part is visible. The cabinet is a communications enclosure rather than a power distribution board, and no mains intake, protective device or earthing arrangement is visible within it.

Confirm the cabinet is correctly identified and that any metallic enclosure is bonded and earthed by a competent person, and verify the supply and protective device arrangement. Testing and certification by a competent person are required before the installation is signed off.

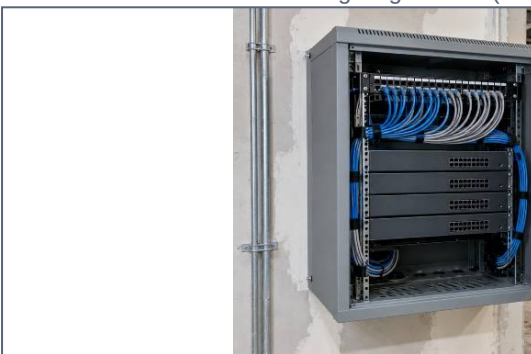
### Pin 2 of 2 - photograph 7

A galvanised steel conduit drop is fixed to the plastered wall to the left of the cabinet with two metal saddles, secured with visible screw fixings. The conduit run terminates below the level of the cabinet without a visible coupling, draw box or terminating accessory at the point shown, and its relationship to the cabinet is not evident from the photograph. The containment is supported and undamaged; the termination of the run cannot be confirmed from this view.

Inspect the full conduit run and confirm it terminates in an appropriate accessory and enters the enclosure or equipment correctly. Rectify any open end or unsupported termination. Testing and certification by a competent person are required where the run carries mains conductors.

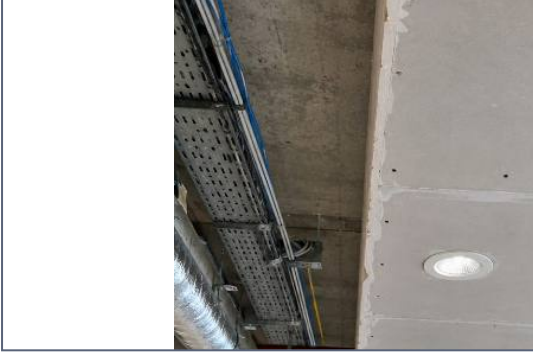
**Pin 3 of 3 - photograph 2**

To the left of the image, cable tray and basket containment are installed at high level above the ceiling line, carrying services in a runs arrangement with drops to plant. The containment is supported at regular intervals and the cable runs within it are laid in an orderly manner. No defect in the containment or its support is apparent at the distance shown.
