# Finding identification & remedial schedule - 8 October 2026

| Project | Riverside Court - Cat B Fit-Out, Phase 2 |
| Reference | SNG-2026-10-006 |

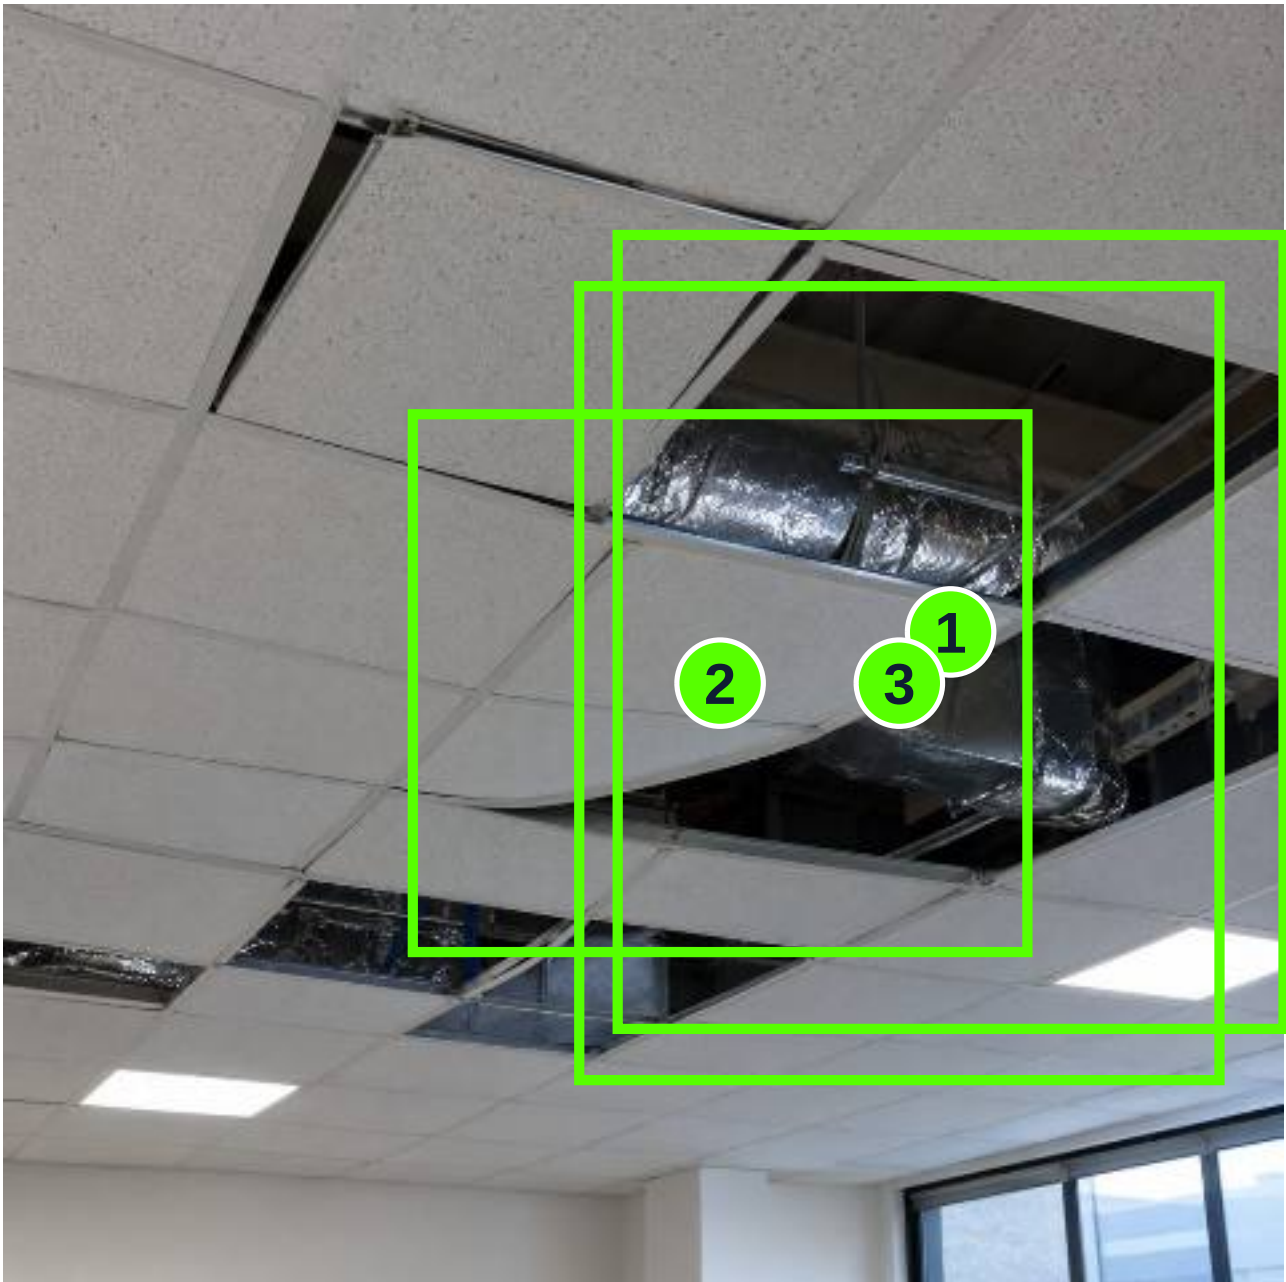
Photograph 8 - 3 items on this photograph, 3 pins on this photograph

Pin 1 - Item 7 - Four ceiling tiles are absent from the suspended grid, exposing the ceiling void.

Pin 2 - Item 8 - Pieces of ceiling tile are sagging below the underside of the grid, one adjacent to the open void at the centre of th...

Pin 3 - Item 9 - Within the open void, a length of insulated ventilation duct wrapped in foil-faced insulation is visible.

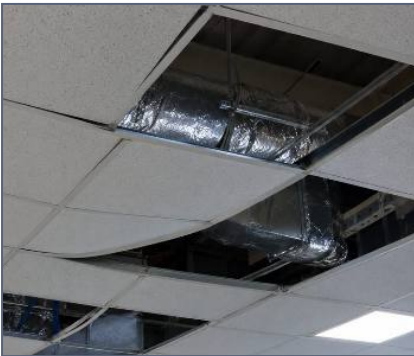
#### Pin 1 of 3 - photograph 8

Four ceiling tiles are absent from the suspended grid, exposing the ceiling void. The surrounding tile edges remain in place within the grid. It cannot be determined from the photograph whether the tiles have been removed for access to the services above or whether they are missing as a defect, and the exclusion for work in progress applies until that is confirmed.

Establish on site whether the tiles have been removed for maintenance access. If they have, they are to be replaced on completion of the works; if not, replacement tiles to be sourced to match the existing pattern and installed. No fix should be specified until the reason for removal is known.

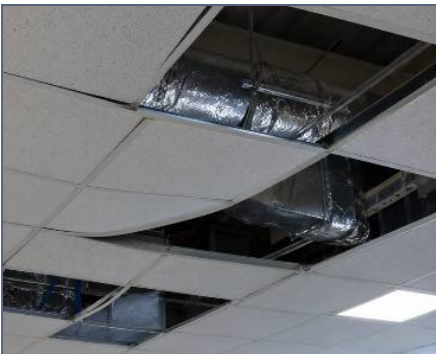
#### Pin 3 of 3 - photograph 8

Within the open void, a length of insulated ventilation duct wrapped in foil-faced insulation is visible. The insulation is creased and reflective where it passes over the grid line at the upper left of the opening. No duct appears to be supported directly off the ceiling grid in the area shown. The visible surfaces appear dry and intact. Duct installation is commonly left incomplete at the time of the photograph, and this cannot be resolved from a single image.

Before handover, verify the duct support spacing and the continuity of the vapour-tight insulation against the duct manufacturer's installation instructions and the project specification. Where the insulation has been disturbed or gapped at the grid line, re-dress and tape the joints to restore the vapour seal.

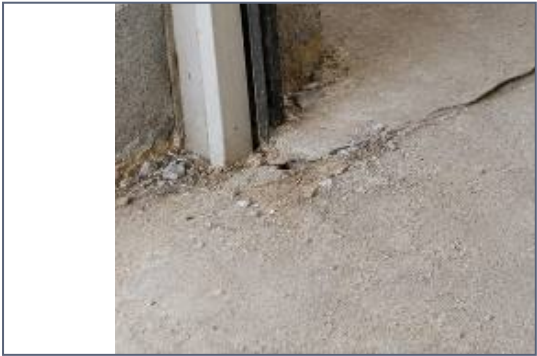
Pin 2 of 2 - photograph 9  
A crop of the area this item refers to.

At the threshold opening, the junction between the concrete floor slab and the base of the blockwork wall and the door frame is broken down, with loose aggregate, mortar and debris present in the gap. The frame sits on a small mortar or screed bed which is crumbly and uneven, and there is a visible gap between the underside of the frame and the slab. The extent of the gap and whether a weather seal or damp-proof detail is present cannot be confirmed from this image.

Likely cause: Most likely the bedding or pointing at the threshold has broken down through impact from traffic or from the frame installation, or the base bed was laid on a dusty or unprepared slab and has debonded. It may also be that the junction has never been properly finished, and this is incomplete work still to be done.

Reference: Approved Document C - site preparation and resistance to contaminants and moisture

Remove all loose mortar, aggregate and debris from the threshold junction and clean back to sound material. Confirm on site whether this is an external opening: if it is, the threshold must incorporate a continuous damp-proof course and a sealed weather detail in accordance with the manufacturer's instructions for the frame system. Re-point and make good the base bed to the frame, sealing the junction with a suitable external-grade sealant, and ensure the damp-proof course is lapped and continuous. Refer the detail to the principal contractor's design lead where the as-built junction does not match the specified detail.

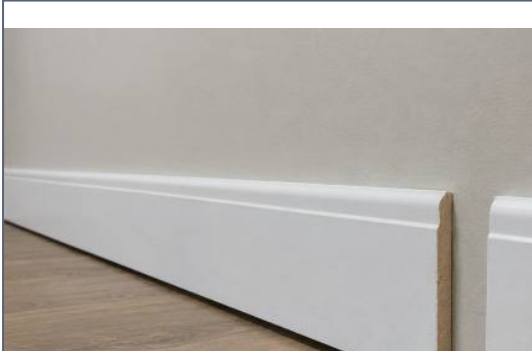
### Pin 2 of 3 - photograph 1

The skirting boards appear to be fitted direct to the wall face with no visible caulk or sealant line to the top edge where the skirting meets the plaster. The junction reads as a hard painted edge rather than a sealed joint. The painted finish to the boards is otherwise sound and the face is free of runs or blistering.

Likely cause: The most likely cause is that decoration has been carried out without the sealing of the skirting junction, or that the sealant has yet to be applied. A photograph cannot confirm which, and the item may simply be work in progress.

Confirm on site whether a caulk line was specified to the top edge. Where it was, rake out and apply a paintable acrylic caulk to the junction, tool it off, allow to cure and decorate. Where no caulk was specified, confirm the specified finish before adding one, as some specifications deliberately call for a dry shadow gap.

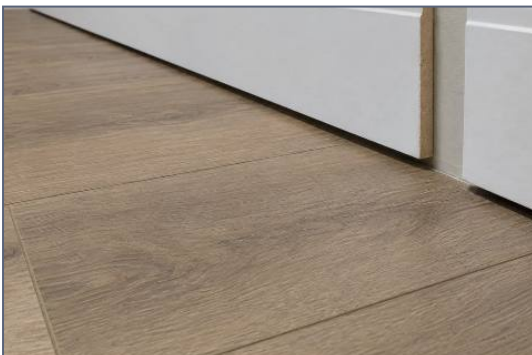
### Pin 3 of 3 - photograph 1

The junction between the floor covering and the base of the skirting is tight and appears to be covered by the skirt. The flooring is laid with the boards running parallel to the wall and the joints are close. No scuffing, lifting or moisture staining to the floor covering is visible in the area shown.

Review the junction at handover once the skirting joint has been rectified, confirming the floor covering is not trapped or damaged by the skirting and that any specified expansion allowance at the perimeter is present. No action is required if the junction remains sound.

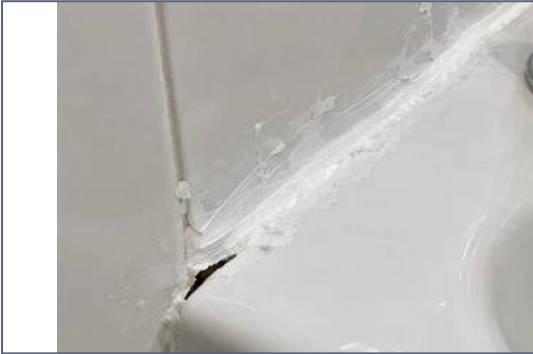
**Pin 3 of 3 - photograph 2**

Sealant residues are present on the glazed face of the basin adjacent to the tap and on the tile faces to the left of the joint. These appear to be surplus material from the sealing works rather than damage to the glaze.

Likely cause: Surplus sealant left on adjacent surfaces during application, without a final clean-up pass.

Remove the residues with a plastic scraper and a suitable solvent or sealant remover, taking care not to abrade the glaze or the tile face, once the joint itself has been rectified.

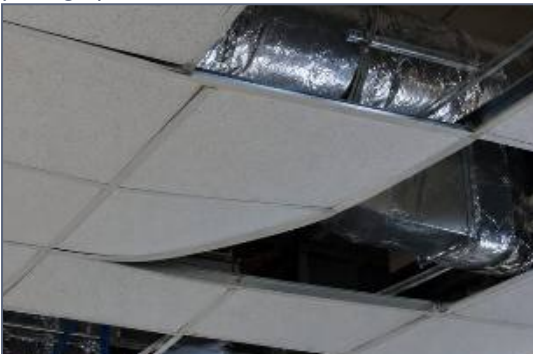
**Pin 2 of 3 - photograph 8**

Pieces of ceiling tile are sagging below the underside of the grid, one adjacent to the open void at the centre of the image and a further two in the lower left of the frame. The tiles have lost flatness and are sitting proud of the grid line. No staining or water marking is evident on the affected tiles from this view.

Likely cause: Moisture uptake, overloading or physical distortion during handling and installation are all plausible. A single photograph does not allow the cause to be established.

Lift and reseal the affected tiles onto the grid flanges. If the sagging recurs or the tiles will not sit flat, remove one tile and inspect the void for moisture, damaged grid sections or overloading. Replace any tile that remains deformed.

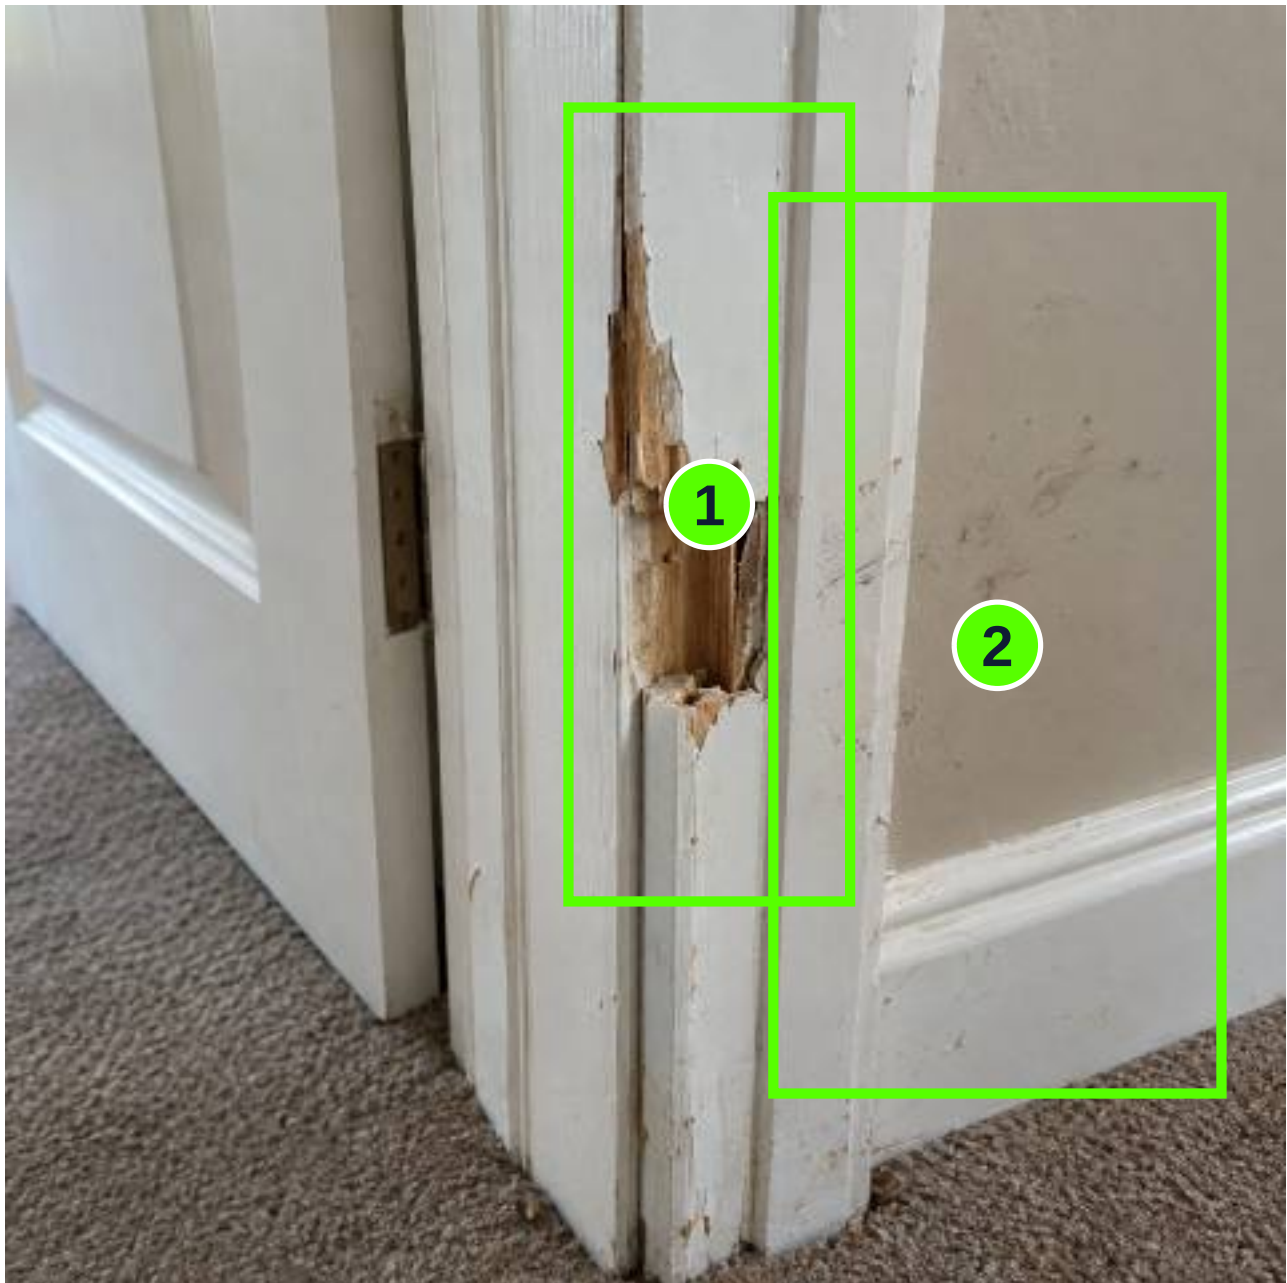
Photograph 10 - 2 items on this photograph, 2 pins on this photograph

Pin 1 - Item 5 - The lower section of the door casing, at strike-plate height and immediately below it, has suffered significant loss ...

Pin 2 - Item 6 - The timber face of the casing to the right of the damaged area, and the adjacent section to the left, carry multiple ...

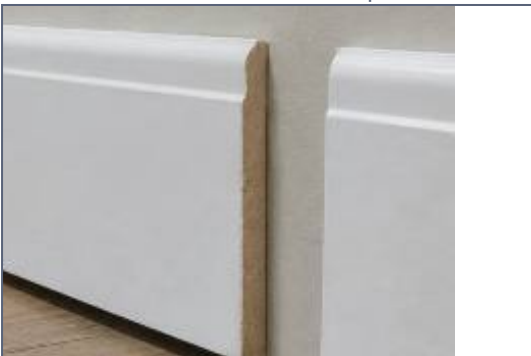
### Pin 1 of 3 - photograph 1

A length of primed skirting board has been fitted short against an adjoining return, leaving an open butt joint of approximately 8 to 10 mm between the two sections. The cut end of the board is exposed and unfinished, showing the bare MDF core with no primer, sealant or paint to the end grain. The gap is open along the full height of the skirting and is not filled.

Likely cause: The most likely cause is that the board was cut short during installation, either through inaccurate setting out or because the run was worked to a closing dimension and the last length was not measured back to the return. A secondary plausible cause is movement of the board after fixing, where insufficient or incorrectly spaced fixings have allowed the joint to open. It is not possible to determine from the photograph which of these applies.

Cut a short infill section of matching skirting to close the gap, or refit the board to a tight butt against the return. Prime all cut ends before fitting, fix to the wall with the specified adhesive and mechanical fixings, fill the joint, then caulk and decorate. Confirm on site who owns the joint between the skirting run and the adjoining return before making good.

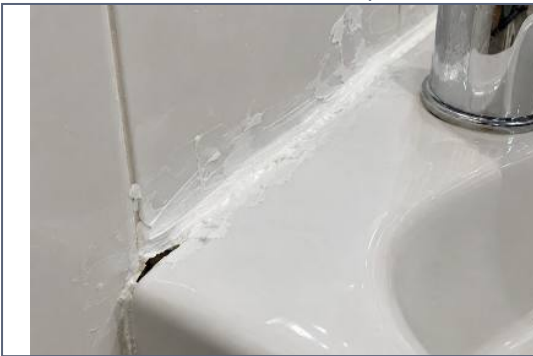
### Pin 1 of 3 - photograph 2

The silicone sealant at the junction between the rear upstand of the white ceramic basin and the tiled wall has been applied poorly and smeared across the tile face and the basin surfaces. The sealant line is irregular in width, feathered against the glaze, and spread in patches over an area roughly 250 mm wide and 120 mm high around the tap. Tooling is absent: the bead is left as a series of smears rather than a continuous fillet.

Likely cause: The most likely cause is application of the sealant without tooling or masking, applied by an operative not experienced in sanitaryware sealing. An alternative or contributory cause is a re-seal carried out over an inadequately cleaned and prepared joint.

Cut out and remove the existing silicone mechanically with a sealant remover or sharp blade, clean both faces with a suitable solvent to remove all residue and grease, allow to dry, then apply a single continuous bead of sanitary-grade silicone and tool it immediately to a consistent fillet. The tiler or sanitaryware installer owns this junction.

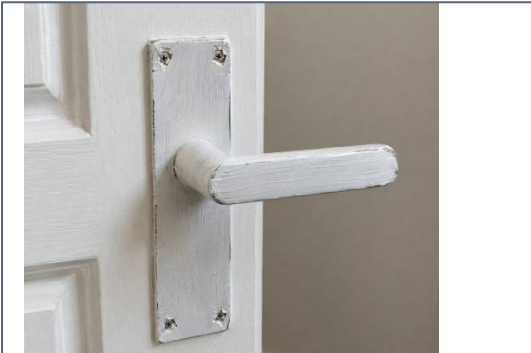
#### Pin 1 of 2 - photograph 3

The door lever handle has been painted over, with the coating bridging the lever, the rose and the backplate as a single continuous film of paint. The lever-to-rose junction is sealed by paint, and the brush marks run across the handle where the hand grips. The coating is heavy along the top edge of the lever, where it is most likely to chip away in use.

Likely cause: The handle was left in place when the door was decorated, so the coating was applied across the lever, rose and backplate. Loss of the screw heads is a consequence of the same work rather than a separate cause.

Strip the paint from the lever, rose and backplate, remove the handle from the door, clean the paint out of the screw slots and the lever pivot, and refit. Make good and redecorate the handle and backplate separately from the door leaf so that the lever is free to operate and is not bridged by paint.

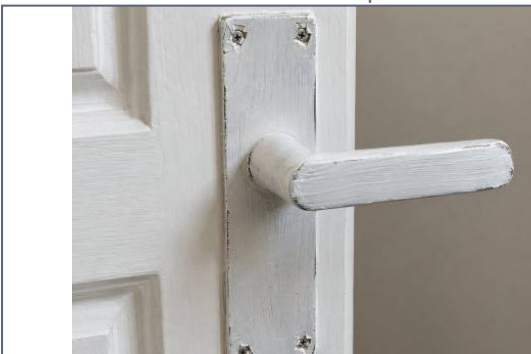
#### Pin 2 of 2 - photograph 3

The four backplate screws have been painted over and the coating has filled the screw slots. The screw heads are buried in the coating and cannot be driven with a screwdriver without first cutting the paint out of each slot.

Likely cause: The screws were not removed or masked before the door was painted, so the coating was applied directly over the fixing heads.

Cut the paint out of each screw slot, remove the backplate screws, clean the threads and slots, and refit the handle. Redecorate with the ironmongery removed, or mask the screw heads individually if the handle must remain in place.

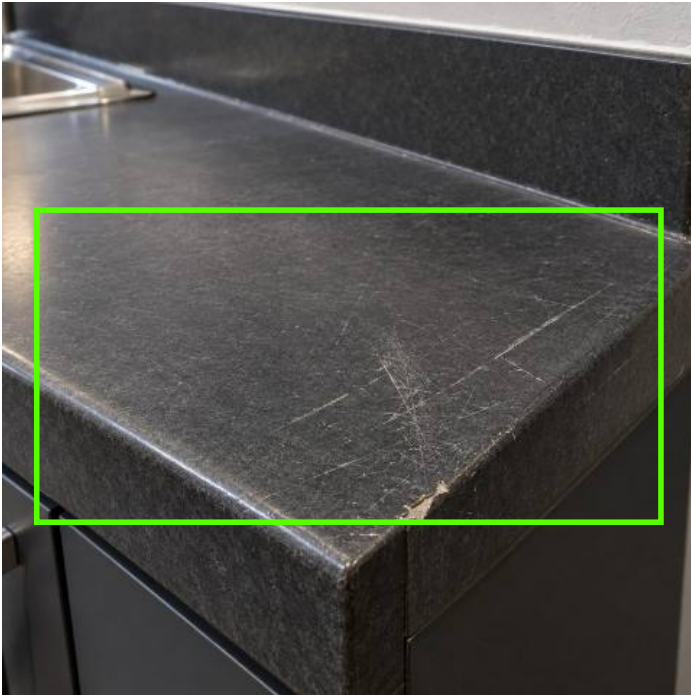
The dark grey worktop surface carries a widespread pattern of fine surface scratching, with a denser concentration extending across approximately the front half of the visible counter and a further cluster of linear scratches running diagonally towards the front corner. The scratches are shallow and appear to be confined to the polished surface layer. The density of the marking indicates mechanical abrasion across a substantial part of the visible area rather than a single localised scuff.

Likely cause: Mechanical abrasion during handling, storage, installation or the protection regime. Protection left in place too long, or grit trapped beneath protective covering, is a common contributor. The photograph does not permit the cause to be established with certainty.

Confirm the worktop material and its specified finishing regime before any action is taken. Establish whether the abrasion is confined to the surface layer or has penetrated the decorative finish; where it is superficial, a specialist stone or solid-surface restorer should undertake a controlled abrasive polish of the affected area and re-establish the specified sheen. Where the marking extends below the surface layer, the affected section will require replacement and re-jointing to the upstand and sink cut-out. Photographic records of the affected area should be taken before works commence, as further scratching is likely during any remaining site activity.

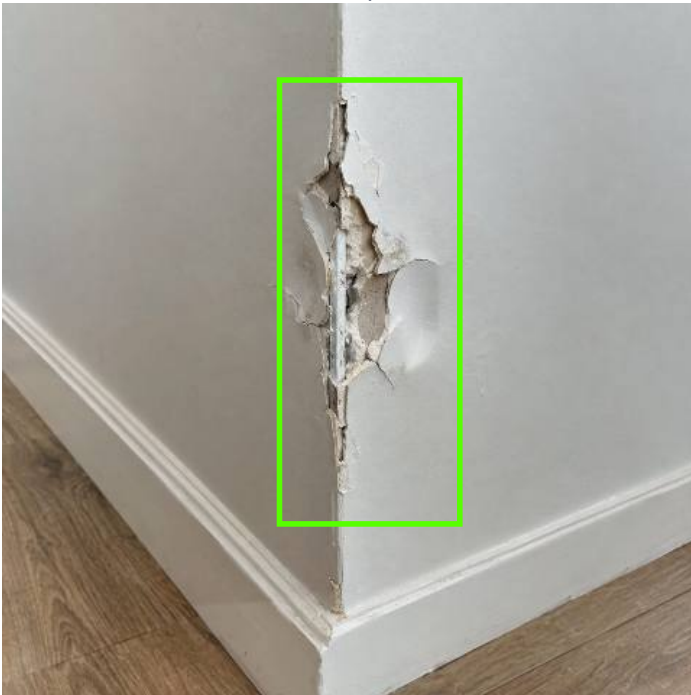
The external corner between the two plastered wall faces is damaged over a vertical run of approximately 200mm. A metal angle bead is exposed along the corner and the plaster skim has broken away from it in irregular flakes, leaving the grey backing coat and the bright metal bead visible. The damage is widest at the upper third of the exposed section, roughly 60mm across on the face to the right, and tapers to a crack below. The remaining plaster edges are proud and feather-edged, and the painted finish is fractured back from the break line.

Likely cause: Most likely impact damage to the corner arris after plastering, either from a trolley, board or other site movement, which has broken the skim away from the bead. A secondary possibility is that the bead was not adequately bedded or fixed, so the plaster never bonded to it and failed under minor contact. The photograph alone does not establish which, and both should be checked on site before the repair is specified.

Cut back the paint and loose plaster to sound, well-bonded material around the full extent of the damage. Check the angle bead is correctly fixed and does not move under finger pressure; refix or replace if it is loose, and confirm it is set plumb and true before making good. Pre-wet the edges, fill flush over the bead with a suitable patching plaster in two coats, allow to dry, then fill and sand the corner to a true arris. Spot prime and repaint the full corner to a natural break in the wall finish so the patch does not read. Carry out after the room is otherwise finished to avoid repeat damage.

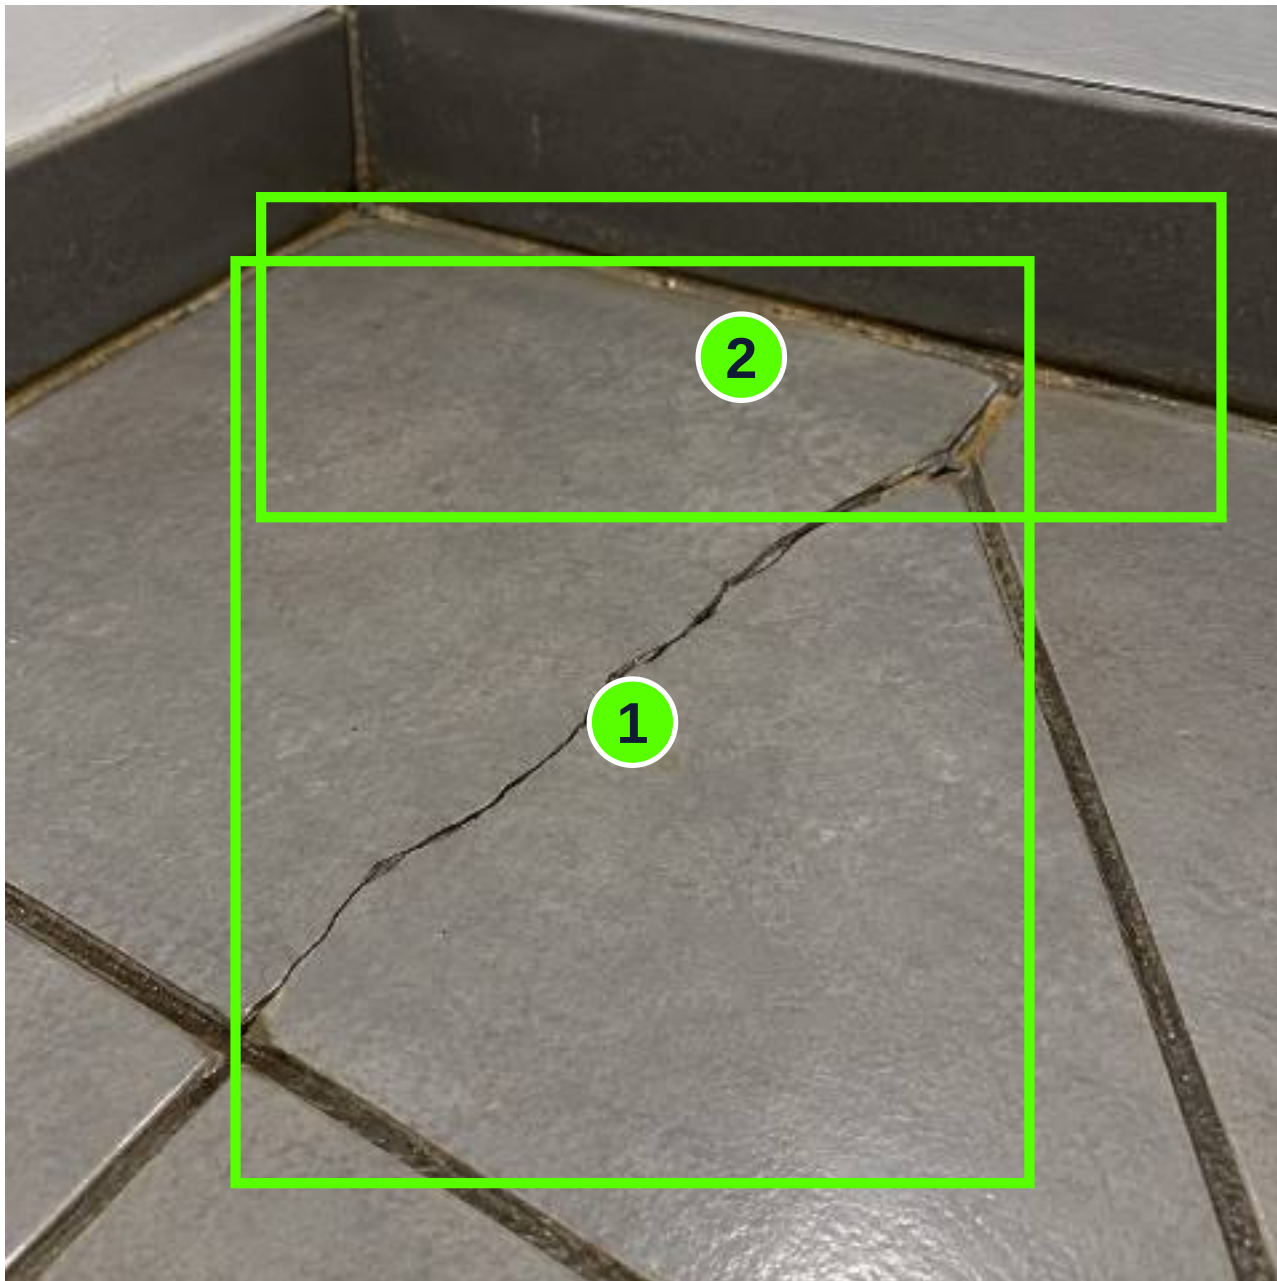
Photograph 6 - 2 items on this photograph, 2 pins on this photograph

Pin 1 - Item 11 - A single diagonal crack runs across one floor tile for approximately 400 mm, passing through the tile body from the j...

Pin 2 - Item 12 - The expansion or movement gap between the perimeter of the tile field and the base of the skirting is filled with gro...

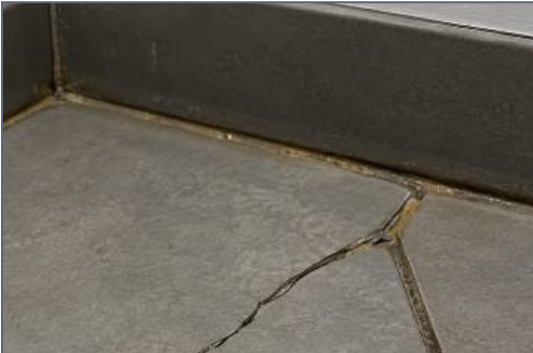
### Pin 2 of 2 - photograph 6

The expansion or movement gap between the perimeter of the tile field and the base of the skirting is filled with grout rather than a compressible sealant. The junction is bridged hard over its visible length of approximately 1.5 m, and the grout line at this interface shows fine hairline separation in places.

Likely cause: The grout appears to have been carried into the perimeter joint in place of a compressible sealant, most likely because the movement joint detail was not identified or was overlooked at installation.

Rake out the grout at the perimeter junction back to a clean, dry, sound substrate and install a compressible backing rod with a flexible sealant compatible with the tile and skirting, leaving the joint free to move. Confirm the joint owner: the perimeter movement joint at a skirting interface is normally the tiling trade's responsibility, with the skirting itself the joiner's, and the interface must be agreed on site before work proceeds.

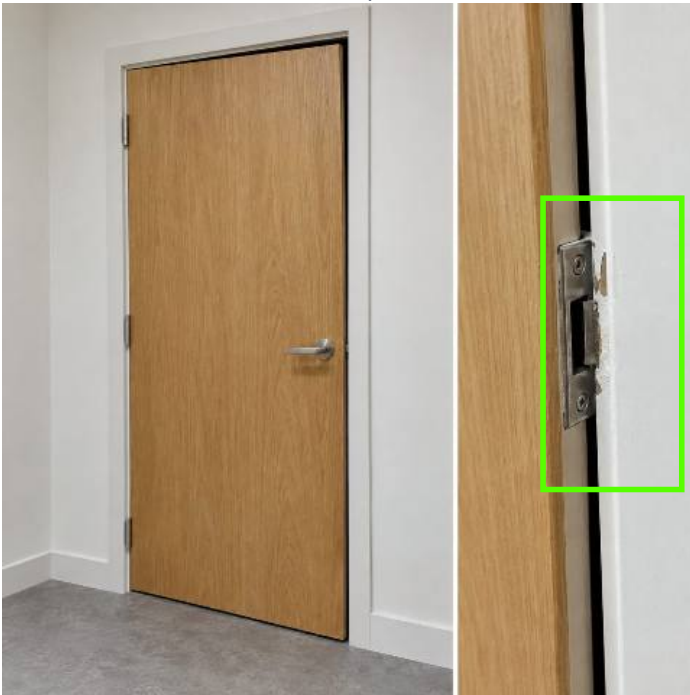
At the striker plate position on the closing jamb, the timber reveal behind the metal plate has broken away and the plate is bedded unevenly against the cut. The painted face of the lining adjacent to the plate is chipped and ragged over an area of approximately 40 mm by 60 mm, and the plate sits proud of the surrounding face. The strike is not rebated flush into sound timber.

Likely cause: Most probably the strike rebate was cut too deep or the fixing screws were over-tightened, causing the plate to pull and the surrounding timber to break out. It is also possible the lining is of a composite or hollow construction that does not accept a rebate well.

Remove the strike plate and ironmongery from the jamb. Cut out the damaged section of lining and let in a solid timber repair, or replace the affected length of lining. Re-form a clean rebate to the correct depth, refit the strike plate flush and true, and make good the paint finish. Confirm the door latch engages fully and the door closes without effort before decoration is signed off.
