# Schedule of Condition - 8 October 2026

| Project | Riverside Court - Cat B Fit-Out, Phase 2 |
| Reference | SOC-2026-10-001 |

## SCHEDULE OF CONDITION

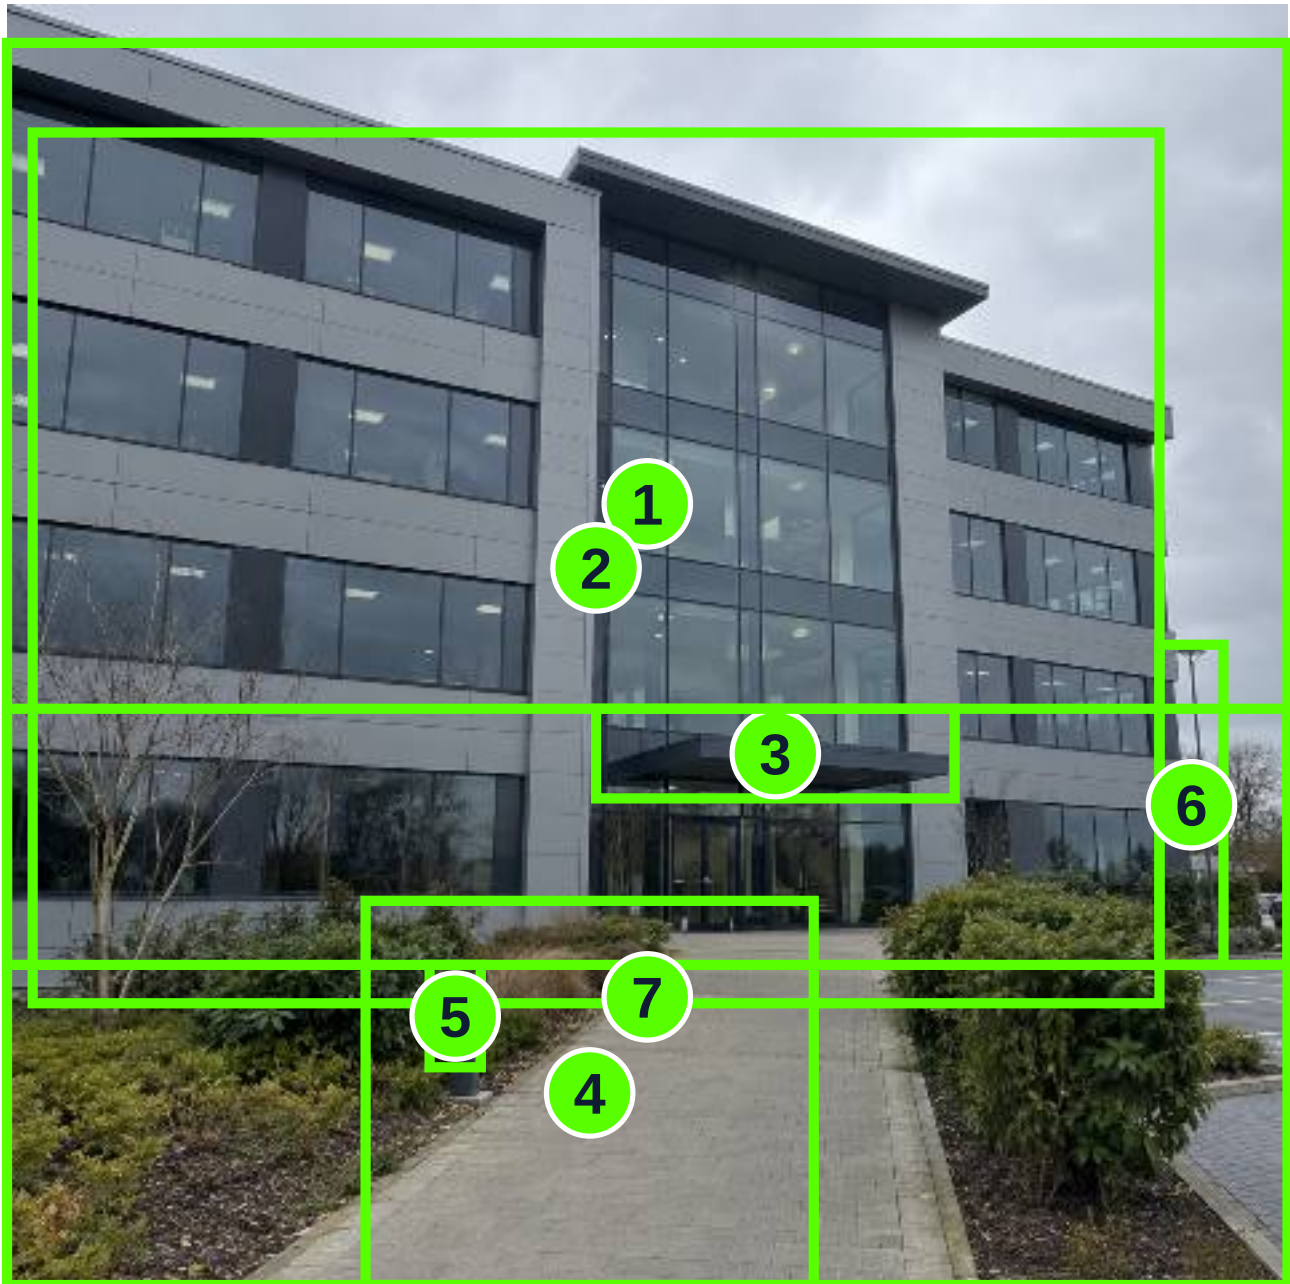
Photograph 1 - 7 items on this photograph, 7 pins on this photograph

Pin 1 - Item 21 - The grey rainscreen cladding panels to the principal elevation are visible across all four storeys.

Pin 2 - Item 22 - The curtain walling and window glazing to the elevation, including the full-height glazed entrance bay, are intact.

Pin 3 - Item 23 - A projecting canopy is present over the main entrance doors, finished in a dark soffit.

Pin 4 - Item 24 - The paved approach to the entrance is laid in modular block paving.

Pin 5 - Item 25 - A single column-form bollard luminaire is visible to the left of the paved approach.

Pin 6 - Item 26 - A lighting column is visible at the right-hand edge of the frame, serving the adjacent parking area.

Pin 7 - Item 27 - Ornamental shrub planting and deciduous trees in the beds adjoining the paved approach are visible.

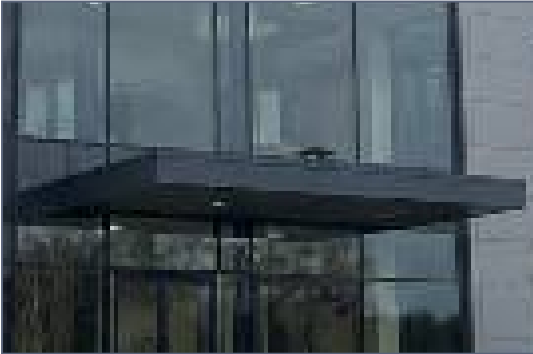
#### Pin 3 of 7 - photograph 1

A projecting canopy is present over the main entrance doors, finished in a dark soffit. The canopy appears generally sound, although the soffit is in shadow and the underside, fixings and drainage outlets cannot be inspected from this position. Minor soiling may be present on the leading edge but cannot be confirmed.

No action on the evidence available. The canopy soffit, fixings and drainage should be inspected from below at close quarters.

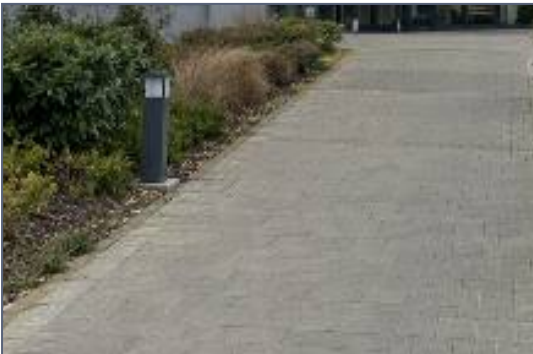
#### Pin 4 of 7 - photograph 1

The paved approach to the entrance is laid in modular block paving. The surface appears level and intact, with no visible cracking, rutting, ponding or missing units. Moss or algae growth is visible in the joints within the landscaped margins, which is typical of the season and the shaded position.

Routine maintenance. Vegetation should be kept clear of the paving edges to prevent joint opening.

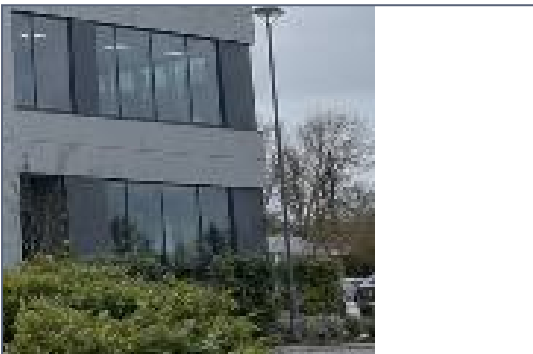
#### Pin 6 of 7 - photograph 1

A lighting column is visible at the right-hand edge of the frame, serving the adjacent parking area. The column appears upright and painted. The base, door, connections and luminaire cannot be examined at this distance or within the frame.

No action on the evidence available. Base condition and earthing should be confirmed at close quarters.

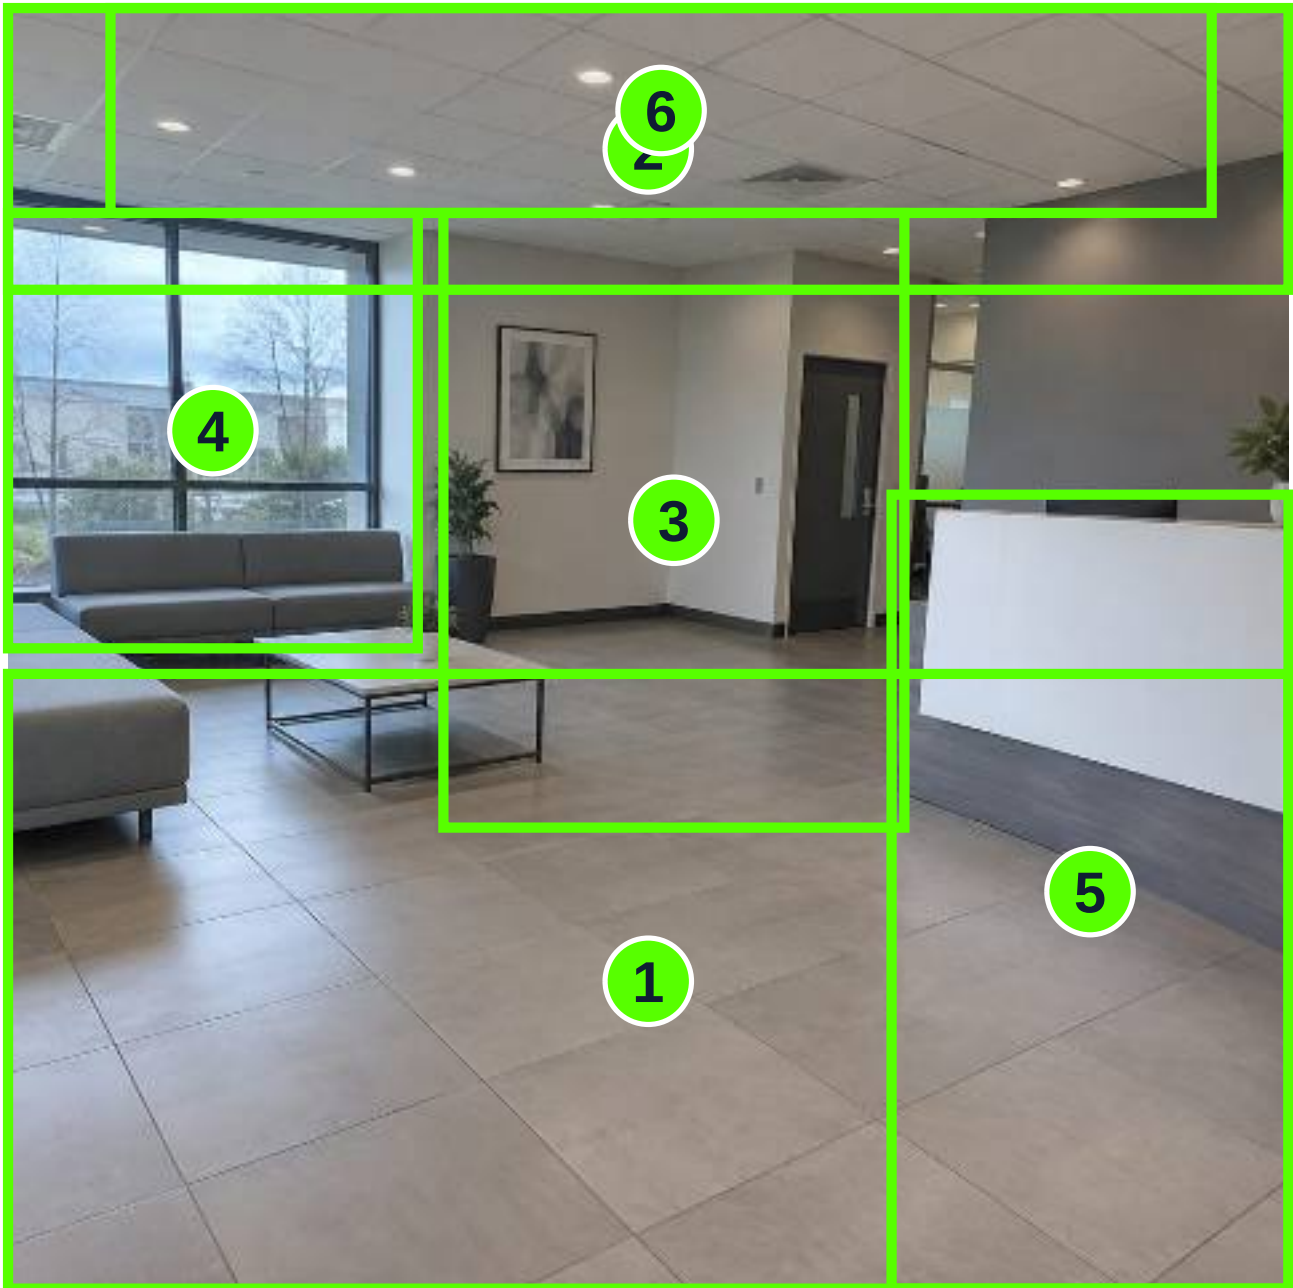
Photograph 3 - 6 items on this photograph, 6 pins on this photograph

Pin 1 - Item 15 - The reception floor is finished in large-format rectangular tiles laid to a regular grid with narrow joints.

Pin 2 - Item 16 - A suspended ceiling of square tiles in a concealed grid spans the reception area, incorporating recessed downlighters...

Pin 3 - Item 17 - Internal partitions are finished in a light neutral paint with a darker contrasting panel to the right-hand wall, and...

Pin 4 - Item 18 - A large fixed glazed screen with dark metal framing forms the left-hand elevation, with a horizontal transom dividing...

Pin 5 - Item 19 - A reception desk occupies the right-hand side of the space, formed of a light-coloured upper face panel over a darker...

Pin 6 - Item 20 - Recessed circular downlighters are set into the ceiling grid and a number are illuminated as shown.

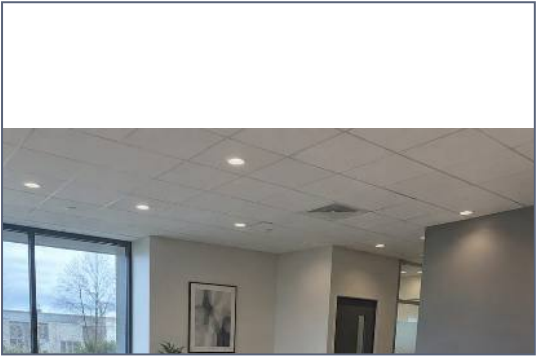
Pin 6 of 6 - photograph 3

Recessed circular downlighters are set into the ceiling grid and a number are illuminated as shown. The fittings are flush with the ceiling plane and no damaged or displaced luminaire bezel is visible. The photograph does not show the fittings at sufficient proximity to assess lamp condition, lens cleanliness or emergency lighting provision.

No action required on the evidence available. Emergency lighting provision should be verified against test records rather than by photograph.

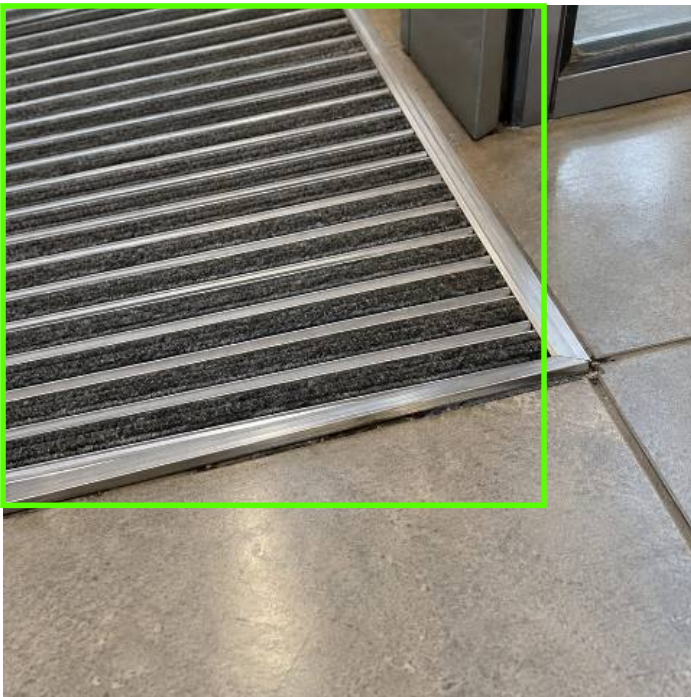
An entrance matting system of the aluminium rail and heel-resistant insert type is present, formed of parallel tread rails with profiled metal capping edges and mitred corner junctions. The insert material is visibly soiled and darkened across the width, indicating accumulated detritus. The aluminium rails present a bright, sound appearance with no visible distortion, displacement or missing sections within the photographed extent. The mitred junction at the left-hand edge is tight and the capping trim sits flat.

Routine maintenance is required. The matting inserts are to be cleaned in accordance with the manufacturer's guidance, and the rail fixings are to be checked and the well vacuumed at the next scheduled maintenance visit.

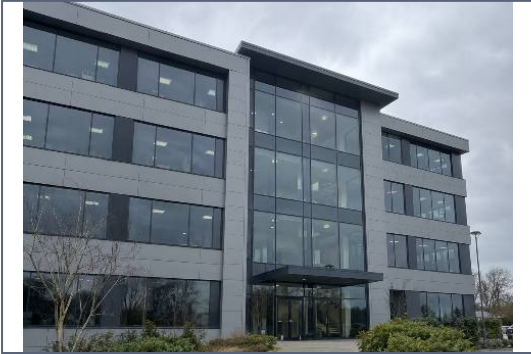
**Pin 1 of 7 - photograph 1**

The grey rainscreen cladding panels to the principal elevation are visible across all four storeys. The panel faces appear sound and consistently aligned, with no separation, impact damage, staining or open joints discernible at this viewing distance. The condition of the panel fixings and the substrate behind the panels cannot be determined from the photograph.

No action. Routine wash-down may be scheduled as part of the standard maintenance regime.

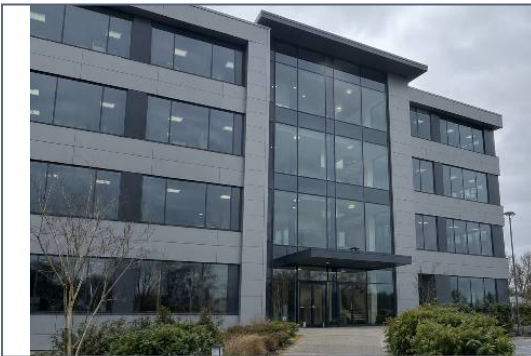
**Pin 2 of 7 - photograph 1**

The curtain walling and window glazing to the elevation, including the full-height glazed entrance bay, are intact. No cracked, crazed or displaced panes are visible, and the glazing lines read straight. Reflection and the viewing distance prevent any assessment of sealant condition, gasket condition or any interstitial condensation.

No action. Sealant and gasket condition should be verified at close quarters as part of routine maintenance.

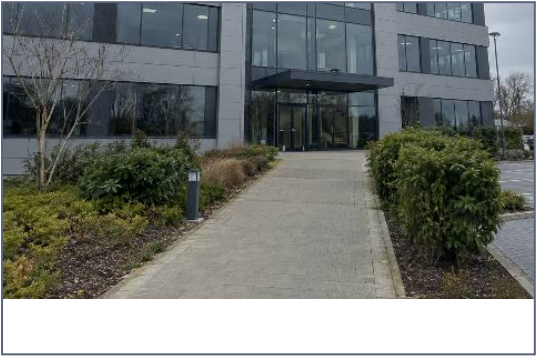
Pin 7 of 7 - photograph 1

Ornamental shrub planting and deciduous trees in the beds adjoining the paved approach are visible. The planting is established and the trees are bare, consistent with the dormant season. No obvious dieback, storm damage or fallen material is visible in the beds.

No action. Seasonal maintenance to continue as programmed.

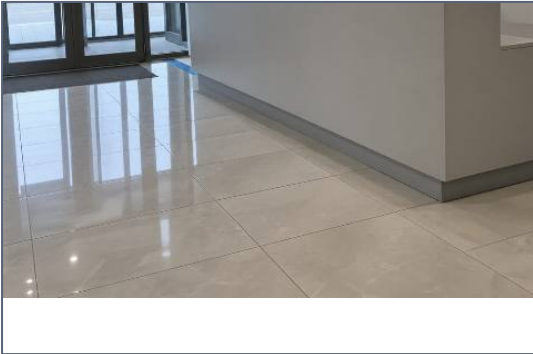
### Pin 1 of 5 - photograph 2

Reception floor finished with large-format polished stone-effect tiles laid to a grid, with a reflective surface. The tiles are visible across the foreground and toward the entrance; the surface appears clean and intact, with no visible cracking, lippage, staining or open joints within the area the photograph supports. Reflections from the ceiling lights and glazing are present, which is inherent to the polished finish. A strip of blue protective tape is present on the floor adjacent to the internal corner of the reception desk; this appears to be a temporary protective measure and is not recorded as a defect.

No action required to the floor finish. Remove the temporary protective tape once the adjacent work is complete and clean the floor in accordance with the finish manufacturer's recommendations.

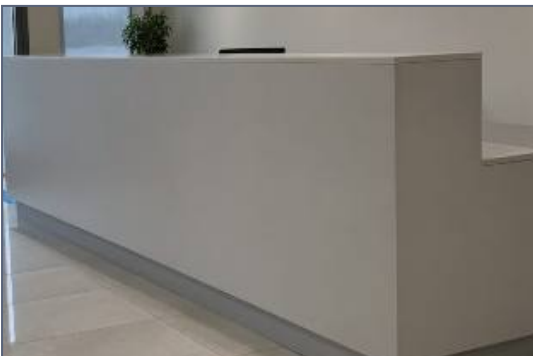
### Pin 2 of 5 - photograph 2

A white reception desk is present to the centre right of the frame, of solid panel construction with a plain front and a matt finish, set on a recessed grey plinth. The desk panels are visible and appear flat and square, with no visible impact damage, joint separation or staining. A plant and a dark object rest on the desk top; both are loose items, not defects. No person is present behind the desk.

No action required. Maintain the finish under a routine cleaning regime and inspect the plinth and panel joints periodically for movement.

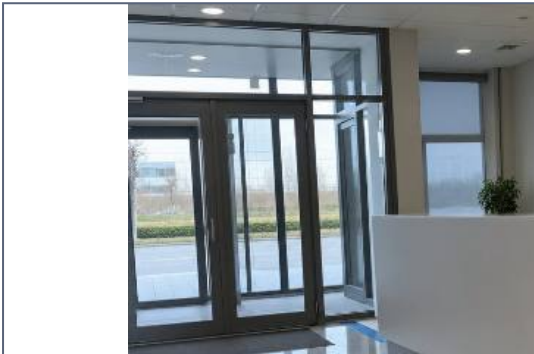
**Pin 3 of 5 - photograph 2**

A full-height glazed entrance screen with aluminium frames is present to the left of the frame, comprising double doors and fixed screens with a transom over. The glazing and frames are visible; the glass is clear, the frames appear straight and fully glazed, and no visible breakage, distortion or open joint is supported by the photograph. A mat is laid inside the threshold. The external paving and planting beyond the glazing are visible through the glass.

No action required to the glazing on the evidence of this photograph. Include the door closers, ironmongery and frame seals in the routine maintenance inspection.

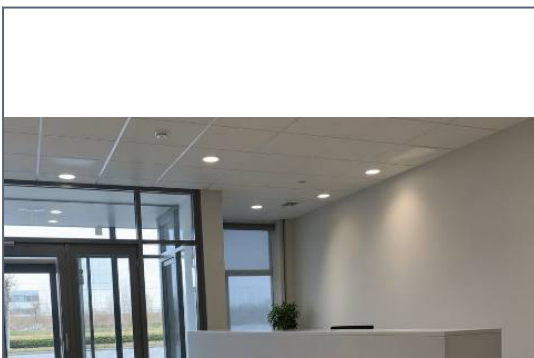
**Pin 4 of 5 - photograph 2**

A suspended ceiling of square lay-in tiles is present across the upper portion of the frame, with recessed downlights and a small ceiling-mounted detector. The tiles are visible and appear level and uniform, with no visible sagging, staining, damaged tile or displaced grid member supported by the photograph.

No action required. Continue routine inspection of the ceiling void and the lighting for the duration of the maintenance regime.

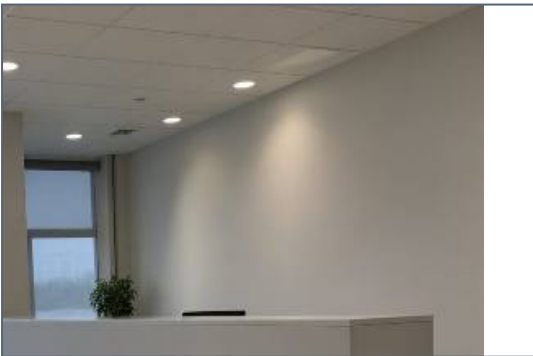
**Pin 5 of 5 - photograph 2**

The walls to the reception area, including the return wall behind the desk, are finished with a plain painted or applied lining in a light grey or white tone. The surfaces are visible and appear uniform, with no visible cracking, staining, blistering or impact damage supported by the photograph. Shadowing at the wall and ceiling junction is consistent with the lighting.

No action required. Maintain under the routine decorative cycle and inspect wall protection in circulation areas as part of planned maintenance.

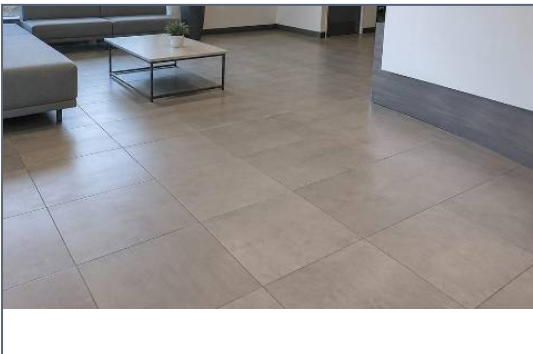
**Pin 1 of 6 - photograph 3**

The reception floor is finished in large-format rectangular tiles laid to a regular grid with narrow joints. Across the area visible in the photograph the tiling is intact and evenly laid, with no visible cracking, lipping, lifting or open joints. The surface is clean and carries a uniform sheen consistent with a recently cleaned floor. The photograph does not permit inspection of the joints at close range or of the floor beneath the furniture.

No action required. Continue routine cleaning and periodic inspection of joints at floor level.

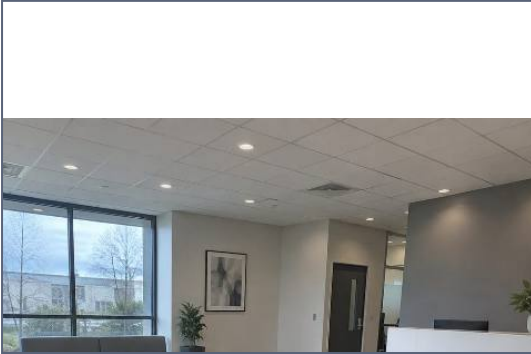
**Pin 2 of 6 - photograph 3**

A suspended ceiling of square tiles in a concealed grid spans the reception area, incorporating recessed downlighters and a square diffuser grille. The tiles visible are flat, closely fitted and free of staining, sagging or displacement. The grid lines run true and no tiles are missing within the field of view. The photograph does not permit assessment of the ceiling above the tiles or of the services within the void.

No action required. Retain routine inspection.

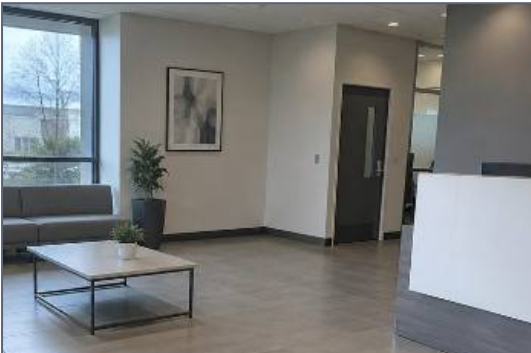
**Pin 3 of 6 - photograph 3**

Internal partitions are finished in a light neutral paint with a darker contrasting panel to the right-hand wall, and a dark skirting is fitted at the wall base. The painted surfaces visible appear even and intact, without blistering, cracking or visible marking. The skirting is present and continuous across the visible length. Lighting conditions create shadow variation across the wall plane which limits assessment of fine surface defects.

No action required. Retain routine decoration cycle.

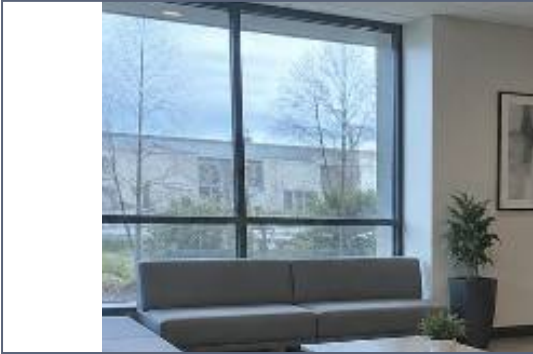
**Pin 4 of 6 - photograph 3**

A large fixed glazed screen with dark metal framing forms the left-hand elevation, with a horizontal transom dividing the units. The glass and framing appear intact from this distance, with no visible crack, seal failure or condensation between panes. The photograph is taken from within the space and does not permit close inspection of the frame, gaskets or perimeter seals, or of any opening light operation.

No action required. Retain periodic inspection of frame, gaskets and perimeter seals.

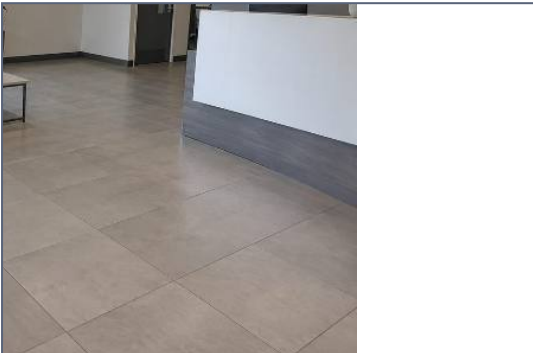
**Pin 5 of 6 - photograph 3**

A reception desk occupies the right-hand side of the space, formed of a light-coloured upper face panel over a darker plinth return. The visible faces are flush and undamaged with no impact damage, chips or lifting at the joins. Only two faces of the unit are visible in the photograph; the concealed elevations and any service access are not assessable.

No action required.

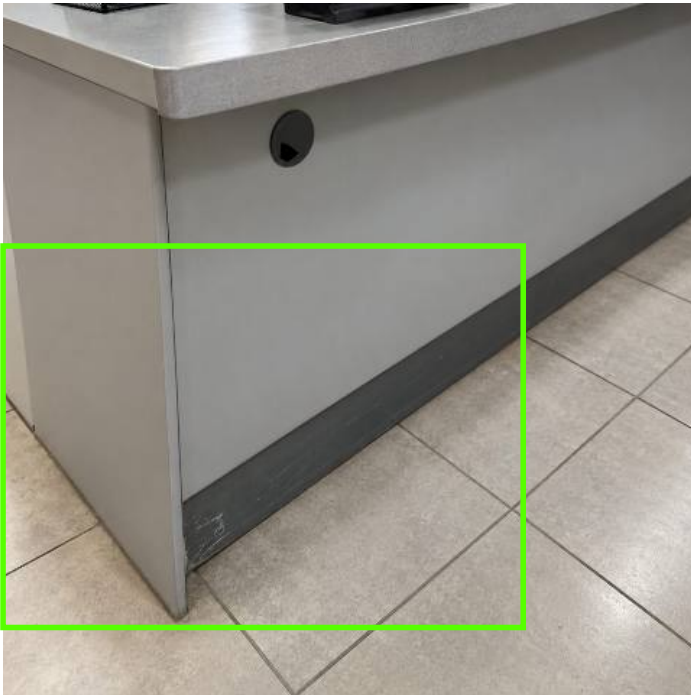
The light grey painted base panel of the counter unit is visible at the front face and the returned left end. The panel is in sound decorative order generally; a dark grey plinth or kick strip runs along the base of the unit and this strip is visibly scuffed and abraded, with the finish worn away in patches along the front elevation and more heavily at the external corner. The corner between the front plinth and the returned end is chipped and the substrate is exposed at the arris.

Planned repair: prepare and redecorate or replace the plinth/kick strip finish to the affected lengths, with the external corner made good. No action is required to the counter carcass.

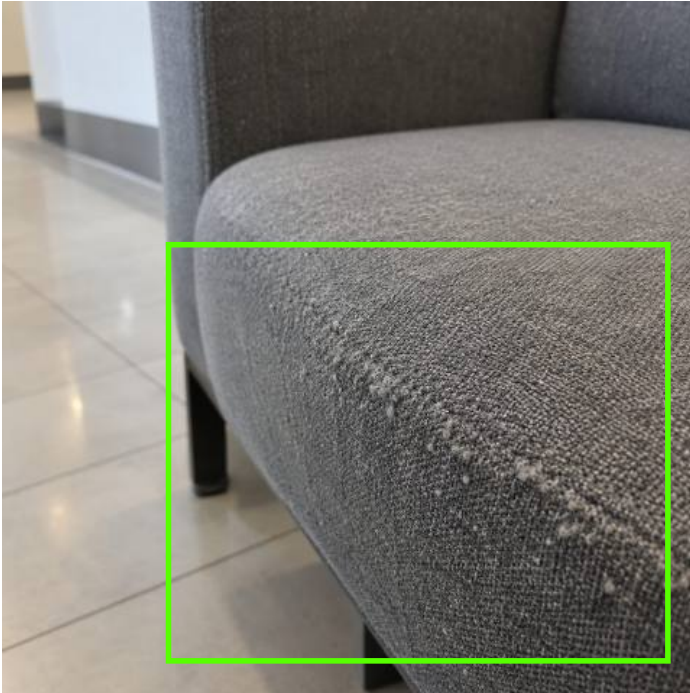
The upholstered seat cushion at the front edge of the armchair is abraded along its leading arris. The woven fabric has worn through to reveal the backing yarns, producing a pale, frayed band approximately 200 mm in length across the front and upper corner of the cushion face. Surrounding fabric remains intact and taut over the foam, with no splitting of the seams and no visible staining, soiling or impact damage. A dark timber or composite leg is visible at the lower left. The floor finish, comprising large-format light tiles with a dark skirting line in the background, is visible beyond the chair and is not the subject of this observation.

Planned repair. The cushion cover requires replacement, or a matched panel insert to the worn arris, at the next available maintenance visit.

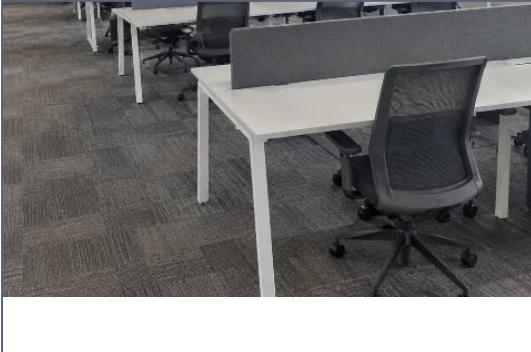
**Pin 1 of 4 - photograph 7**

Open-plan office floor finish comprising grey loop-pile carpet tiles laid in a quarter-turn pattern. The finish is continuous and appears recently laid, with no visible lifting, fraying, staining, delamination or joint separation within the extent of the view. Minor local soiling is evident in the circulation areas.

Routine maintenance. Clean in accordance with the manufacturer's maintenance regime and maintain a small stock of replacement tiles for future localised renewal.

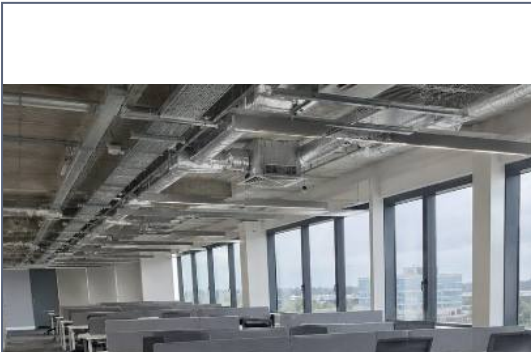
**Pin 2 of 4 - photograph 7**

Exposed soffit above the office area with galvanised ductwork, cable tray, pipework and services suspended from hangers. The services are installed in an orderly arrangement. A number of linear light fittings are suspended below the soffit. Damage in the form of dents, impact damage, displaced supports, water staining or corrosion is not evident in the areas visible.

No action on the visible condition. Confirm support spacings, fire stopping at penetrations and service labelling as part of the completion record before handover.

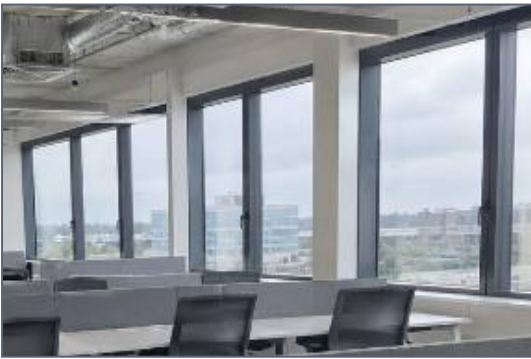
**Pin 3 of 4 - photograph 7**

Full-height glazed curtain walling to the external elevation, comprising dark-framed units with opening lights. The frames, gaskets and glazing visible in the elevation appear intact, with no visible cracking, sealant failure, water ingress staining or damaged ironmongery. Reflections in the glass limit the inspection of the lower frame junctions.

No action on the visible condition. Verify gasket compression, drainage path and perimeter sealant as part of the faade completion inspection.

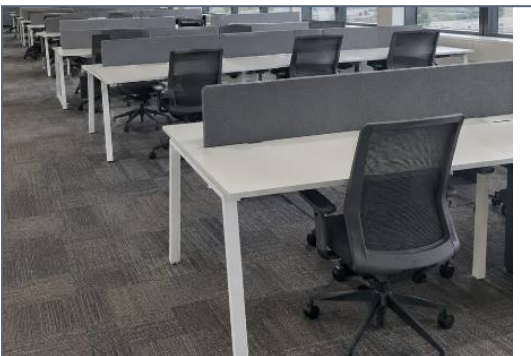
**Pin 4 of 4 - photograph 7**

Bench desking in white finish with grey fabric screen dividers and mesh-backed task chairs on castors. The desking appears recently installed and undamaged, with edge banding intact and leg frames undented. The furniture is in place and the installation reads as complete.

No action. Record the condition at handover for dilapidations purposes.

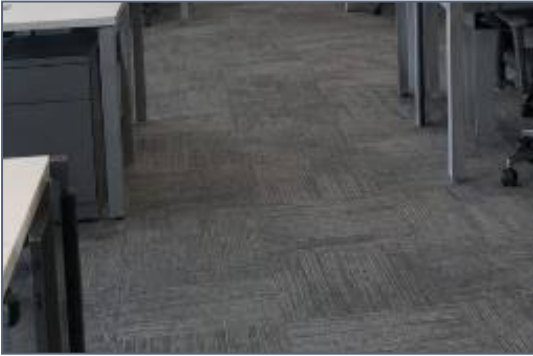
Pin 1 of 2 - photograph 8

The carpet tiling to the open-plan floor area is visibly stained and discoloured in the central circulation zone, with a dark marking running across the tiles between the desk rows. The staining appears established rather than fresh. The pile across the general floor area is otherwise laid flat and sound, with no visible lifting, open joints or edge fraying at the tiles examined in the foreground.

Planned maintenance. The stained tiles should be identified and replaced from retained stock, or the affected area accepted as recorded wear, at the next fit-out or dilapidations review.
