# Finding identification & remedial schedule

| PROJECT | Riverside Court - Cat B Fit-Out, Phase 2 |
| REFERENCE | SNG-2026-10-006 |
| REPORT DATE | 8 October 2026 |

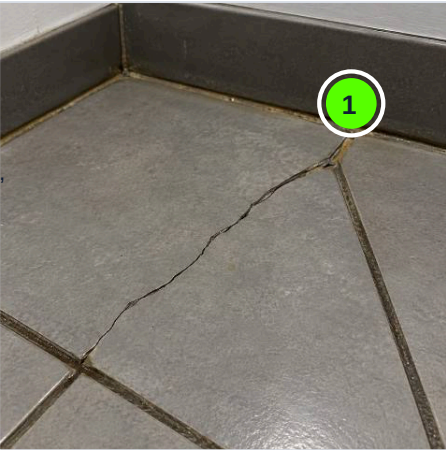
Photograph 6, pin 1 - area this item refers to

| NO. | ITEM | | TRADE | SEVERITY | PHOTO / PIN |
|---|---|---|---|---|---|
| 1 | F-011 | Floor tile fractured diagonally, approx. 400 mm, open crack | Tiler | Performance | Ph 6 / pin 1 |

Floor tile fractured diagonally, approx. 400 mm, open crack

**FINDING**  
A single diagonal crack runs across one floor tile for approximately 400 mm, passing through the tile body from the joint at the lower left corner up to the joint at the upper right, where it terminates at the wall skirting. The crack is open and continuous over its full length, with slight lippage visible at the fracture line. The tile remains in place but is fractured through its thickness.

**LIKELY CAUSE**  
Most likely impact damage from a dropped object or point load during construction traffic, or thermal or moisture movement where no movement joint has been provided. A defect in the screed or bedding beneath the tile is also plausible and cannot be excluded from the photograph.

**REQUIRED ACTION**  
Cut out and replace the affected tile. Rake back the bedding and adhesive to sound material, check the screed beneath for cracking or debonding, and re-lay on a full bed of flexible adhesive to the manufacturer's instructions, leaving the correct perimeter and movement joints. Confirm whether the crack propagates into adjacent tiles or the screed before replacement is specified.

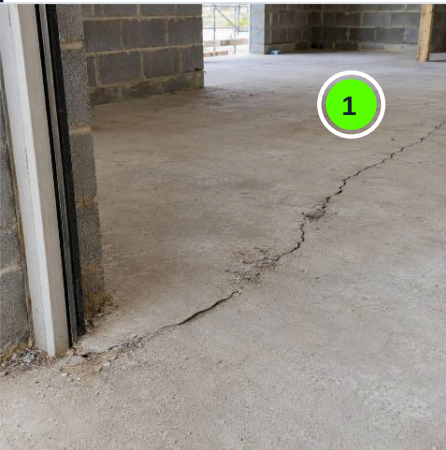
Photograph 9, pin 1 - area this item refers to

| NO. | ITEM | | TRADE | SEVERITY | PHOTO / PIN |
|---|---|---|---|---|---|
| 3 | F-019 | Continuous crack to floor slab with local spalling at threshold junction | Structural | Performance | Ph 9 / pin 1 |

Continuous crack to floor slab with local spalling at threshold junction

**FINDING**  
The concrete floor slab carries a continuous crack running diagonally across the visible floor area, from the threshold of the opening in the lower left towards the right edge. The crack is irregular and meandering, with a width generally in the order of 2 to 4 mm, opening slightly wider at the junction with the wall and threshold, where the slab edge is visibly broken down and spalled. The crack extends beyond the frame of the photograph, and its full length and termination cannot be established from this image.

**LIKELY CAUSE**  
The crack is most likely a shrinkage or early-age movement crack in the slab, or a settlement crack at the junction between the slab and the wall or threshold. A single photograph cannot establish the cause with certainty, and the pattern and width need to be confirmed on site.

**REQUIRED ACTION**  
Establish the full extent and depth of the crack by opening up with a proprietary crack-width gauge and, where depth is in doubt, a limited core or drilled investigation. Where the crack is confirmed static, rake out to a sound profile and fill with a semi-rigid epoxy or cementitious repair mortar. Where the crack is wider than 5 mm or shows vertical displacement, refer to the structural engineer. Record with a tell-tale where movement is suspected.
