**Customer Complaint Notification — safety-relevant characteristic**

| <b>Complaint no.</b> | <b>C-OEMN-2026-0312</b> | Date issued | 2026-09-22 |
| <b>Supplier part no.</b> | <b>AR-1003</b> | OEM drawing no. | ON-114203 rev. D (fictitious) |
| <b>Part description</b> | Battery tray bracket LH | Repeat indicator | <b>YES</b> — same supplier part no. and same characteristic within 24 months |

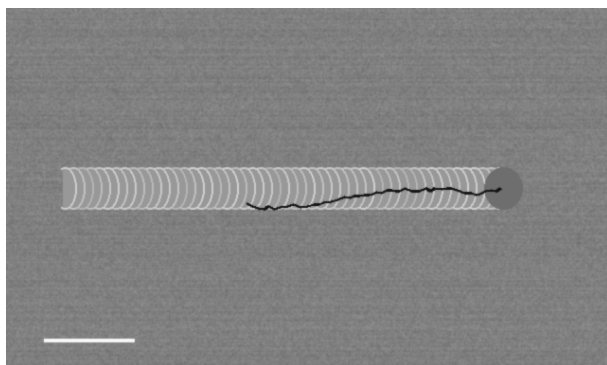
During the in-line pull-out audit of battery module assembly (1 part every 2 hours) on 2026-09-21, **3 battery tray brackets LH** broke at **MIG weld seam W2** below the minimum pull-out load (drawing note 7:  $\geq 18$  kN). The fracture starts at the end crater of W2 and runs along the weld root; the root side shows lack of fusion. The bracket carries the battery tray: characteristic classified CC (safety).

| Sample | Pull-out load (kN) | Requirement | Failure mode | Crack length (mm) |
|---|---|---|---|---|
| BM2-0921-A | 12.4 | $\geq 18$ kN | Fracture in W2, root side | 9 |

OEM Norte laboratory, macro-section of sample BM2-0921-B (report LAB-ON-26-4471): root penetration 0.4 mm (drawing:  $\geq 1.0$  mm), porosity and spatter inclusions near the end crater, irregular bead width along W2 (unstable arc suspected by our lab). Base material hardness and chemistry within specification.

Fig. 1 — Sample BM2-0921-A after pull-out, seam W2 (scale bar 10 mm). Crack from the end crater along the root.

1. **Containment within 24 h** (due 2026-09-23): block all suspect stock at the supplier and in transit, sort OEM Norte stock through your resident team or a third party, and confirm the suspect scope from your own traceability (production lots, material lots and delivery notes), not only from the lot on the label. Certified parts must carry a clean-point label.

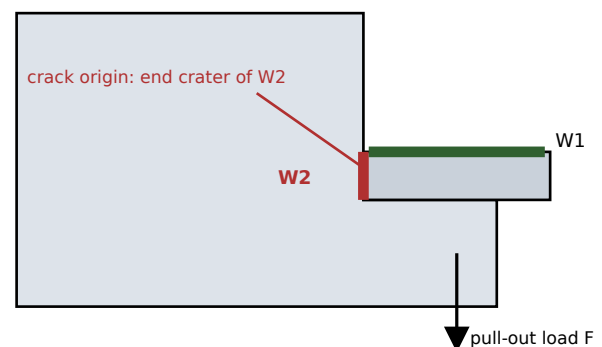
Fig. 2 — Sketch of the bracket: seams W1 and W2, crack origin and load direction of the pull-out test.
