Customer Complaint Notification — e-coat appearance / corrosion protection

| Complaint no. | C-OEMN-2026-0327 | Date issued | 2026-09-23 |
| Supplier part no. | AR-1009 | OEM drawing no. | ON-118870 rev. B (fictitious) |
| Part description | Low-temperature radiator bracket | Repeat indicator | POSSIBLE — e-coat porosity complaint on this part no. in 2024 (our ref. C-OEMN-2024-0163) |

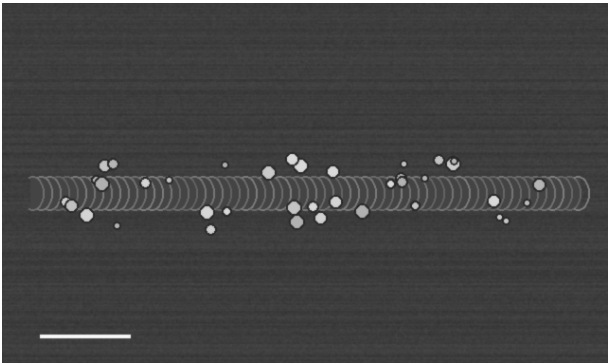
Incoming audit on 2026-09-22 found **pores and craters in the e-coat** of low-temperature radiator brackets from lot **L26250-AR1009-01**. After sorting the parts available at the cooling module line, **60 parts** are NOK. The craters are round, Ø 0.3–1.0 mm, some down to bare metal.

| Observation (OEM Norte paint lab, report LAB-ON-26-4502) | Result |
|---|---|
| E-coat thickness at crater rim | 4–8 µm |
| EDX at crater centre (3 craters) | Si, Mn and O detected (glassy residue); P and Zn not detected |

Fig. 1 — Rear face of a NOK part: craters next to the MIG seam (scale bar 10 mm).

1. **Containment within 24 h** (due 2026-09-24): block all suspect stock at the supplier and in transit, sort OEM Norte stock through your resident team or a third party, and confirm the suspect scope from your own traceability (production lots, material lots and delivery notes), not only from the lot on the label. Certified parts must carry a clean-point label.

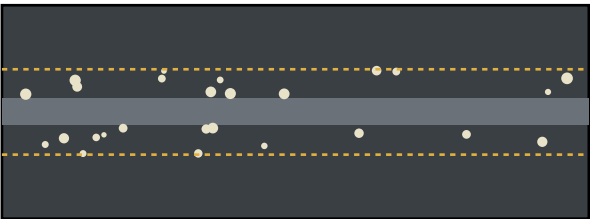
| Observation (OEM Norte paint lab, report LAB-ON-26-4502) | Result |
|---|---|
| Location of craters | Along the MIG seam on the rear face and within ± 5 mm of it; 0 craters on flat areas outside that band |

rear face — MIG seam and ± 5 mm band (dashed)

flat areas outside the band: no craters found

Fig. 2 — Distribution of the craters found on 10 NOK parts (schematic).
