## Kiki Marine Survey

15 May 2025 / Cali Quigley / Appraisal / Condition and valuation  
/ 2006 42 Carver Super Sport

2006 42 Carver Super Sport

**Marine Survey Report for the vessel: "My Bad", a 2006 Carver Super Sport 42**

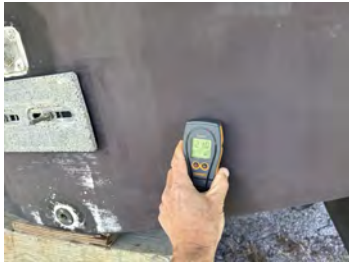
Photo 3

The only areas in the hull with elevated moisture readings were in the lower transom. These were low - between 207 and 212 (on a relative scale of 0-999). These areas should be monitored between seasons for any delamination or softness.

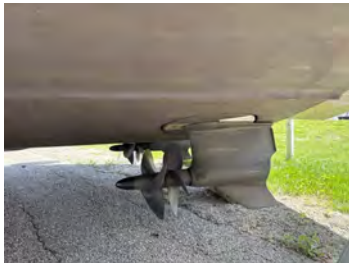
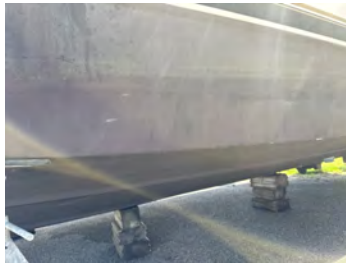
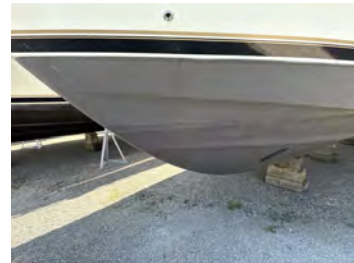
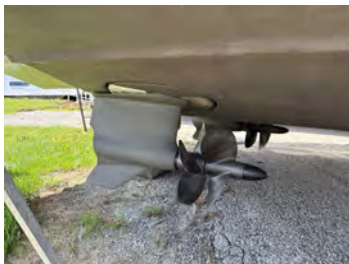
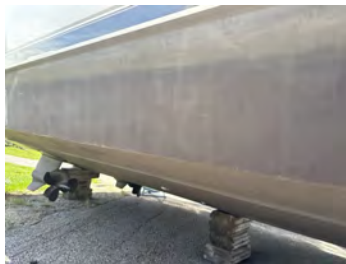
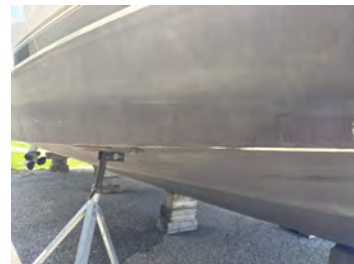
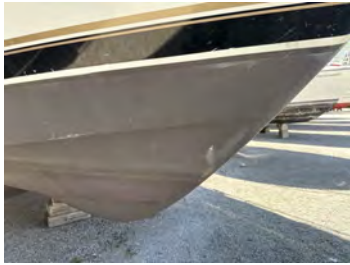
### Primer, barrier coat, anti-fouling

C - Serviceable

The anti-fouling coat appeared to be newly applied and was in good condition.

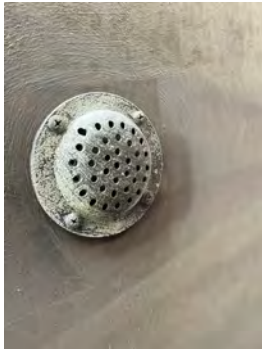
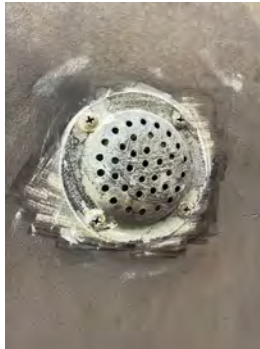
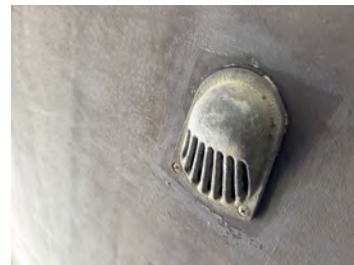
C - Serviceable

All strainers were in serviceable condition.

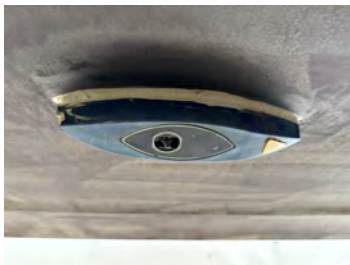
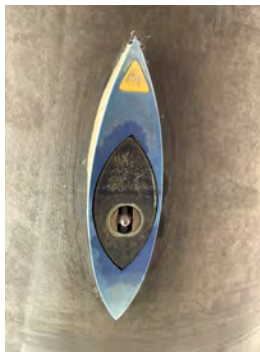
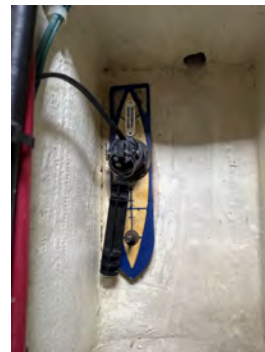
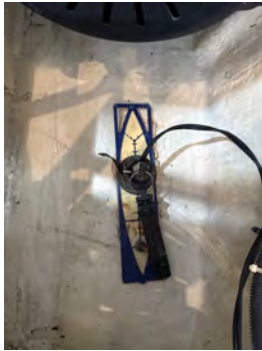
### Transducers (speed, depth, etc.)

C - Serviceable

The transducers were solidly applied to the hull and carefully installed in the engine bay, including emergency bungs.

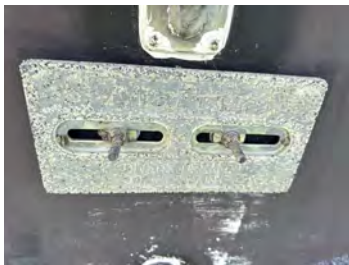
Photo 20

| Item | Rating | Notes |
|---|---|---|
| Hull anodes | A-Critical | The hull anode was very corroded and required immediate replacement. |

The hull anode was very corroded and required immediate replacement.

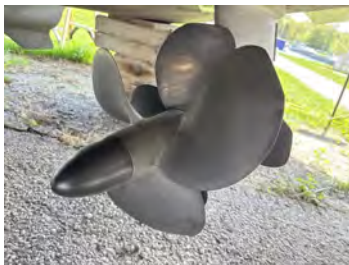
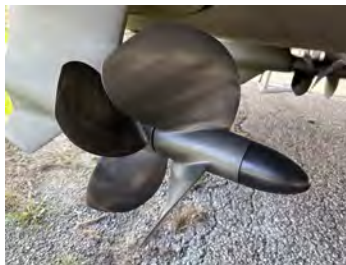
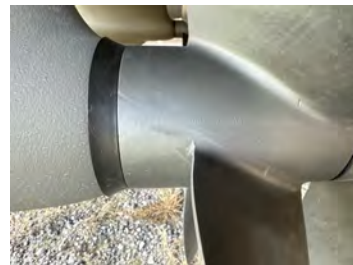
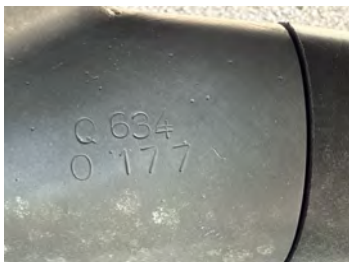
## Propeller(s)

C - Serviceable

The Volvo IPS propellers were in good condition.

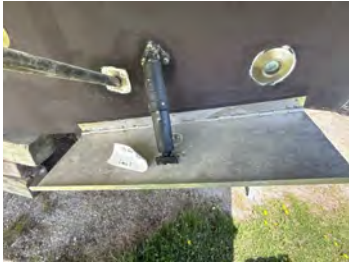
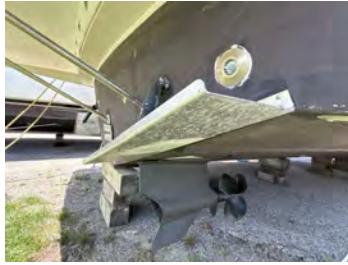
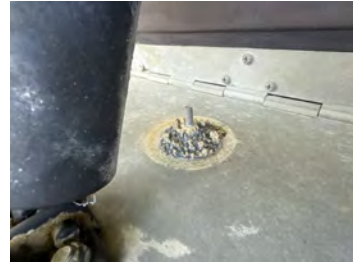
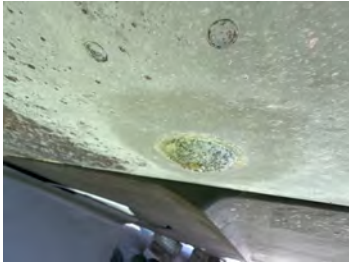
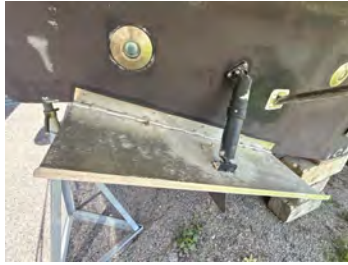
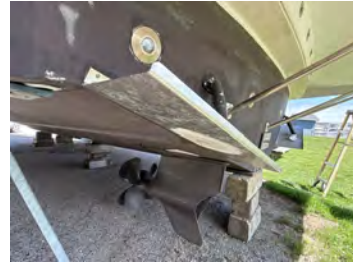
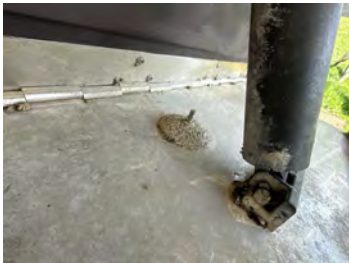
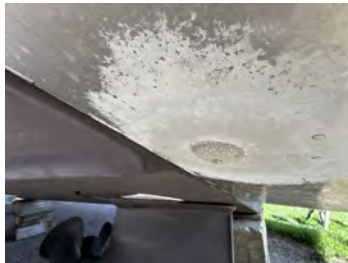
| Item | Rating | Notes |
|---|---|---|
| Trim tabs (exterior tabs, actuators, mounts and anodes) | A-Critical | Although the trim tabs and actuators were solidly mounted on the transom, the anodes were corroded and should be replaced immediately. Also, hydraulics were not sighted in the engine bay. The trim tabs should be tested under load during the sea trial. |

## Trim tabs (exterior tabs, actuators, mounts and anodes)

under load during the sea trial.

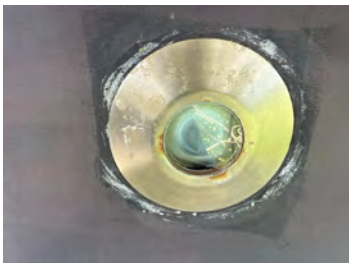
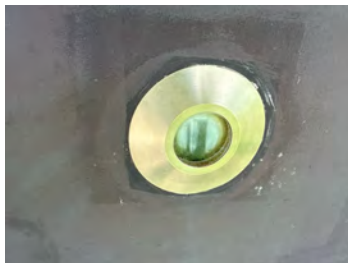
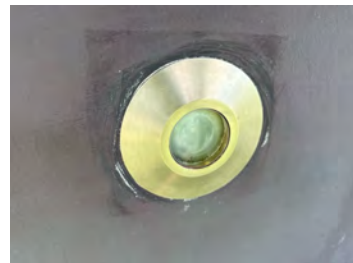
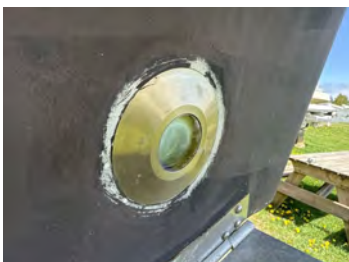
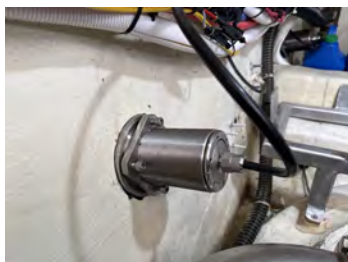
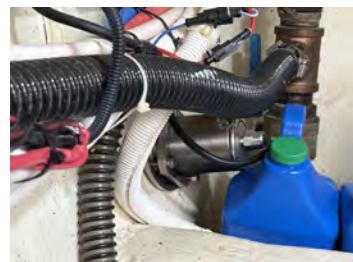
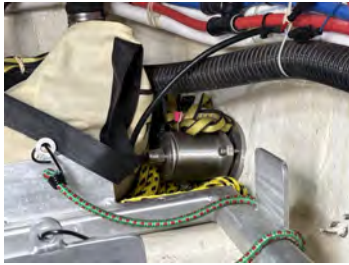
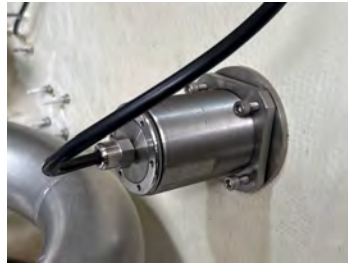
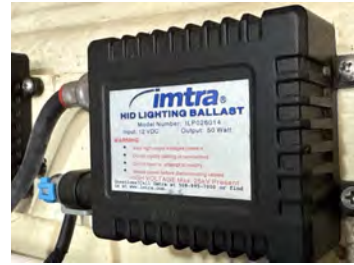
## Underwater lighting

C - Serviceable

The Imtra underwater lights were solidly mounted to the transom, showed no signs of leaking to the interior and functioned properly.

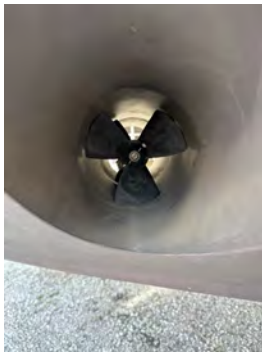
Photo 43

## Bow thruster

B - Needs Attention

As the boat was on shore, the bow thruster was not tested. However, the oil for the gear leg was low and should be topped up. The bow thruster should be tested under load during the sea trial.

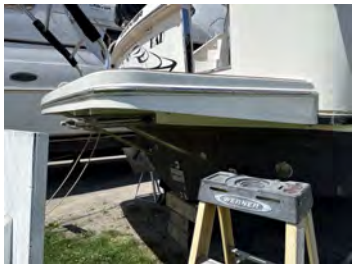
Photo 48

| Item | Rating | Notes |
|---|---|---|
| Swim platform and ladder | A-Critical | The swim platform was in serviceable condition. However, there were some issues that should be addressed: 1. There was a repair in the form of a steel plate at the top and an epoxy/gelcoat patch at the bottom. This is likely due to removing an optional stainless steel tow pylon. This repair on the bottom was beginning to degrade and should be addressed. 2. The swim ladder stuck in a partially open position. Either there's a trick to this - or it gets stuck. 3. One plastic step cover was missing and one was repaired. 4. There were pressure indentations where the swim platform supports attached to the transom. There was also some leaking seen in the interior around the middle bolts. These supports should be reinforced on the outside and the inside with stainless or Coosa plates spread as widely as possible to distributed the load. |

also some leaking seen in the interior around the middle bolts. These supports should be reinforced on the outside and the inside wih stainless or Coosa plates spread as widely as possible to distributed the load.

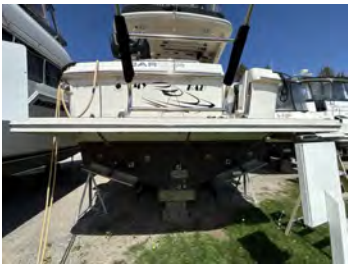
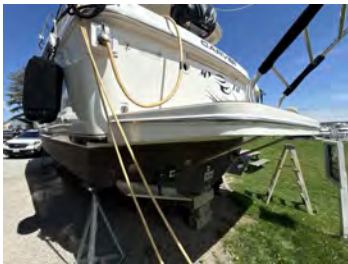
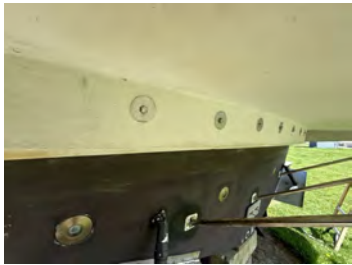
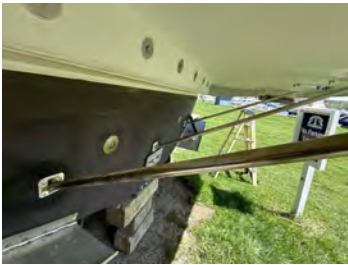
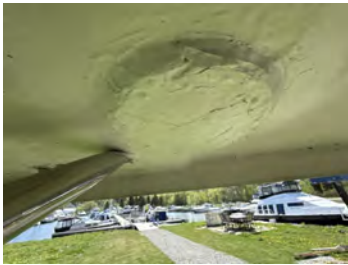
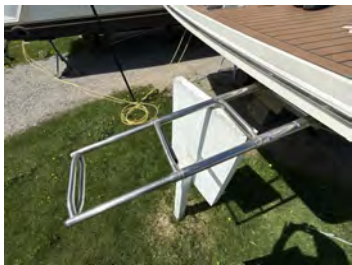
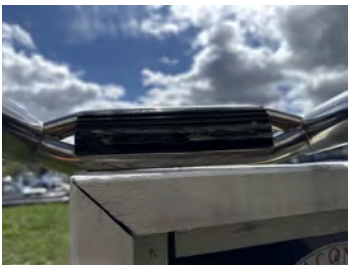
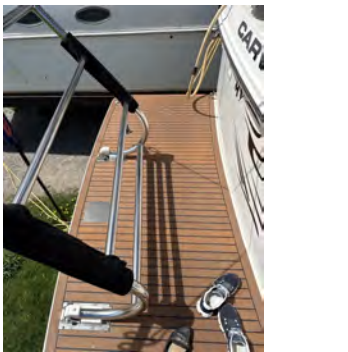
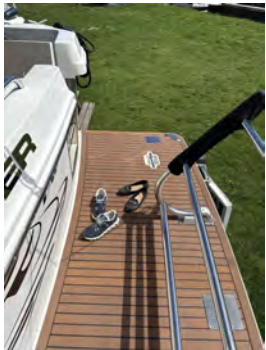
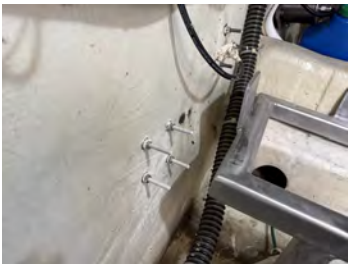
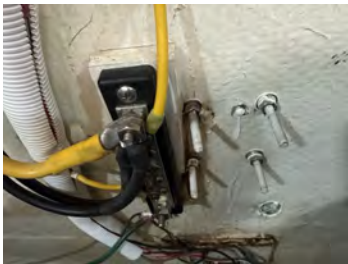
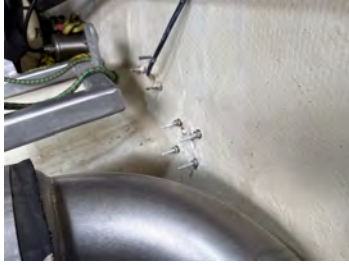
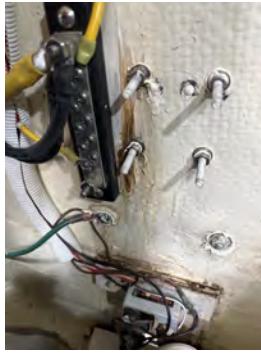
The swim platform was in serviceable condition. However, there were some issues that should be addressed:

1. There was a repair in the form of a steel plate at the top and an epoxy/gelcoat patch at the bottom. This is likely due to removing an optional stainless steel tow pylon. This repair on the bottom was beginning to degrade and should be addressed.
2. The swim ladder stuck in a partially open position. Either there's a trick to this - or it gets stuck.
3. One plastic step cover was missing and one was repaired.
4. There were pressure indentations where the swim platform supports attached to the transom. There was

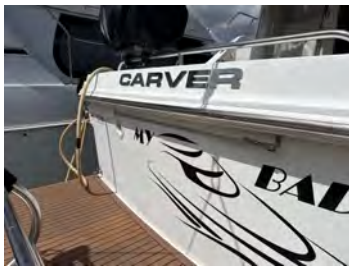
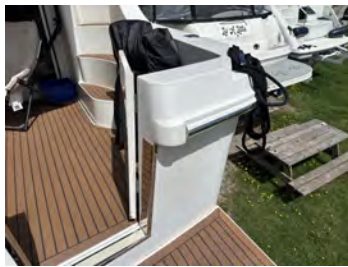
The transom and door from the swim platform to the aft deck were in serviceable condition.

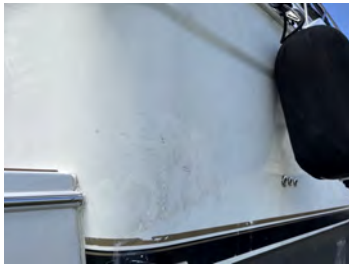
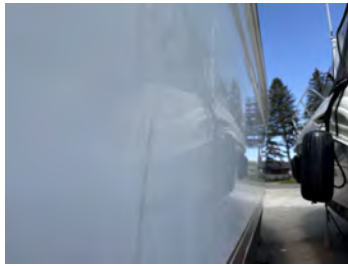
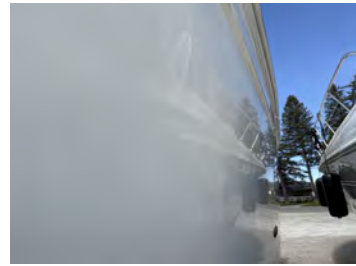
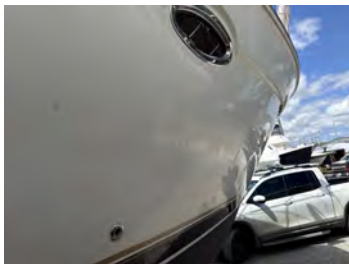
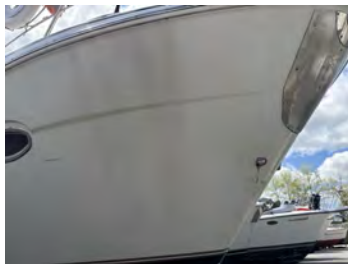
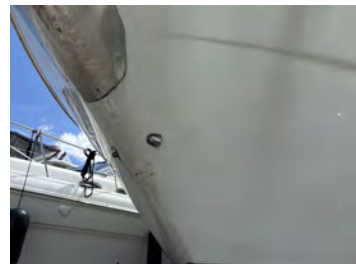
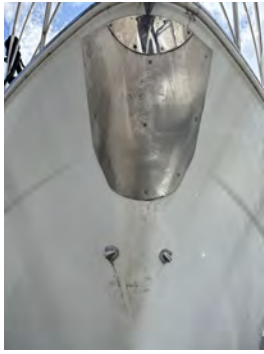
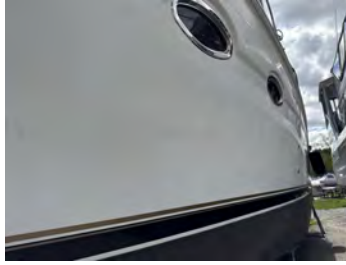
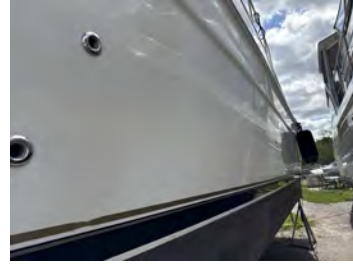
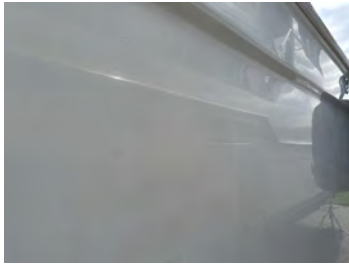
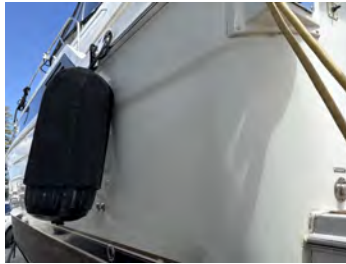
The hull above the waterline was in good condition overall, showing only minor blemishes and light scratches typical for a vessel of this age.

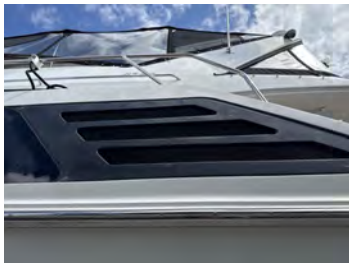
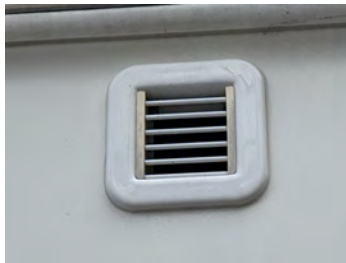
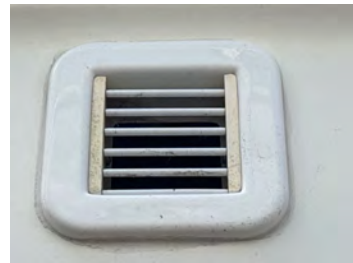
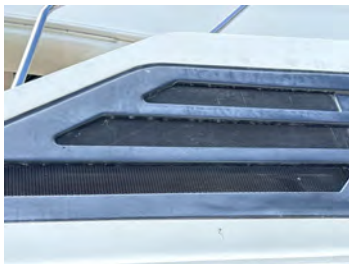
All ventilation grills were in serviceable condition.

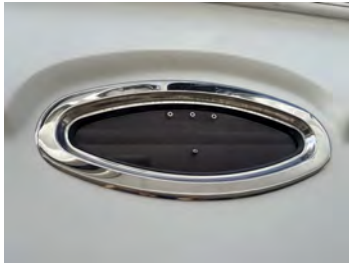
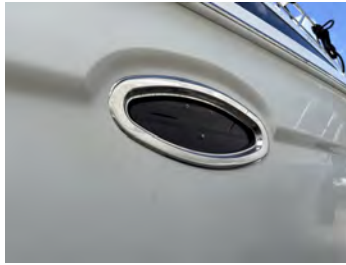
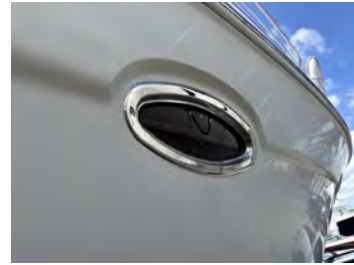
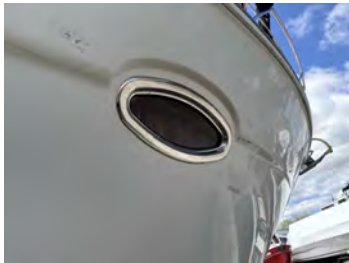
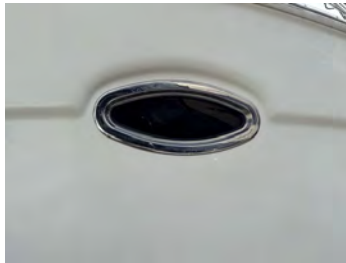
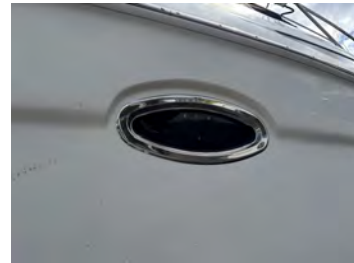
All exterior portholes were in serviceable condition.

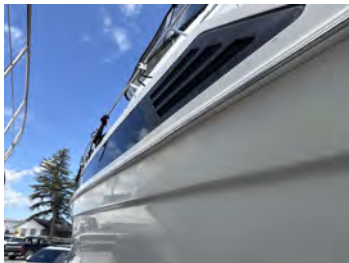
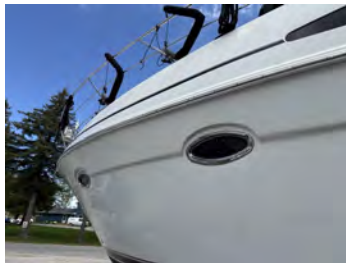
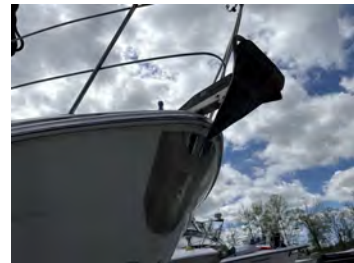
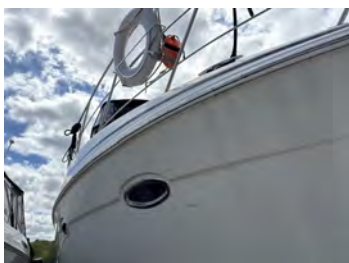
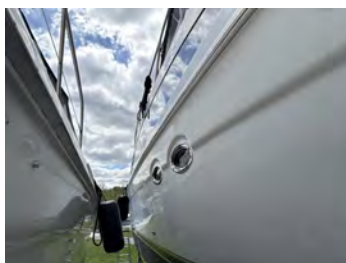
The rub rail was solidly attached to the hull/deck joint and in serviceable condition.

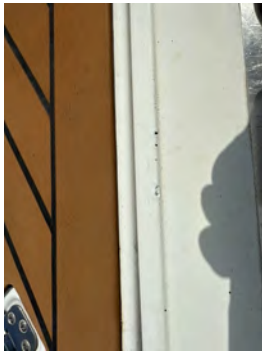
Photo 93

There were some minor cracks and repairs on the deck and coachroof. Otherwise, the deck and coachroof were in serviceable condition.

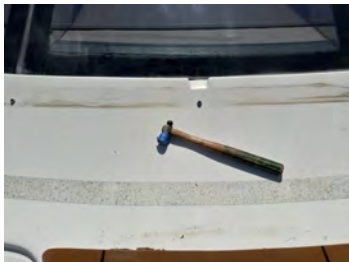
Photo 97

| Item | Rating | Notes |
|---|---|---|
| Deck and coachroof/pilot house impact and resonance testing | B-Needs Attention | A percussion test indicated a single thud just ahead of the windshield. This is due to moisture ingress (as confirmed by moisture testing). |

A percussion test indicated a single thud just ahead of the windshield. This is due to moisture ingress (as confirmed by moisture testing).

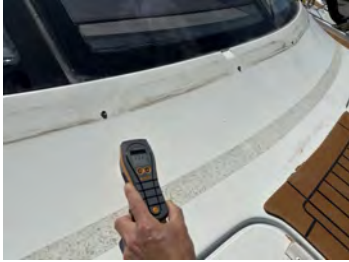
Photo 98

| Item | Rating | Notes |
|---|---|---|
| Deck and coachroof/pilot house moisture testing | B-Needs Attention | Only a single area on the coachroof showed a concerning level of moisture (499 on a relative scale of 0-999). This was at the base of the windshield in the same area as the failed acoustic hammer test. This area should be opened, dried, re-bedded as required and sealed. The sealing around the base of the windshield should be removed and replaced to prevent further water incursion. |

Only a single area on the coachroof showed a concerning level of moisture (499 on a relative scale of 0-999). This was at the base of the windshield in the same area as the failed acoustic hammer test. This area should be opened, dried, re-bedded as required and sealed. The sealing around the base of the windshield should be removed and replaced to prevent further water incursion.

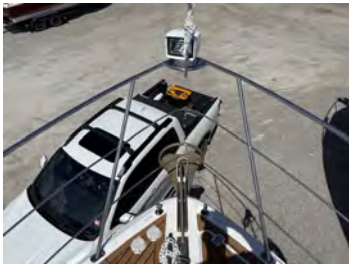
Photo 101

The pulpit was solidly attached to the deck and in serviceable condition.

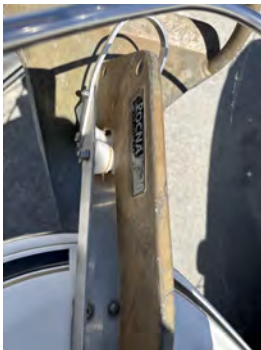
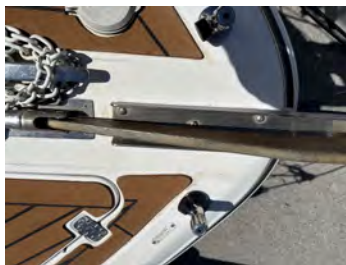
The bow roller was in serviceable condition.

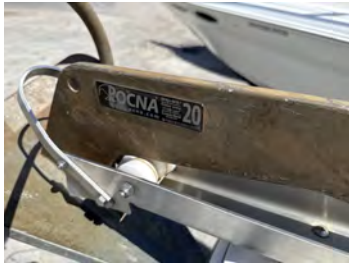
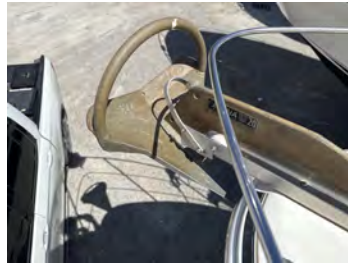
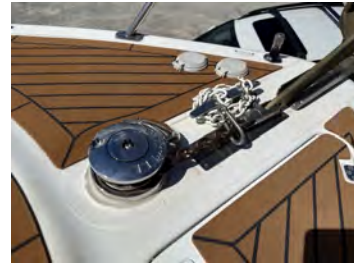
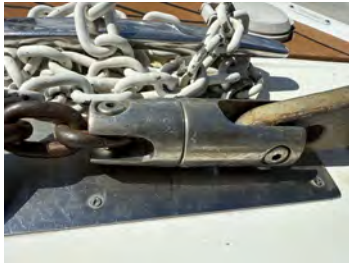
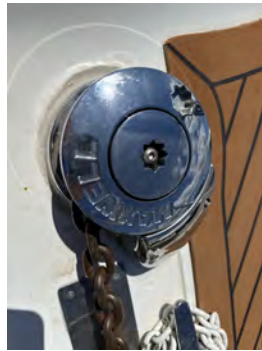
A 20Kg Rocna anchor was properly attached to a stainless swivel, then to chain. All appeared in serviceable condition.

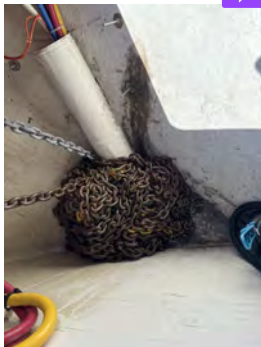
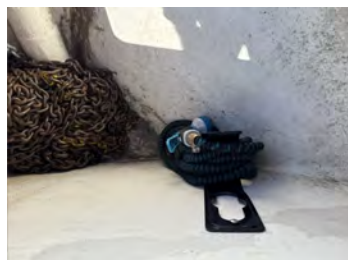
The anchor locker was serviceable. There was a deck wash hose in the locker. Suggest testing the deck wash during the sea trial.

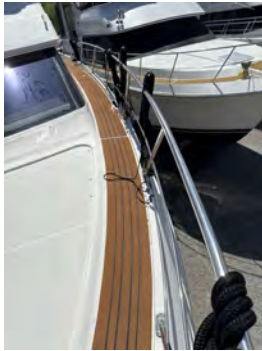
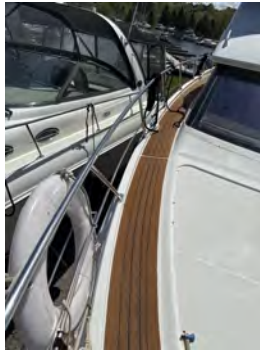
The safety rail extended from the top of the side-deck staircases on both sides, forming the pulpit at the bow. All stanchions were firmly attached to the gunwale and in serviceable condition.

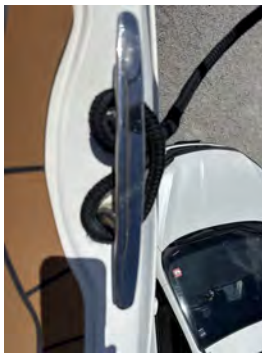
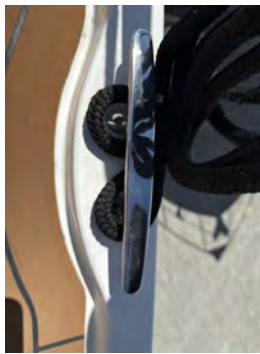
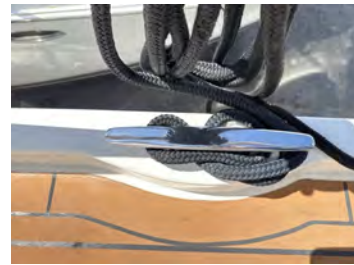
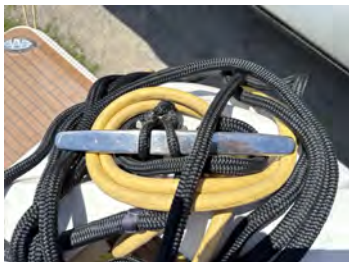
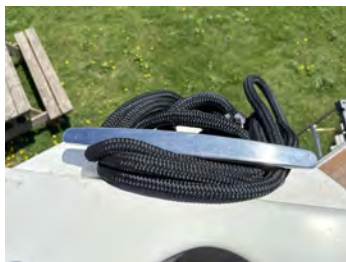
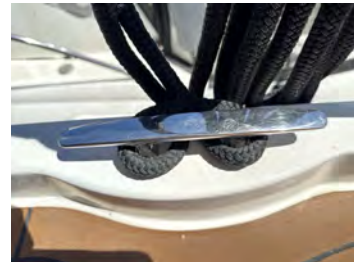
All mooring cleats were firmly attached to the deck/gunwale and were serviceable.

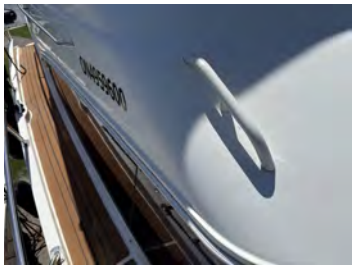
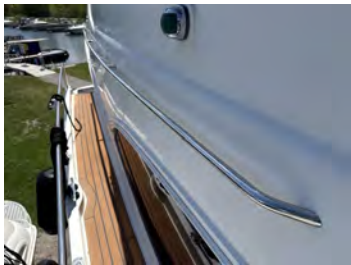
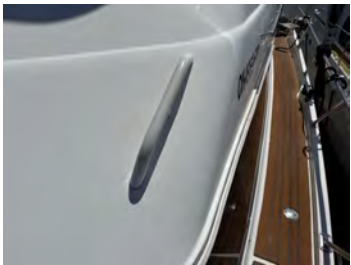
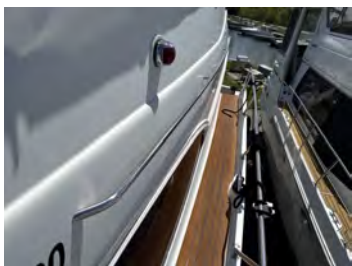
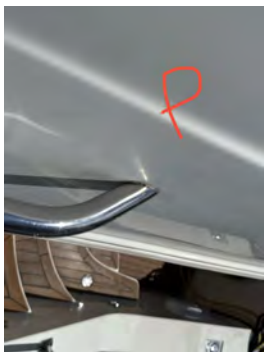
The port grab rail was coming away from the flybridge and should be resealed and tightened.

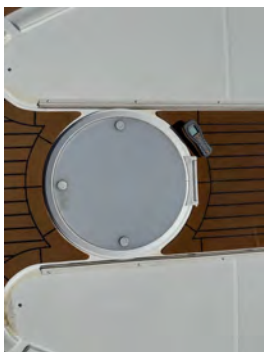
Photo 126

The single deck hatch in the coach-roof appeared serviceable from the outside.

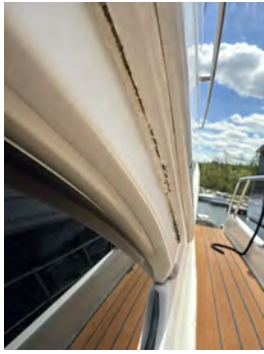
Photo 127

aflex was beginning to come away in several areas of the window seals. This was especially concerning along the windshield base, where water could potentially flow under the gelcoat in the coachroof. As stated earlier, it is suggested that the affected Sikkaflex be removed and reapplied.

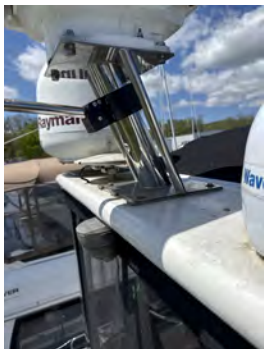
Photo 135

There were no signs of stress/pressure cracks along the top edge of the arch where equipment was attached. However, this is a common problem area and should be monitored.

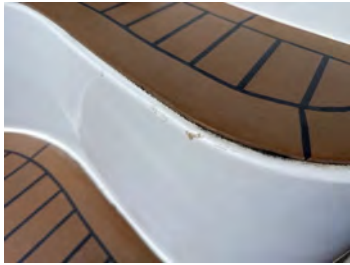
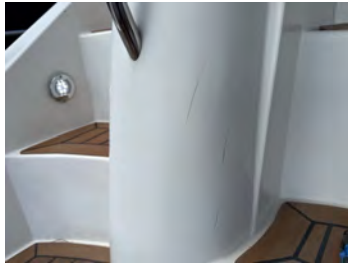
C - Serviceable

There were some small scuffs and scratches along the starboard flybridge/deck staircase typical of a boat this age. If desired, these can be ground out and filled with some thickened gelcoat.

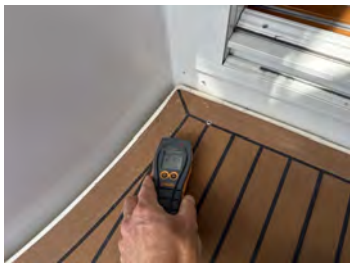
Photo 151

| Item | Rating | Notes |
|---|---|---|
| Aft deck moisture testing | C-Serviceable | There were a few areas of minor moisture readings in the aft deck, ranging from 187 to 215 (on a relative scale of 0 to 999). These areas were next to the port flybridge stairs, on the forward starboard side of the engine bay hatch and along the bottom of the sliding cabin door. These areas should be tested periodically to ensure moisture levels are not rising. |

There were a few areas of minor moisture readings in the aft deck, ranging from 187 to 215 (on a relative scale of 0 to 999). These areas were next to the port flybridge stairs, on the forward starboard side of the engine bay hatch and along the bottom of the sliding cabin door. These areas should be tested periodically to ensure moisture levels are not rising.

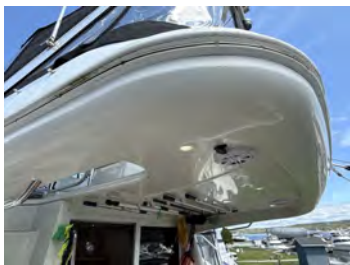
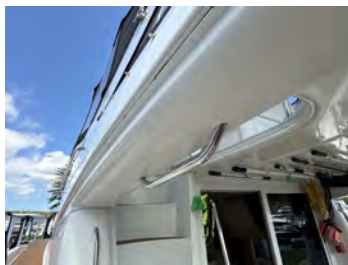
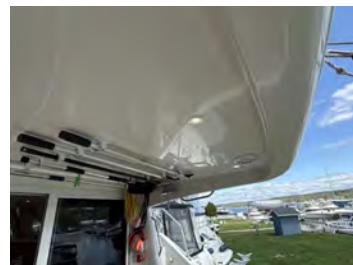
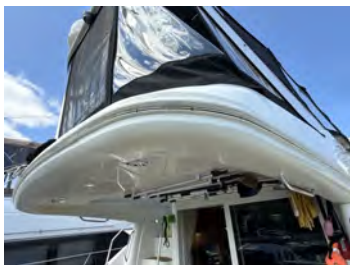
C - Serviceable

The aft deck cover was secure and in good condition. There was also an assortment of deck brushes and boat hooks attached to the underside.

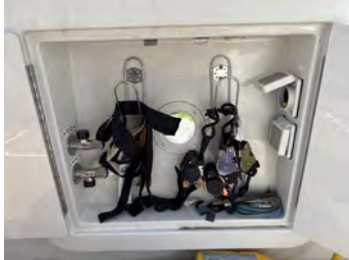
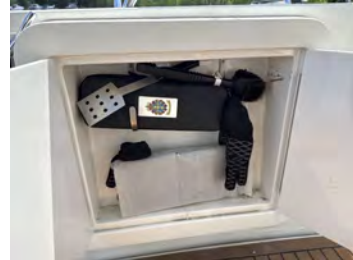
C - Serviceable

All aft-deck storage was in serviceable condition. One locker contained a washdown station that should be tested during the sea trial.

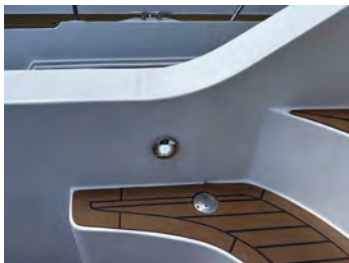
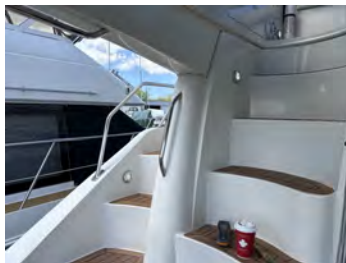
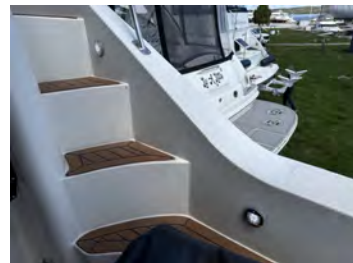
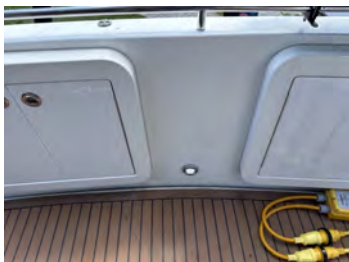
C - Serviceable

All aft-deck lighting functioned properly.

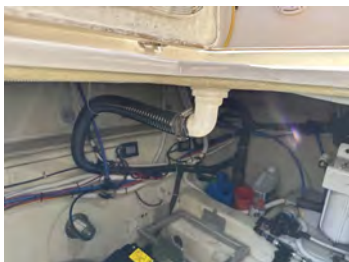
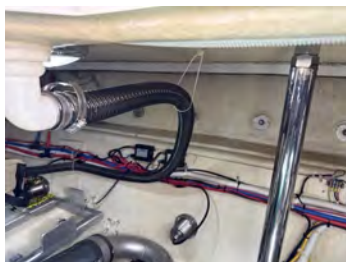
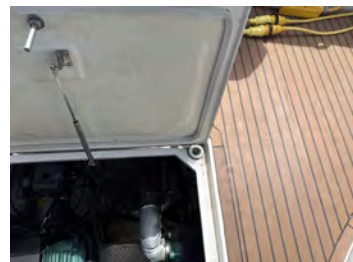
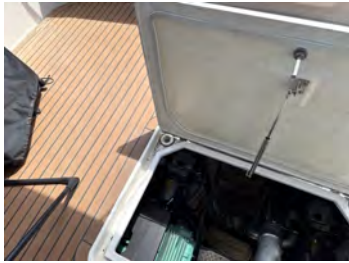
C - Serviceable

The aft deck drains were contained under the engine bay hatch in the aft corners. They were properly connected to drain hose on the underside and appeared serviceable.

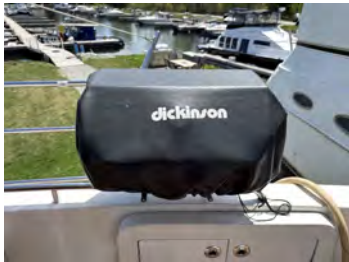
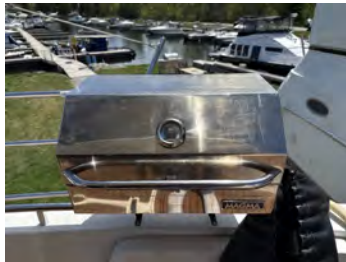
Not tested/not verified

Despite needing a good clean, the Magma propane BBQ appeared serviceable. However, it should be tested.

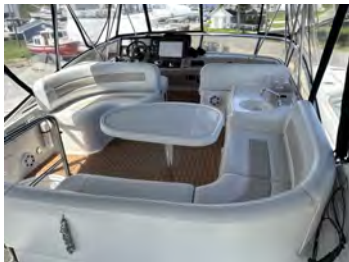
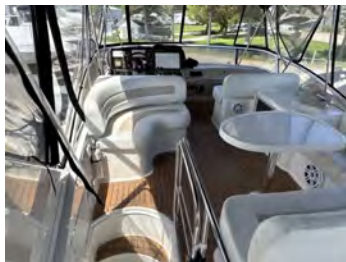
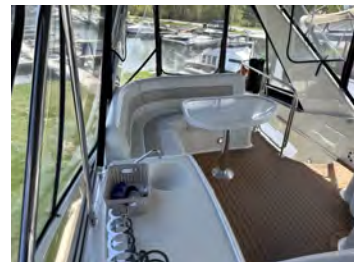
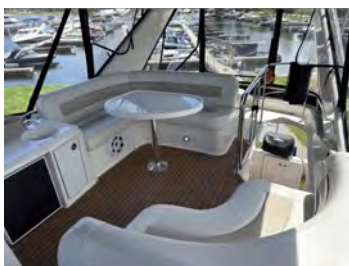
The flybridge was generally in good condition with very few spider cracks, scratches or scuffs.

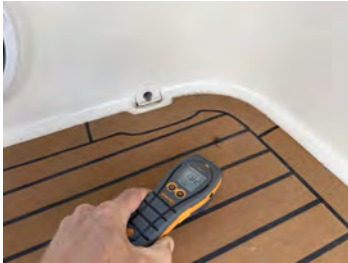
Photo 176

| Item | Rating | Notes |
|---|---|---|
| Flybridge moisture testing | C-Serviceable | Two areas of the flybridge showed somewhat elevated moisture readings of 182 and 215 (on a relative scale of 0-999). Although these levels are not currently concerning, suggest monitoring these areas between seasons to ensure moisture levels do not rise. |

Two areas of the flybridge showed somewhat elevated moisture readings of 182 and 215 (on a relative scale of 0-999). Although these levels are not currently concerning, suggest monitoring these areas between seasons to ensure moisture levels do not rise.

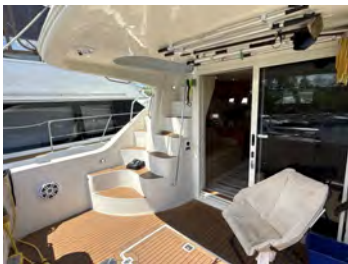
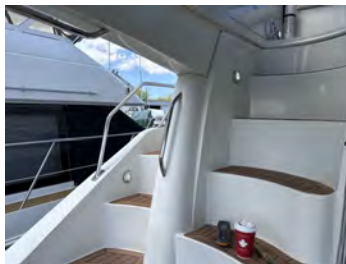
Aside from the scuffs and scratches mentioned earlier, the staircase was serviceable.

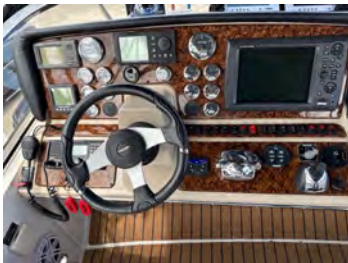
Photo 180

The helm station was in serviceable condition. However, because the engines were not started, the IPS steering could not be tested.

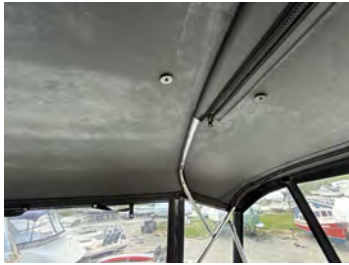
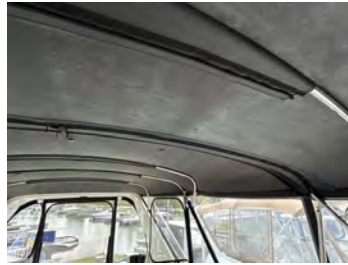
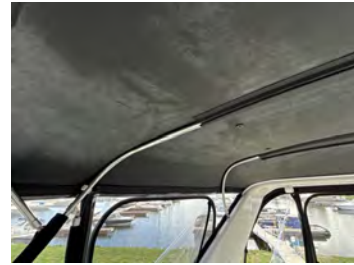
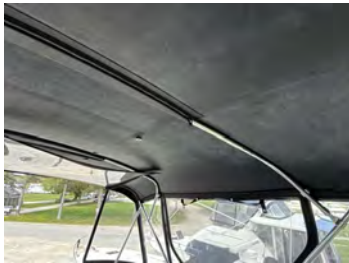
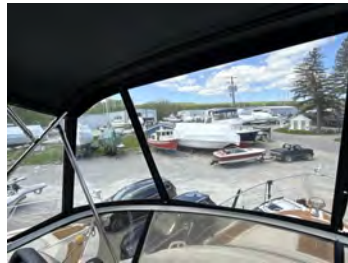
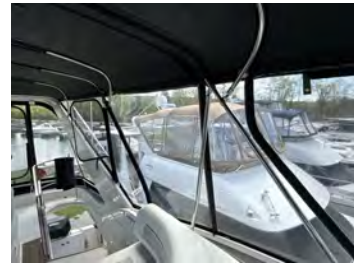
The bimini and associated windows and zippers were in good condition.

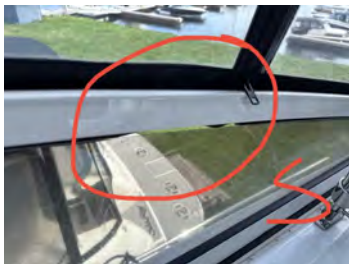
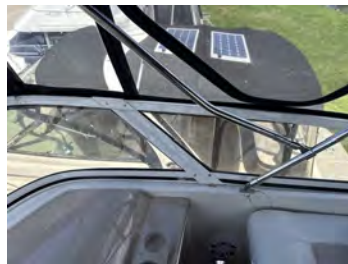
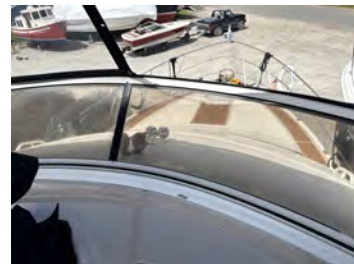
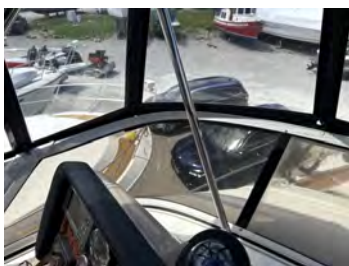
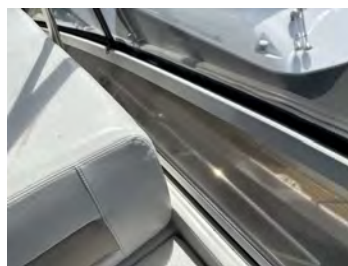
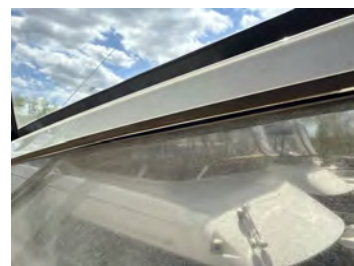
B - Needs Attention

The flybridge spray screen had extensive crazing. Further, the frame on both port and starboard sides had been pulled away from it because of the tension imparted by the bimini.

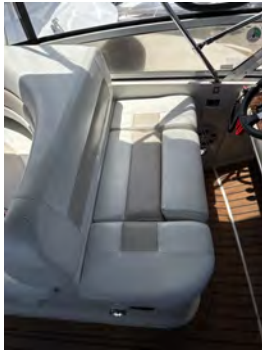
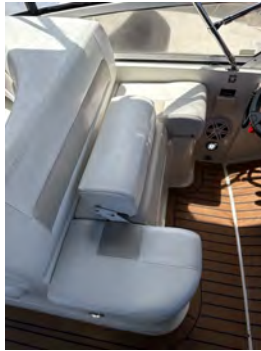
The helm seat was in serviceable condition.

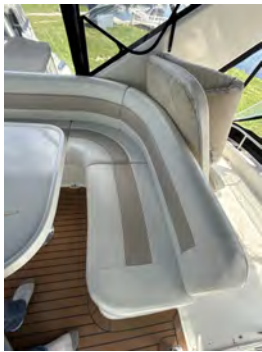
Photo 197

| Item | Rating | Notes |
|---|---|---|
| Seating (Flybridge) | C-Serviceable | Generally, the flybridge seating was in serviceable condition. However, there were two minor issues. The first was some staining on the seat immediately aft of the helm station. The second was a small repair on the seat furthest aft. |

Generally, the flybridge seating was in serviceable condition. However, there were two minor issues. The first was some staining on the seat immediately aft of the helm station. The second was a small repair on the seat furthest aft.

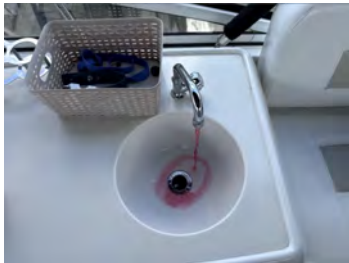
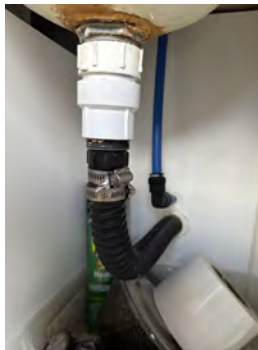
The sink and drain functioned properly.

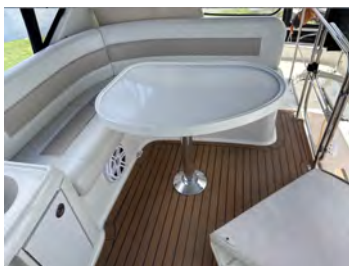
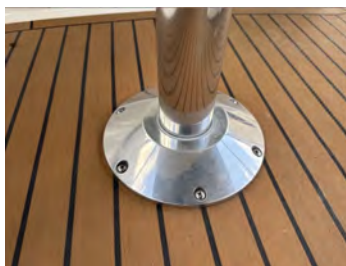
The table was firmly mounted to the deck was in serviceable condition.

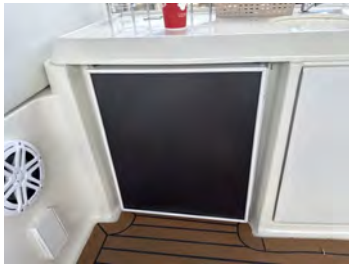
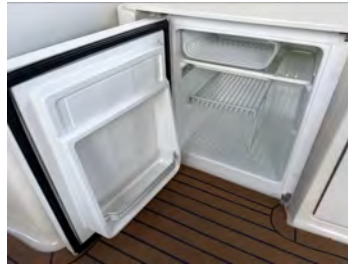
The flybridge refrigerator (Nova Kool WR2600) functioned properly and was in serviceable condition.

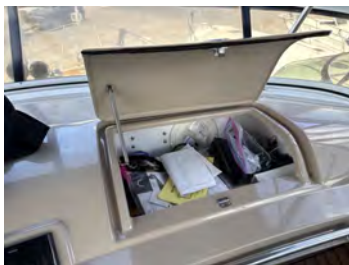
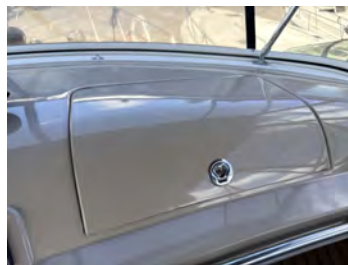
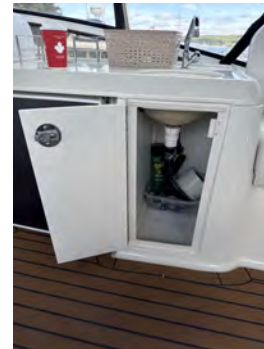
The flybridge storage compartments were in good condition.

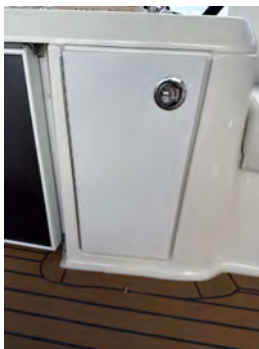
Photo 214

The safety rail and safety gate were solidly mounted and serviceable.

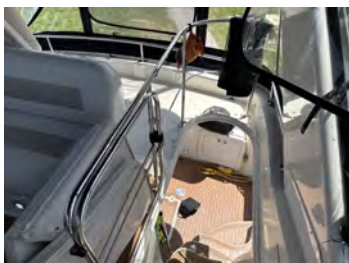
Photo 215

All lighting on the flybridge functioned properly.

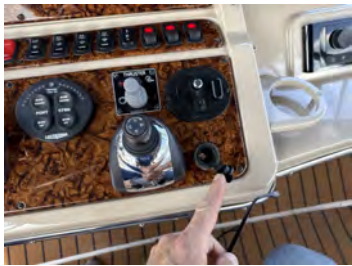
Photo 222

The flybridge 12V port was not tested.

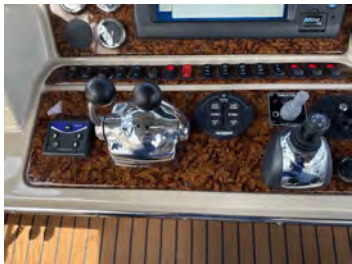
Photo 229

Because the engines were not started, the engine controls were not tested.

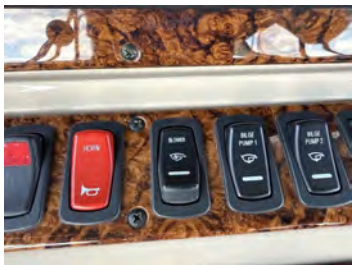
Photo 230

The blower functioned properly.

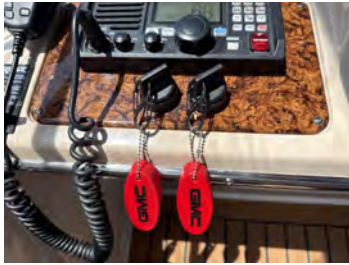
Photo 231

The engines were not started.

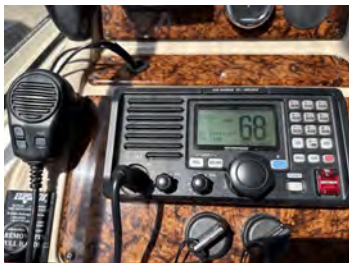
Photo 234

The iCom IC-M602 VHF operated properly.

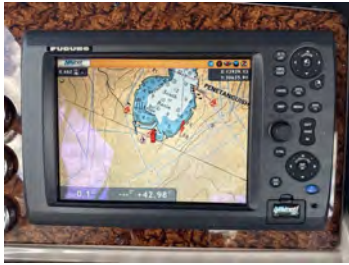
Photo 235

The Furuno Navnet MFD/Chartplotter powered up and appeared to function properly.

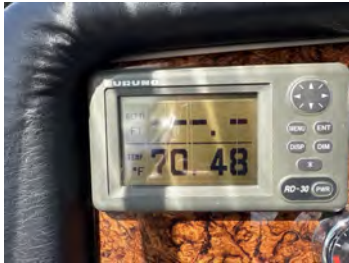
Photo 236

The Furuno RD-30 depth sounder powered up but could not be tested as the boat was on shore.

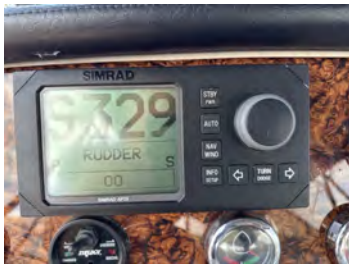
Photo 237

The Simrad AP25 autopilot powered up but could not be tested as the boat was on shore.

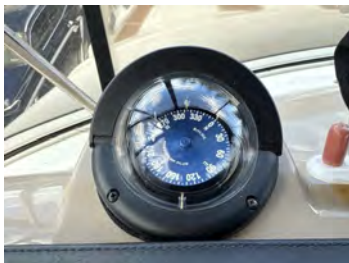
Photo 238

The Ritchie Prodamp Plus magnetic compass appeared to function properly.

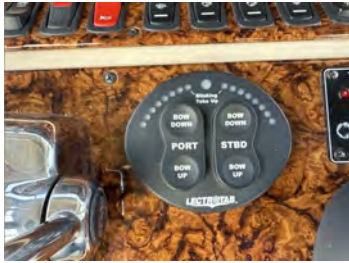
Photo 239

The trim tabs were not tested. Suggest testing under load during sea trial.

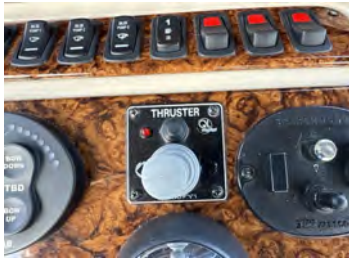
Photo 240

The bow thruster controls were not tested. Suggest testing under load during sea trial.

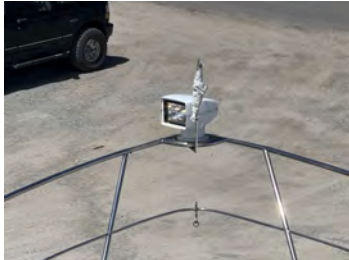
Photo 241

The searchlight functioned properly.

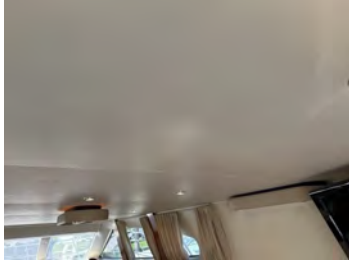
Photo 254

The cabin liner was serviceable. However, there were minor scuffs and perforations, primarily above the windows.

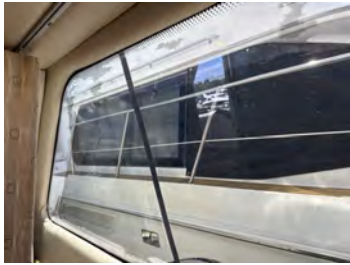
Photo 266

| Item | Rating | Notes |
|---|---|---|
| Deck hatches, windows and portholes (interior observations) | B-Needs Attention | All portholes, hatches and windows functioned properly. However, the poly windows had considerable crazing. Also, the tinting on the rear port window was worn away in places. |

All portholes, hatches and windows functioned properly. However, the poly windows had considerable crazing. Also, the tinting on the rear port window was worn away in places.

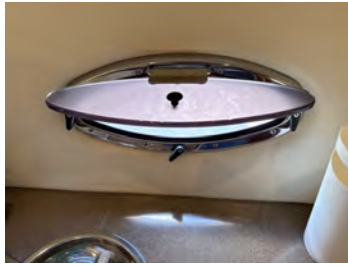
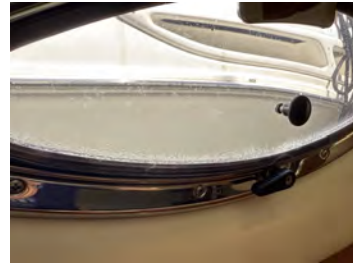
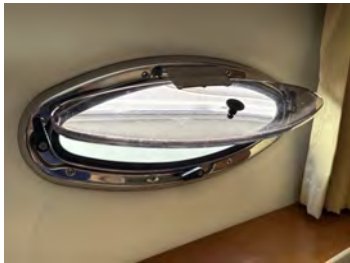
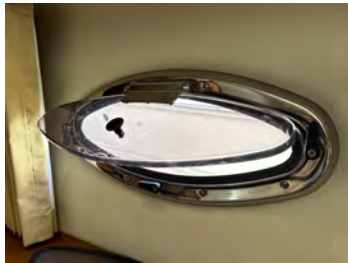
### Deck hatches, windows and portholes (interior observations)

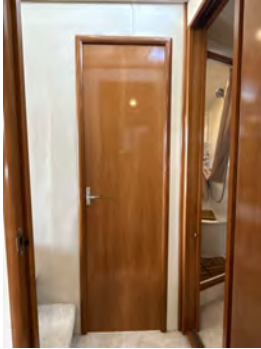
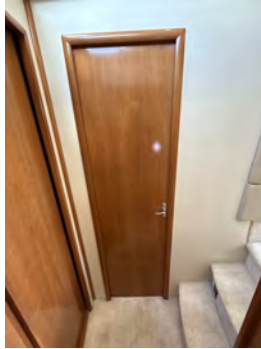
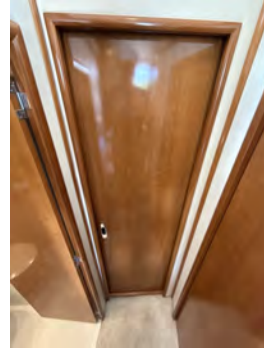
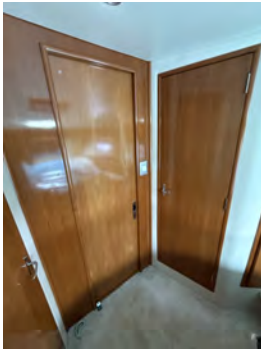
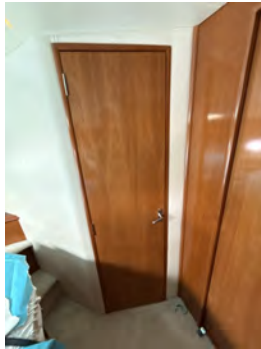
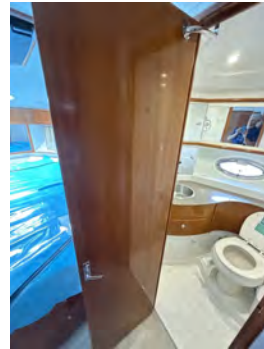
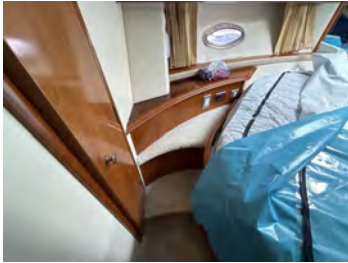
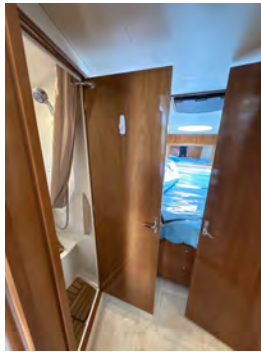
## Woodwork, doors and framing

C - Serviceable

All woodwork, doors and framing were in good condition and serviceable.

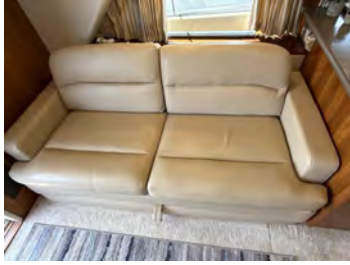
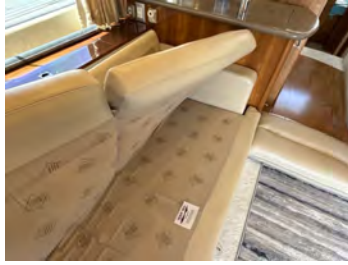
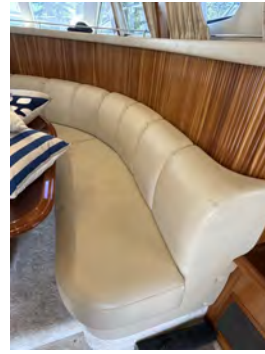
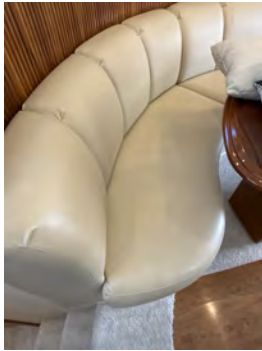
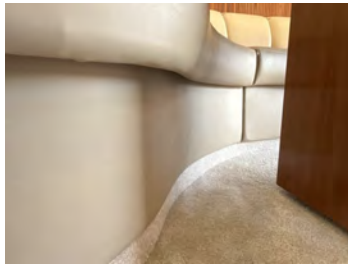
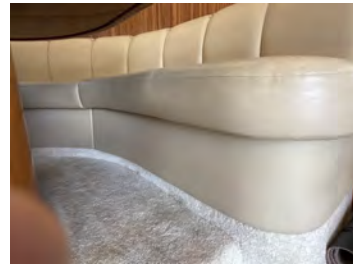
## Upholstery

C - Serviceable

All upholstery was in serviceable condition. The Hide-away bed was not pulled out and inspected.

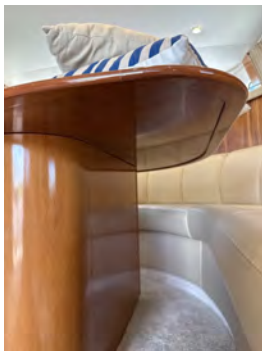
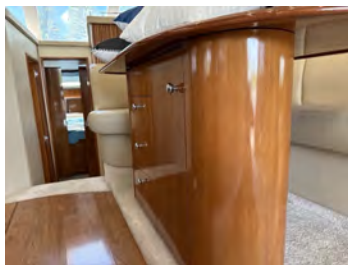
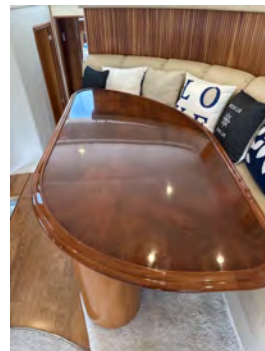
## Table

The table was in good condition.

C - Serviceable

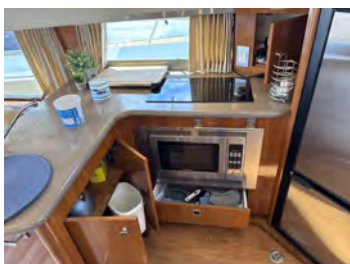
Photo 296

## Storage, galley cabinets, drawers and galley counter

All galley cabinets, drawers and the galley counter were in serviceable condition.

C - Serviceable

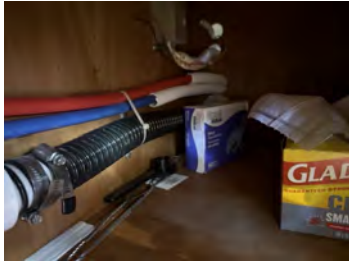
Photo 297

| Item | Rating | Notes |
|---|---|---|
| Galley faucet, sink and drain | B-Needs Attention | The galley faucet, sink and drain functioned correctly. However, the drain pipe on the port-side sink has been taped to fix a leak. This may be fine for the life the boat - however, it should be monitored. |

The galley faucet, sink and drain functioned correctly. However, the drain pipe on the port-side sink has been taped to fix a leak. This may be fine for the life the boat - however, it should be monitored.

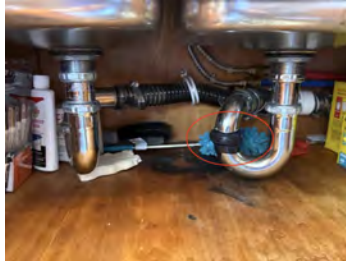
Photo 298

## Galley faucet, sink and drain

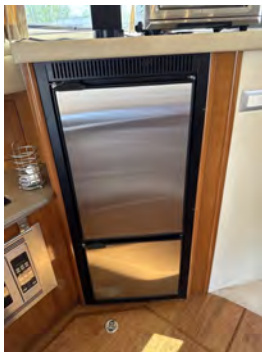
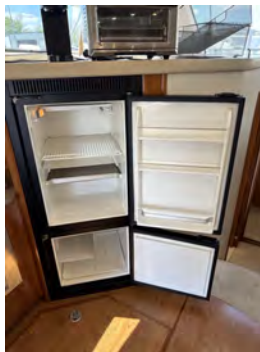
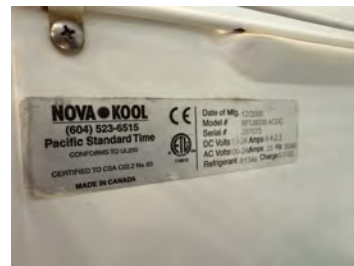
The refrigerator (Nova Kool RFU 8000) functioned properly and was serviceable.

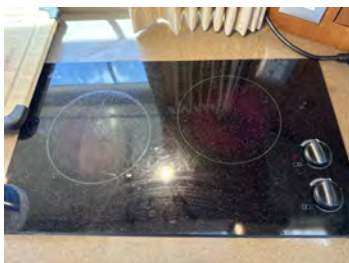
Photo 303

| Item | Rating | Notes |
|---|---|---|
| Stove | B-Needs Attention | The two-burner electric stove functioned properly. However, the lower knob should be glued in place. |

The two-burner electric stove functioned properly. However, the lower knob should be glued in place.
