## Kiki Marine Survey

15 May 2025 / Cali Quigley / Appraisal / Condition and valuation  
/ 2006 42 Carver Super Sport

2006 42 Carver Super Sport

**Marine Survey Report for the vessel: "My Bad", a 2006 Carver Super Sport 42**

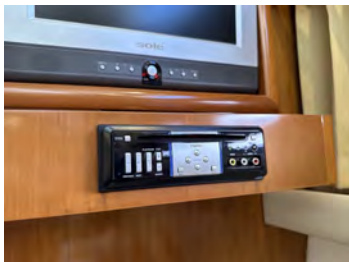
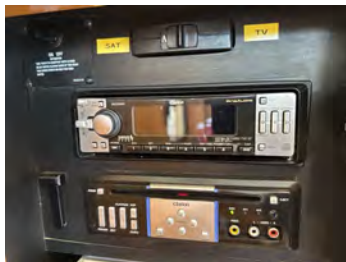
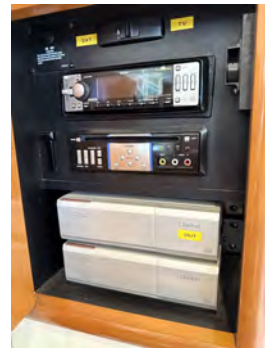
B - Needs Attention

The Clarion Pro-Audio stereo in the salon could not be made to power up.

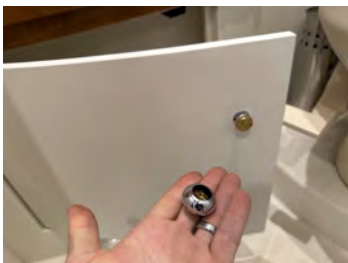
Photo 331

B - Needs Attention

The handle has come off the port-side washroom cabinet door.

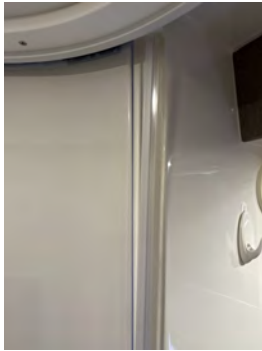
Photo 340

B - Needs Attention

The port side shower functioned properly. However, the seal along the plexi edge was coming away.

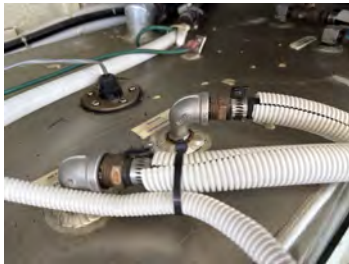
Photo 342

| Item | Rating | Notes |
|---|---|---|
| Fuel tank(s) | A-Critical | There were two Florida Marine Tanks, Inc. aluminum fuel tanks (Model FMT-191S-CV, P/N 6113218). Each tank held approximately 191 US gallons (722 L). Several fuel hose terminations were found to be secured with only a single clamp rather than the two clamps required by ABYC H-27.9.1, which states that "fuel hose connections shall be secured at each termination with two corrosion-resistant hose clamps," and H-27.9.3. These single-clamp connections do not comply with ABYC standards and should be corrected. |

There were two Florida Marine Tanks, Inc. aluminum fuel tanks (Model FMT-191S-CV, P/N 6113218). Each tank held approximately 191 US gallons (722 L). Several fuel hose terminations were found to be secured with only a single clamp rather than the two clamps required by ABYC H-27.9.1, which states that "fuel hose connections shall be secured at each termination with two corrosion-resistant hose clamps," and H-27.9.3. These single-clamp connections do not comply with ABYC standards and should be corrected.

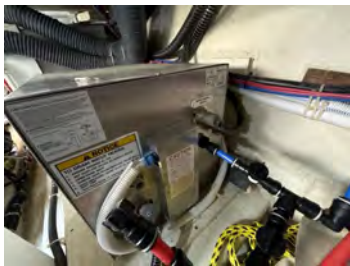
Photo 349

| Item | Rating | Notes |
|---|---|---|
| Hot water tank(s) | A-Critical | The 11-gallon Seaward hot water tank appeared properly installed. However, the pressure relief valve appeared corroded and may not function properly. According to ABYC H-27, Section 8.4 ("Water Heaters Relief Valves"), "Each water heater shall be fitted with a properly rated combination temperature-pressure relief valve". It is recommended this valve be replaced. |

The 11-gallon Seaward hot water tank appeared properly installed. However, the pressure relief valve appeared corroded and may not function properly. According to ABYC H-27, Section 8.4 ("Water Heaters — Relief Valves"), "Each water heater shall be fitted with a properly rated combination temperature-pressure relief valve". It is recommended this valve be replaced.

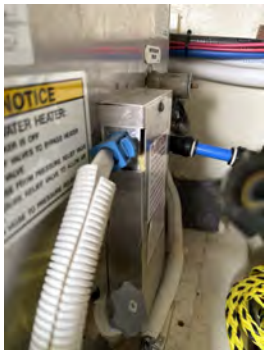
Photo 352

The wiring to the hot water tank appeared to be of the proper type and gauge, properly retained and serviceable.

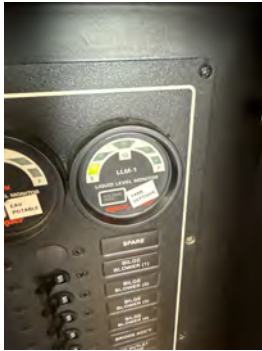
Photo 353

The black water gauge was located on the 12V panel. However, its accuracy could not be corroborated.

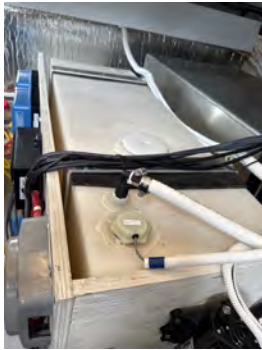
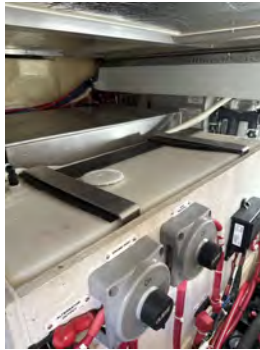
## Fresh water tank(s)

Two polyethylene freshwater tanks of unknown capacity were located in the engine bay and appeared serviceable.

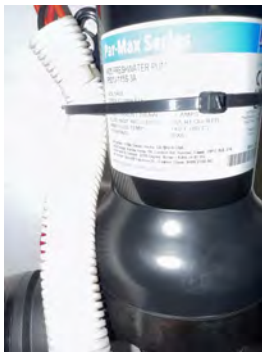
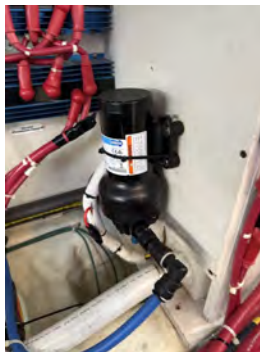
## Fresh water plumbing

The Jabsco Par-Max Series HD5 freshwater pump (Model P501J-115S-3A), operated smoothly under load and was serviceable.

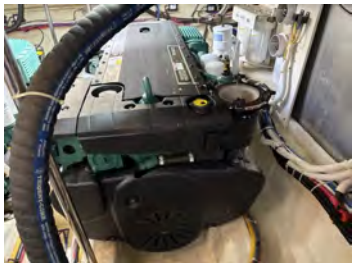
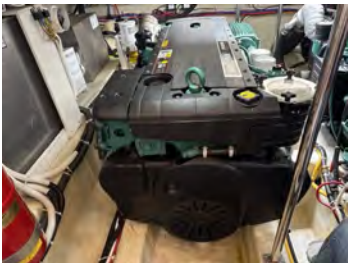
Engine(s) and drive(s) photos

The engines appeared to be clean and well maintained.

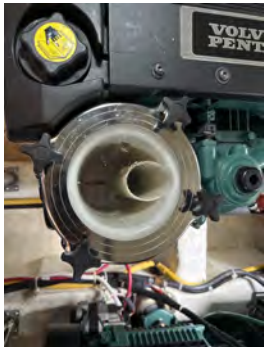
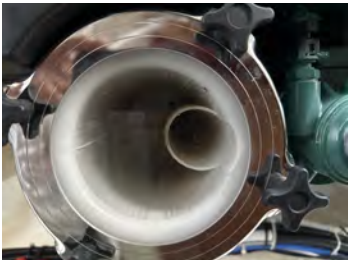
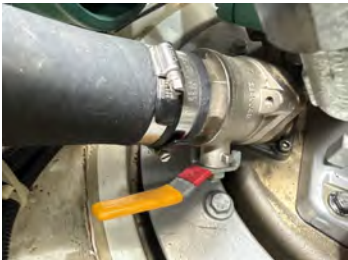
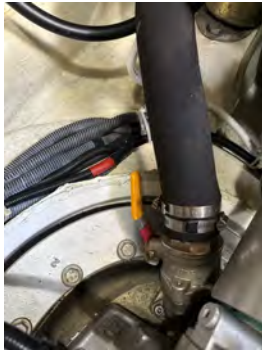
Both cooling water intake valves and strainers were in serviceable condition.

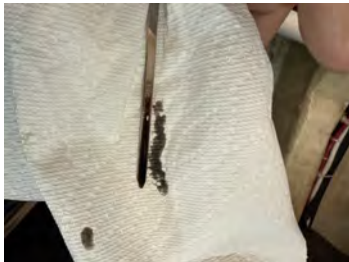
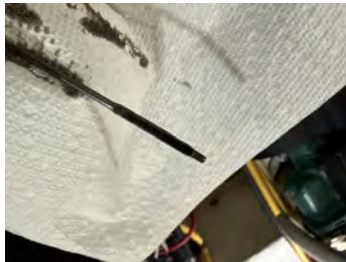
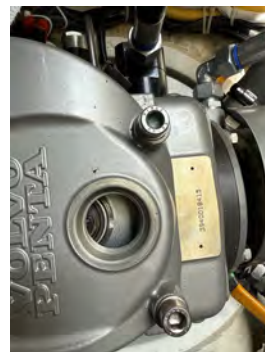
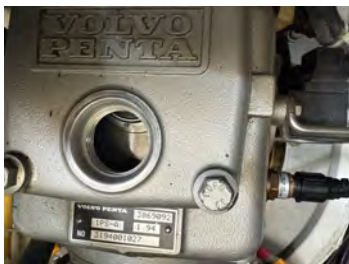
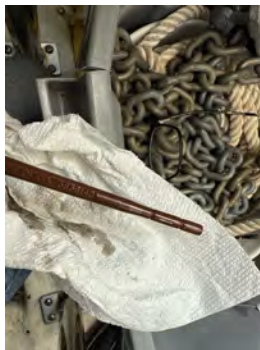
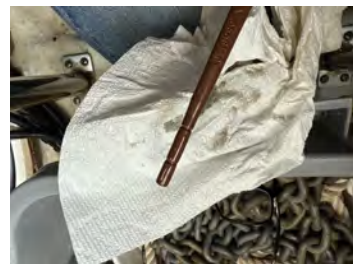
### Oil level and condition

B - Needs Attention

The oil level in both the engines and the IPS drives was sufficient. However, the oil in the engines required changing.

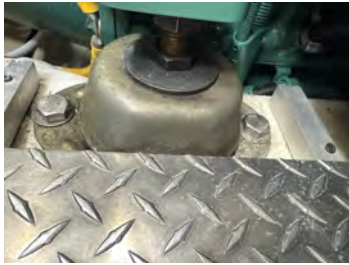
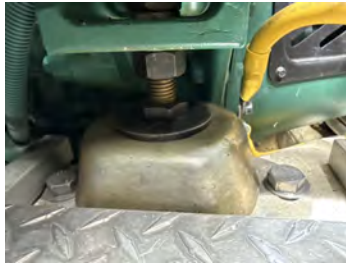
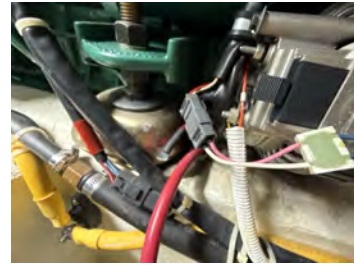
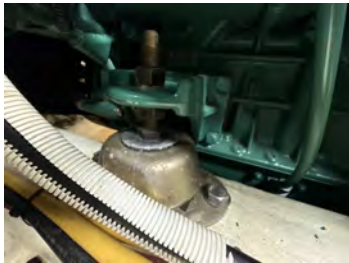
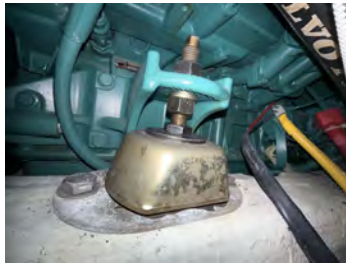
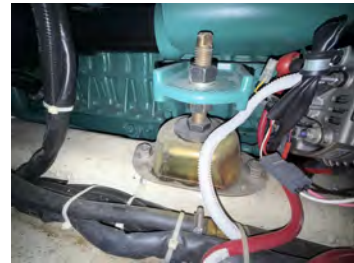
All anti-vibration mounts appeared serviceable.

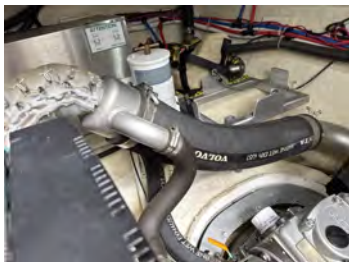
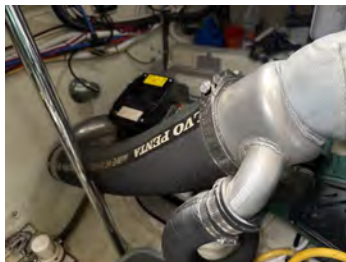
## Exhaust condition

C - Serviceable

The exhaust for both engines appeared serviceable.

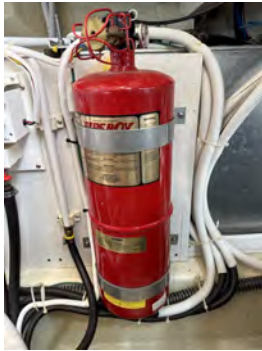
Photo 382

The Fireboy automatic extinguishing system appeared serviceable. However, it was not tested.

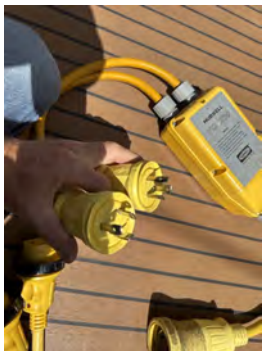
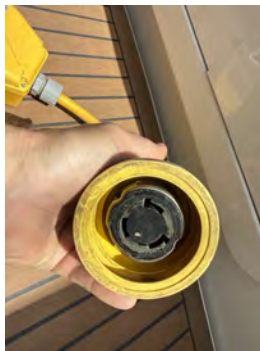
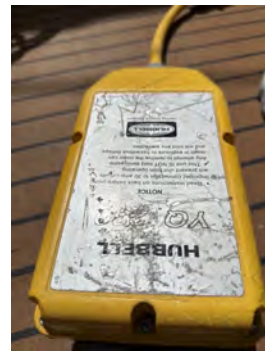
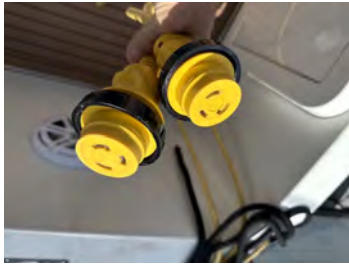
The Hubbell 50A shore power splitter and the associated two shore power cords were in serviceable condition.

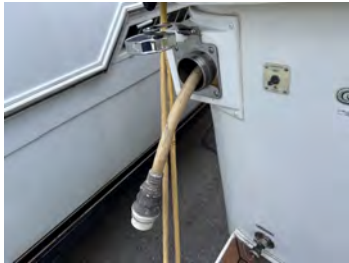
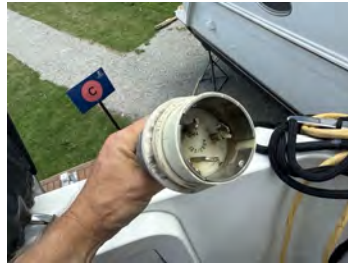
The shore power receptacle was serviceable. The shore-power cable reel functioned properly.

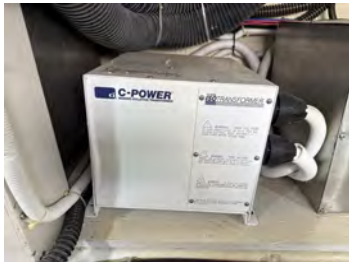
Photo 393

The C-Power Isolation transformer appeared to function properly.

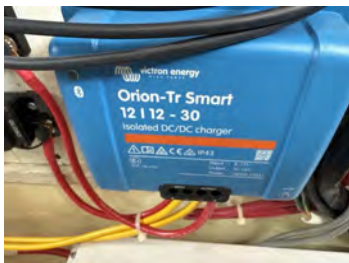
Photo 394

The DC to DC charger for the lithium batteries appeared serviceable.

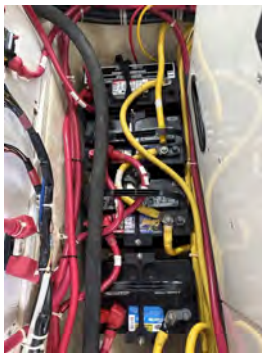
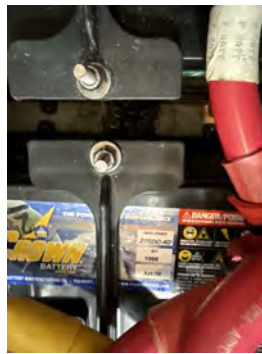
Four 12V, 100 Amp hour, 1000 MCA starter batteries appeared in serviceable condition.

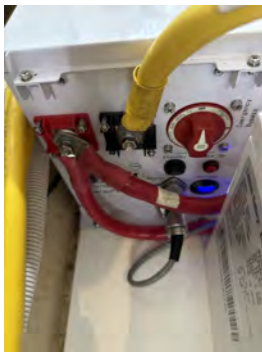
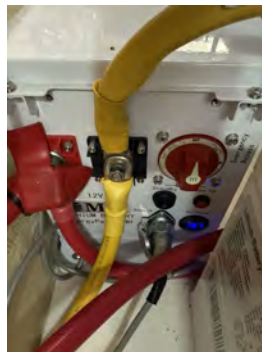
A - Critical

One of the lithium house battery terminals did not have a boot over its positive terminal. Under ABYC E-11.16.4.1 ("Battery Terminal Protection"), all exposed battery terminals must be covered with nonconductive boots or caps to prevent accidental short-circuits and protect against arcing. A boot must be installed over the positive terminal.

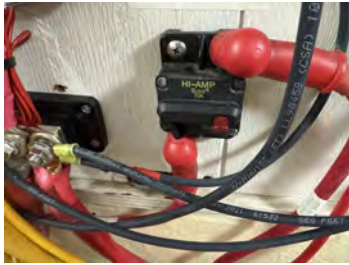
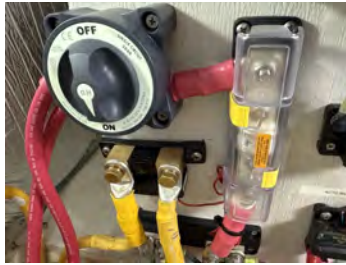
Both the house bank and the lithium bank have the proper overcurrent protection.

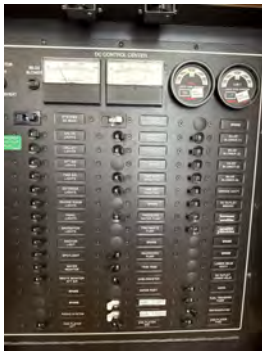
Photo 404

The DC distribution panel was inspected and found to be well-mounted, clearly labelled, and serviceable.

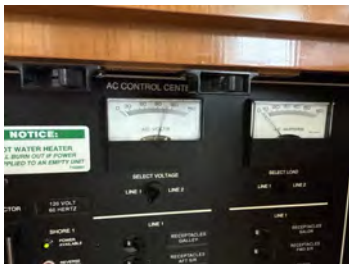
Photo 405

The AC distribution panel was inspected and found to be well-mounted, clearly labelled, and serviceable.

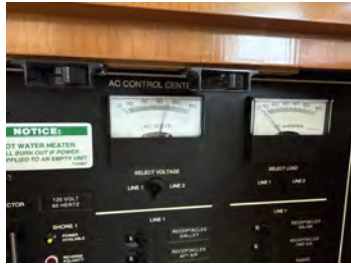
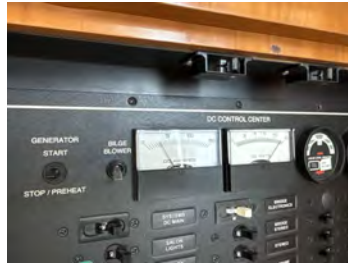
All volt meters and ammeters functioned properly.

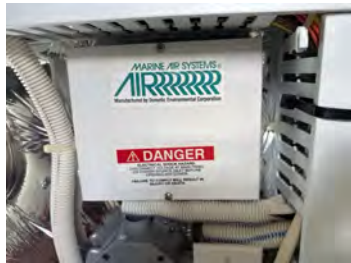
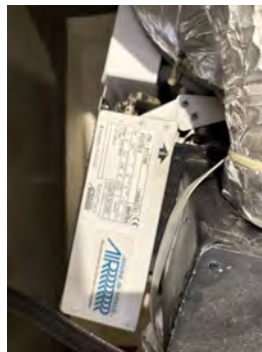
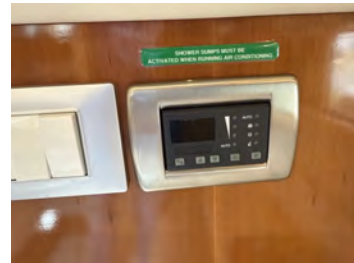
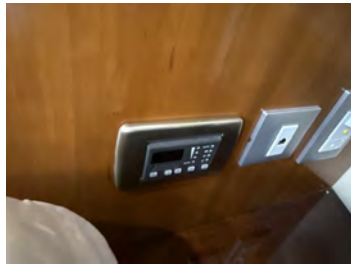
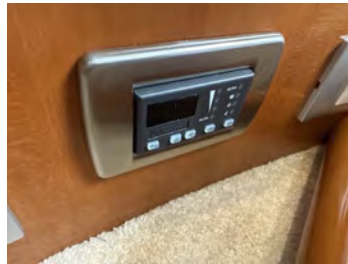
The Marine Air Systems Vector Compact VCD7K-Z reverse-cycle air conditioning and heat pump unit appeared to be properly installed. However, due to the boat being out of the water, it was not tested.

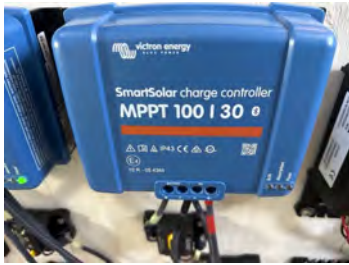
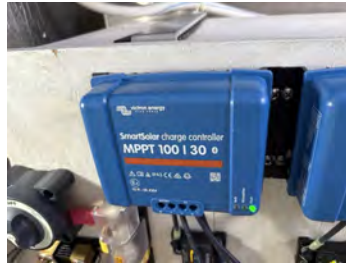
Two Victron Smart Solar controllers appeared serviceable. However, the serviceability should be verified via the appropriate Victron app.

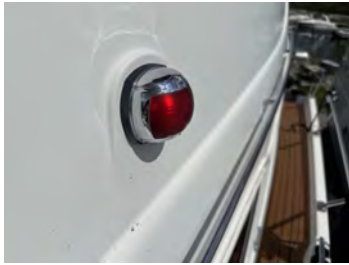
Photo 419

The port and starboard navigation lights functioned correctly. However, the white 360 light could not be seen due to daylight. This should be tested in lower light conditions.

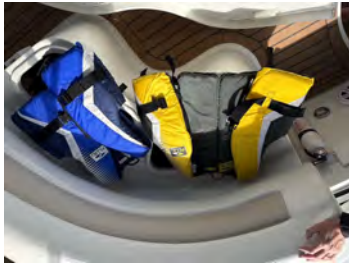
Photo 421

There were a number of UL approved lifejackets on board.

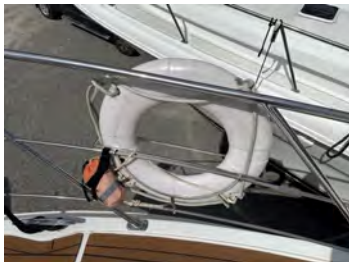
Photo 422

There was a lifebuoy and heaving line mounted to the liferail at the bow.

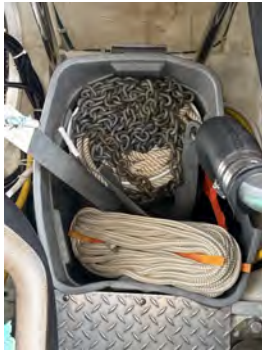
Photo 423

A spare anchor - a Danforth with adequate chain and rode - was in the engine bay.

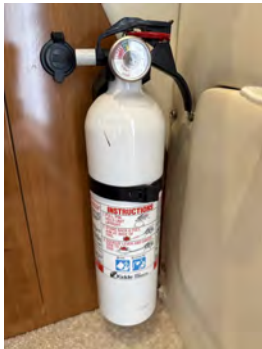
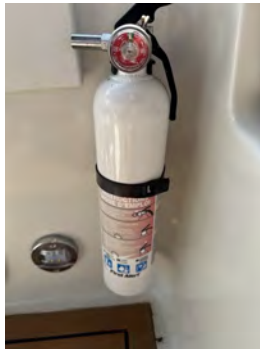
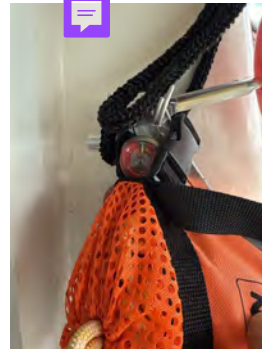
There were three charged fire extinguishers on board.

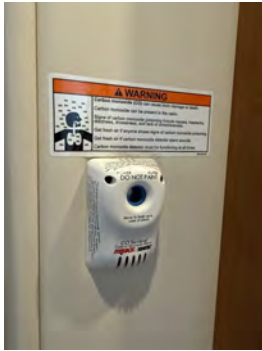
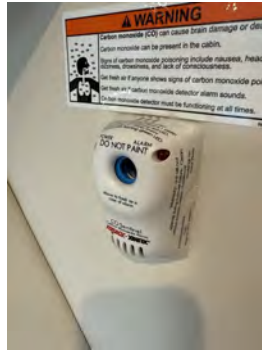
Two carbon monoxide detectors were on board, which was all the vessel required. However, could not be tested.
