## 2006 J/100 Sailing Sloop

# **Report of Condition & Value Pre-Purchase Marine Survey**

**2006 J/100 Sailing Sloop**

Inspection performed on: 11 February 2026

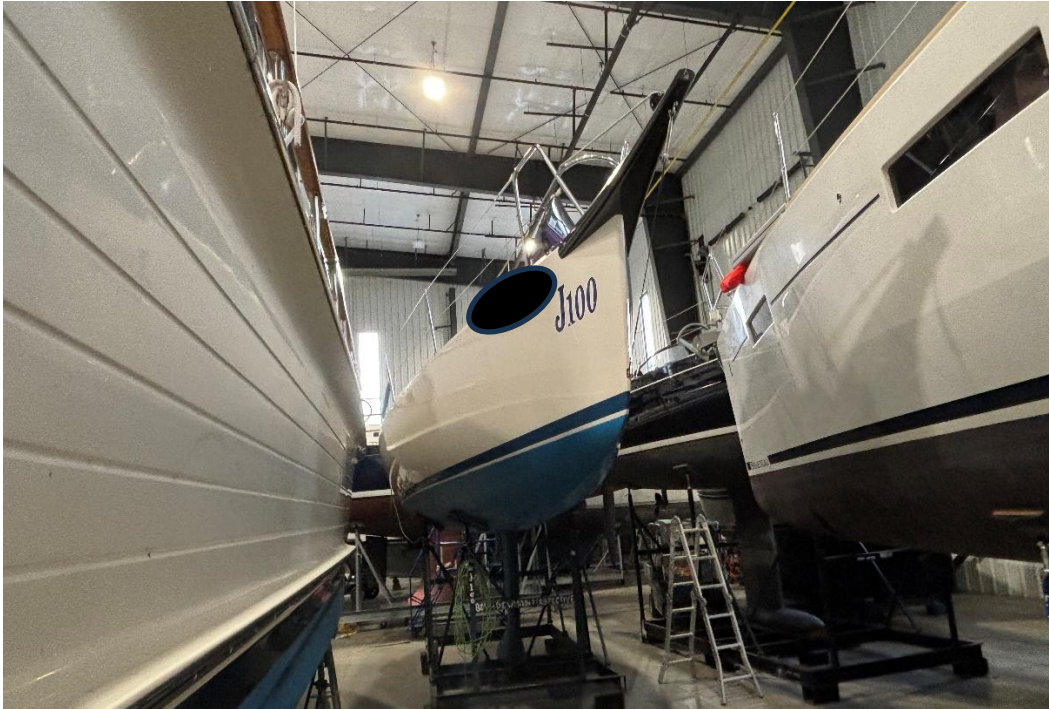
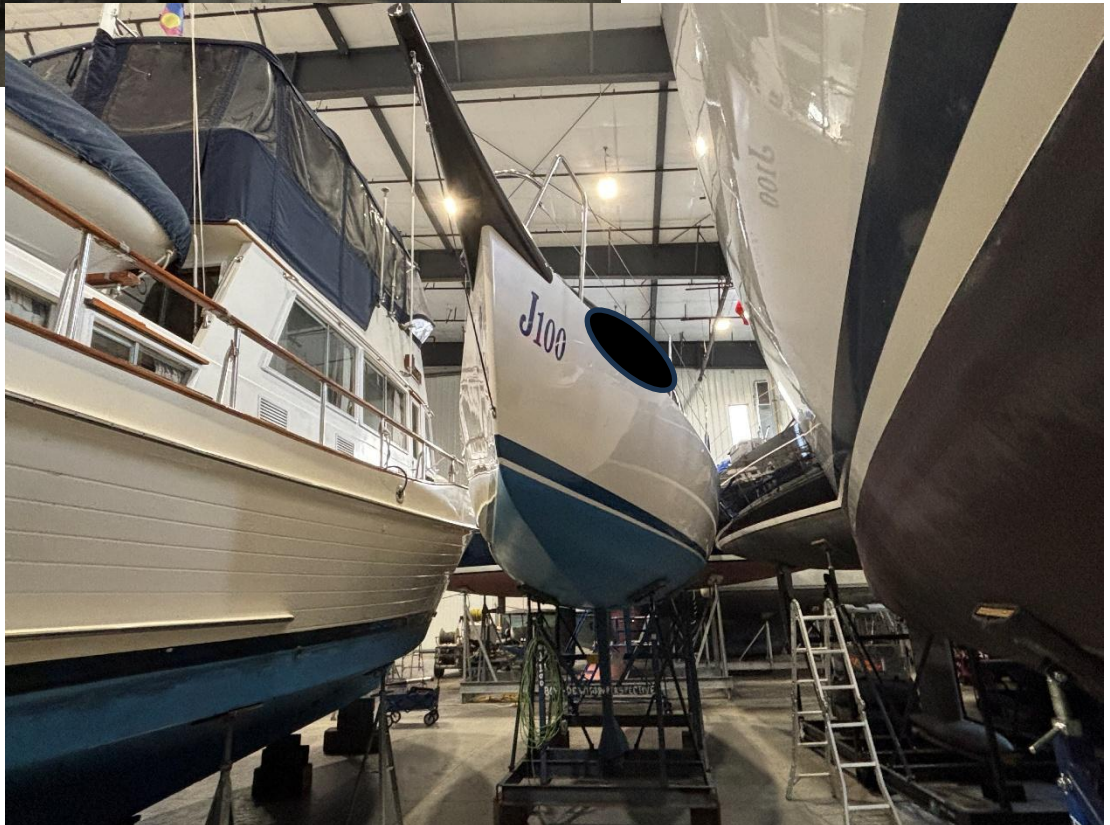
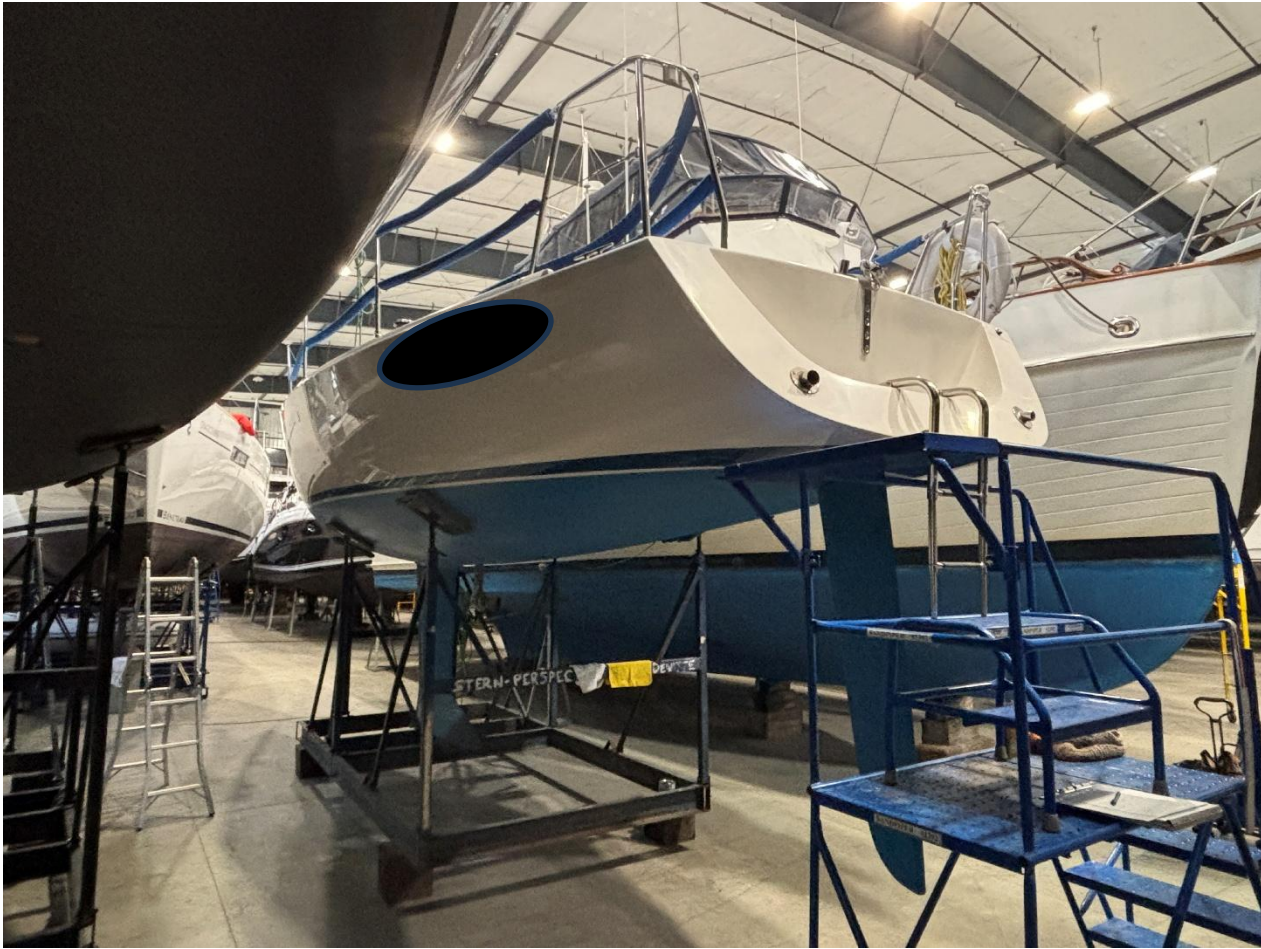
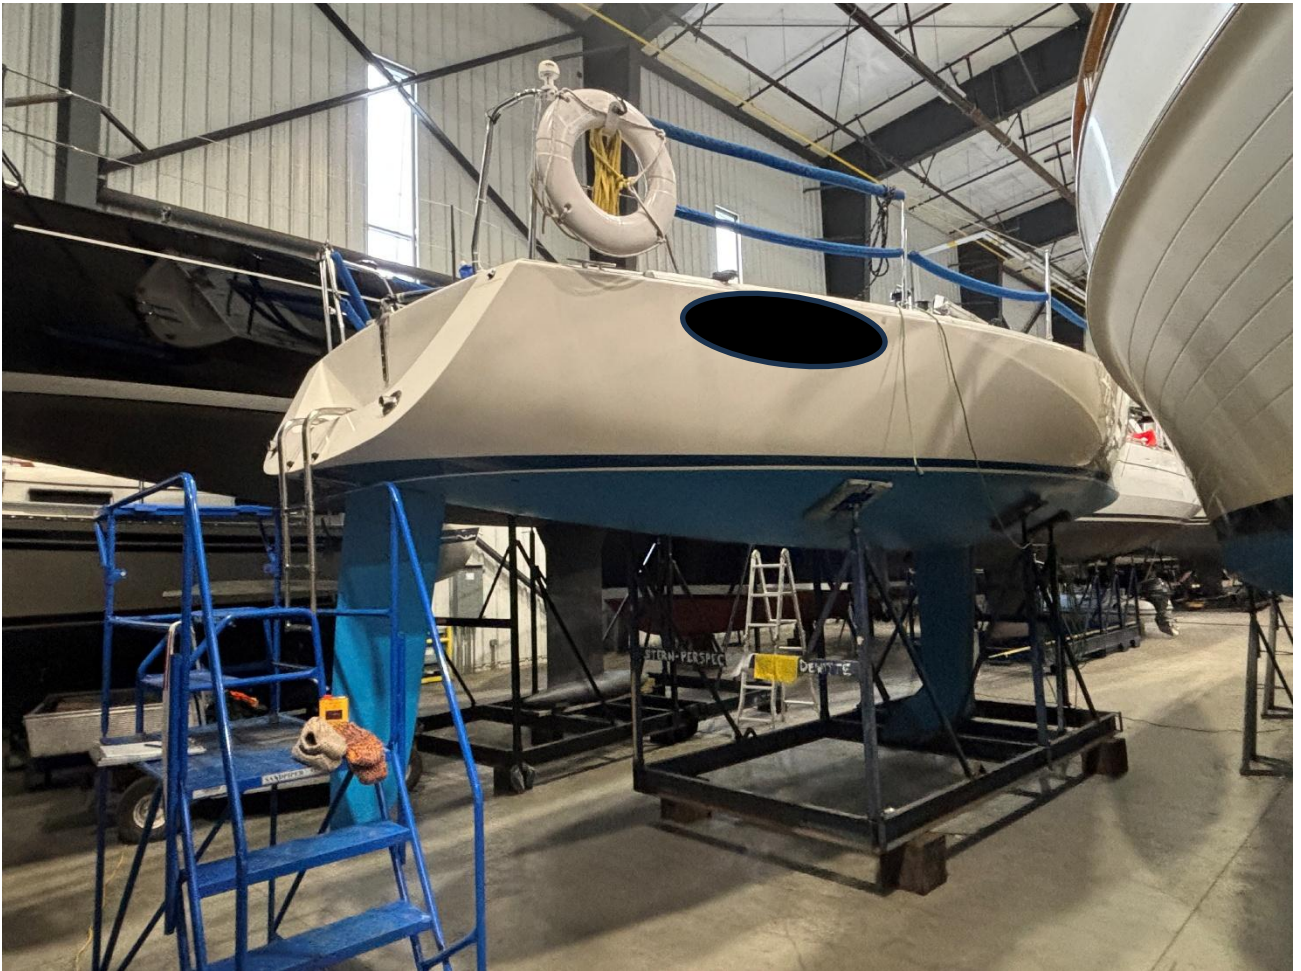
The broker disclosed; previously this vessel collided with another vessel, while racing, and the area of impact was on the starboard/forward quarter. No evidence was sighted of the previous damage with exception of a spliced toe rail. The hull, deck, and area hardware were all professionally restored.

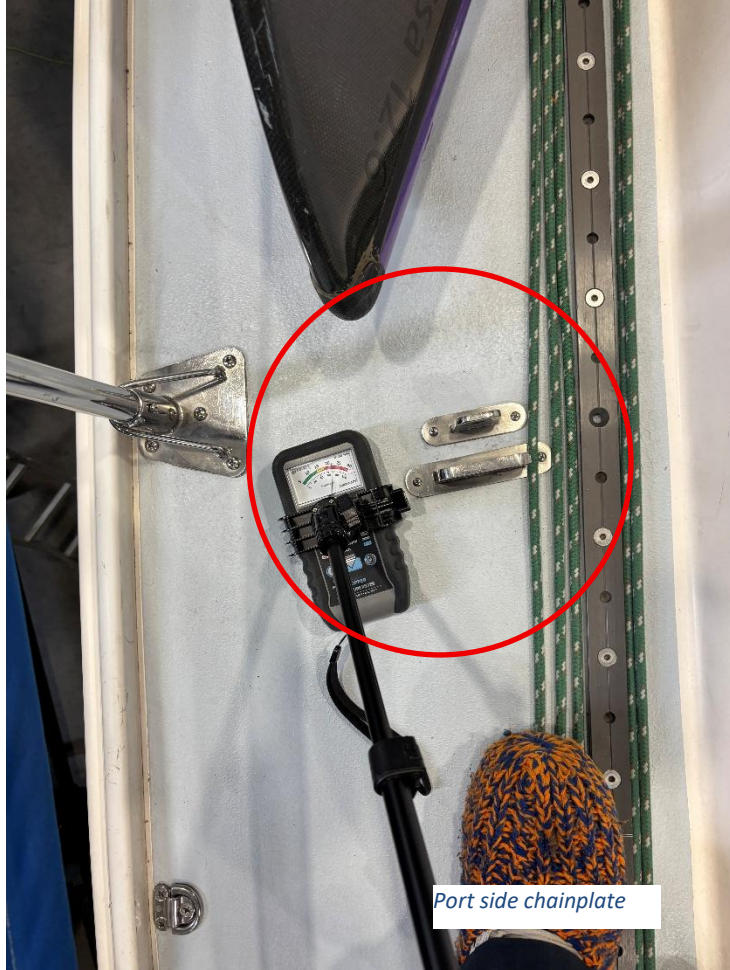
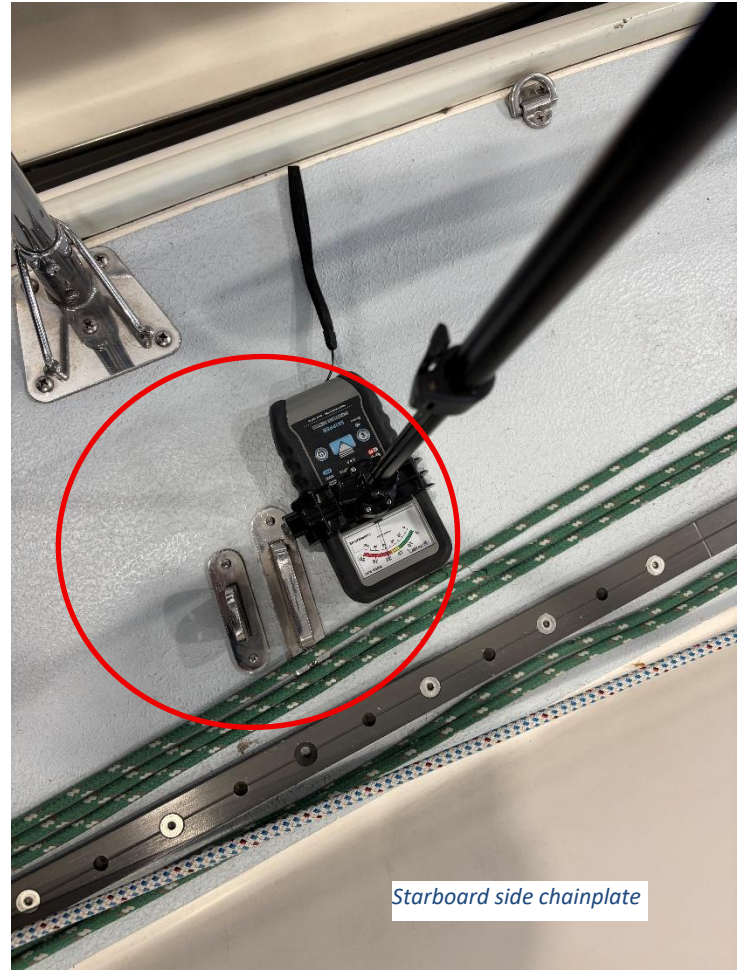
Conductivity meter readings – normal with exception to elevated readings in close vicinity of the side shroud chainplates (**Finding C-2**).

Deck - conductivity meter readings – normal with exception to elevated readings in close vicinity of the side shroud chainplates suggesting possibility of water intrusion.  
*If moisture did contaminate the chainplate area, recommend re-bedding area around chainplate to help protect from further water intrusion.*

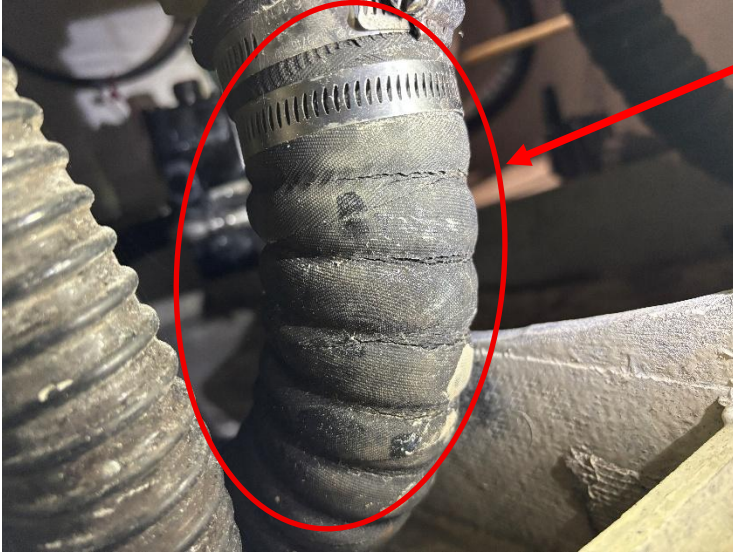
All hoses secured, however, cockpit scupper hoses found to have age related cracks (**Finding B-1**).

*Port side cockpit scupper hose*

All hoses secured, however, cockpit scupper hoses found to have age related cracks.

*Recommend replacing both cockpit scupper hoses with marine rated hoses to minimize the risk of failure (ABYC H-4).*

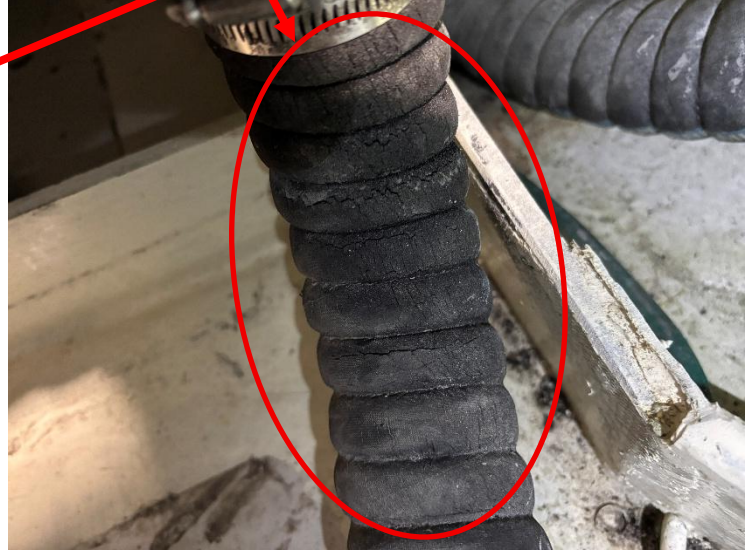
*Starboard side cockpit scupper hose*

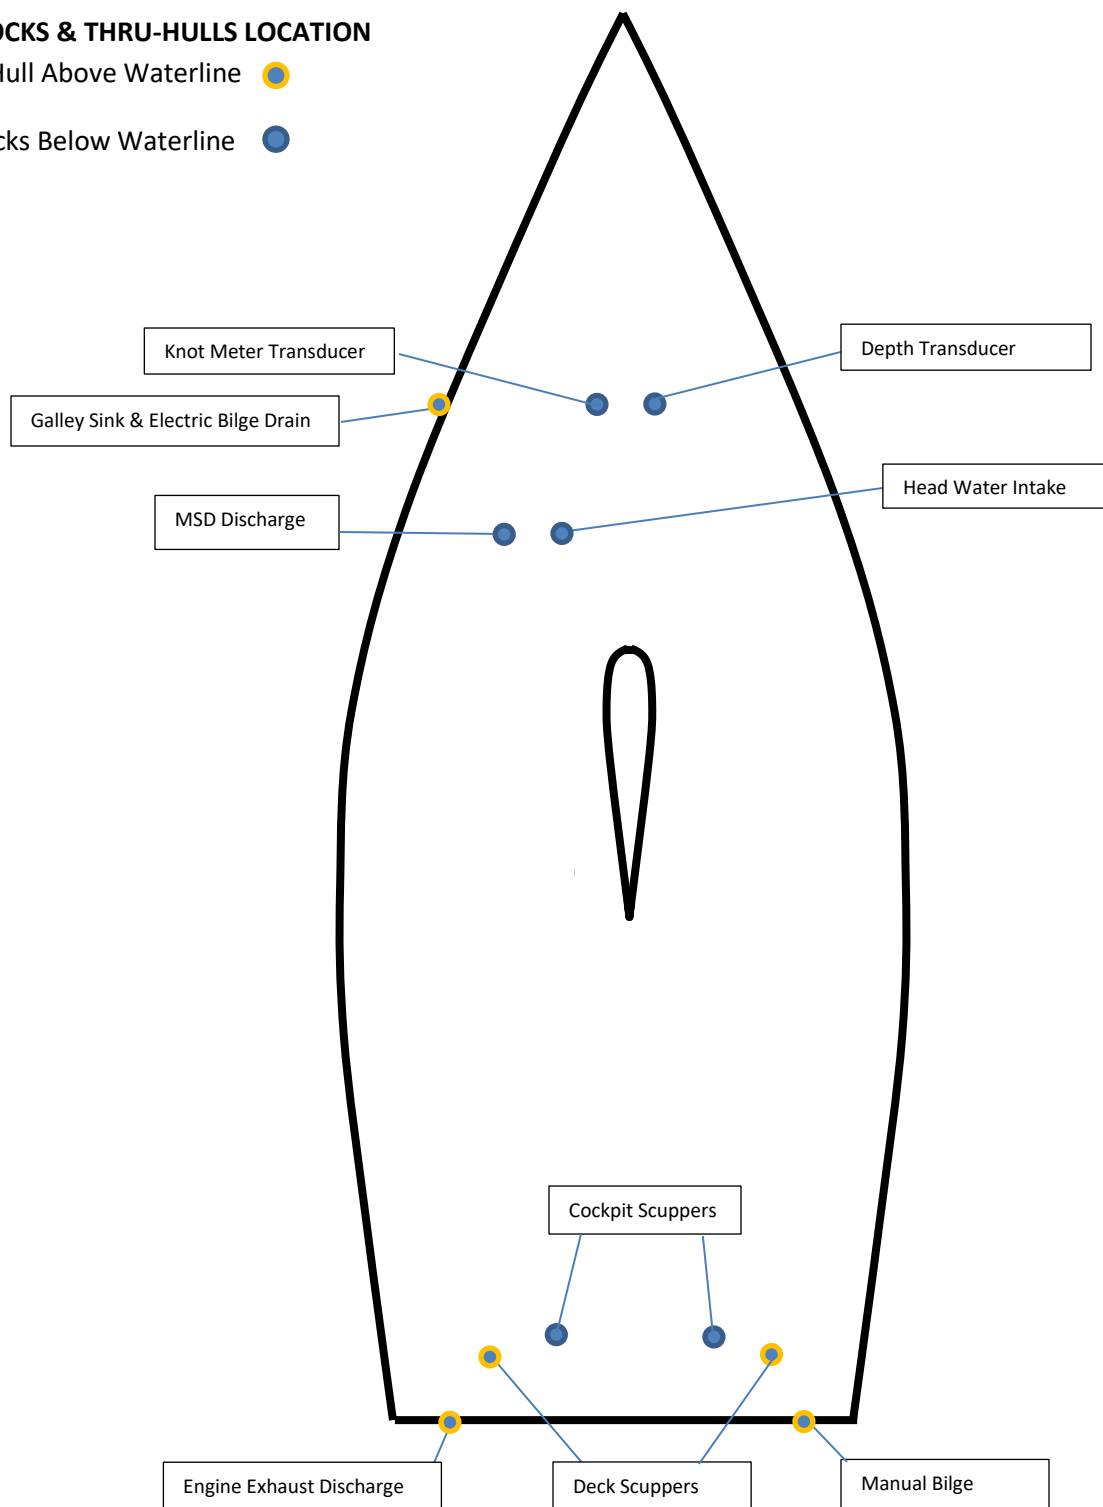
All wetted surface seacocks were Marelon ball-type valves. All valves operated with minimal force.

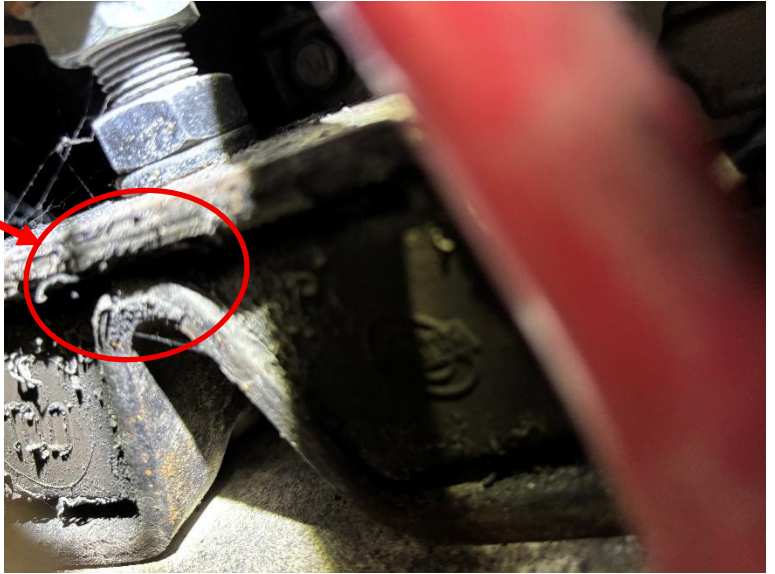
Engine oil: low-end of range on dipstick and dirty (**Finding B-3**).

*Recommend replacing engine oil to minimize the risk of engine damage due to poor lubrication.*

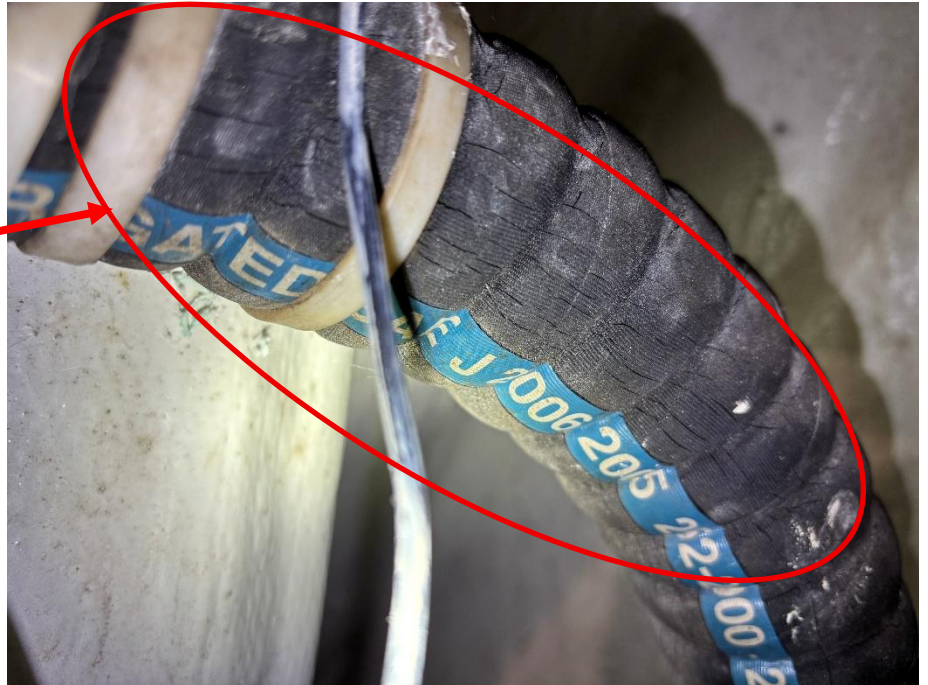
Exhaust hoses – secured and of proper rating, however sighted age-related cracks along several areas of the hose section from the muffler to the transom (**Finding B-4**).

Exhaust hoses – secured and of proper rating, however sighted age-related cracks along several areas of the hose section from the muffler to the transom.

*Recommend replacing the exhaust hose section with proper marine rated hose (ABYC P-1) to minimize the risk of failure.*

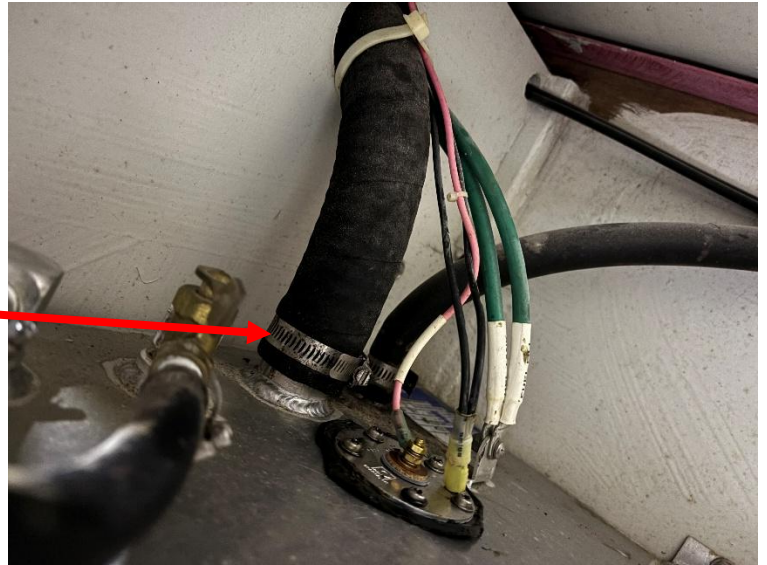
Fuel filler hose of proper rating, no cracks sighted, double clamped at the deck-end, however, single clamped at the tank **(Finding B-5)**.

Fuel filler hose of proper rating, no cracks sighted, double clamped at the deck-end, however, single clamped at the tank.

*Add second stainless steel hose clamp at fuel tank connection (USCG 33 CFR 183 & ABYC H-33).*

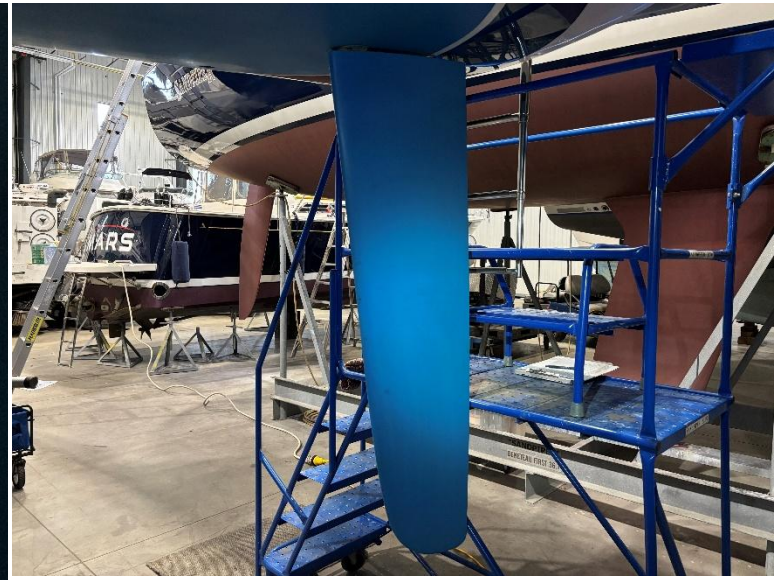
Rudder – Port Side

Rudder - soundings with a phenolic hammer indicated two small areas of delamination as shown in adjoining photos.  
*When vessel is laid up, yearly, for future Winter storage, recommend inspecting/monitoring the rudder for new crack(s) and if (small) delaminated areas increase in size. Repair as required if crack(s) appear and/or area of delamination increases.*

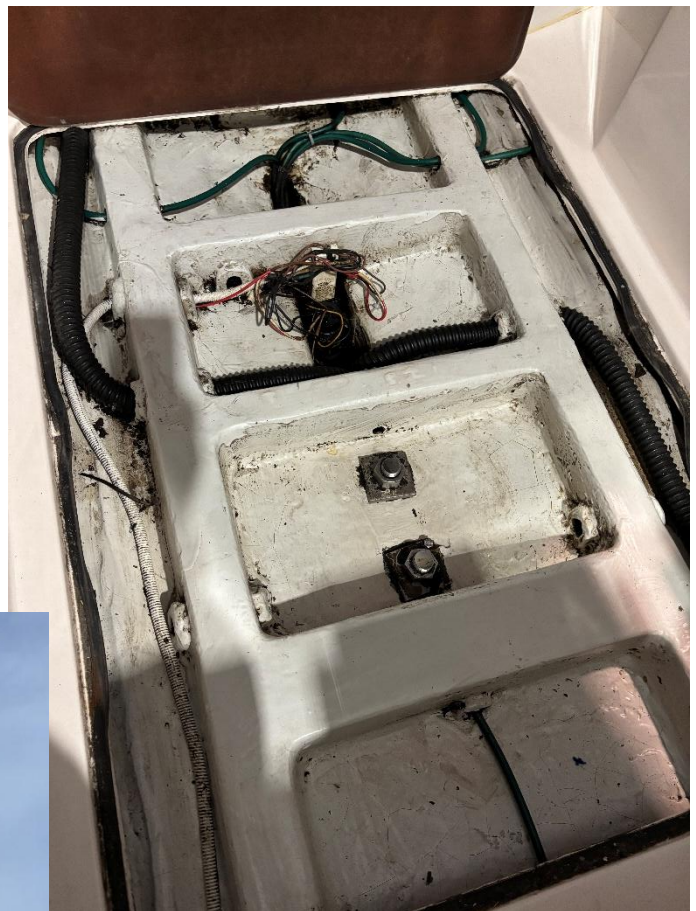
Bilge

Mold sighted in some hard-to-reach areas of the bilge; recommend washing/rinse with suitable detergent to remove.
