Created: Tue 07 July 08:03 2026  
Location: 381 Reddall Parade Mount Warrigal  
Title: Roof Report # S67771=SP=01  
No. Items: 10

I inspected the single storey concrete tile roof which is approximately 33 years old with a roof pitch of approximately 18° and is in good condition for its age.

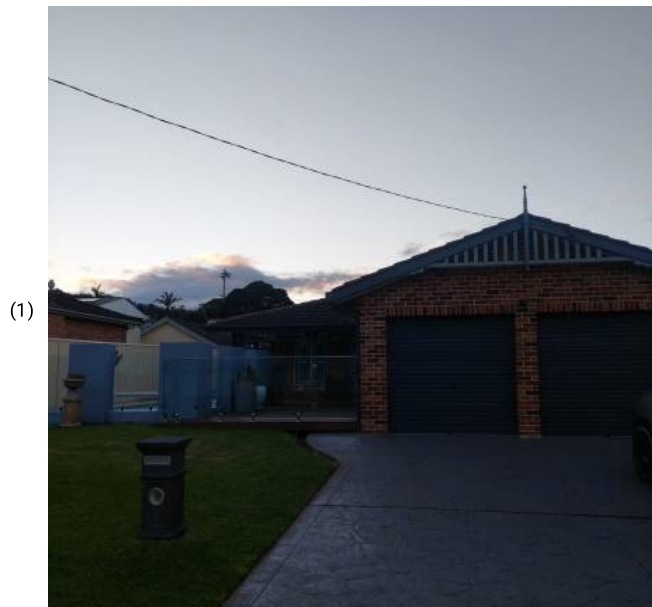
7896.jpeg

I inspected the area over garage ceiling after NBN contractors accessed internal roof space via man hole in garage.

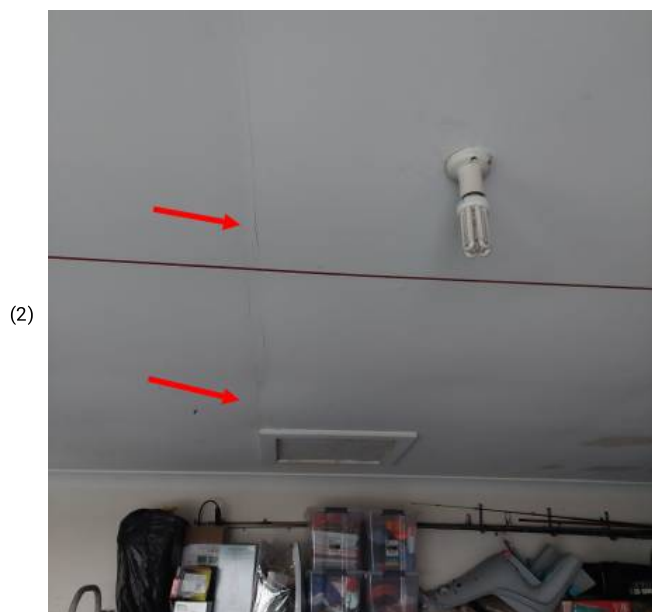
7897.jpeg

Arrow's show gyprock joint which has separated.

**CONCLUSION:** In my opinion separation between gyprock ceiling sheets is due to glue failure and not due to water ingress.

This is a maintenance issue and not storm related or due to NBN installation.

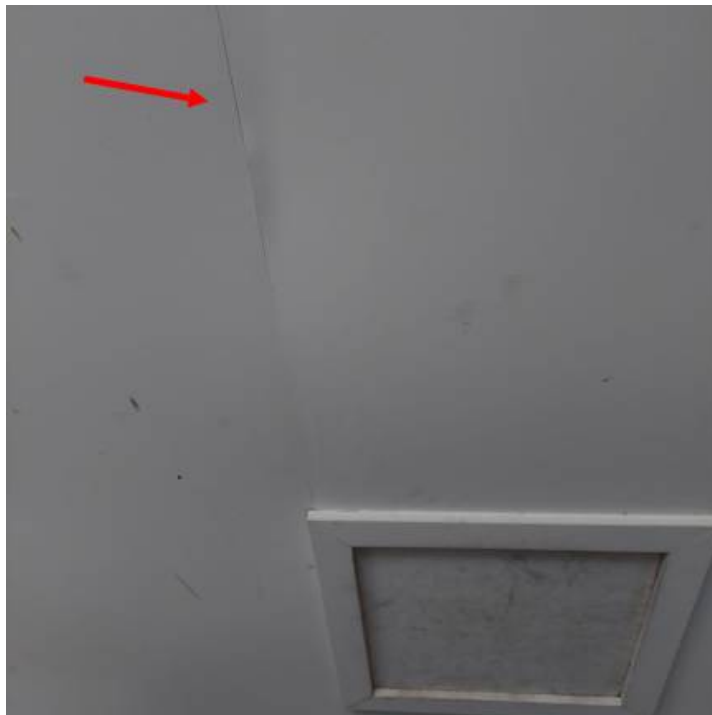
(3)

Arrow show's gyprock joint which has separated.

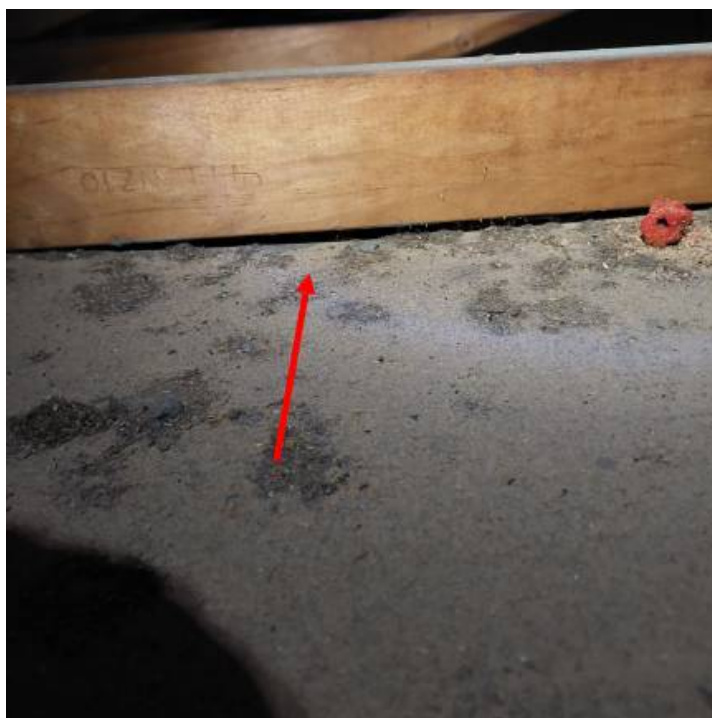
(4)

Arrow show's the gyprock sagging between trusses. Gyprock fixings are intact.

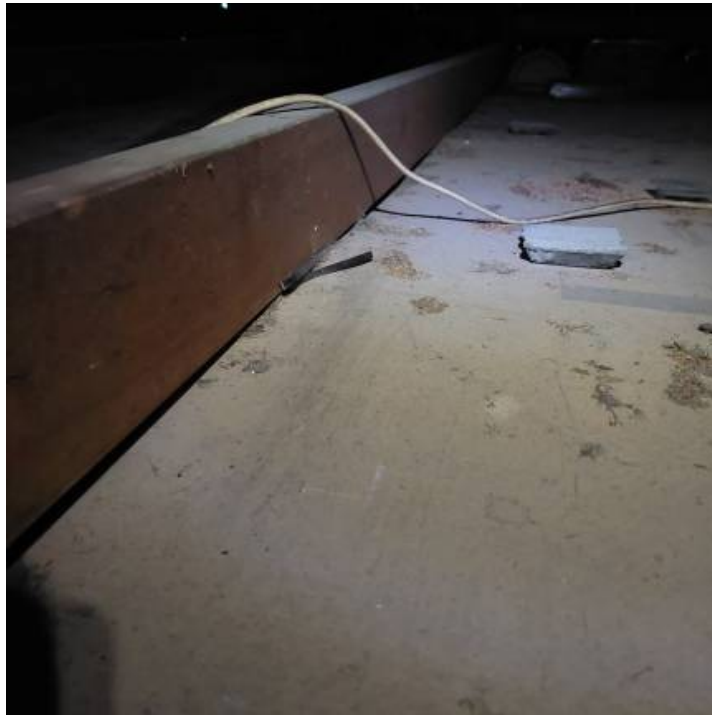
(5)

There is no evidence of water ingress into roof space over garage ceiling.

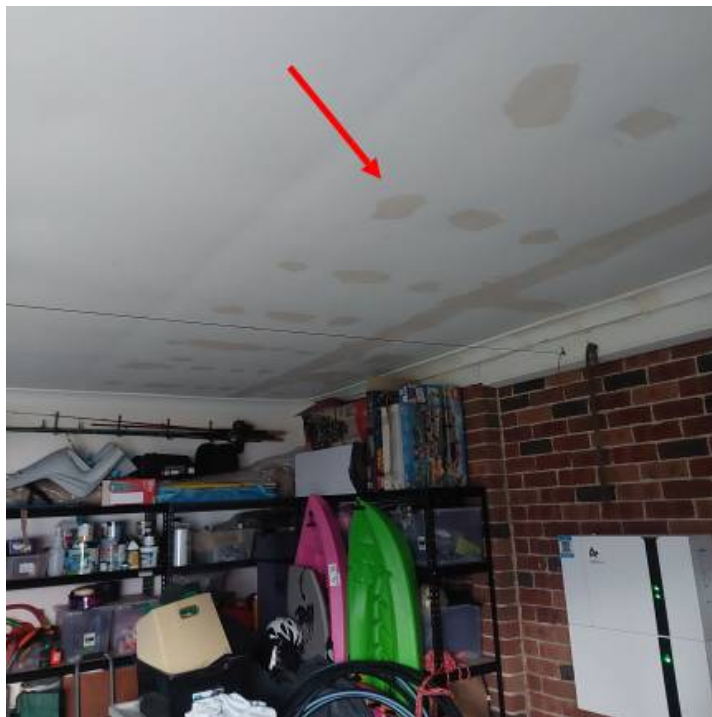
(6)

Owner has previously repaired gyprock ceiling in garage.

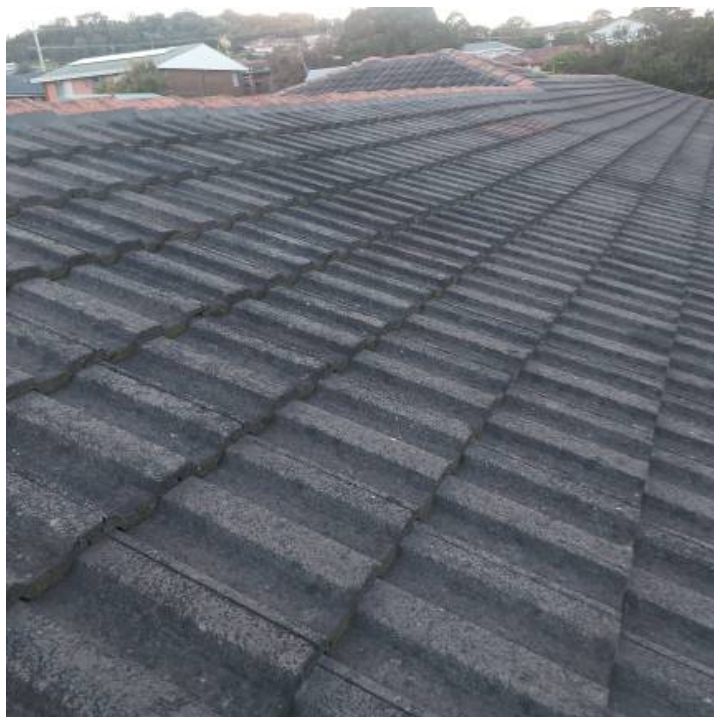
(7)

No broken tiles noted over garage ceiling.

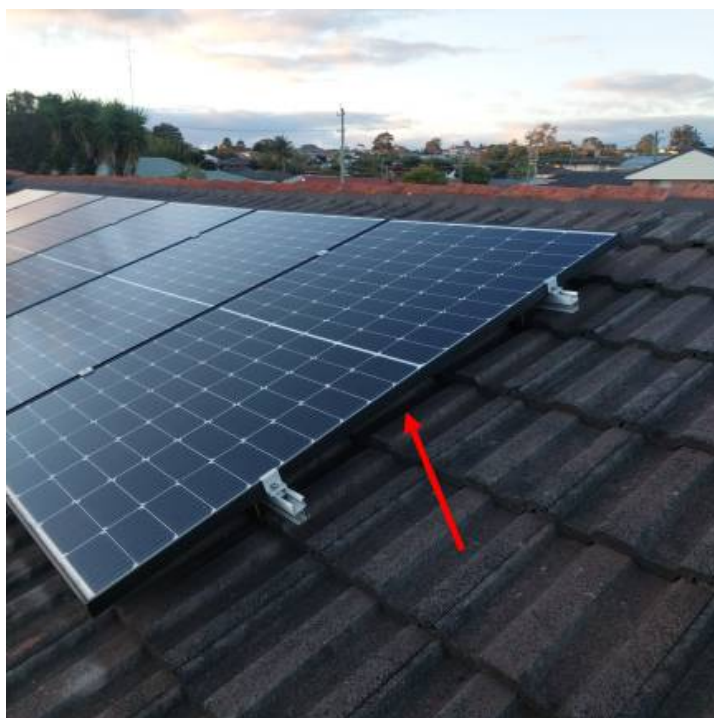
(8)

Owner has installed solar approximately 3 years ago over garage ceiling by contractors.

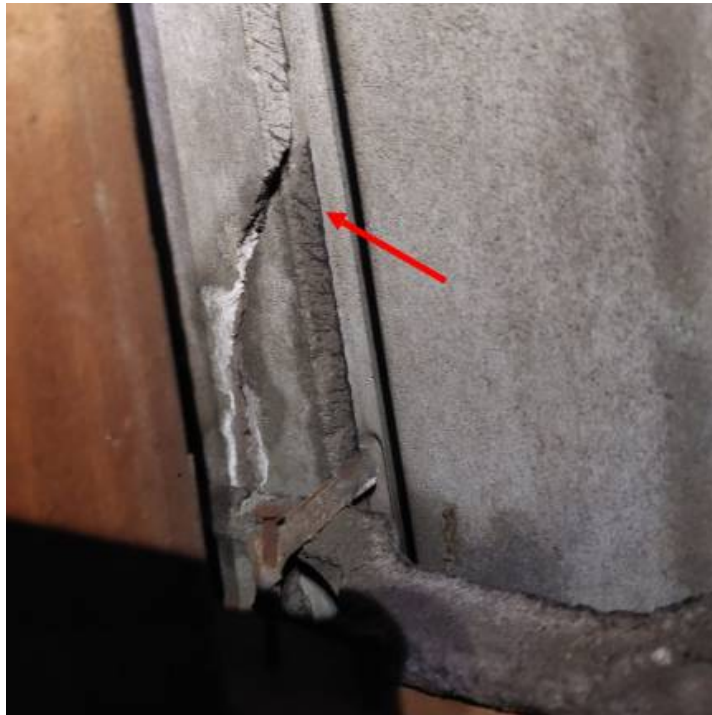
(9)

Photo show's broken watercourse under solar panels over garage ceiling.

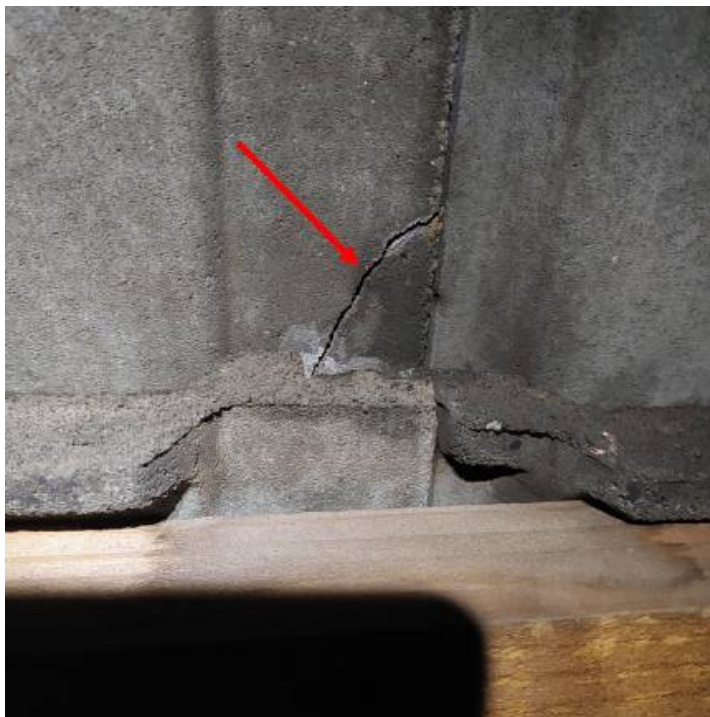
(10)

Photo show's broken watercourse under solar panel over garage ceiling.
